**PRELIMINARY PROJECT REPORT**

**RESTORATION OF  
ST. MARY'S CHURCH, AJMER,  
RAJASTHAN**

**MAY 2024**

**ARCHITECTURAL HERITAGE DIVISION  
INDIAN NATIONAL TRUST FOR ART AND CULTURAL HERITAGE  
(INTACH)  
NEW DELHI**

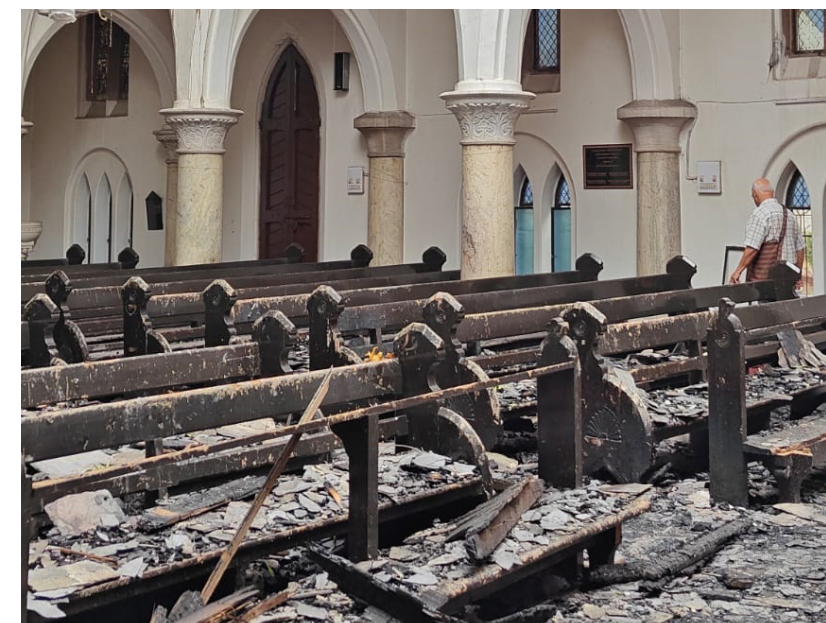
The fire on 13th April caused the roof members to collapse, resulting in severe damage. The fallen roof sections have inflicted considerable harm to the furniture located below. The wooden benches, integral to the church's seating arrangement and historical ambiance, suffered irreversible damage due to the debris from the collapsed roof. The chandeliers and the ceiling-mounted fans, suspended from the wooden trusses, have also been damaged. The fire's intensity, coupled with the collapse of the roof, has either dislodged or destroyed them completely which need to be either repaired or replaced based on the extent of the damage. A detailed assessment is required to ascertain the degree of intervention and restoration approval. **"All the interventions should aim at minimum replacement and maximum reuse and restoration of historic fabric."**

Fig. 33 - Damaged wooden benches in the nave of the Church

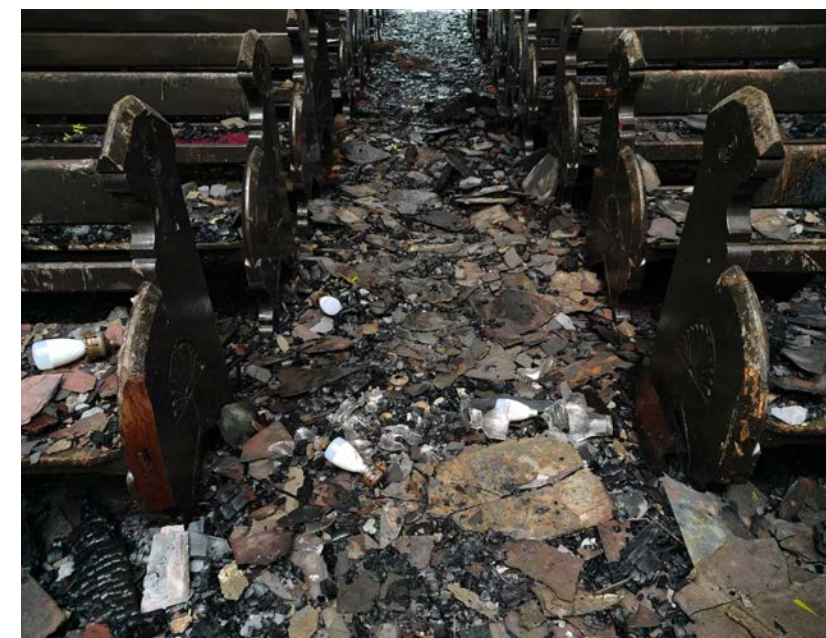
Fig. 34- Debris from the roof damaging the benches and the floor

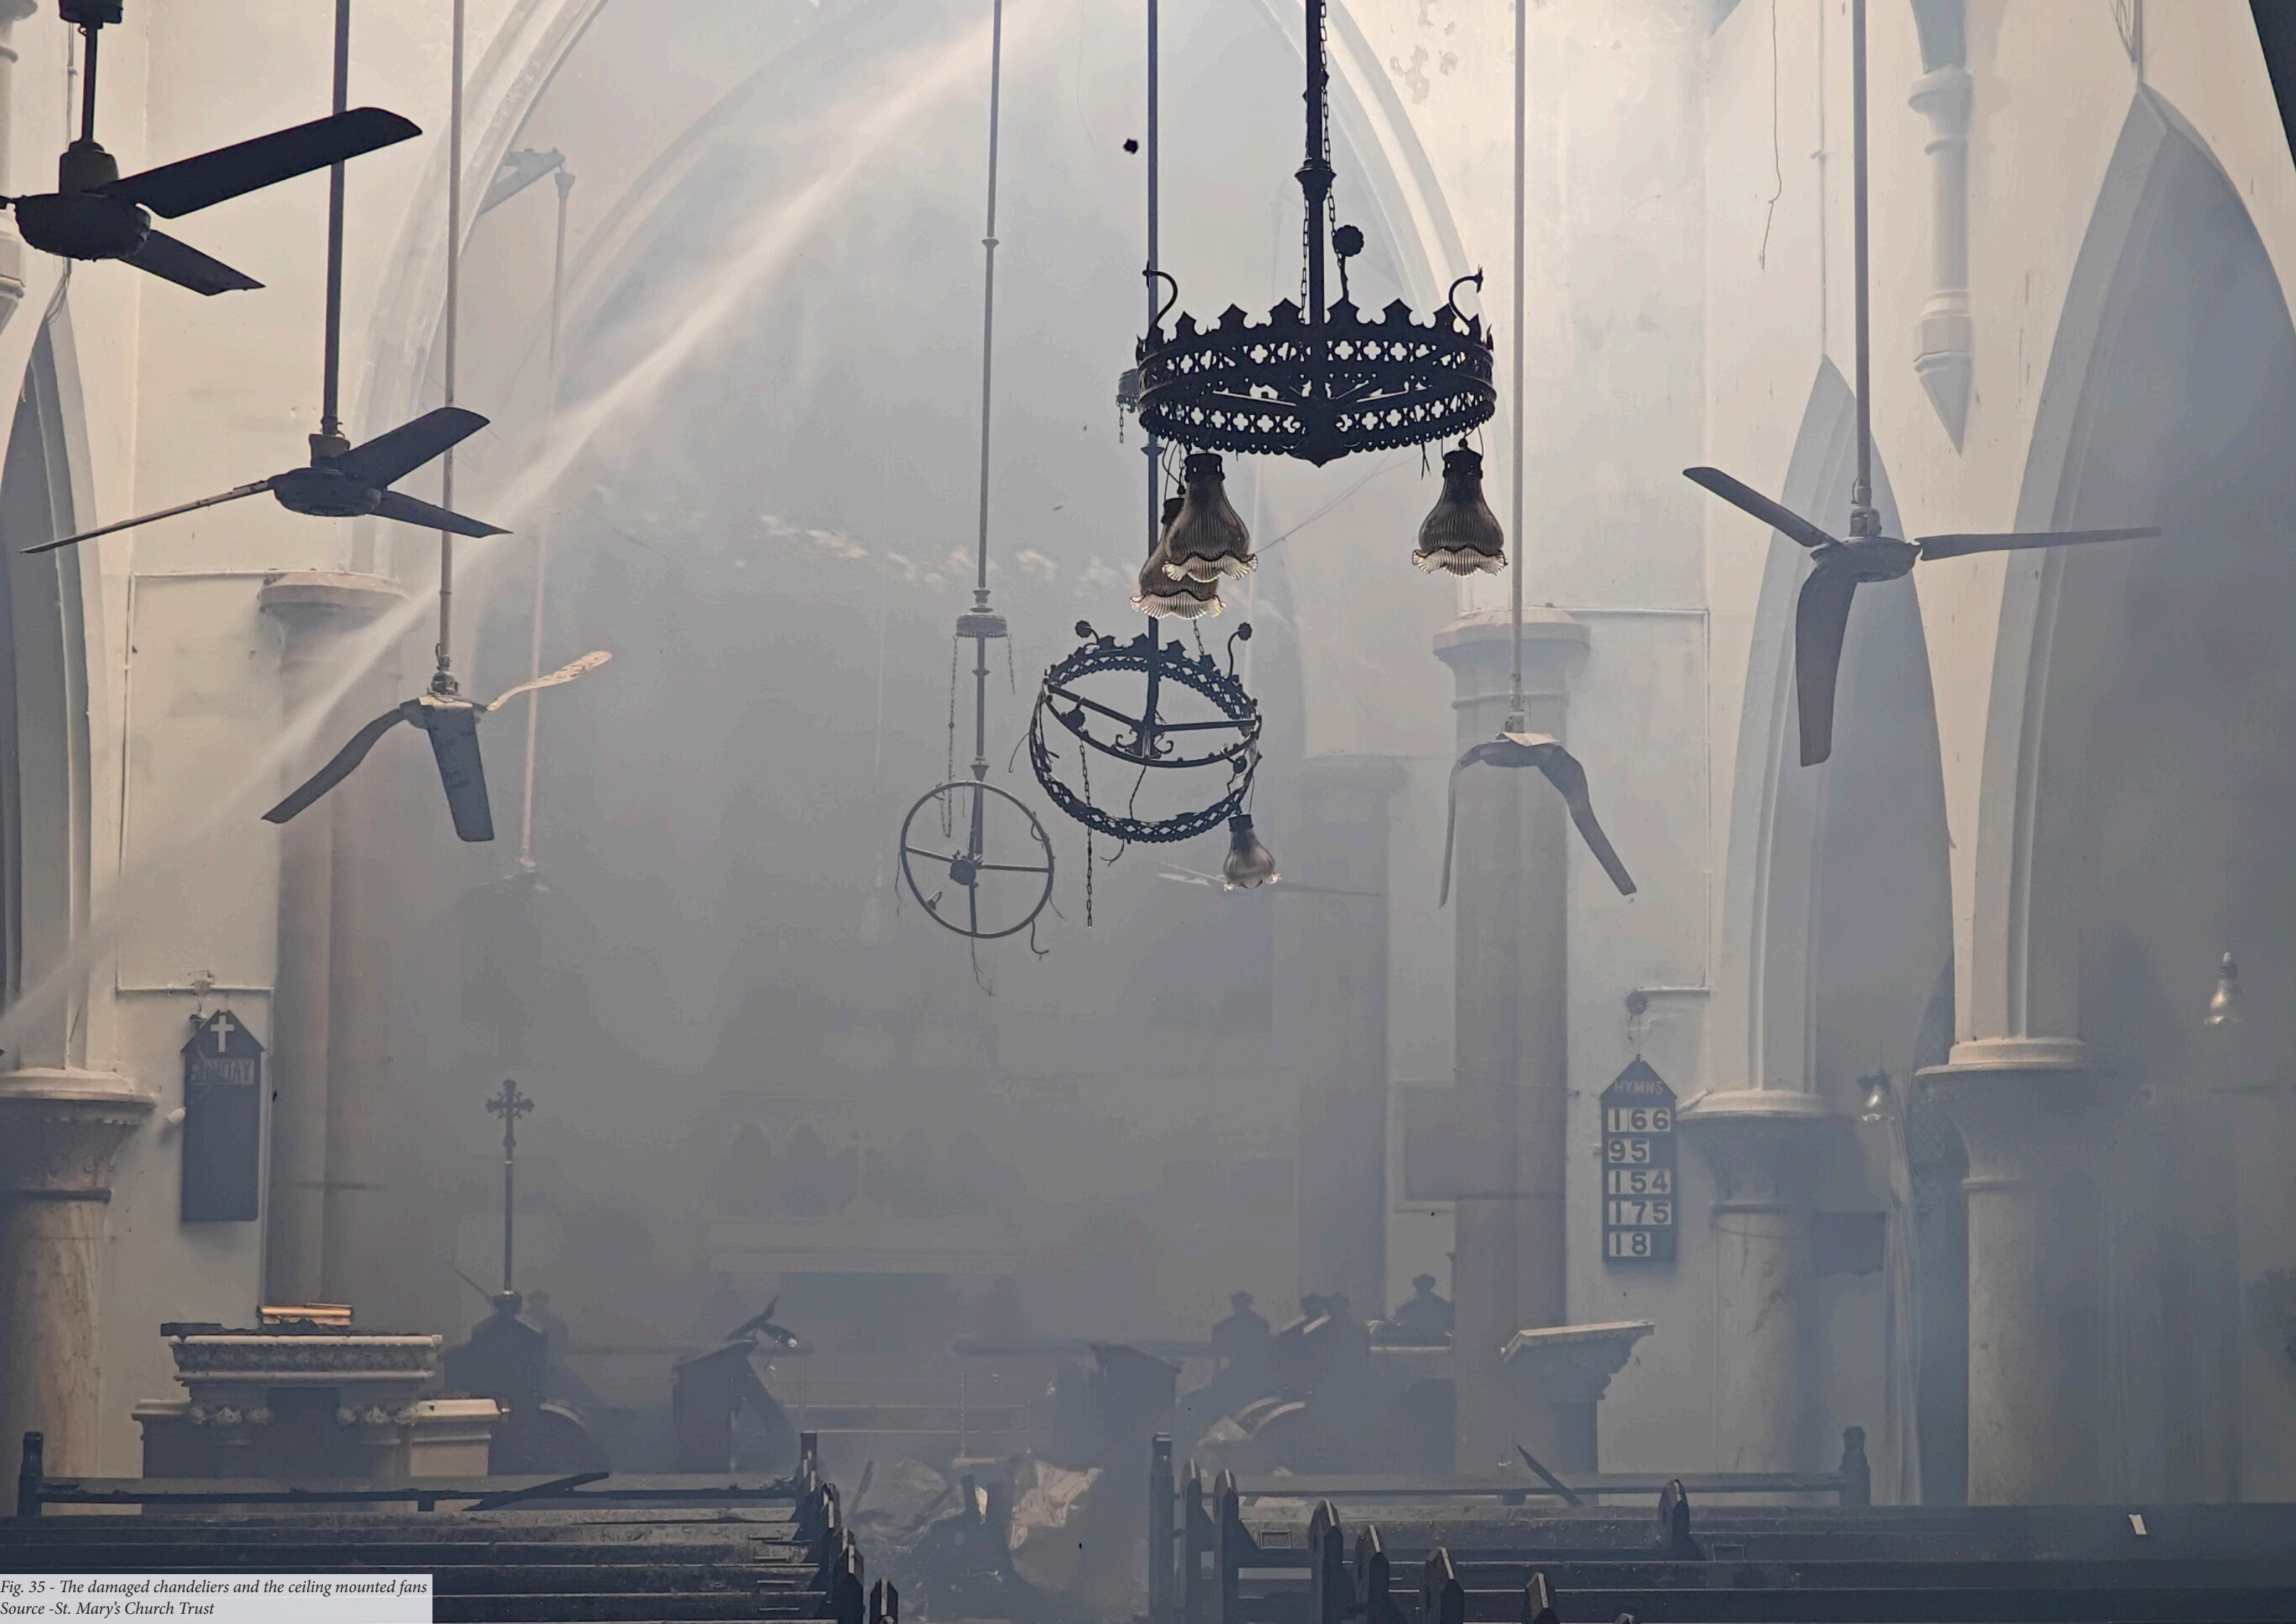
Fig. 35 - The damaged chandeliers and the ceiling mounted fans  
Source -St. Mary's Church Trust
