## Fragment of a feedback circuit

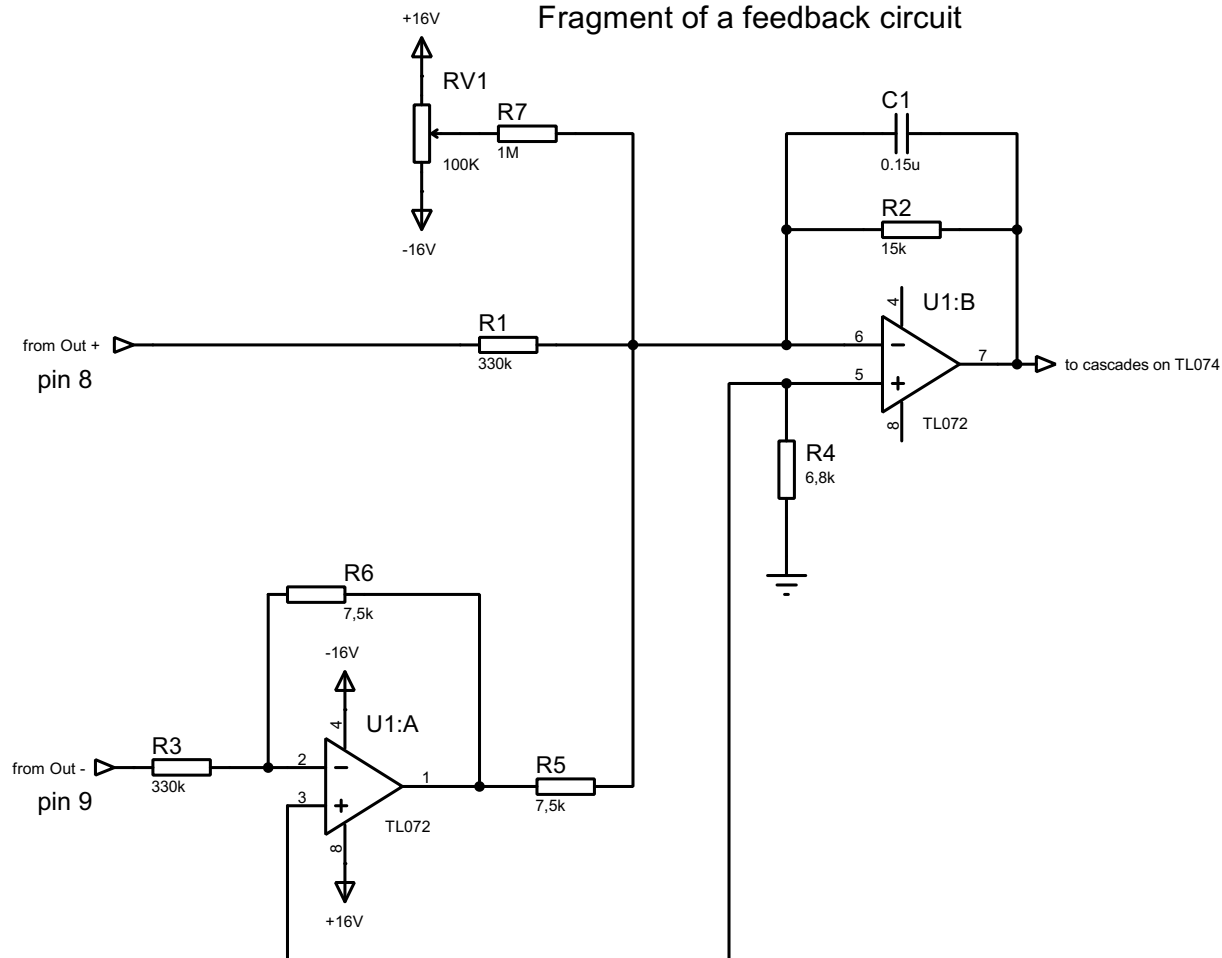
1. The diagram is a reconstruction of a separate node. The positional designations of the components are entered for convenience of description and do not coincide with the marking of the components on the original board.
2. RV1, R7 — added during repair for DC offset adjustment.
3. C1 was missing from the board being repaired. Installed during the repair to ensure the stability of the node.
