Spindle Non-Contact Encoder (NCE) - Troubleshooting Guide - NGC

Introduction

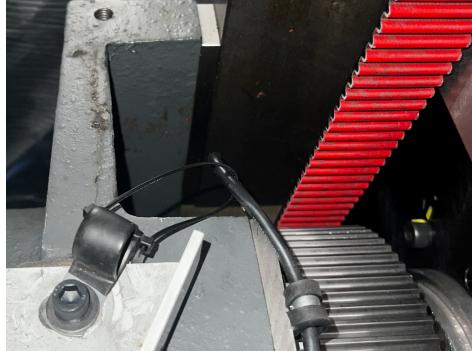
Spindle encoder cable has broke due to rubbing against the spindle belt	Replace the cable and add a cable clamp and zip tie to move the cable out of the spindle belt path. See Spindle Encoder Cable Rubbing section for further information.
Alarm 4.116 S (SPINDLE) SPINDLE ORIENTATION FAULT	Encoder Alignment is not correct	Inspect the Radial runout, the encoder gapping and the axial position of the read head relative to the encoder ring. See the Encoder Ring to Read Head Alignment section below.
Positioning error are occurring	Check the spindle encoder cable to see if it is damaged from rubbing against the spindle belt.	Replace the cable and add a cable clamp and zip tie to move the cable out of the spindle belt path. See Spindle Encoder Cable Rubbing section for further information.
Alarm 4.153 SP-AXIS ZERO CHANNEL MISSING and/or Alarm 4.103 S (SPINDLE) AXIS SERVO ERROR TOO LARGE	The encoder ring is damaged due to contact with the ring head (VF-Series 50T Only).	See the Non-Contact Encoder Cable Connection section below.

Order and install **59-2042 CABLE CLAMP 11/16 RICHCO SPNW-11** in the location shown in the image. Using a zip tie move the cable out of the path of the spindle belt, the cable will not be able to go in the cable clamp as it is not long enough to reach.
