Starlink South Pole Modifications

Version: 1.0

February 02, 2023

This document describes the modifications we implemented to the Starlink antenna in order to improve the viability for general operations at the South Pole. In addition to the modifications we also discuss the results and experience gained from testing the modified antenna.

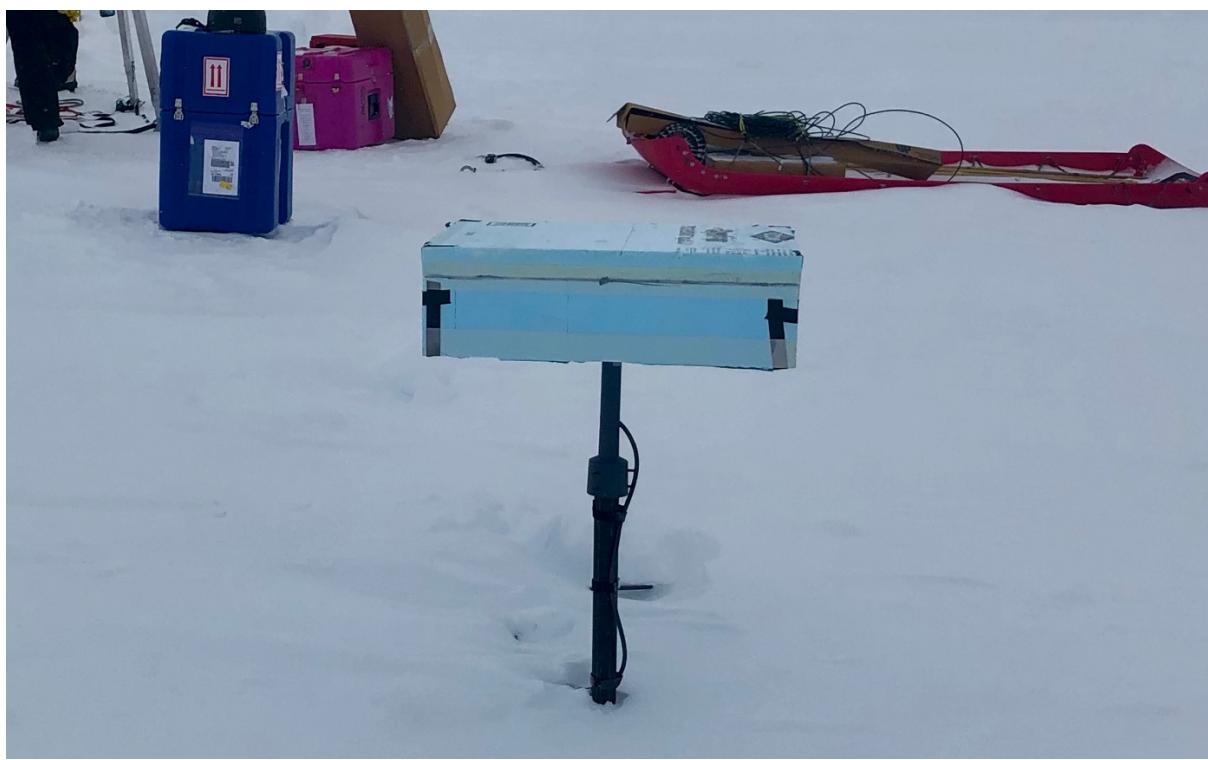
Winter temperatures at the south pole are typically around -80 deg F and peak as sol as -100 deg F. Most devices will not be able to operate at such low temperatures, hence the need for thermal insulation. Based on the experience from station personnel we embedded the Starlink antenna in 1.5-inch-thick Styrofoam, see picture below. Similar insulations are added to the Vessel link antennas.

When we installed the antenna at SPRESSO with the thermal insulation we wanted to test if the Styrofoam causes any problems with the connectivity of the satellite link. As far as we can tell in a 2 hour test period, we had about 100 percent connectivity.

After about 2 hours of operation, we saw in Grafana that the antenna shut down due to overheating. Note, that the heaters have not been activated during this time. This result shows that if we want to thermally insulate the antenna for winter operation, we will need to adjust the amount of insulation. (reduce thickness or only cover certain parts of the antenna)
