# BHS Corrugator Machine – HQM Unit Breakdown & Resolution Report

# BREAKDOWN REPORT

**Equipment:** CF Glue Guide Drive Encoder

# HH DF Glue Roll Bearing Housing Repair

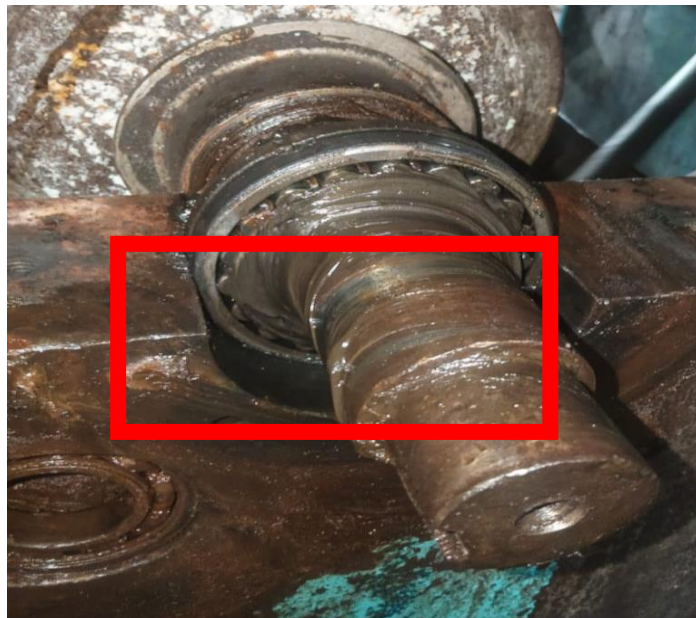
During inspection, severe wear was identified on the **Glue Roll bearing housing/seat** & Drive Shaft bearing housing/seat of the DF-HH machine.

- **Glue Roll:** The bearing housing/seat size on the drive side is significantly worn out.

The Drive Side bearing housing was found badly worn, causing the bearing to fit loosely. To restore the damaged area, metal build-up welding was carried out on the bearing seat. After welding, the excess material was carefully finished using a pencil grinder to achieve a smooth and uniform surface. The bearing fit was checked several times during grinding to ensure proper seating and alignment before final assembly.

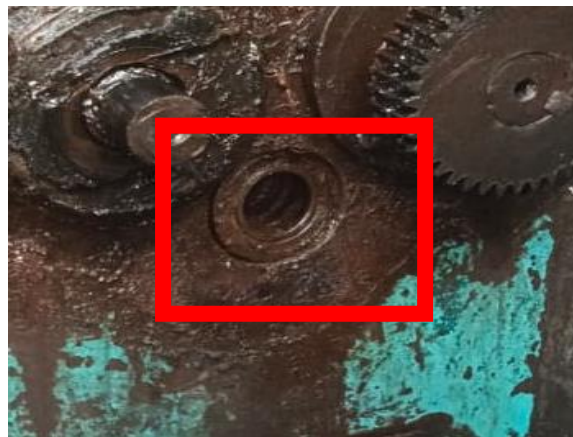
- **Drive Shaft:** The bearing seat size on the drive side shaft Bearing seat is also worn out, leading to improper bearing fit and structural play.

The **22212 spherical roller bearings** on both the Operator Side (OS) and Drive Side (DS) of the glue roll were replaced. Additionally, the **6209 drive shaft bearing** on the Drive Side was also replaced to ensure proper shaft support, smooth rotation, and reliable machine operation.

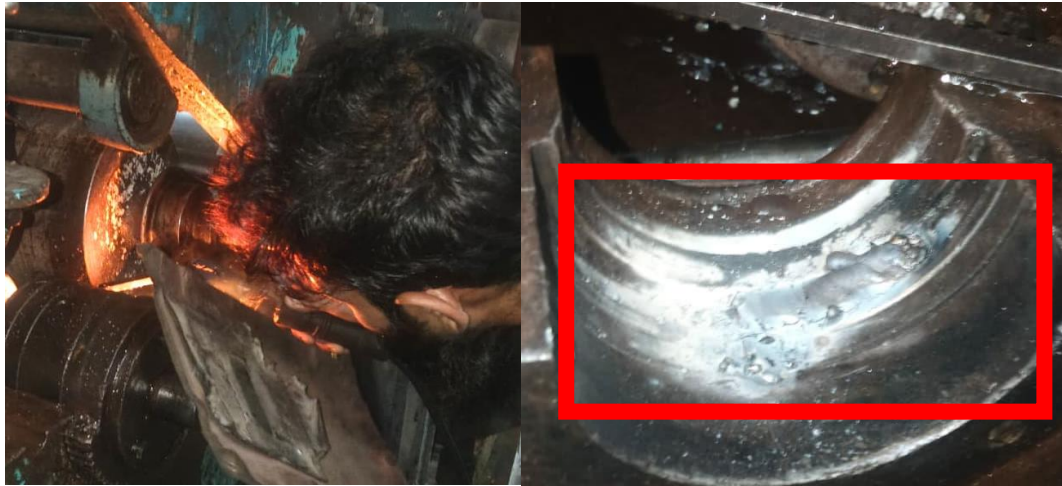
Metal build-up welding on the Drive Side bearing housing.

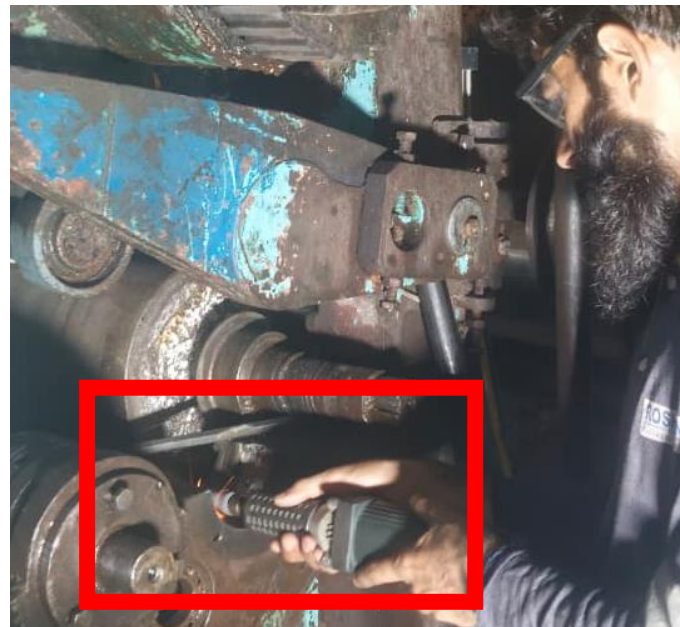
Grinding and finishing of the welded bearing housing to restore proper bearing fit.
