# FI Finland – Cable Condition Analysis Report

## FI Finland – Field Feedback (gkybxi / DC3)

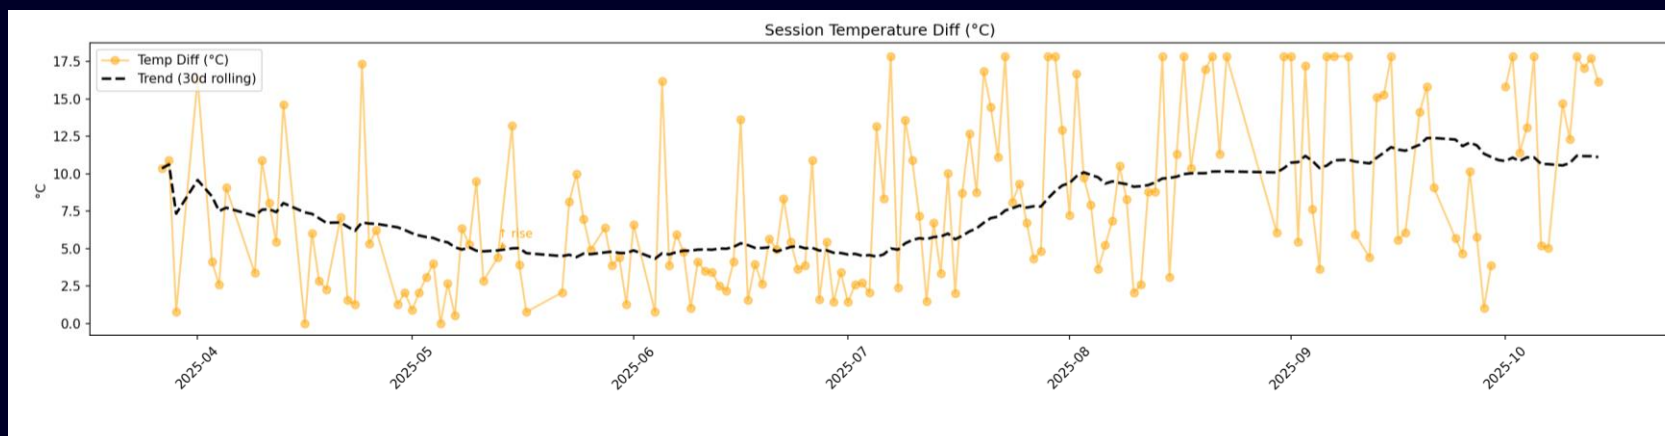
- ✓ No critical trends in most outlets.
- ✓ One outlet (**gkybxi – Outlet 3**) shows a **steady temperature increase** worth checking.

❖ Gradual temperature rise pattern ( $\Delta T > 5\text{ °C}$ )

- Inspect the physical connector of Outlet 3 (gkybxl)
- **Clean** contacts and check for mechanical stress or oxidation.
- Continue monitoring temperature and event data in the next 2–4 weeks to confirm if the trend stabilizes

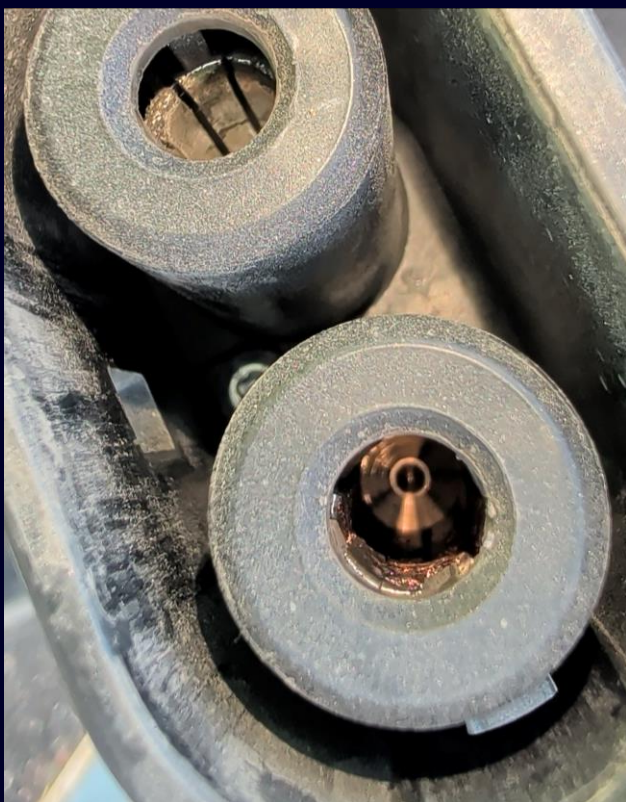
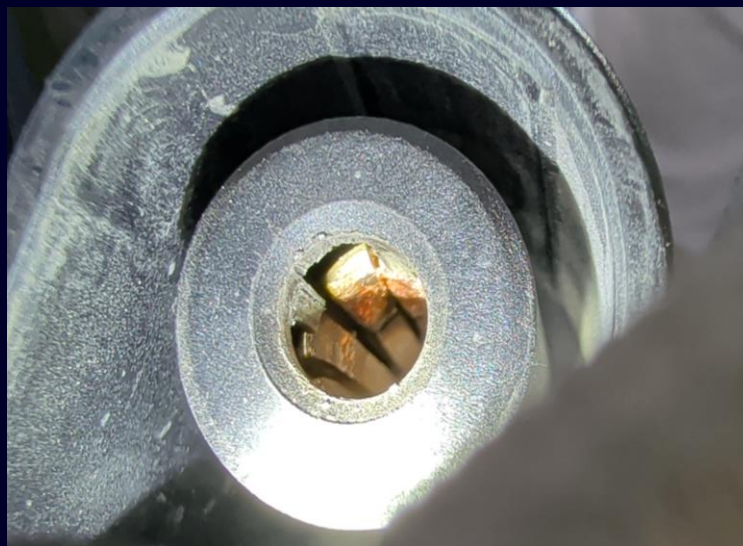
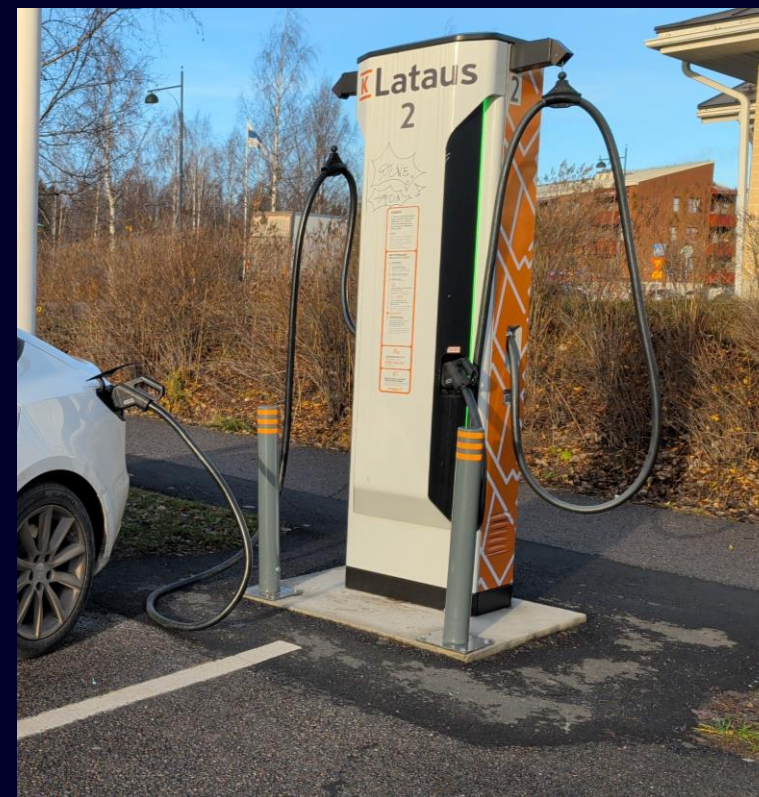
- DC3 plug showed **burnt** and **melted contacts** with **visible gaps** and **pin deformation**.
- **Cable Holder (gland) broken**, so the cable leaned down, adding mechanical stress to the connector.
- After **cleaning** the pins, the charger worked for about **2 minutes**, then **stopped** due to **temperature difference**.
- Repeated tests started the session, but **no power was delivered**, suggesting internal contact damage or safety cutoff.
