## nqymby – Outlet 1

## 28juh – Outlet 1

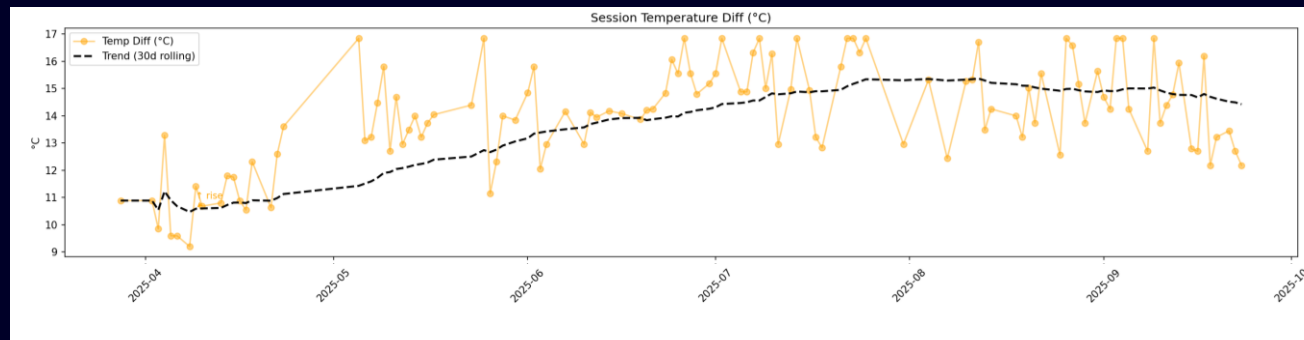
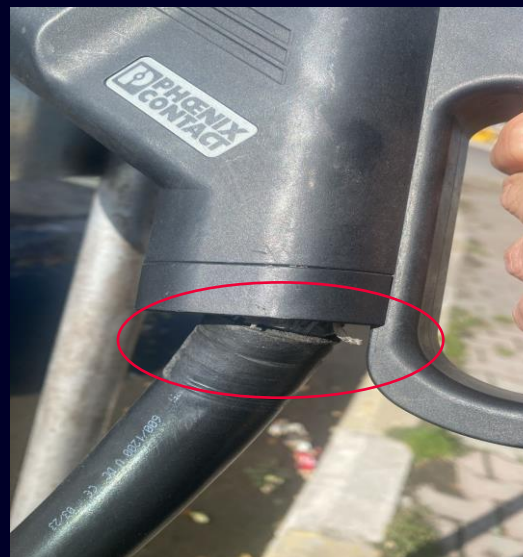
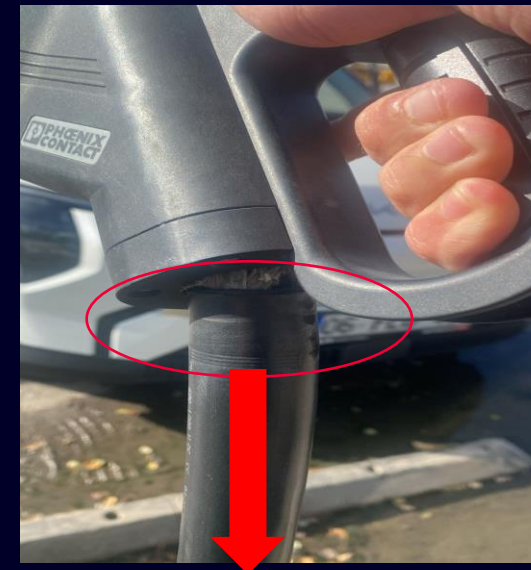
- Sustained **temperature** increase above 10K across several months.
- Loose contact inside plug, likely from cable bending or stress.
- Cable near handle torn / bent, possibly pulling conductors inward.
- Result: unstable electrical contact and localized overheating.

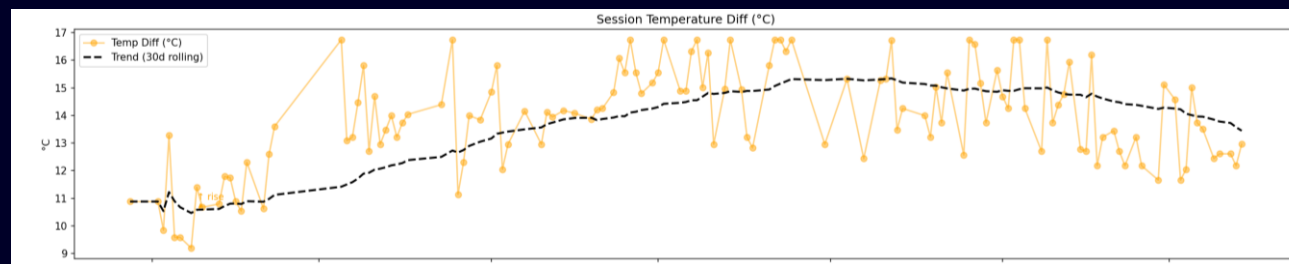
- around 2 weeks later
- Stabilized situation

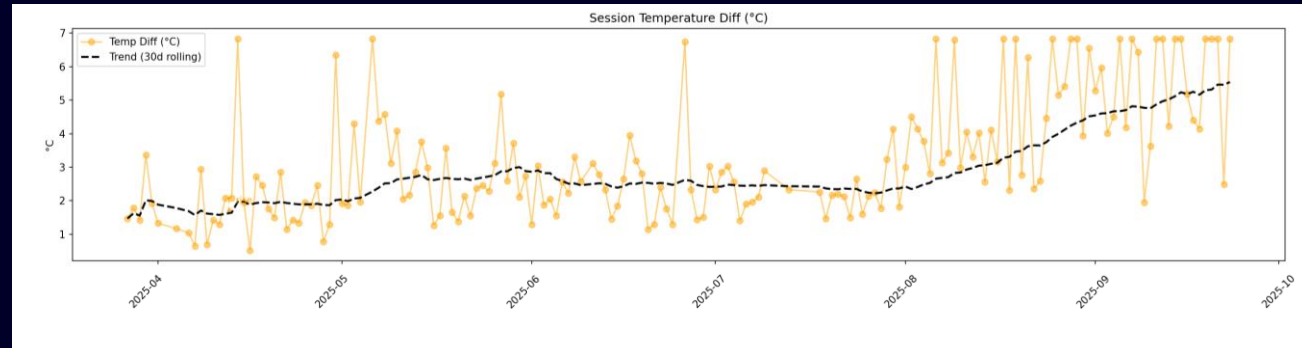
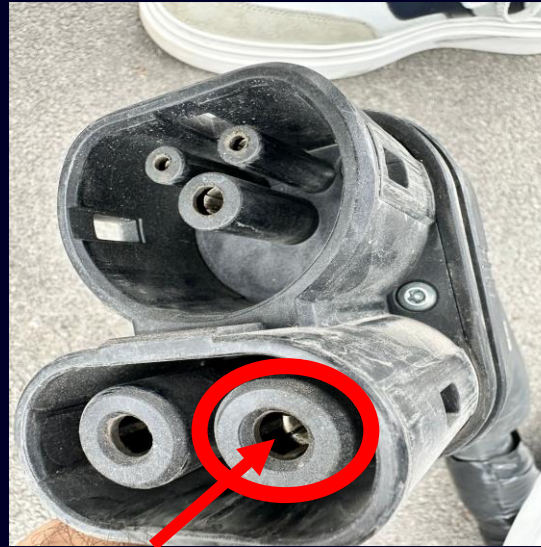
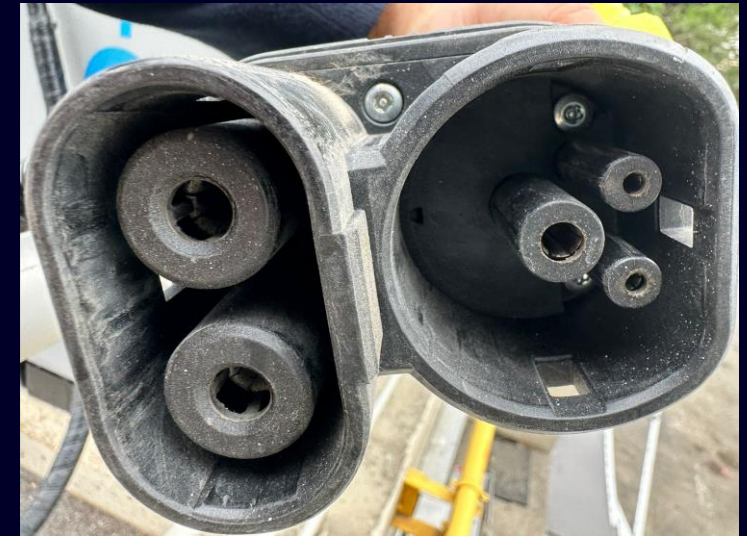
- Gradual temperature rise from 2K → 7K over several months.
  - Connector heating up, poor heat transfer over time.
  - Field inspection: DC pins partly pushed back inside the housing.
  - Reduced contact area → early-stage contact degradation confirmed.
- 
- around 2 weeks later
  - Stabilized situation
