Pre-Purchase Building & Pest Inspection Report

BUILDING & PEST REPORT

Property Address: Unit 13 50 Merton Street, Sutherland NSW 2232, Australia

Date of Inspection: 18/11/2024

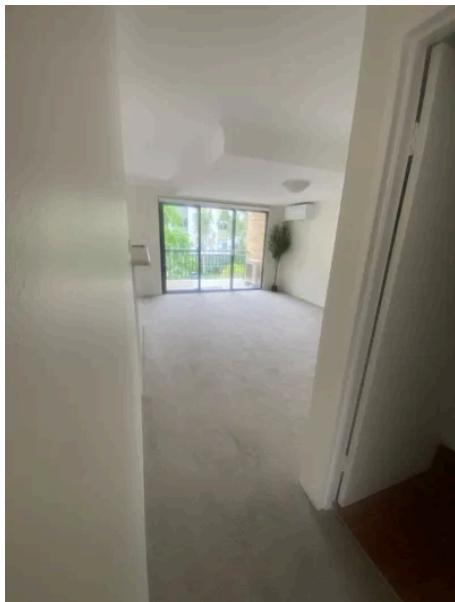
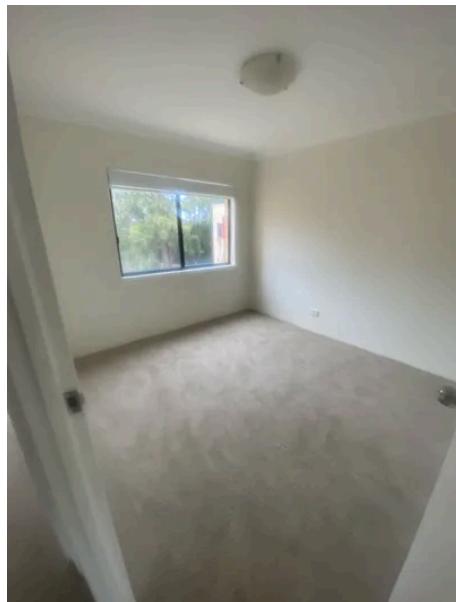
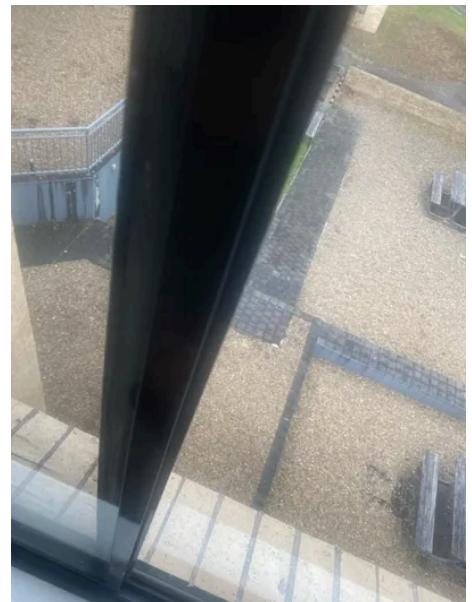
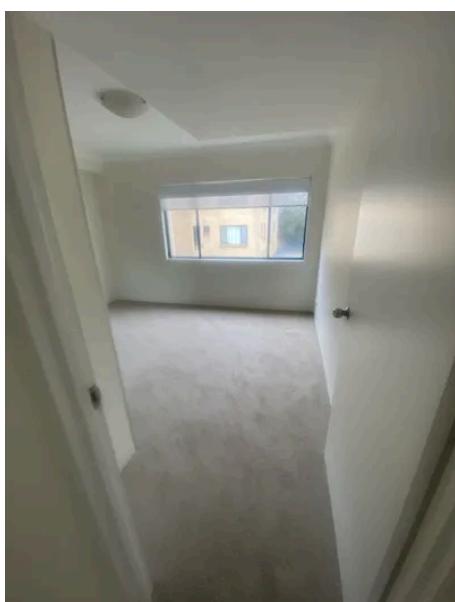
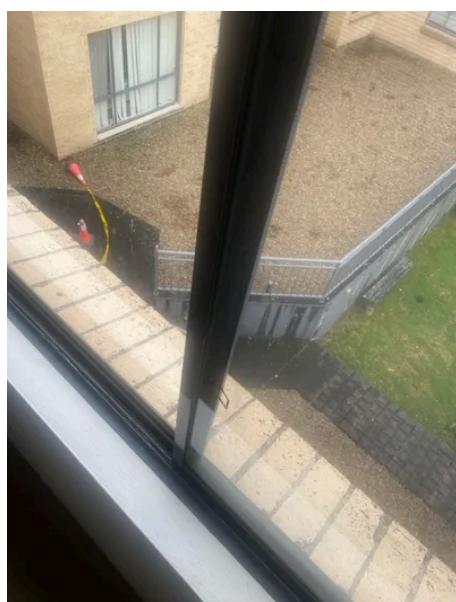
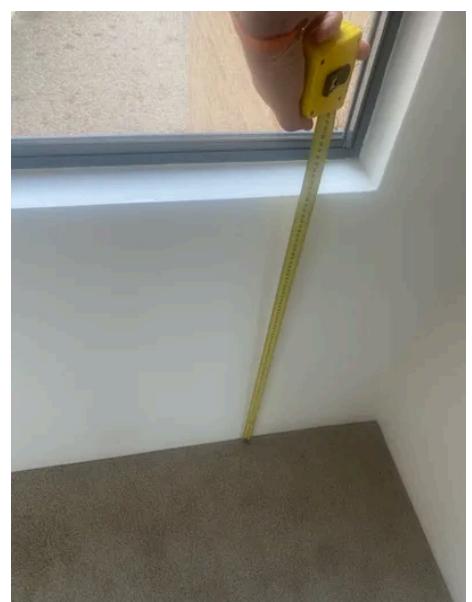
NO, All other windows are compliant with current regulations

To my best knowledge, the windows in the other internal rooms are compliant with current regulations as per the date of my inspection

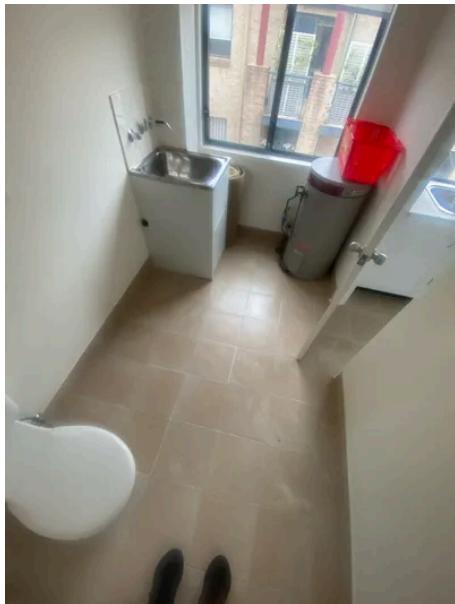
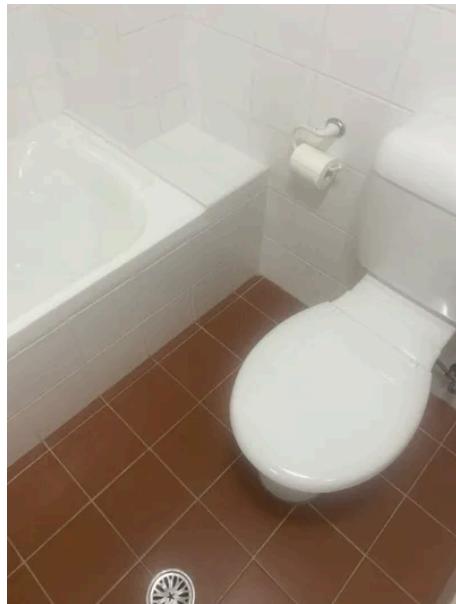
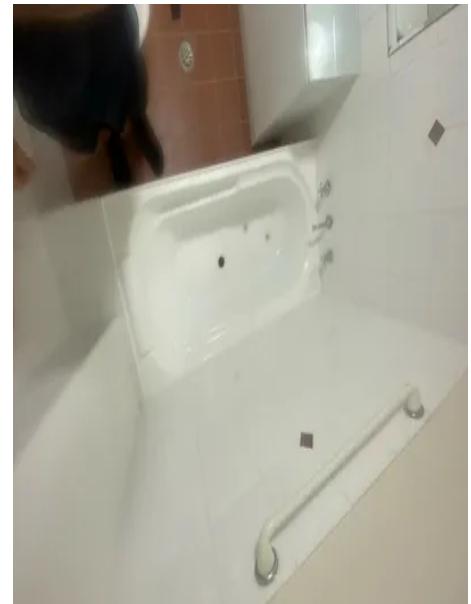
The bathroom has missing silicon within the wall and floor tile junctions and vertical wall tile junctions

Within the laundry and combine bathroom, there is missing silicon within the internal junctions of the wall and floor tiles together with no pan or tray underneath the hot water system which is sitting directly on the floor

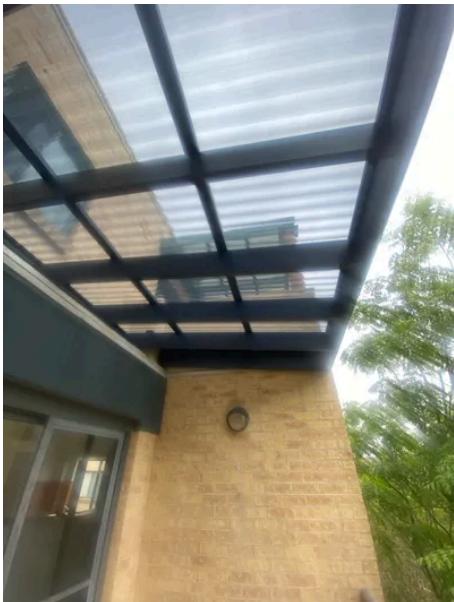
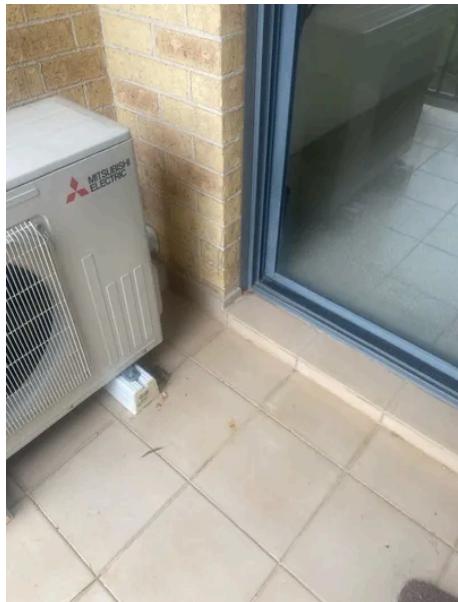
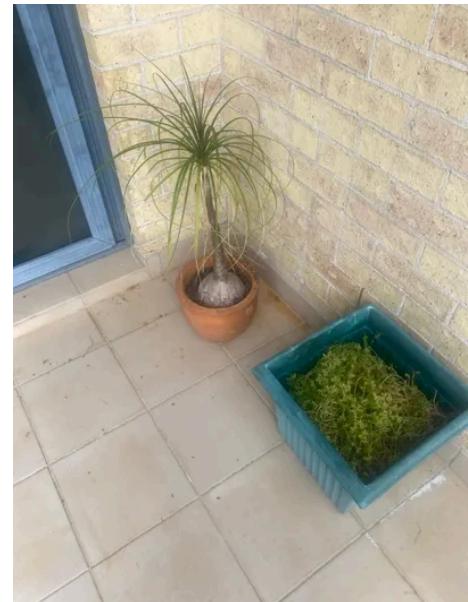
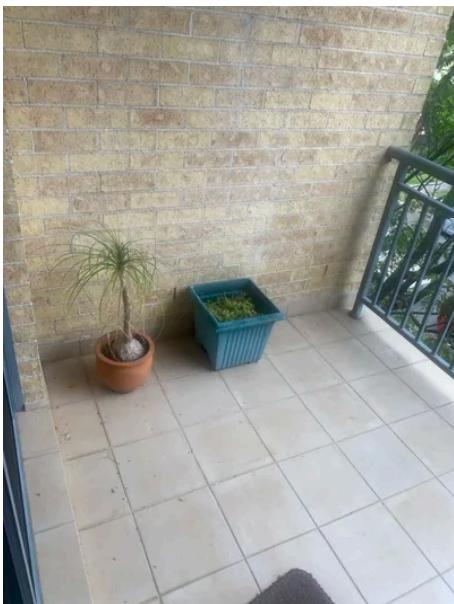
I found weep holes within the external masonry walls, I could see a few missing weep holes in various locations

Area of improvement should moisture be found within the internal or external walls Weep holes should be found along the baseline of the wall at the flashing level at every 1m interval and weep holes should be found above and below all external doors and windows that are wider than 1m in width Weep holes should be found at the top of any roof flashings / wall flashings / capping or any other break in external damp proof courses
