## Pre-Purchase Building & Pest Inspection Report

## BUILDING & PEST REPORT

**Property Address: 16 Cormack Road, Beacon Hill NSW, Australia**

Date of Inspection: 25/11/2024

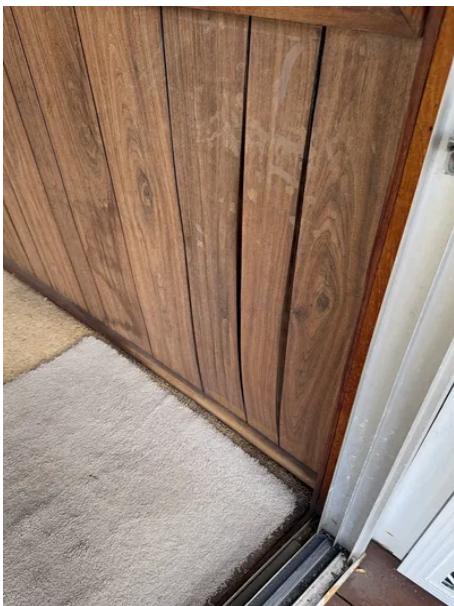
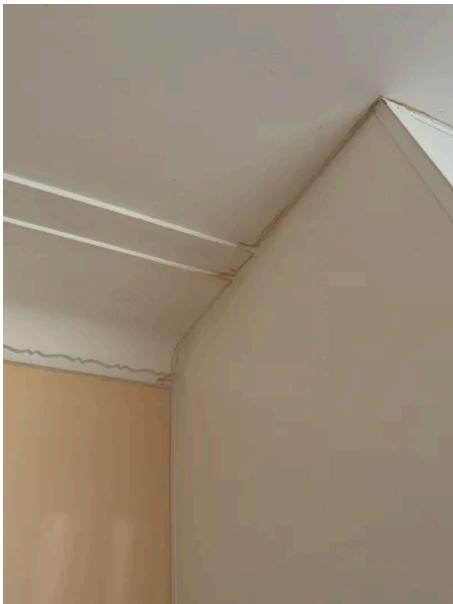
#### **Incomplete Works - Area Under Construction and Excluded from this report**

*Works to this area are incomplete and non-compliant with AS4349.1-2007 Further inspection is required once works have been completed*

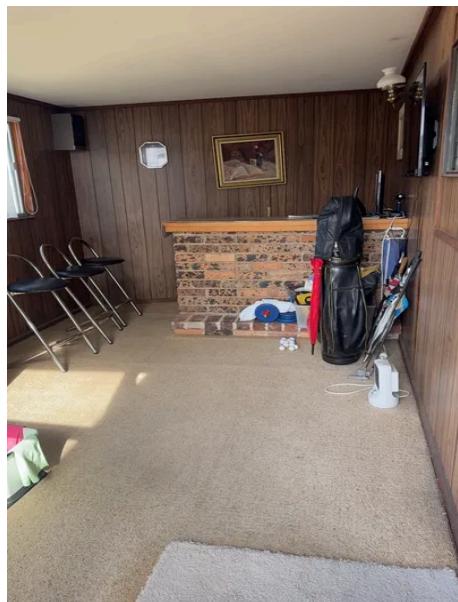
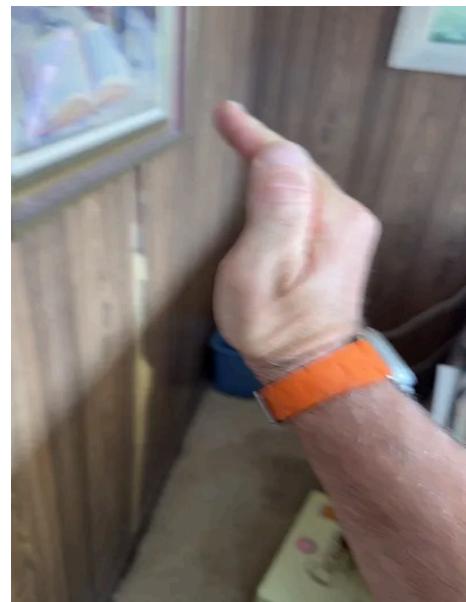
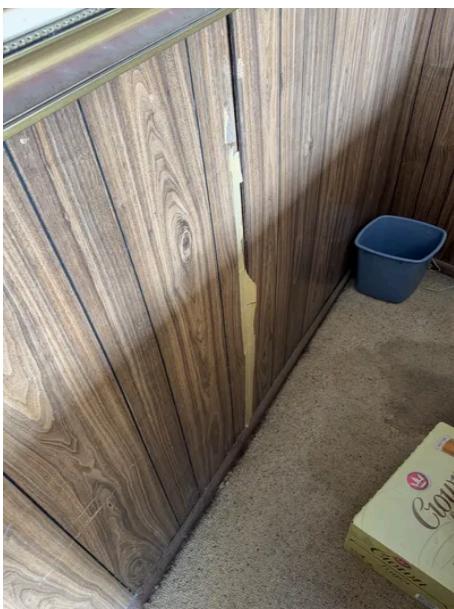
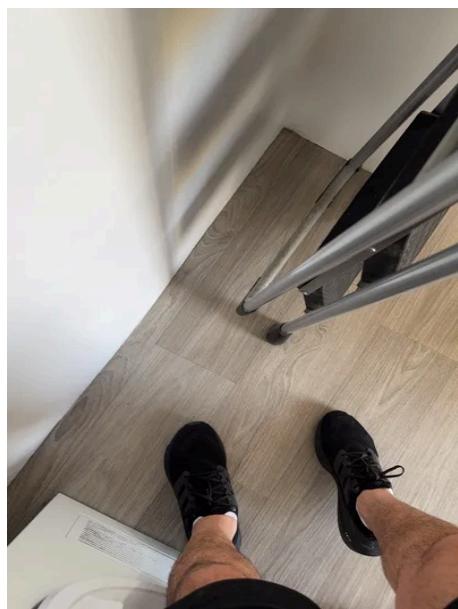
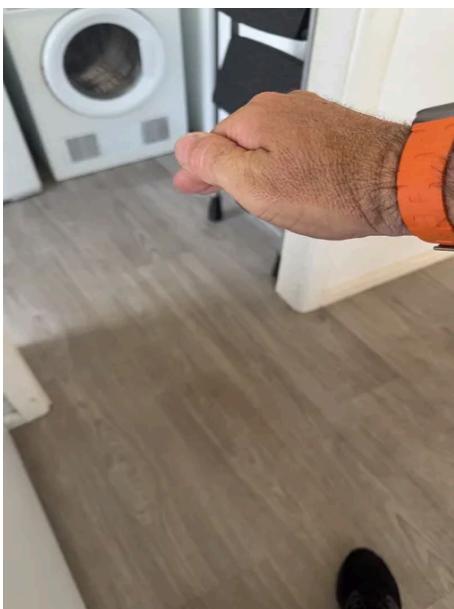
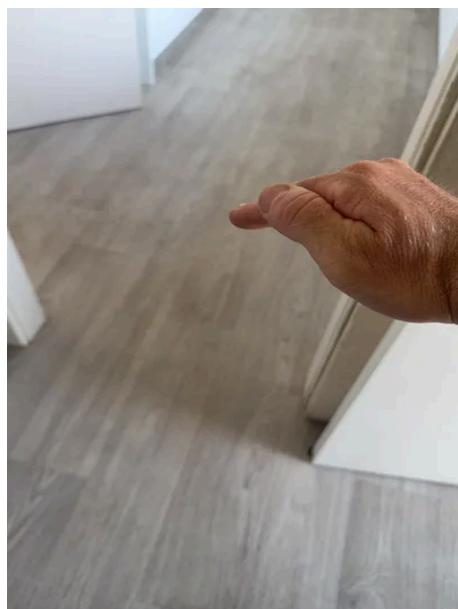
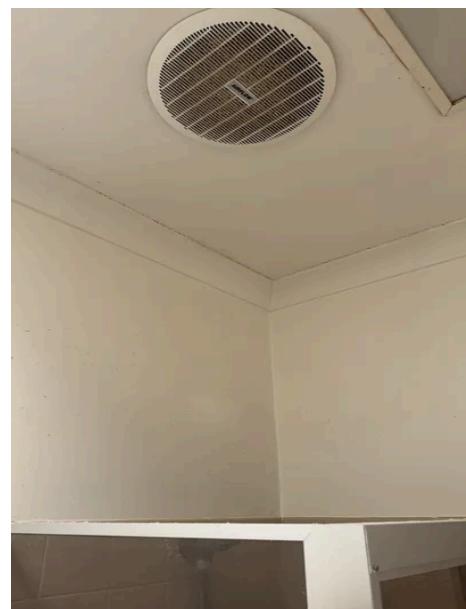
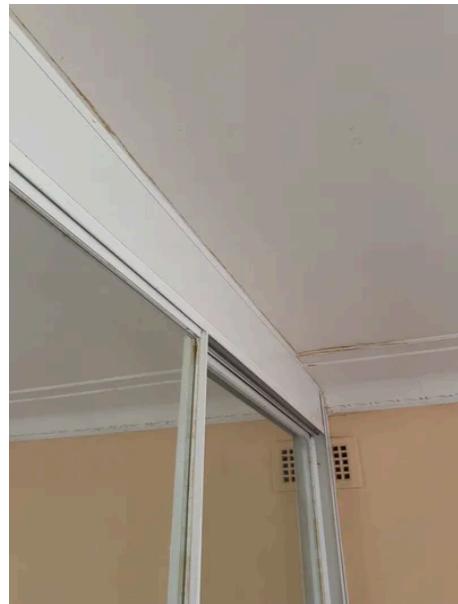
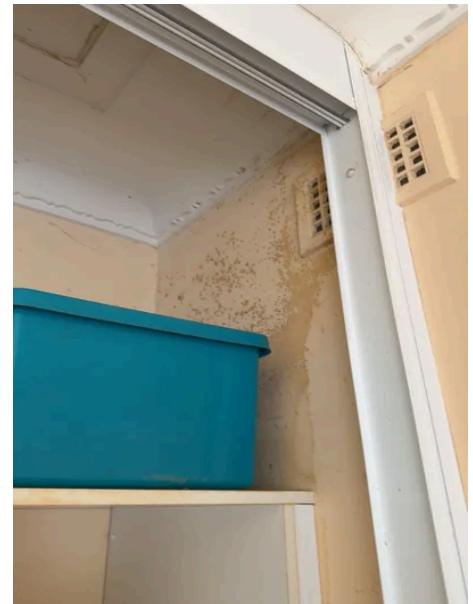
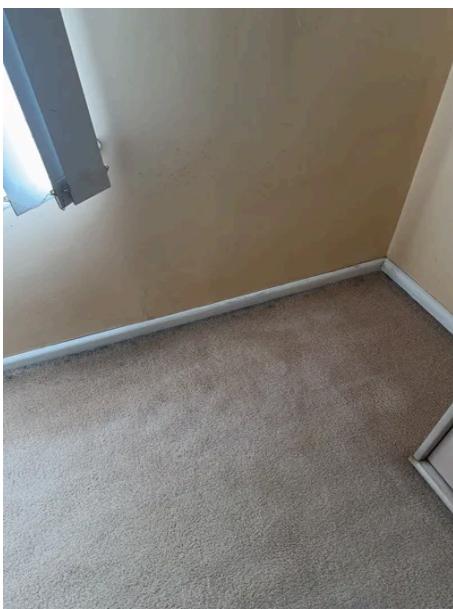
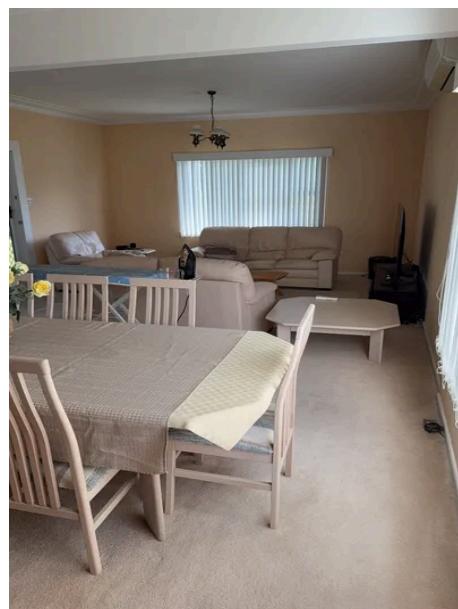
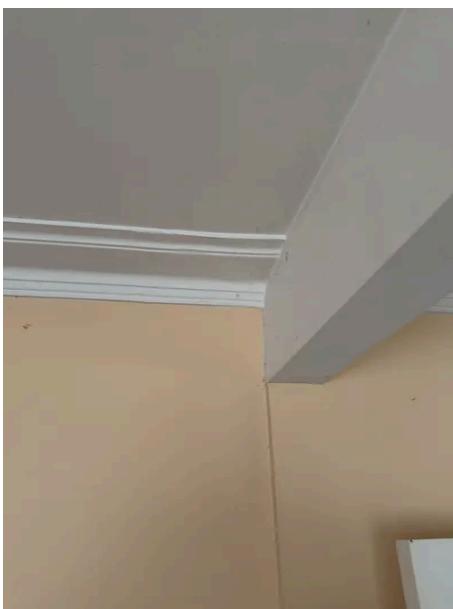
Minor sagging and / or minor imperfections in places, I can see there is a combination of the following: 1. Sagging of the plasterboard ceilings in various locations 2. Minor defects found within the plasterboard ceiling linings 3. Minor cracks found in the cornices and wall junctions 4. Minor cracks found in the cornices and ceiling linings NOTE: Any property beyond two years old can have cracks in the plasterboard and cornices and this will be rated a minor defect, and those defects may not all reach this report If the property was recently painted, we cannot pick up defects in the plasterboard ceilings nor old or existing moisture issues within the ceilings and cornices We only report on major defects and not minor imperfections or typical wear and tear issues within older plasterboard ceilings and cornices Our objective is to advise on areas of concern that may involve future liability or expenses, I cannot see any major issues within this property within the ceiling linings or cornices in their current condition Any cracks in the ceiling linings that have roof access above could have been created by a service contractor or owner when accessing the roof void, making the cracks within the ceiling non-critical I recommend that all roof voids are not to be used as storerooms, as the additional loads to the roof framing, plasterboard linings and cornices may create or contribute towards cracks within the ceilings and cornices (Unless a new timber floor structure and floor lining boards are installed and are detached to the ceiling joints)

Minor cornice cracks are seen between the cornices and ceilings as well as the cornices and walls, this is possibly due to normal movement within a property and is considered an acceptable and non-structural issue 1. Cracks were found within the cornices where each length of cornices meet and are set together 2. A good plasterer and painter can repair and make good these issues quite easily and cost effectively. All properties with the above issues should be monitored and if they further develop, a structural engineer should be engaged to assess and report on the entire property

Minor cracks evident at the plasterboard ceiling joints, these cracks are not structurally significant. 1. Some sagging of the plasterboard ceiling is evident in places 2. Minor defects found within the plasterboard ceiling linings 3. Minor cracks found in the cornices and wall junctions 4. Minor cracks found in the cornices and ceiling linings NOTE: A property beyond two years old can have cracks in the plasterboard and cornices and it is not a major defect

There are imperfections in the ceiling, it appears to be old moisture stains within the ceiling / cornices A painter can repair and make good these issues quickly and inexpensively

*Yellow stains normally mean that there was or still is water / moisture ingress into the internal elevations of the property, this should be looked at to see if it is a current issue or an old and past / rectified issue, and then all that is required is prep work and re-painting of the area in question*

*Yellow stains in cornices are not ideal as it could mean that there was or still is water / moisture ingress into the property Further investigation is recommended to see if it is a current issue or an old issue*

## **Moisture damage to the bedroom ceilings**

*Minor cracks were seen within the internal wall linings due to normal settlement and can be left as is. Hairline cracks in the wall linings are normal and they are normally fixed up by a painting contractor when a property is re-painted. A normal life cycle for painting a property internally is every six to ten years. Note If the property was recently painted for sale, we will not be able to see the defects (structural or cosmetic) concealed by the recent work. Defects, if any, will normally re-appear within the next three to twelve months (in the change of seasons). The most common periods to see cracks in walls are in the summer period when properties foundation moisture content is lowered or in the reverse if the improvements were carried out in summer, if this is the case, please re-contact our office to re-engage us to carry out a second inspection to obtain a true position of the property.*

*I saw moisture within the internal non-cavity walls, this is a common issue found in : WC rooms, laundries, garages, rooms that used to be external veranda's which are now a habitable room, period buildings were commonly built with non-cavity brick walls, so every period building*

*Further investigation recommended confirming the source of the moisture*

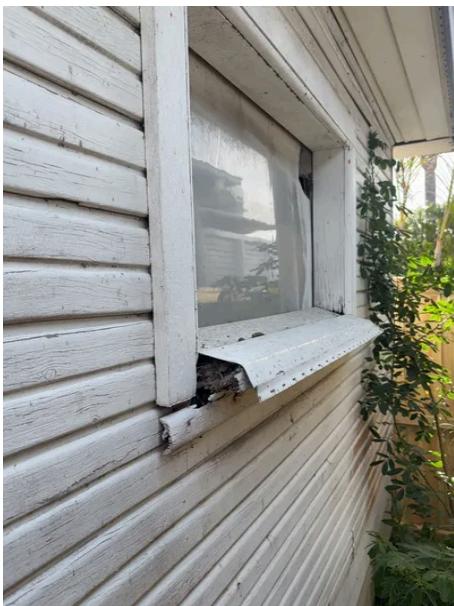
## **YES, there are non-compliant windows within this property that do not comply with current regulations. "I assume the windows may have complied when they were originally built".**

*There is a window sill found within the property that is lower than 865mm from the internal finished floor level with a fall greater than 4 metres The window in question must not open greater than 125mm and must have a fixed barrier installed at a minimum of 865mm The barrier must not have horizontal elements between 150mm and 760mm that facilitate climbing*

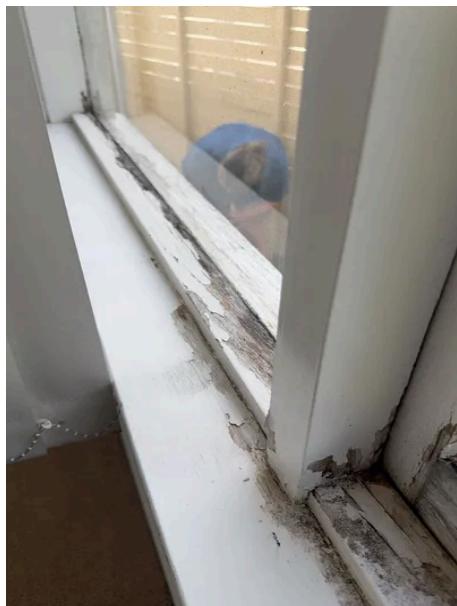
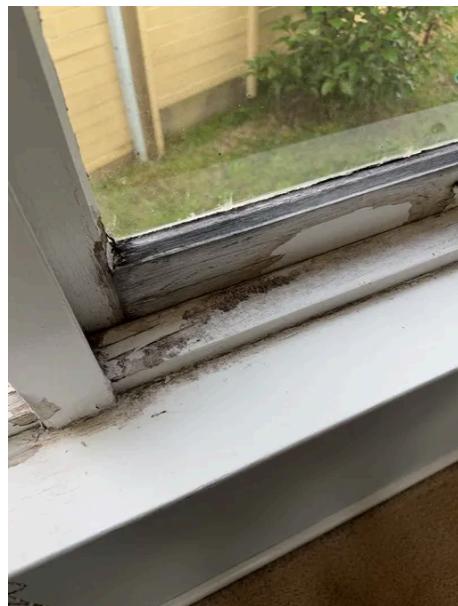
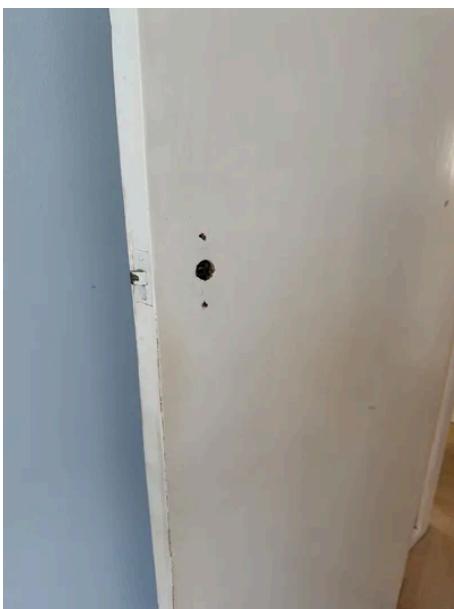
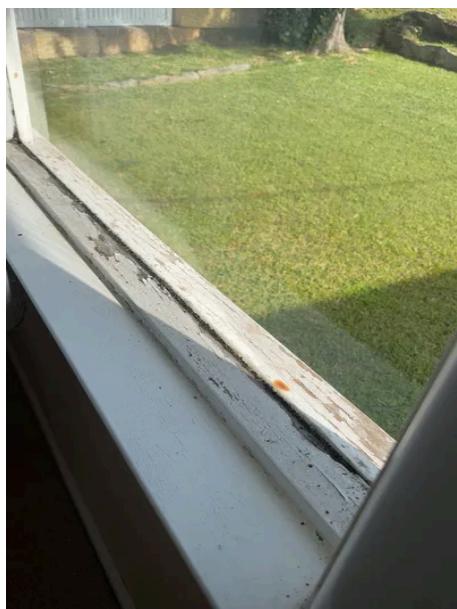
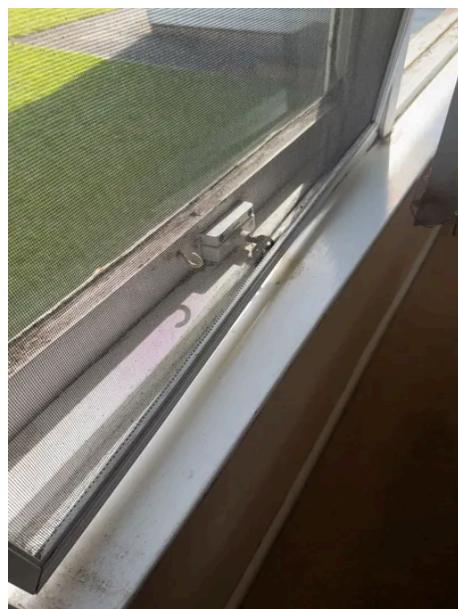
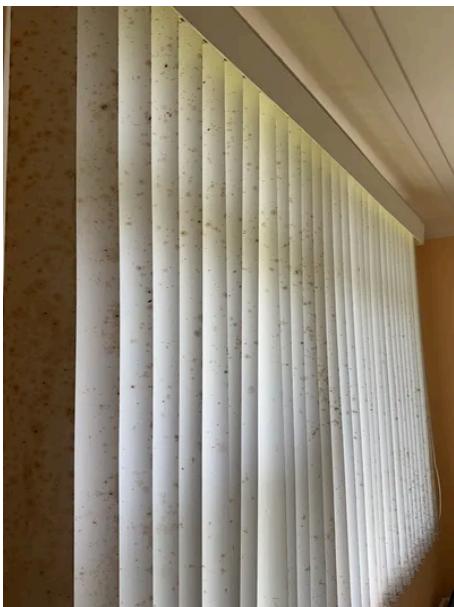
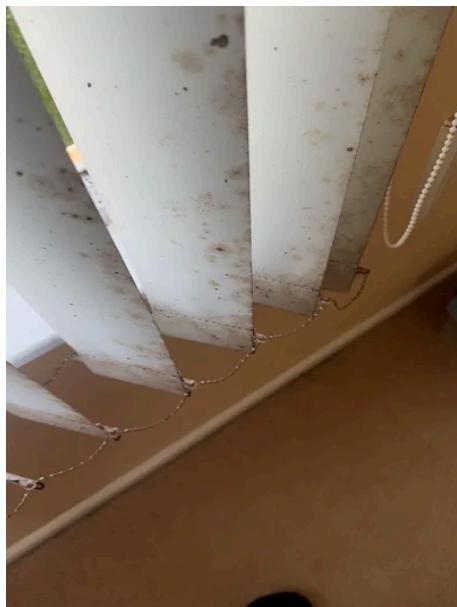
*External door(s) are damaged due to not being adequately protected from the weather*

*One or more doors bind on the door frame. The doors require minor adjustment and once rectified the doors are to be appropriately protected (Painted or Stained, so they are sealed)*

#### Doorjambs have moisture damage seen at the base of the door jambs

*Evidence of minor rotting found within the external doors / windows. Repairs and re-painting are required by a painting contractor to preserve the timber members*

*Timber fungal decay evident within the external door and window suites. A carpenter needs to replace the rotten timber and have the new and existing timber re-painted by a painter*

*External door(s) are damaged due to not being adequately protected from the elements.*

*The external window(s) are damaged due to not being adequately protected from the elements*

*All external timber windows and doors should be re-painted or stained, as the existing timber units are slightly deteriorated and in need of re-coat / repair, Minor defect*

*A flood test should be commissioned to see where the moisture is coming in from*

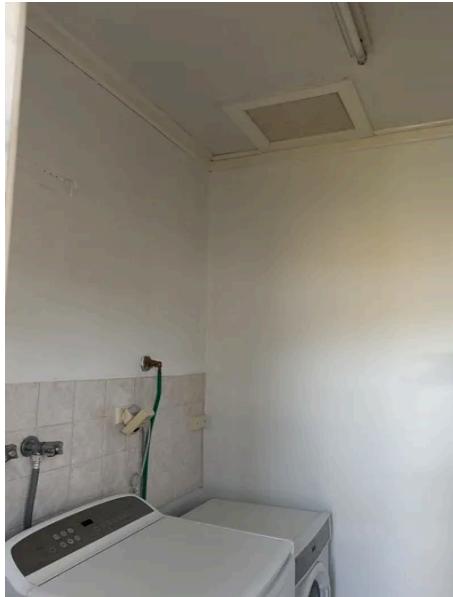
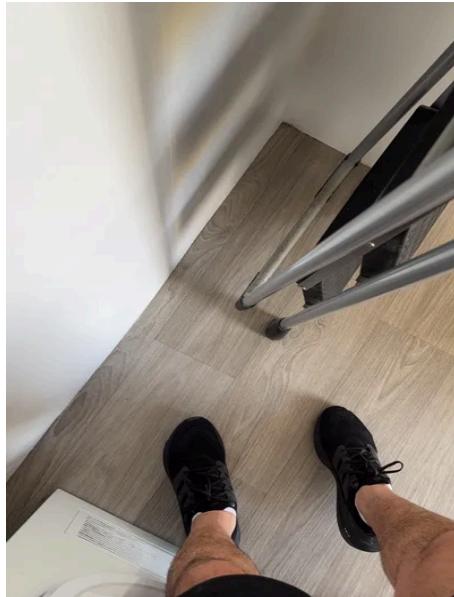
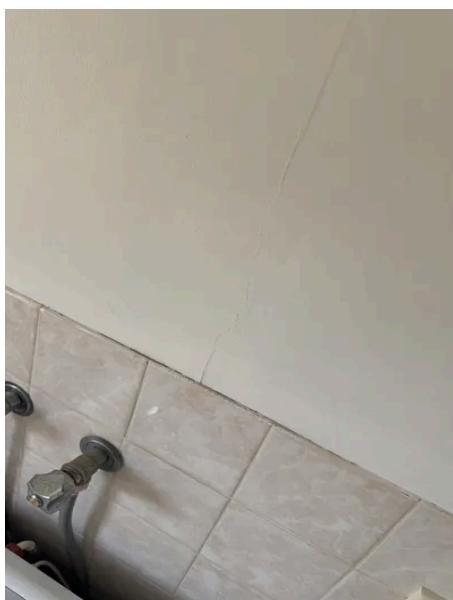
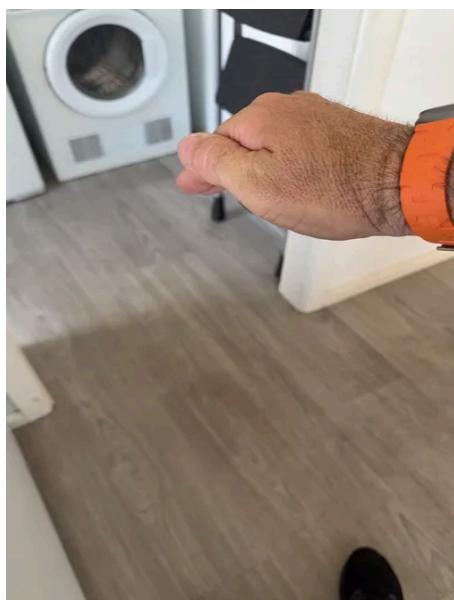
#### SPECIAL NOTE: LAUNDRY DEFECTS

- *The washing machine and dryer needs to be removed in order to have a standard stepladder installed beneath the current manhole for compliant access into the roof for a single Inspector*

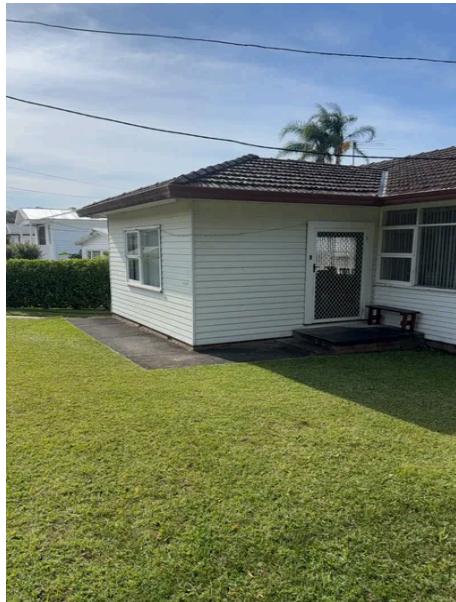
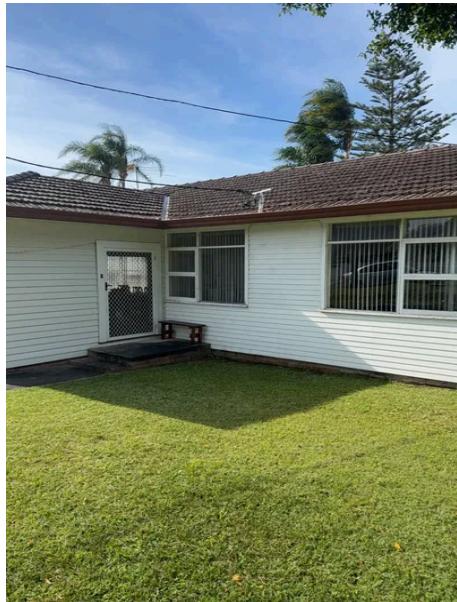
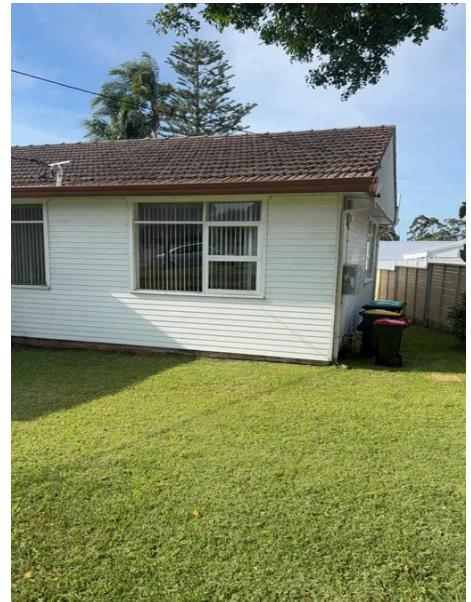
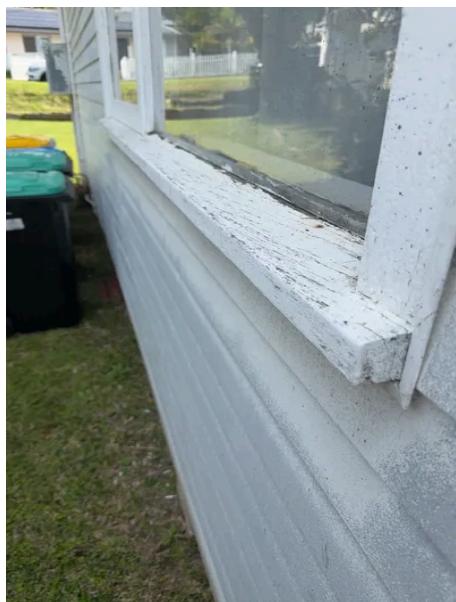
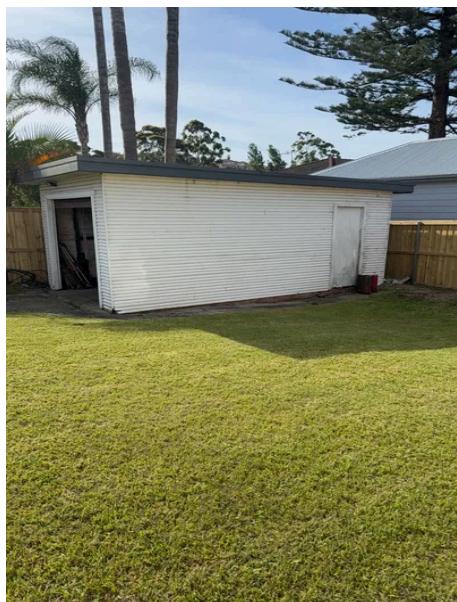
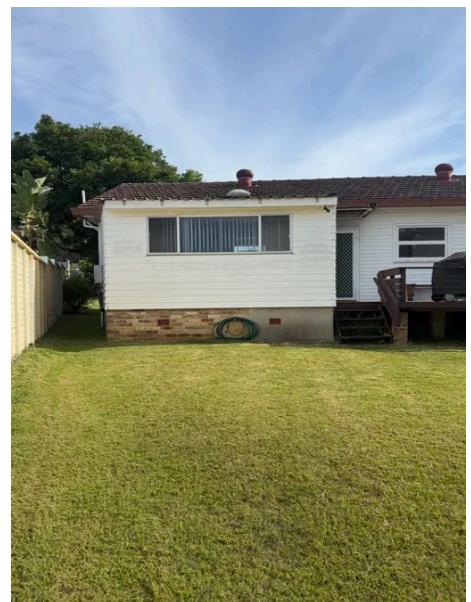
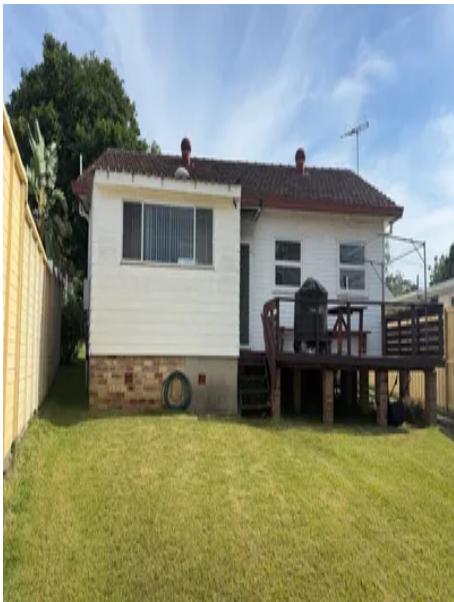
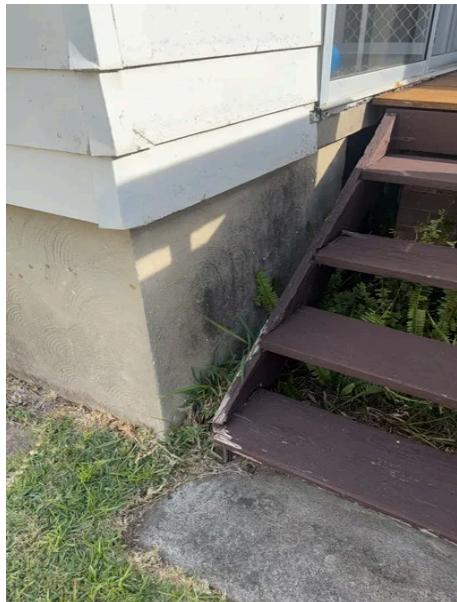
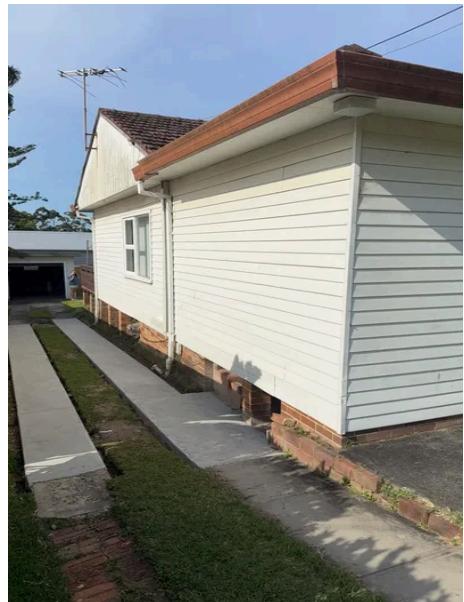
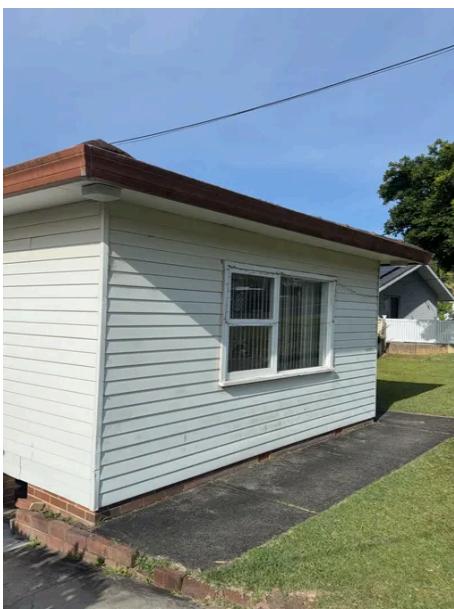
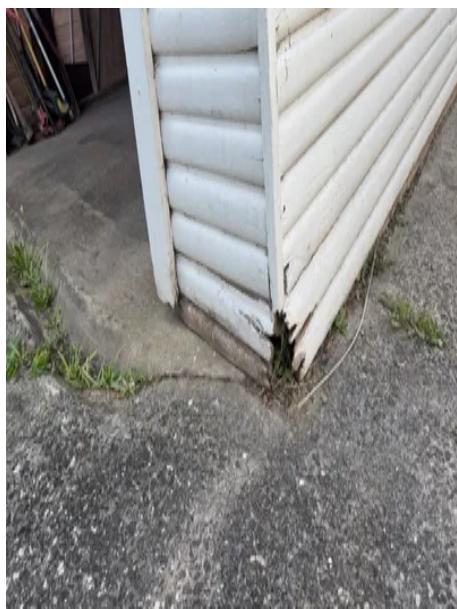
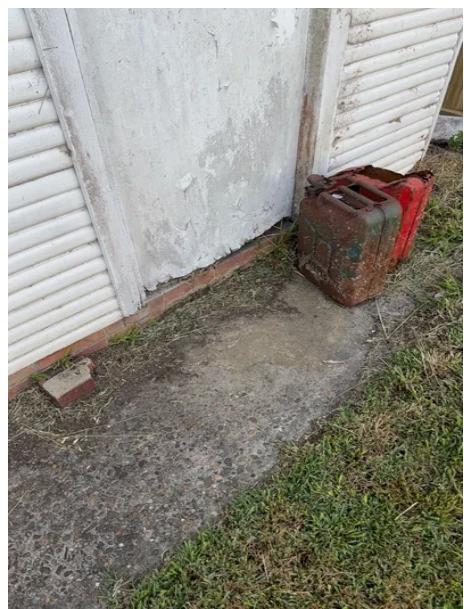
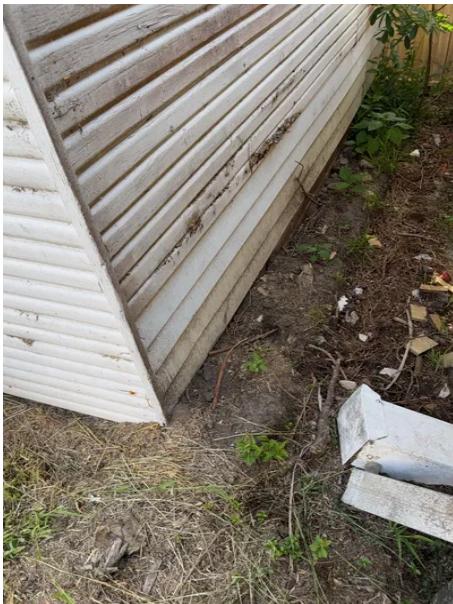
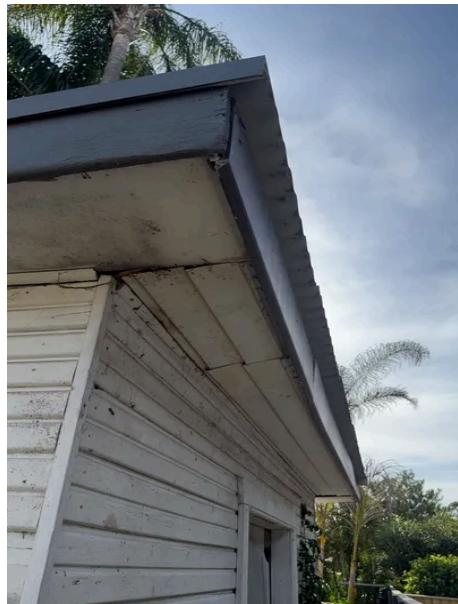
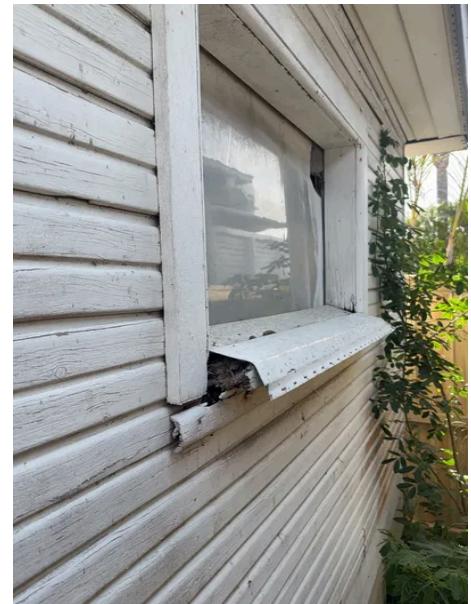
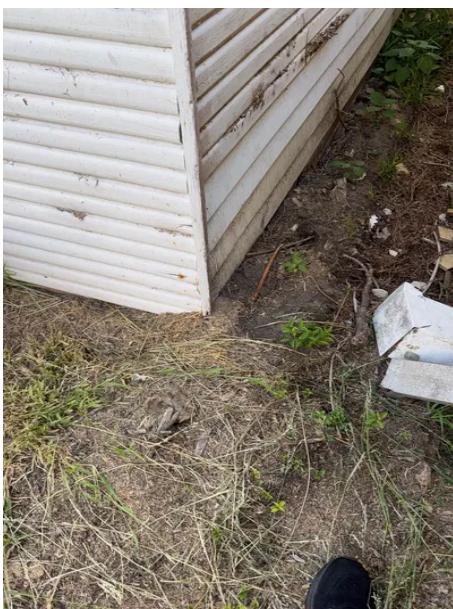
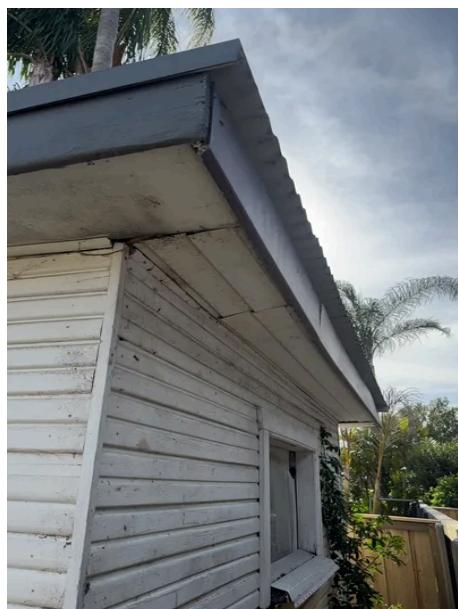
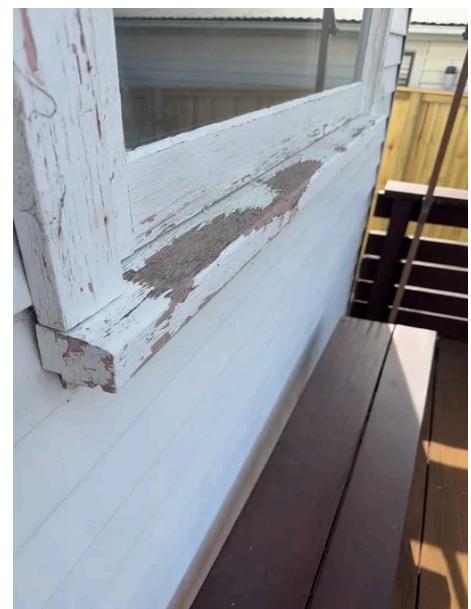
## **Missing sill beading / sealant within the external walls**

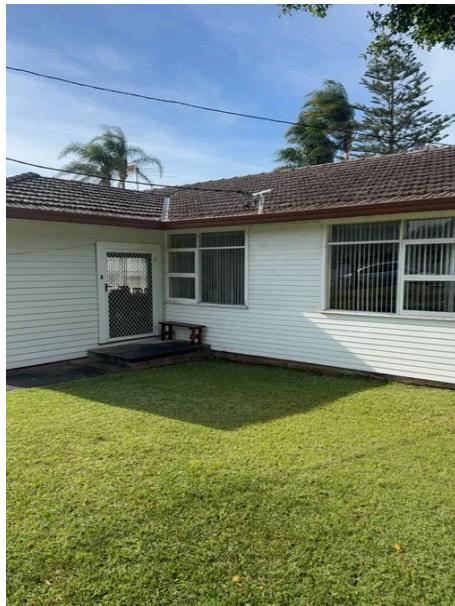
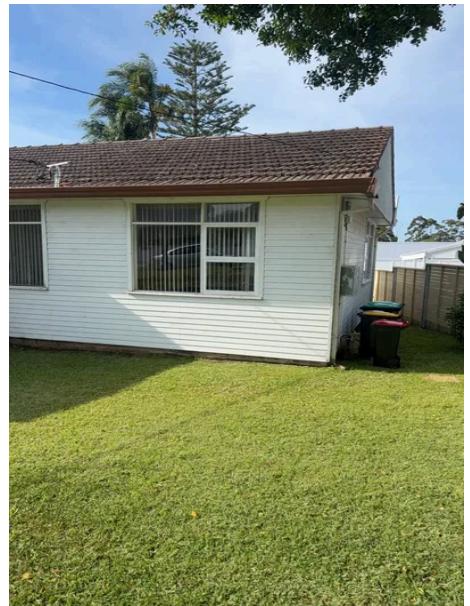
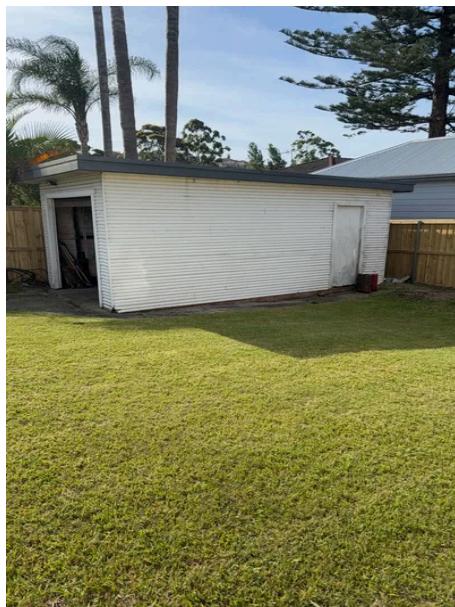
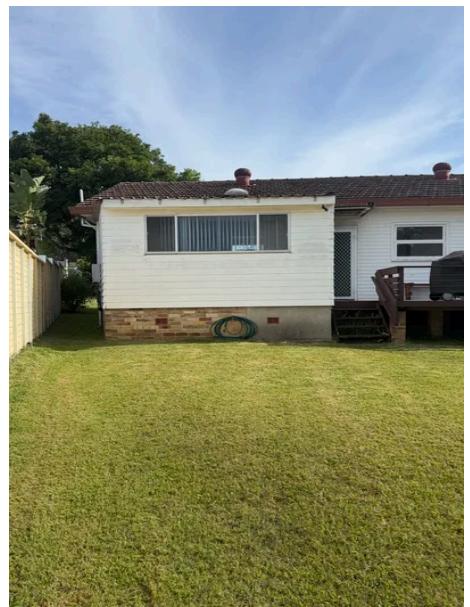
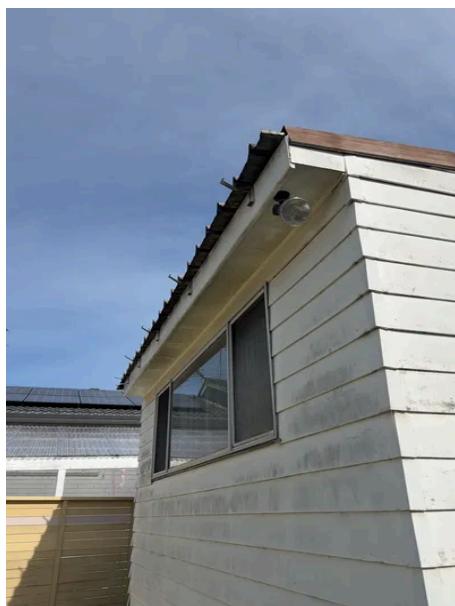
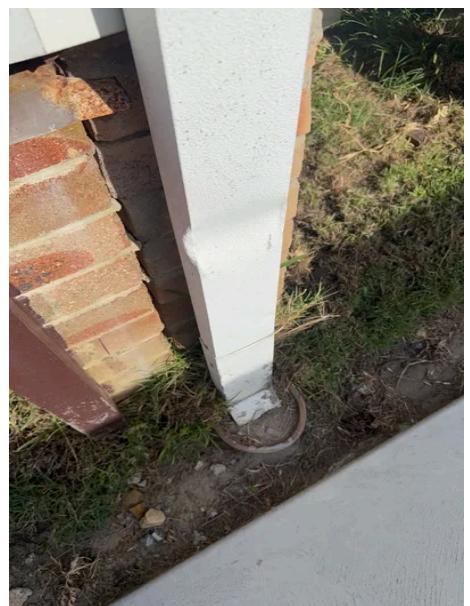
### **The timber bargeboard have fungal decay**

*Fungal decay seen to be present on the bargeboards Repairs to this area should be undertaken by a carpenter and painter*

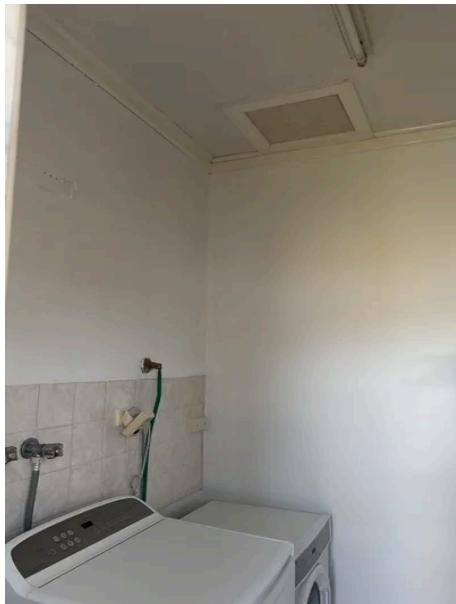
- I went to inspect the roof void and I found the manhole located with the laundry above the dryer. The dryer and washing machine needs to be removed so I can install a step belief the manhole for direct access into the roof void
- I did not inspect nor report on any aspect of the roof void due to these obstructions

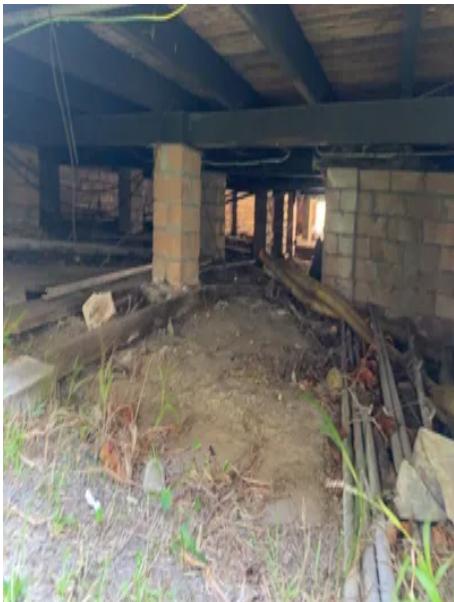
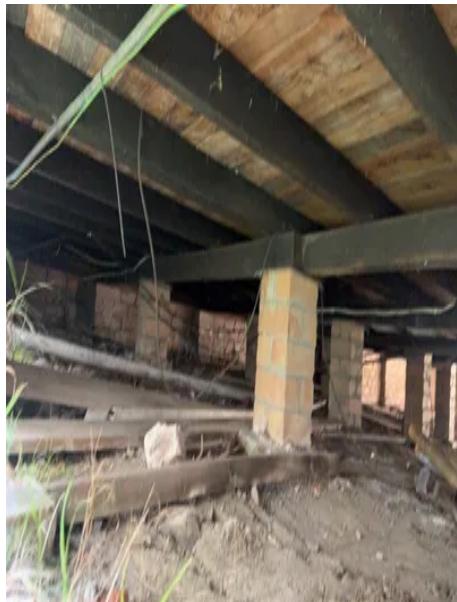
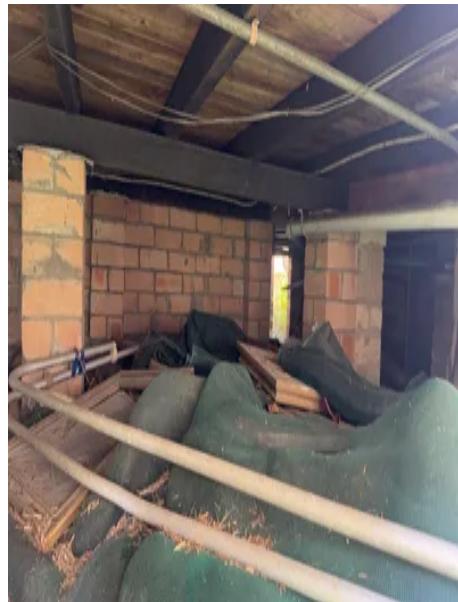
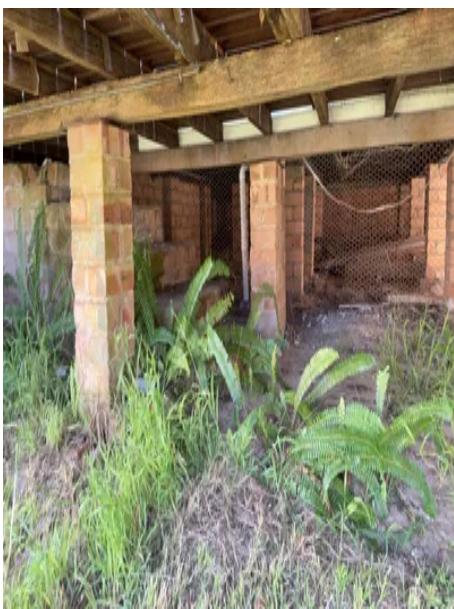
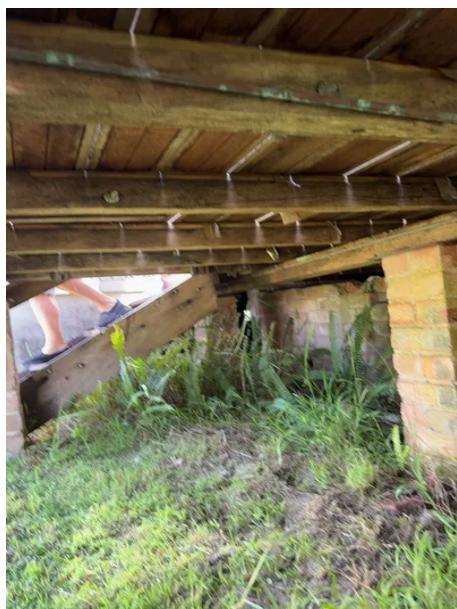
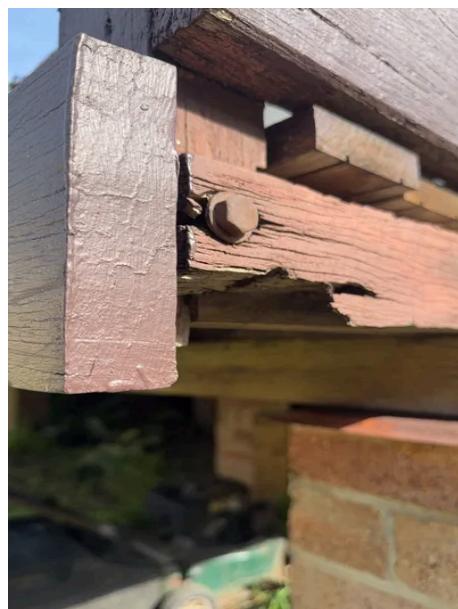
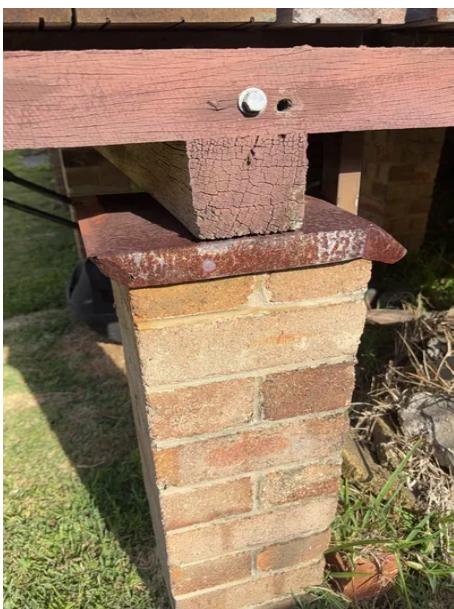
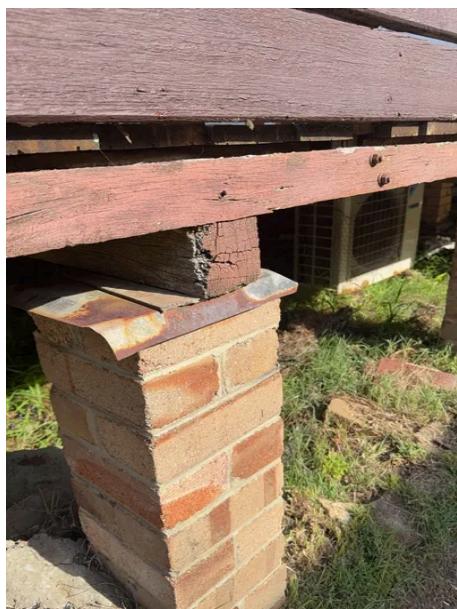
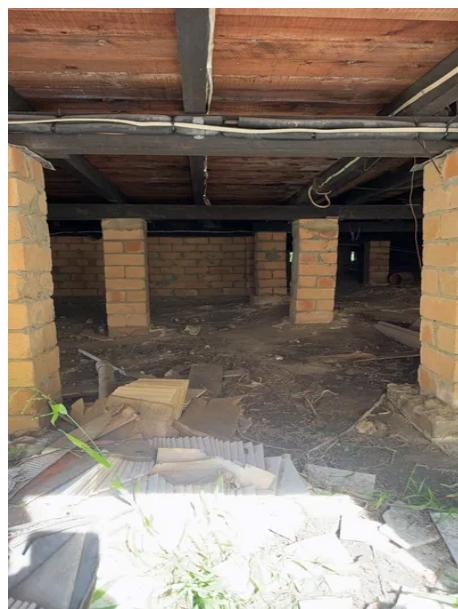
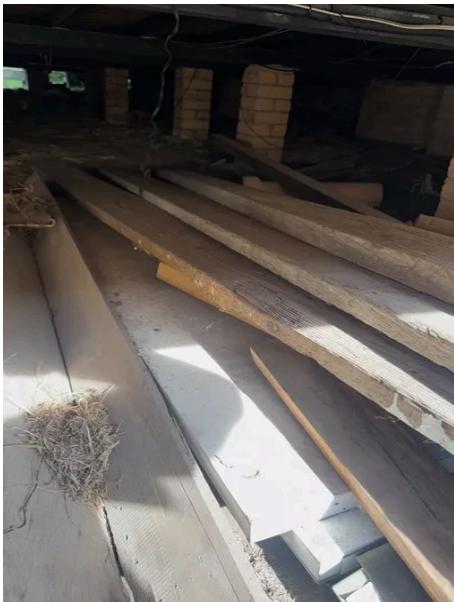
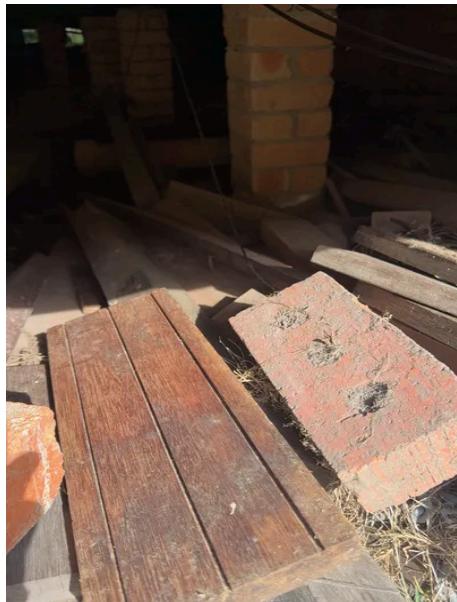
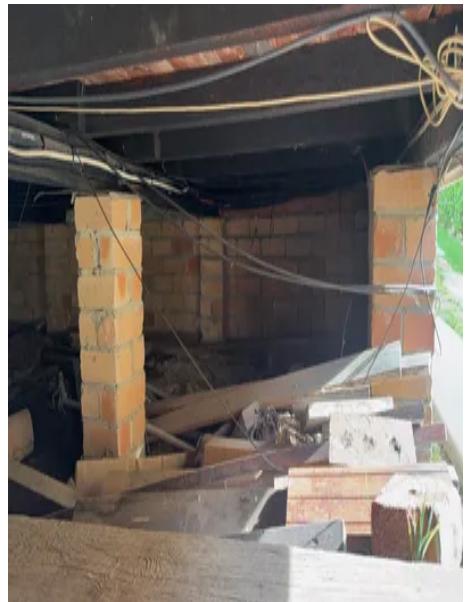
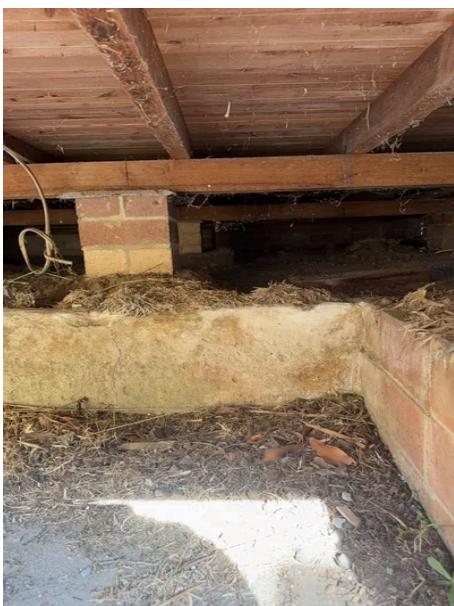
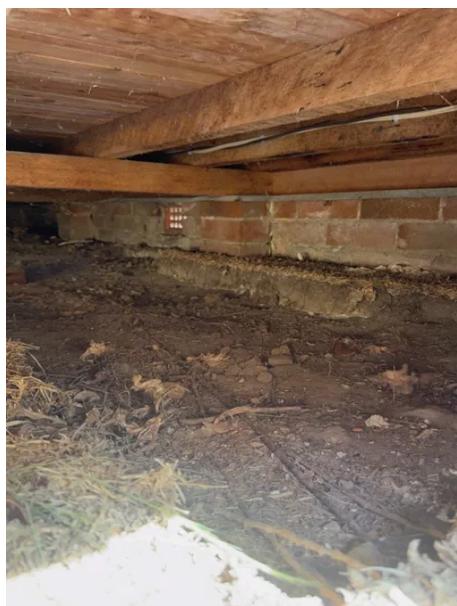
**Excess building waste was seen to be stored within the subfloor, it's best to have it removed for clear access within the subfloor area**

**All subfloor areas should be kept clear, clean, dry / damp free and well ventilated to avoid attracting termites to the subfloor**
