## Pre-Purchase Building & Pest Inspection Report

## BUILDING & PEST REPORT

**Property Address: 16 Cormack Road, Beacon Hill NSW, Australia**

Date of Inspection: 25/11/2024

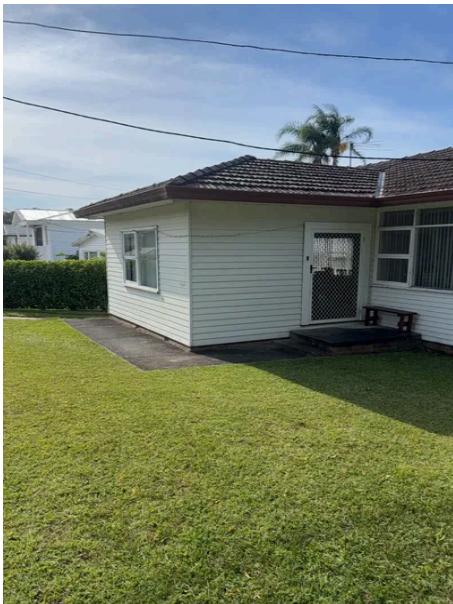
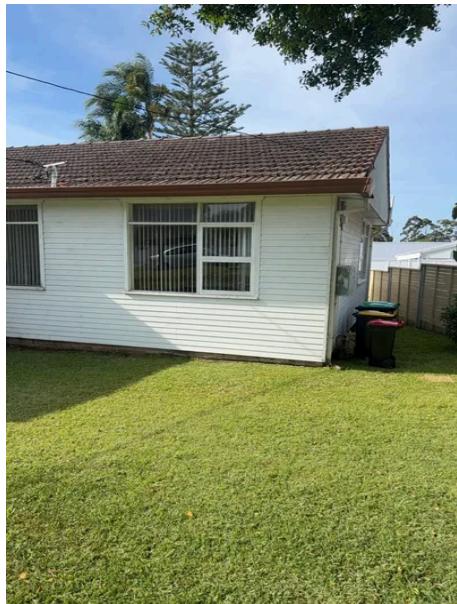
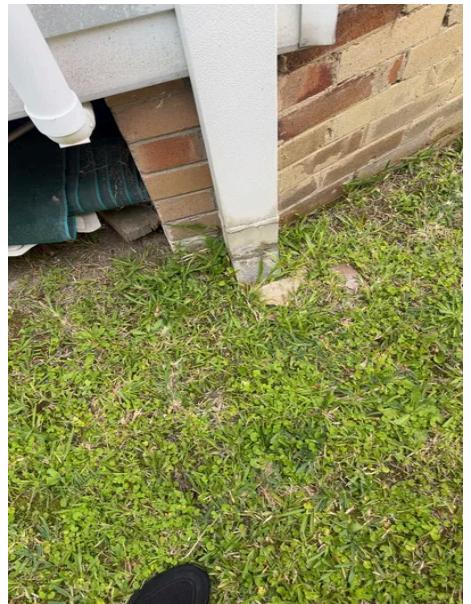
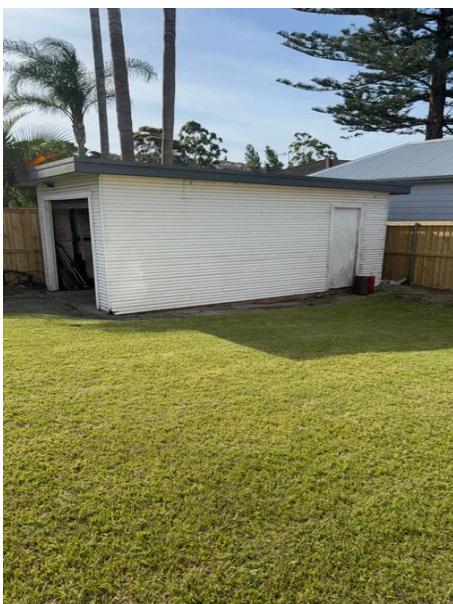
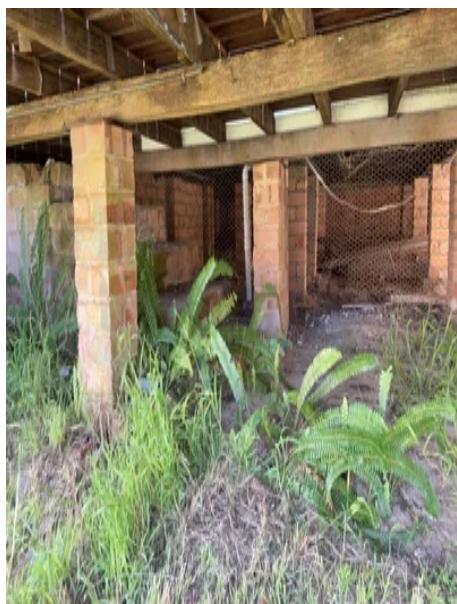
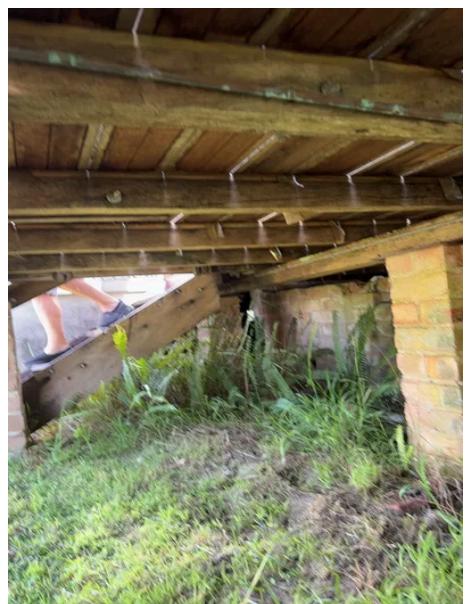
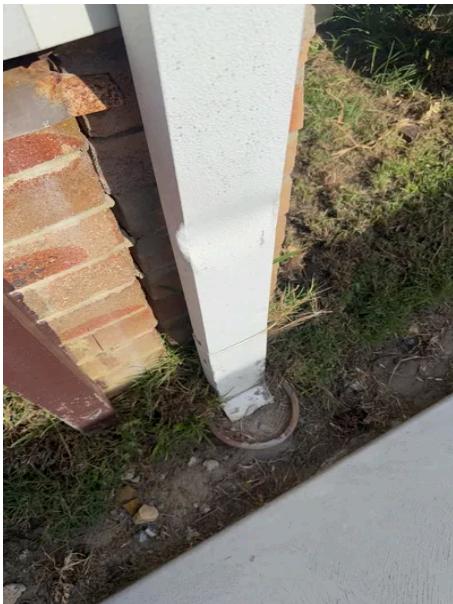
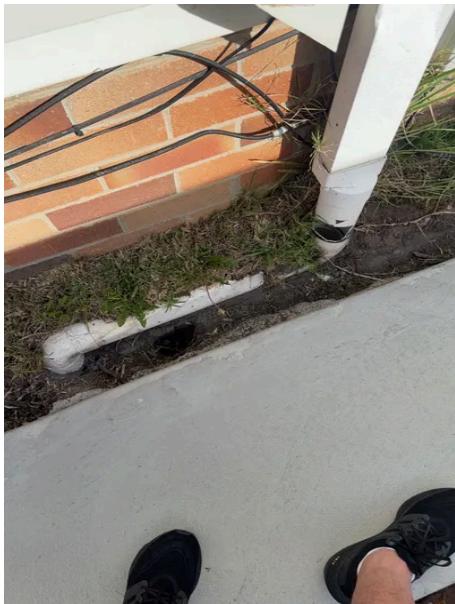
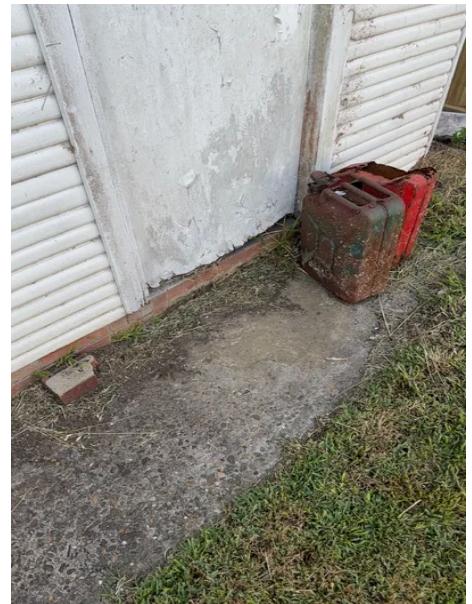
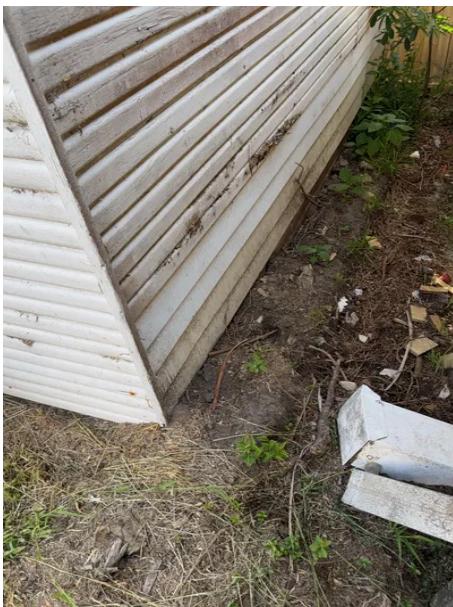
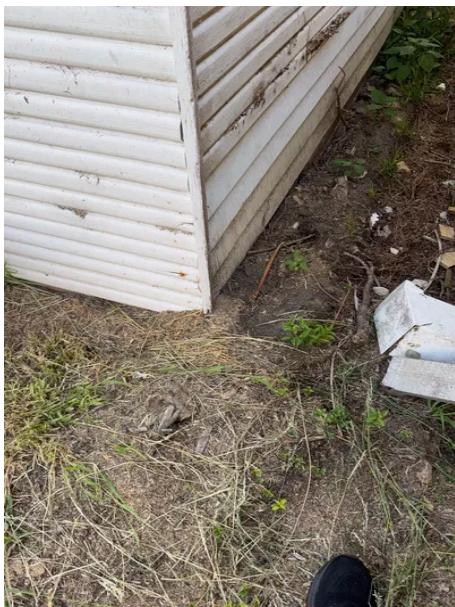
**There is Natural Ground / Soil / Lawns found hard up against the buildings - Water is able to pond against the building**

**The boundary fences appears to be in reasonable condition for their age**

*Having garden beds installed close to or hard up against a building / your property is not ideal. Most homeowners love the idea of having soft landscaping next to a hard structure but in fact, it attracts moisture to the foundations, footings and subfloor areas of the property. All moisture should be directed away from a building/supporting wall/member and subfloor areas. It is common to find masonry walls within subfloor areas to be affected by dampness/moisture, with no building defect to be found but the moisture within the subfloor walls, this can be due to the owners watering their gardens which are in close proximity to the subfloor walls or adjacent foundations of a property.*

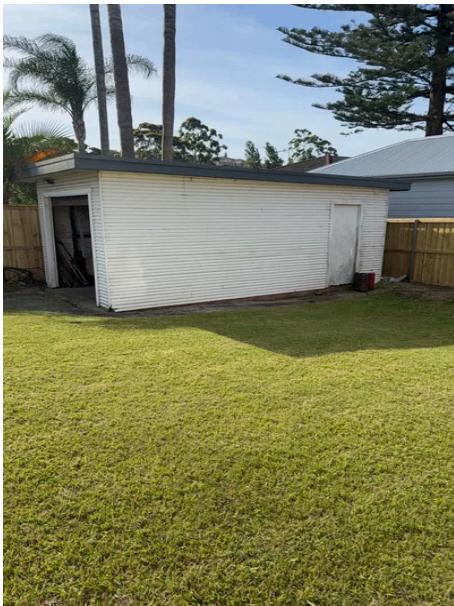
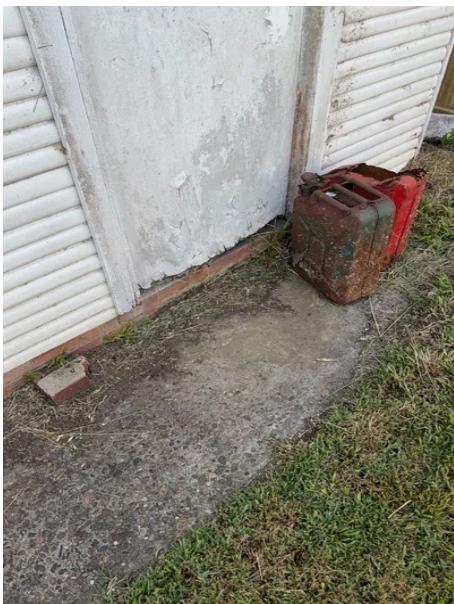
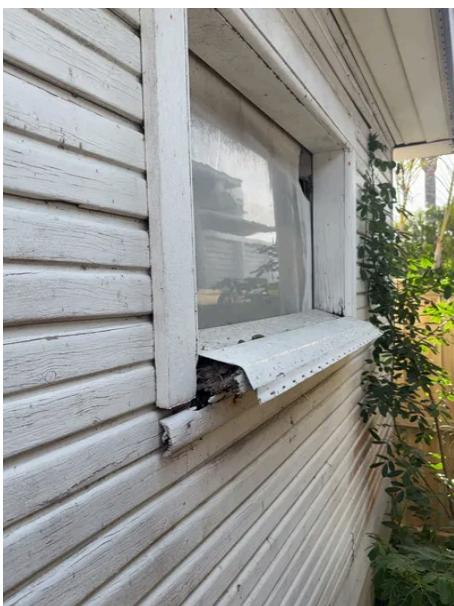
**Walls within the garage have minor cracks within the walls**

**The walls within the garage have moisture within the walls above 1m in height form the floor**

### **External wall linings are weatherboard cladding which are damaged and in need of repair**

#### **Timber decay within the door unit**

#### **Timber decay within the external window**

#### **Timber decay within timber posts on either side of the garage door**

**Timber framing / wall plates are in direct contact with the slab, wet and dry rot can develop in these timber due to constant moisture from the floor**

*No gutters installed and this is creating moisture issues within the foundations, footings and wall frames/structure, together with attracting pest infestations to reach the building due to pooling and ponding water*

#### **No downpipes**

*The timber door has decayed. Replacement required. It is preferable to have a solid core door fitted when exposed to weather.*

*The timber window is affected by wet and dry rot. Replacement/repairs to the timber members are required. It is preferable to have a solid timber member fitted when exposed to weather.*

*Wet rot could be present at the base of the posts, it's best to have all timber posts or wall frames not in contact with the floor or moist / damp areas / surfaces to prevent wood rot developing within the timber framing*
