## Pre-Purchase Building & Pest Inspection Report

**Property Address: Unit 10 63 Crown Road, Queenscliff NSW 2096, Australia**

Date of Inspection: 18/11/2024

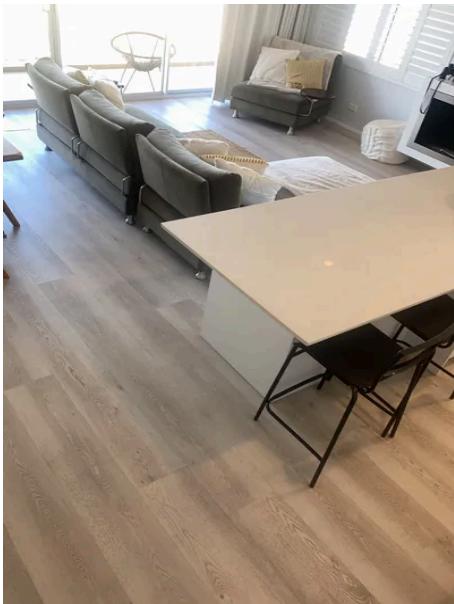
### No significant defects were sighted within the internal CEILINGS of this property

### No major defects were noted within the WALLS within this building

### I saw no significant moisture issues within the internal habitable rooms within this building

### No significant defects were seen within the walls, floors and ceilings within this building at the time of my inspection based on using no mechanical equipment (no torches, no thermal cameras, no moisture meters)

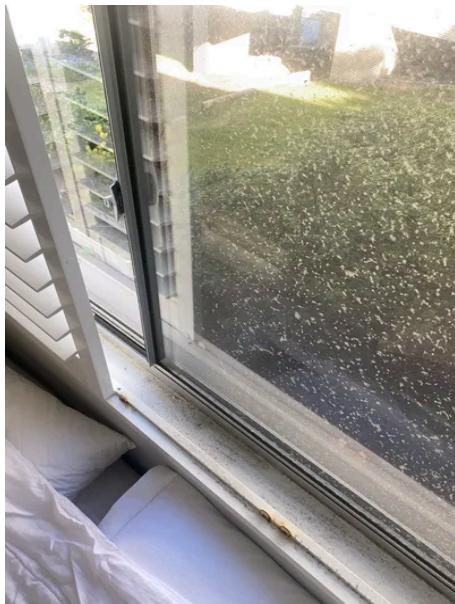
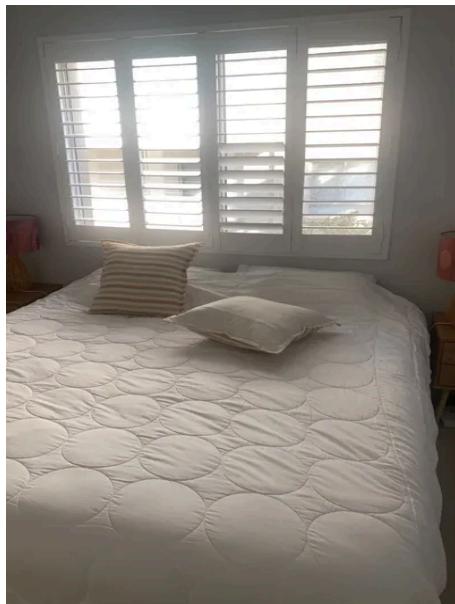
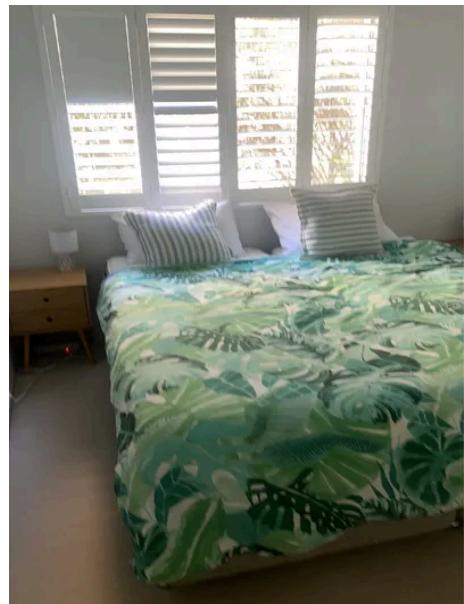
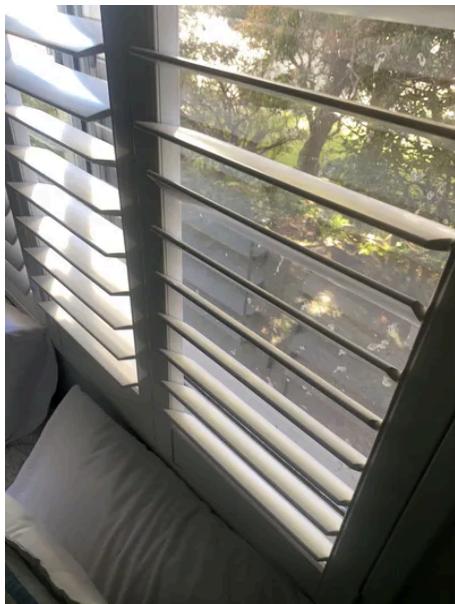
The windows should be brought up to current regulations for the safety of the occupants and visitors of the property. When windows can open greater than 125mm with a fall greater than 2m, a window restriction lock should be installed. If you choose not to install window locks to the bedroom windows, it's best not to install a bed or objects near the windows in order to limit the possibility of a falling person / children from the windows (Kids tend to jump on beds and this could be fatal if a child was to jump out / fall out of a window which has a fall greater than 2m). Installing a window restriction lock is a quick and easy task and its inexpensive for the new owners of this property. This is a Safety hazard / Major defect

## Overall Defect Rating: SAFETY HAZARD

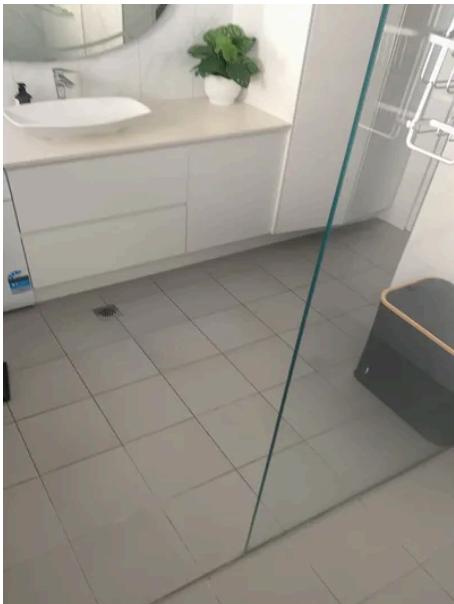
### **There were no defects sighted within the bathroom wall and floor tiles**

### **There were no leaks seen within the bathroom, shower cubicle or adjacent areas**

### **All lights, fans and powerpoints appeared to be in working order with no defects to report on within the electrical trade within the bathrooms**

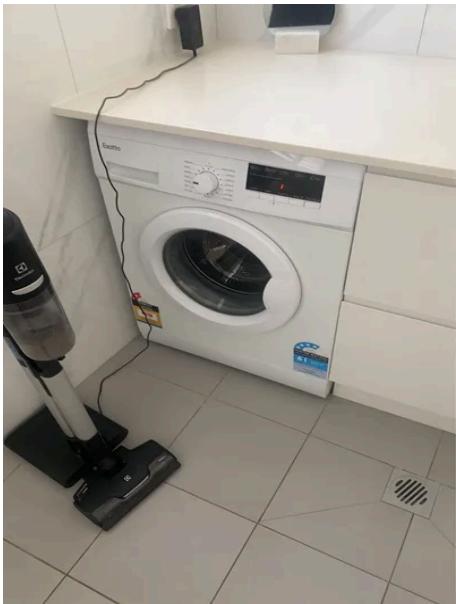
### There were no significant defects seen within the laundry

**The laundry water supply, waste line, tub & tapware appear to be in working order with no significant faults or defects seen at the time of my inspection**

**The electrical fitout within the laundry appears to be all in good order, there were no issues seen within the power supply, powerpoints, light fittings, switches and exhaust / ventilation within the laundry**

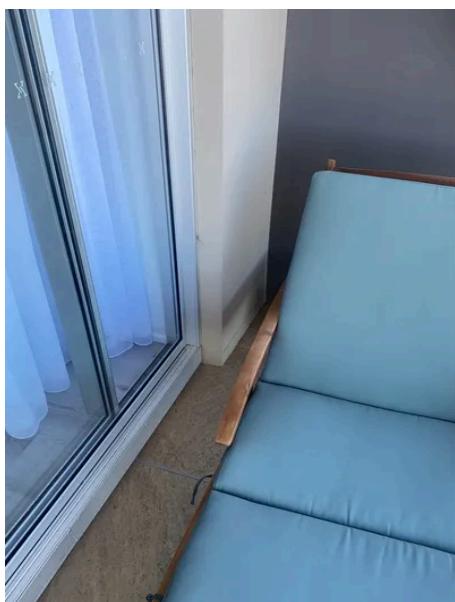
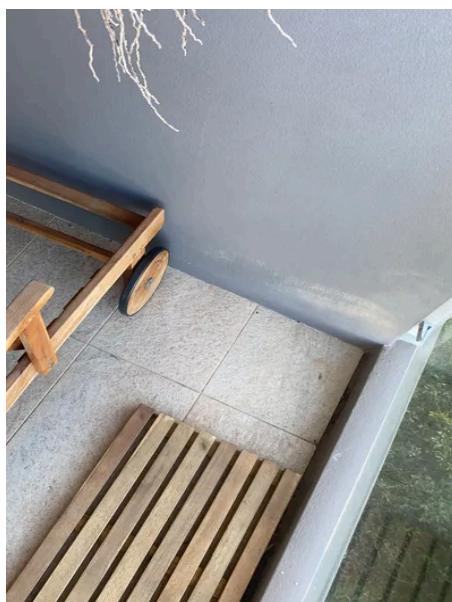
**I found weep holes within the external masonry walls, I could see a few missing weep holes in various locations**

*Area of improvement should moisture be found within the internal or external walls Weep holes should be found along the baseline of the wall at the flashing level at every 1m interval and weep holes should be found above and below all external doors and windows that are wider than 1m in width Weep holes should be found at the top of any roof flashings / wall flashings / capping or any other break in external damp proof courses*
