VEHICLE TECHNICAL VALUATION REPORT

REGISTRATION NO	KCM 514K	CHASSIS NO	chas12346	COLOUR	Red
NO OF AIRBAGS	2 Airbags	YEAR OF MANF.	2010	MAKE	Toyota
ENGINE RATING	1800 CC	ENGINE NO	ENG123	ODOMETER-CURRENT READING	185000
TYPES OF LIGHTS	LED Headlights and Brake lights	DATE OF REG.		TYPE	AUTO 5 SEATER S/WAGON
FUEL TYPE	Petrol

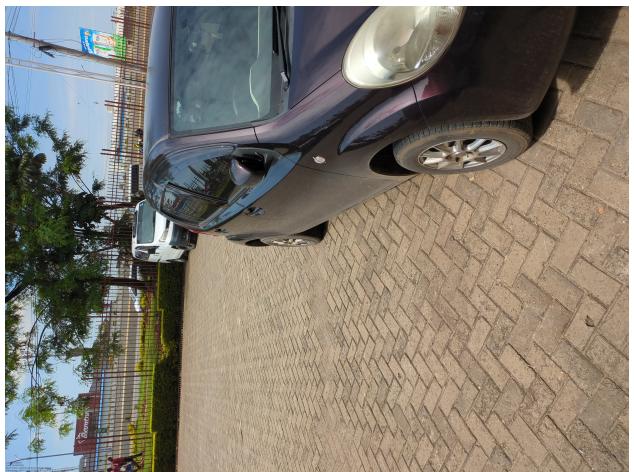
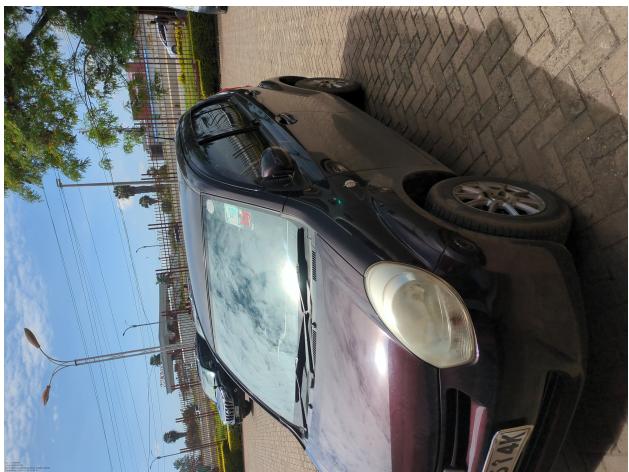
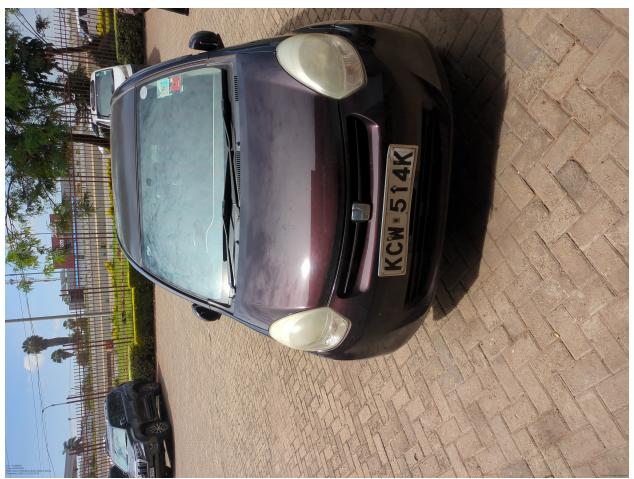
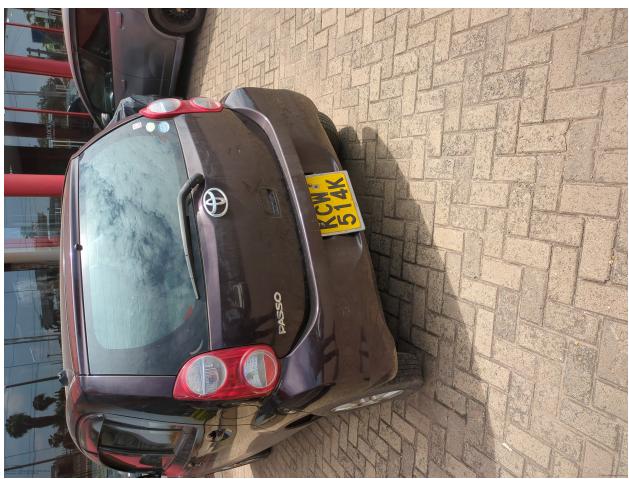
Coachwork notes	Minor scratches on the right side, cracked rear bumper, scratches noted on doors, wings and bumpers.		
Electrical notes	Instrument panel lights flicker occasionally		
Mechanical notes	Suspension system needs attention, worn out arm bushes, engine and gearbox mountings		
Extras	AC, ABS, Alloy rims, Fog Lamps, Xenon Lights, Side Mirror Indicator, Wing Indicator, Wind Breakers, Tint Windows, Car Identity, CDL, Cup Holder, 2 Cut Off, Rear Disk brakes, Rear Spoiler with high mounted brake lights, Rear Wiper, Roof aerial, Head rest, Foot Rest, Arm Rest, Digital Odometer, Dual SRS Airbags, Inbuilt R/CD/TV Player, Paddle shifters, Power mirror, Power Steering, Power Window, Sun Visors, Tiptronic Gearbox, Telescopic Bonnet Damper, Wood Print Finish,		
Anti theft	CAR ALARM		
Tyres	4 GOODYEAR TYRES 225/65R17 AND BRIDGESTONE T165/80R17 DONUT SPAREWHEEL ALL OF GOOD THREAD DEPTH		
General condition	Fair	Assessed value	850,000 /= (Eight Hundred And Fifty Thousand, Shillings Only)

Remarks	Assessed value consistent with low usage.		
N.B	N/A		
Remedy	Recommended suspension system repair and respray the affected panels, replace worn out arm bushes, engine and gearbox mountings.		
Country of origin	Japan	Date of inspection	2023-05-15
Examiner	John Valuer	Destination	MUA Insurance
Lcation of inspection	Nairobi, Kenya	Amendment:	None
Signed	John Doe	Receipt No:	REC12345
NB: This Report reflects the estimated Market Value of the subject vehicle in its present condition, at the time of valuation. Any future assessment will take into account any changes in the meantime, due to usage e.t.c. This report is based on information on the logbook/importation documents.
