## The Baroque architecture of Scicli (south-eastern Sicily): characterization of degradation materials and testing of protective products

In this study, through a diagnostic analysis, the degradation materials occurring in the churches of St. Matteo, St. Michele and Carmine in the city of Scicli, as well as residues of treatments carried out in the past, have been identified.

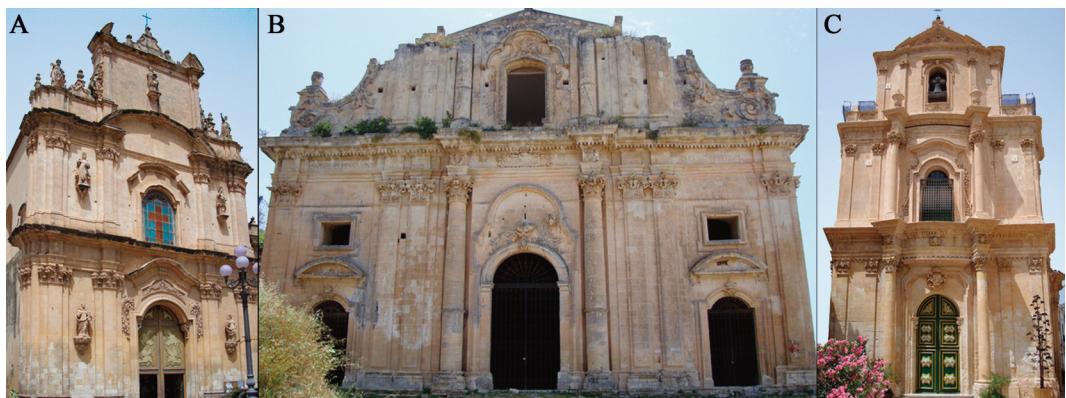
Figure 2. Façades of the three investigated churches: a) Carmine; b) St. Matteo; c) St. Michele.

refer to previous interventions, but only indicating the periods in which these restorations were made (1990 in the church of Carmine, 1980-90 in St. Matteo and 2008 in St. Michele), without any specific indication of the products used for treatments.

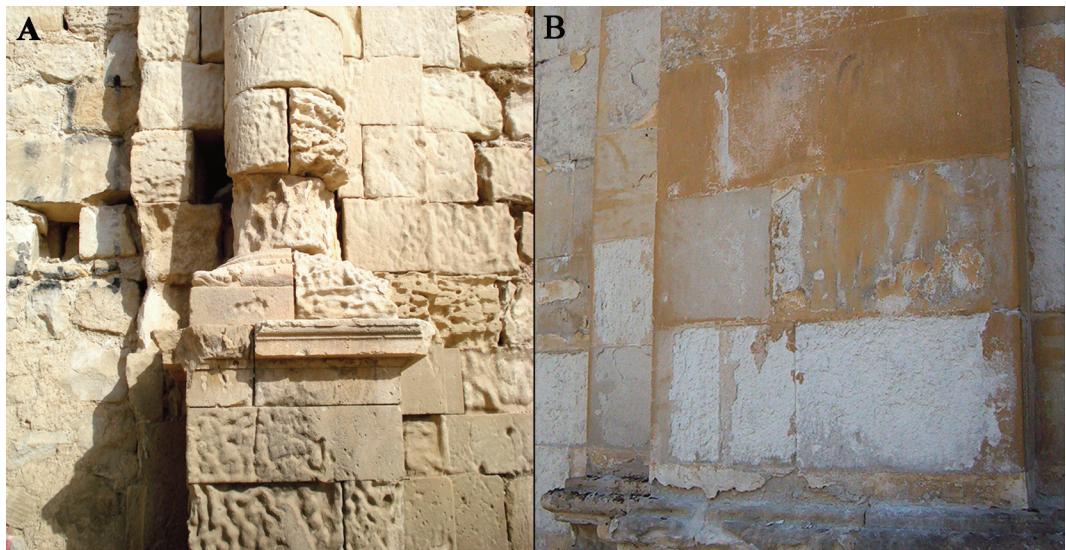
Figure 3. Two examples of the commonest degradation forms observed in most of the monuments of the city: a) alveolization (church of St. Matteo); b) chromatic alteration and exfoliation (church of Carmine).

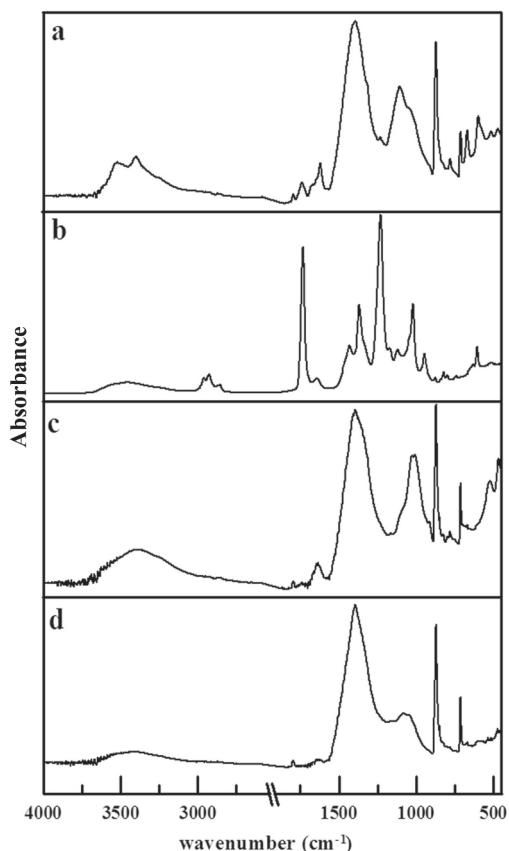
The extracted phase of sample SC1 shows the stretching vibrations of polyvinyl acetate, centred at 944  $\text{cm}^{-1}$  (C-O), 1365  $\text{cm}^{-1}$  (C-H), 1735  $\text{cm}^{-1}$  (C = O). The band at 708  $\text{cm}^{-1}$  indicates the torsion of the C-H group (Derrick et al., 1999).

Figure 4. FTIR spectra of: a) sample SC1 from the church of Carmine; b) organic phase of sample SC1, extracted with acetone; c) sample SC5 from the church of St. Matteo; d) sample SC12 from the church of St. Michele.

performed on the same. In particular, regarding the church of Carmine, the presence of sulphates, such as gypsum and thenardite, has been recognised. Thenardite is considered to be one of the most aggressive salts for carbonatic rocks. As known in fact, at specific temperature and humidity ranges, a phase transition of thenardite to mirabilite occurs with a resulting volume increase in the order of 300% (Flatt, 2002). Hence, the necessity to select protective products which are able to inhibit the salt action. In

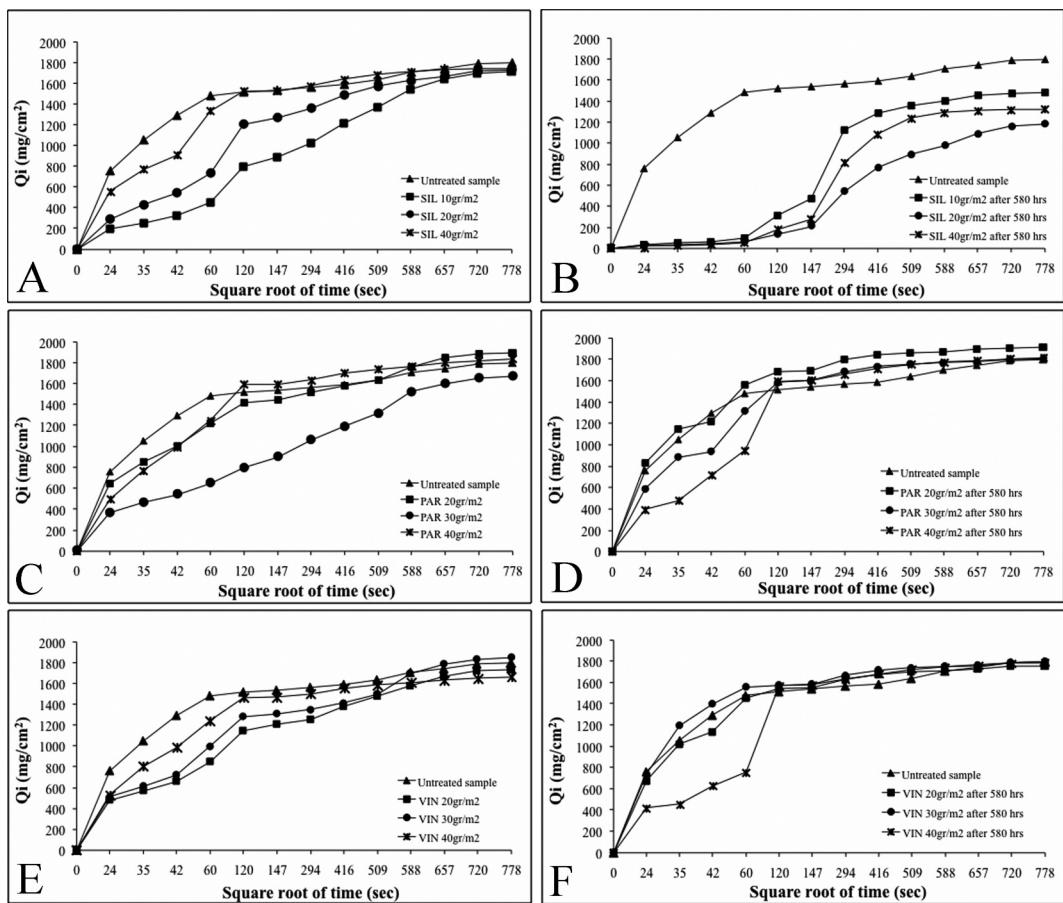
Figure 5. Water absorption curves relative to the three types of tested products. A and B refer to samples treated with SILO non-aged and aged, respectively; C and D refer to samples treated with PAR non-aged and aged, respectively; E and F refer to samples treated with VIN non-aged and aged, respectively.

Water capillary absorption tests showed that the same type of material interacts with the three tested products in different ways. In particular, samples treated with SILO 111 (Figure 5) display a different variation of hydrophobicity which is correlated with the different applied amounts and with the UV exposition period. All treatments with the three amounts give the stone a

hydrorepellent property though the best result has been obtained with SIL 20 g/m<sup>2</sup>, as demonstrated by the IC<sub>rel</sub> values. As can be observed in Figure 5, samples treated with this amount show a considerable decrease of absorption between freshly treated samples and those 580-hrs aged. This result can be ascribed to the slow reticulation of the applied product which increases during the UV exposition. Concerning samples treated with SIL 10 and 40 g/m<sup>2</sup>, results can be considered acceptable compared with the curve of untreated samples (Figure 5), even if IC<sub>rel</sub> values are lower. Results obtained for samples treated with Paraloid B72 highlight that this resin is not appropriate for this type of carbonatic substrate. Particularly, specimens treated with PAR 20 and 40 g/m<sup>2</sup> do not show any hydrophobic property. The absorption curves of freshly treated and aged samples are in fact close to curves of the untreated ones. Lastly, regarding samples treated with PVA K40, the relative absorption curves (Figure 5) show that their hydrophobic property decreases during the UV exposition thus indicating a scarce stability over time. It's worth noting that the data obtained for the vynilic resin are in strong contradiction with respect to the last restoration works which have interested one of the investigated churches. As above discussed, in fact, evidences of this type of product have been found in the samples taken from the façade of church of Carmine.

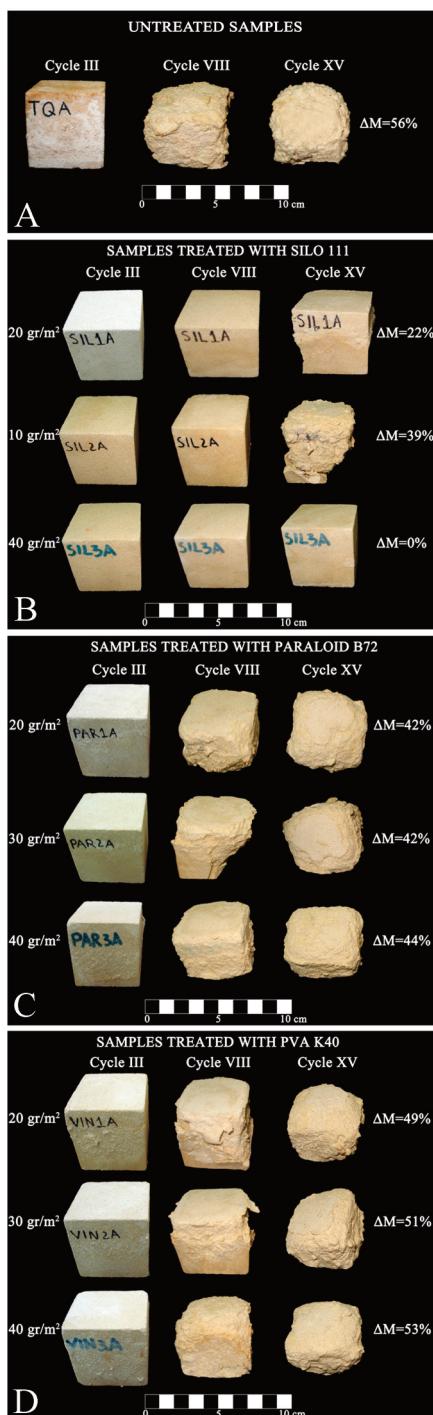
The salt crystallization test also revealed different interactions between each protective product and the substrate. The results show that untreated samples start their chromatic alteration at the third cycle, while since from the fourth cycle sub-efflorescences appear and the capillary rise front is well visible. At the fifth, other

Figure 6. Degradation forms and weight modifications after salt crystallization aging test performed on samples treated with different amounts of protective products.

degradation forms, such as surface exfoliation and detachment, start developing. The weight loss at the fifteenth cycle is of 56%. Samples treated with SILO 111 show different behaviour depending on the applied amount. In particular, those with SIL 10g/m<sup>2</sup> highlight the capillary rise front at the fifth cycle, a slight chromatic alteration at the eighth and loss of edges together with marked exfoliation at the following cycles. The weight loss was of 39%. Regarding samples treated with SIL 20g/m<sup>2</sup>, the capillary rise front is well visible only at the twelfth cycle, fissuration appears at the fourteenth and loss of edges at the fifteenth. The total weight loss was of 22%. Lastly, samples treated with 40 g/m<sup>2</sup> show a behaviour totally different from the previous ones since no degradation phenomenon has been observed until the end of the test. A slight weight increase (0.3%), probably due to small quantities of salts trapped inside, has been recorded. All samples treated with PAR show the same trend of degradation: at the second cycle a slight chromatic alteration occurs, at the fourth sub-efflorescence and surface swelling, while exfoliation and loss of edges during the following cycles. The weight loss was of 42%

for samples treated with 20 and 30 g/m<sup>2</sup>, 44% for those with 40 g/m<sup>2</sup>. All samples treated with VIN starting from the second cycle display a slight chromatic alteration and an initial development of sub-efflorescence, at the fifth the capillary rise front is visible, from the seventh considerable weight losses occur, which progressively intensify until the end of the test. Samples treated with VIN 20g/m<sup>2</sup> show a total weight loss of 49%, those with 30g/m<sup>2</sup> of 51% and those with 40g/m<sup>2</sup> of 53%.

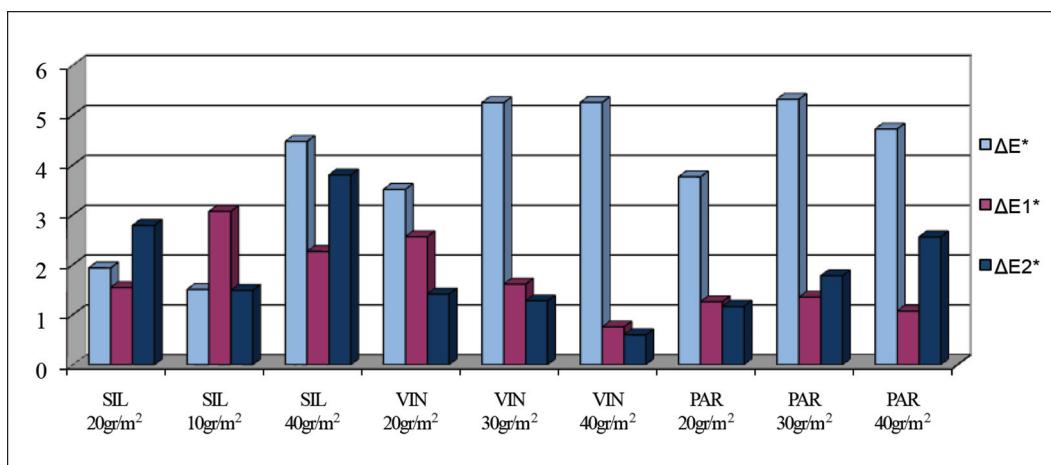
untreated and treated samples are indicated with  $\Delta E^*$ , those between treated and 340 hrs -aged samples with  $\Delta E1^*$ , and between treated and 580 hrs-aged samples with  $\Delta E2^*$ . The results can be also visualized in the histogram of Figure 7.

Figure 7. Histogram showing  $\Delta E^*$ ,  $\Delta E1^*$ ,  $\Delta E2^*$  values for samples treated with different amounts of SIL, PAR and VIN.
