Minor Project report

"STUDY OF IMPLEMENTATION OF SIX SIGMA IN PLASTIC INDUSTRY" $\,$

DEPARTMENT OF INDUSTRIAL AND PRODUCTION ENGINEERING Dr. B.R.AMBEDKAR NATIONAL INSTITUTE OF TECHNOLOGY, JALANDHAR

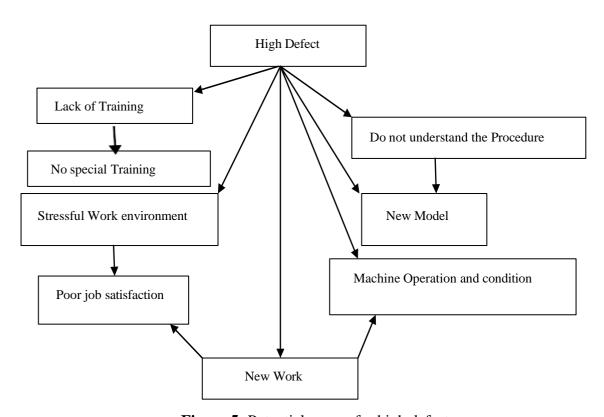
Figure 5: Potential causes for high defects

Analyzing the rejects based on models indicates that the highest percentage of defects occurred in model Round Jar-3004. Figure 6 shows the potential causes for high defects. The number of defects is high when there are new models being introduced. It may be due to the operators not given enough training or no special training for the operator to understand the correct method to produce the part. Besides that, the high defects might contributed by the machines. The machines Might operate by new technicians that lack of training or experience. This will lead to misjudging in solving the problem during the machining process. Stressful environment also can lead to high rejects. It's a human nature, where when workers find that the working environment stressful, this will lead to dissatisfaction in working condition and at the same time it also leads to high defects. Besides that the method or standard operation principles also can lead to high defects. Methods or SOP for the particular process might be varying from the actual SOP for the process and this will contributes to wrong machine setting or operation parameters.

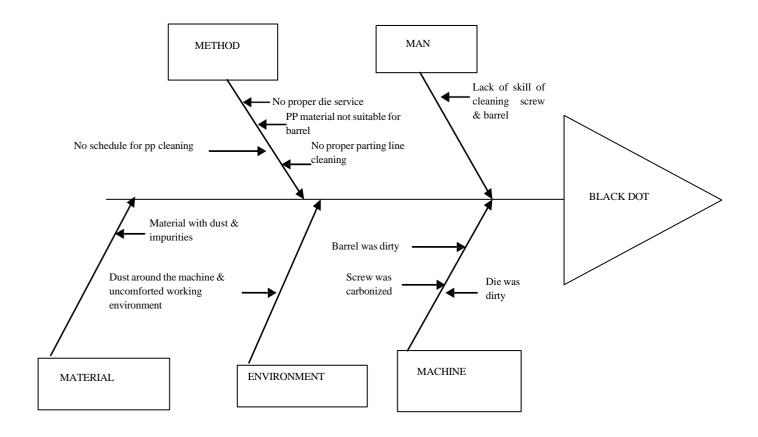
Figure 6: Root causes analysis for black dot

The wrong part defect is caused by five major factors, which are machine, environment, man (operator), method and the material. Figure 5 shows the cause and effect diagram for the black dot defect. Machines are one of the factors that must be given black dot consideration. The machine contributes a lot of possibilities to black dot rejection defect. Examples, without proper parameter setting it will result to a carbonized screw. Aging machines also can lead to defects. Maintenance also plays and important part because, without maintenance the performance of machine will be affected and the desired output could not been gained. When an operator does not have enough experience and practice, it is quite obvious that the operator produces more defects than the others. Defects might occur when jobs carried out without guidance of leader or without any instruction. Besides that, number of defect will increase when untrained operator or new operators are assigned to do the job.

The work method is another major cause of the problem. It was found that the operator did not know the correct method set the machine and the parameters but only followed the instructions without knowing the correct method. As a result the operator can lead to black dot defect or other rejection. Working environment was another cause for the defect. It is based on company policy where, there are two shift with 12- hours working period each in the production department. This can cause the operator to loose concentration, become tired and bored doing the job. As a result the organizations will hire new operator who do not have any knowledge or experience in the production line. Besides that, a material as an important medium in injection molding process also contributes to some major defects. Examples, when material are contaminated with other foreign particles it will effects the properties of the part and at the same time it lead to major defects.

The injection screw was carbonized before cleaning, which was used to mould the Round jar-3004. After a request as a suggestion to the engineering group to clean the screw. Sand paper and some chemical solvents were used to clean the screw. Most of the dirt was identified from the material which was carbonized because of overheated in the barrel. The overheated material will stick on the screw and will released slowly each time injection and caused for the black dot on the surface of the Round jar-3004.

It was seen at the time of study the condition of machine which was not cleaned properly where a lot of scrap material surround the tie bar and hydraulic unit area. This condition will lead to a situation where the foreign materials or scrap material will mixed original material and at the same time leads to black dot and other defects.

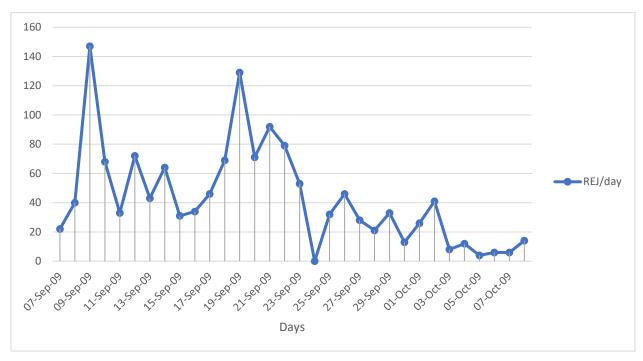
Figure 7: black dot trend before and after screw cleaning for machine E03

Figure 7 shows a run chart that represent the Black Dot trend before and after screw cleaning process for machine E03. Based on the figure 7, the trend before cleaning shows that the defects per day from 7th September to 23rd September is higher than the trend after cleaning where the cleaning process perform on 24th of September. This clearly shows that the machine factor plays an important role and it needs to maintain for time of period in order to eliminate or reduce the black dot problem.

The chart itself concludes that one of the main causes for the black dot is the machine condition. These results will be used by the production in charge member to perform continues action and at the same time improve the sigma level for the process.

From the analysis done for this project, a conclusion can be made that machine condition is the major contributor for the black dot problem. Since the engineering group member cannot clean the injection screw or the barrel every day, a new cleaning material agent was proposed or suggested to solve this problem.
