Project Big Ford

Ford LTD Crown Victoria LX Country Squire

September 2009

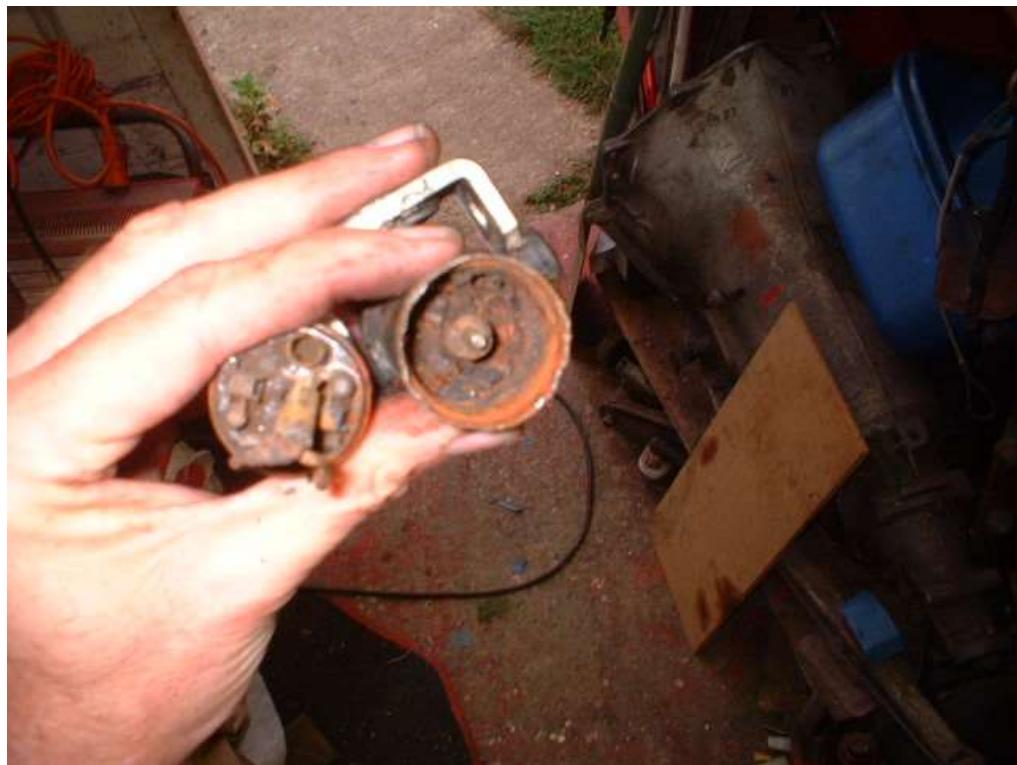
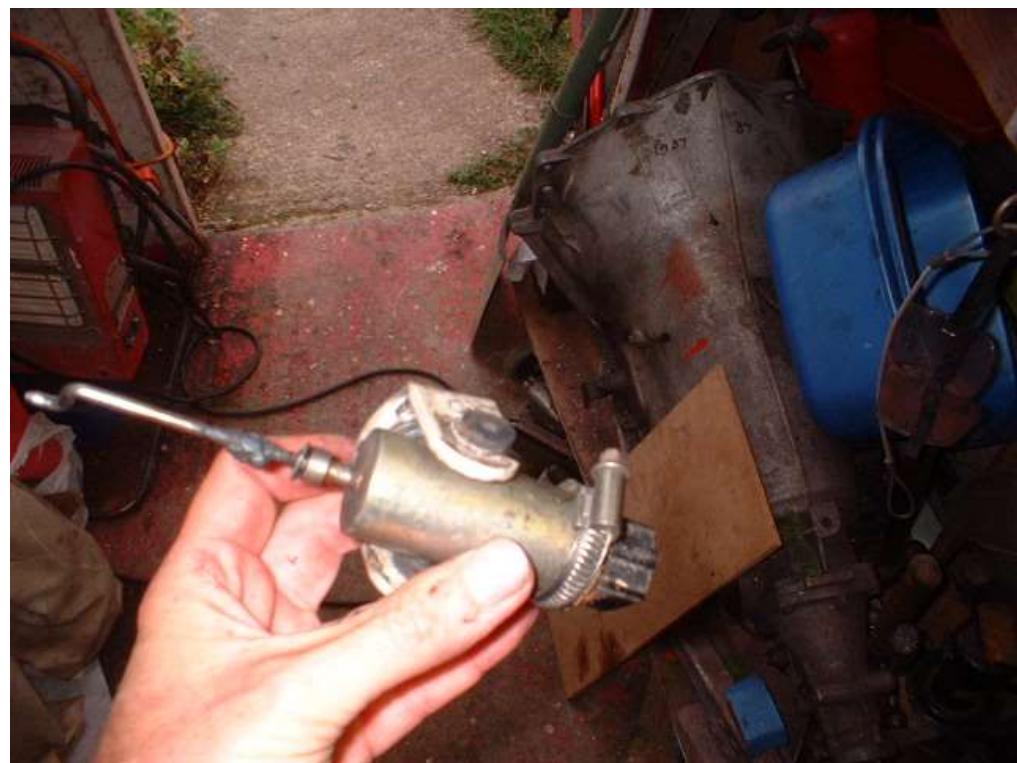
Picked up a new angle grinder from the new B & Q. Used it to grind the head off the rivet that holds the solenoid in. This is the view when dismantled:

Can't repair that one then! I'll look for a replacement.

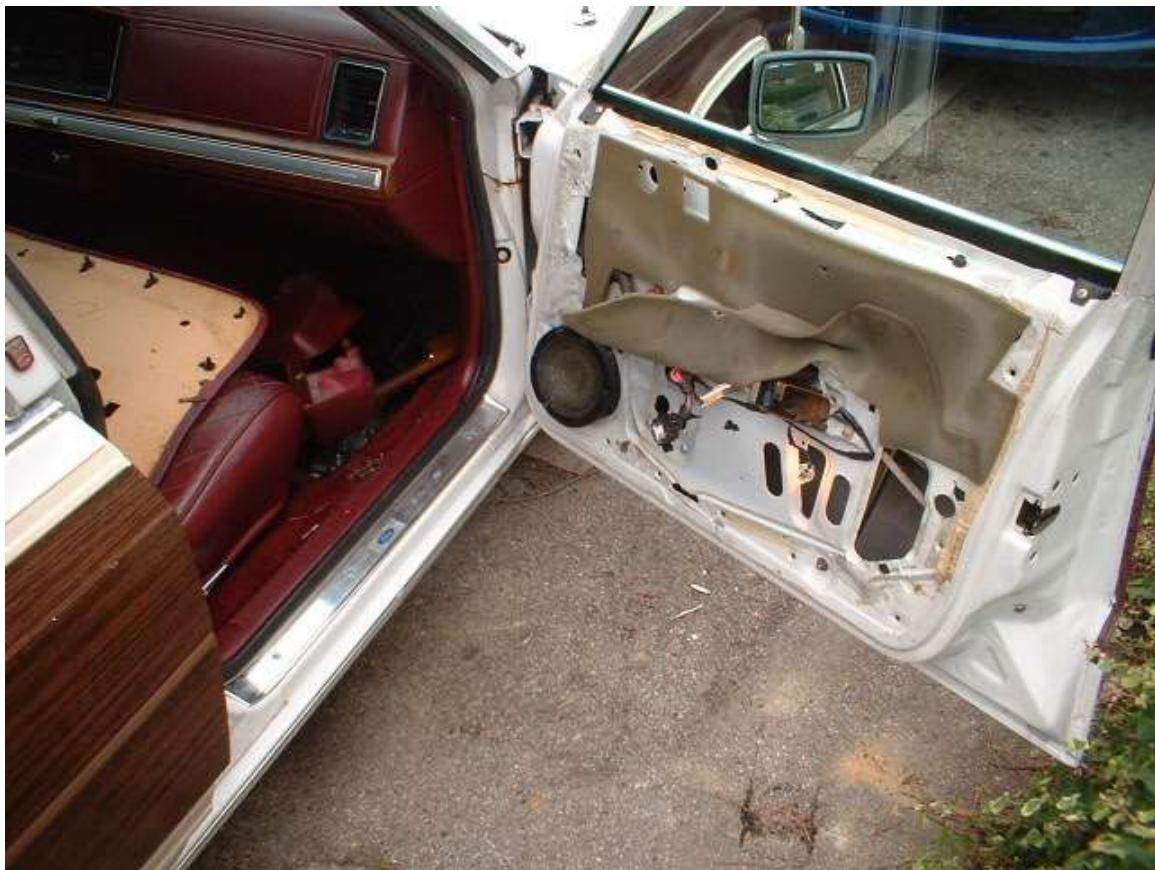
One stripdown later and somebody has been in there before. The solenoid is loose inside and is not moving. I need to grind the rivet head off outside the door and have a careful look. Also check the signal to it. Then I may replace it with the old camaro ones I took off. Probably won't need them because the handles may be disappearing.

Here is a view of the part dismantled door.

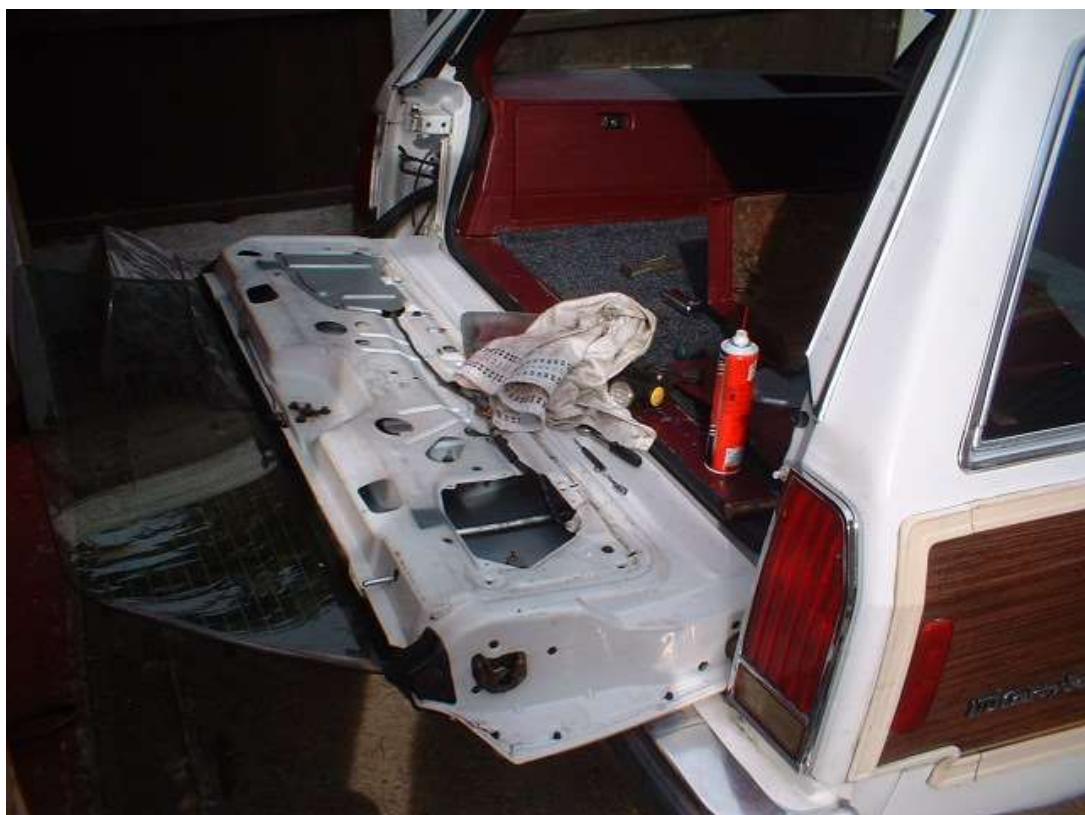
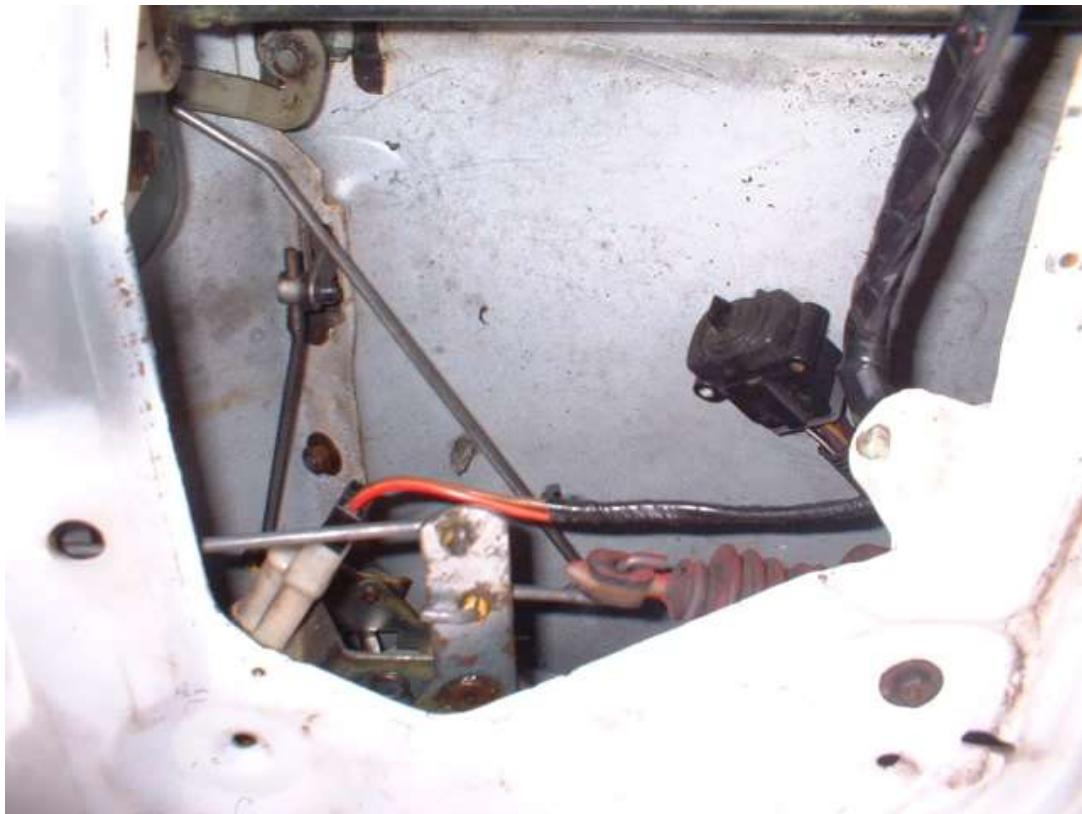
Went to tailgate and removed the lock mechanism and solenoid. This was in order to find out why it was hard to put up the rear window with the key. All this was due to a misadjustment at one of the rods. Working well now. Solenoid was beyond repair, so a camaro one was substituted and is working fine.

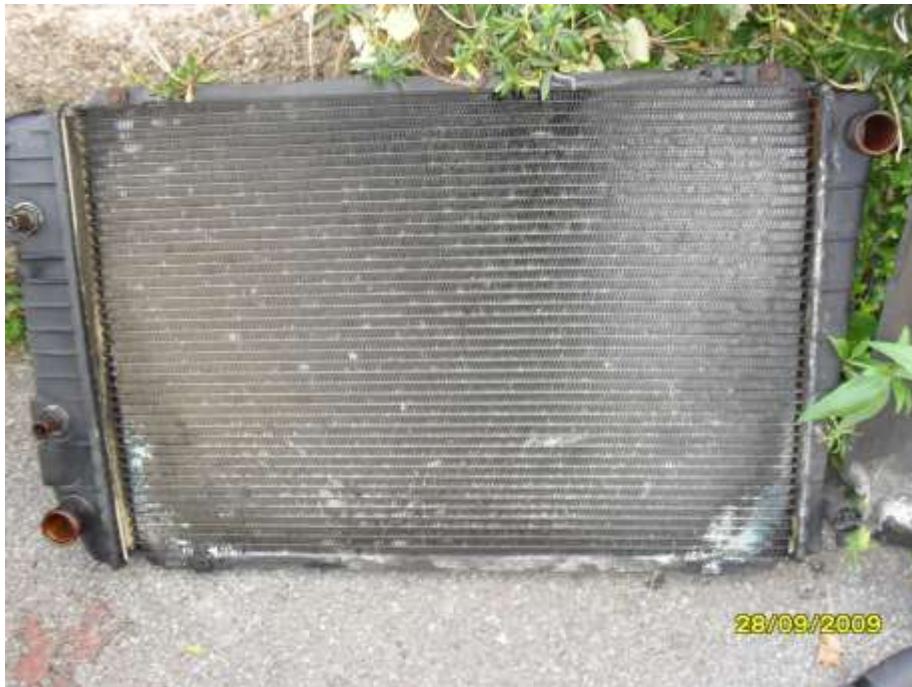
Flushed the block out with the hosepipe in the top hose and water out the bottom hose. Then disconnected the heater matrix pipe from the front of the inlet and put the hosepipe in that and flushed through the bottom hose.
Took ages for the brown water to become clear (about 30 mins).

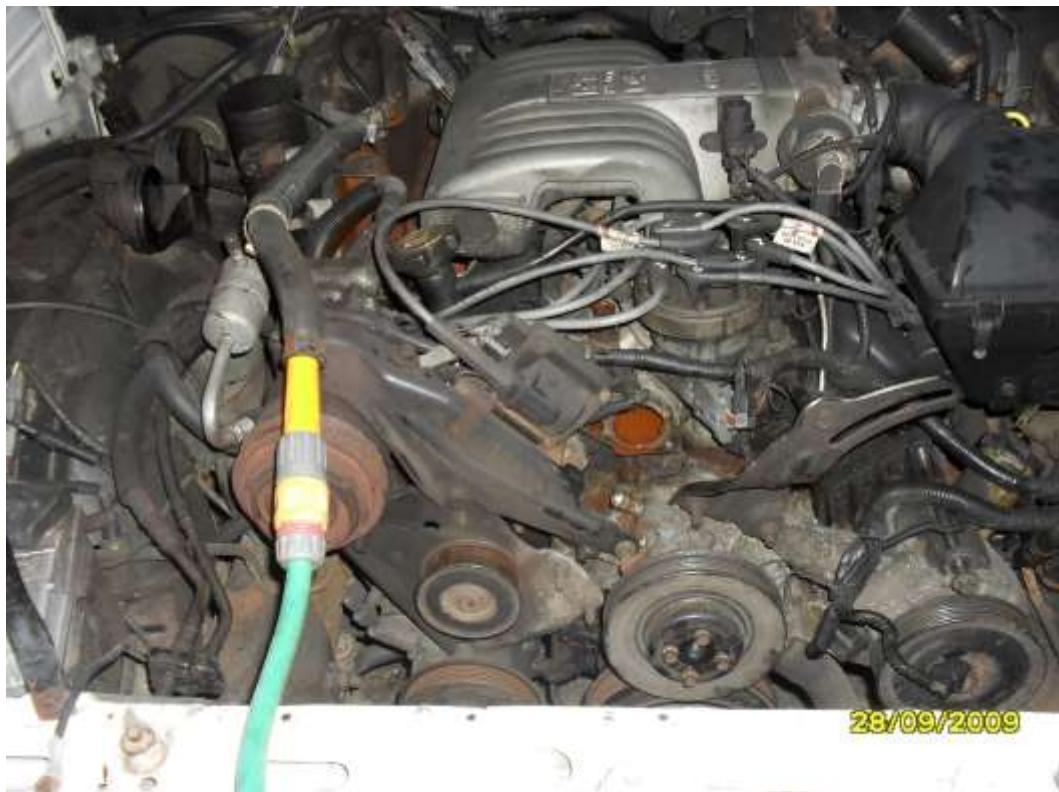
Then flushed and reverse flushed the rad

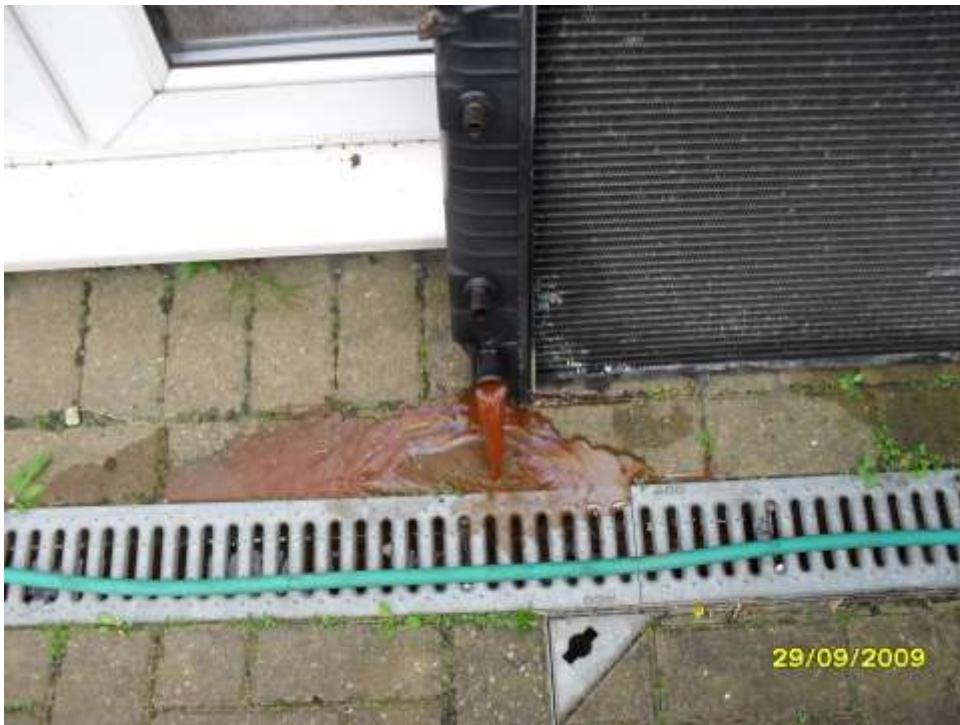
Here is a bucket of sludge!

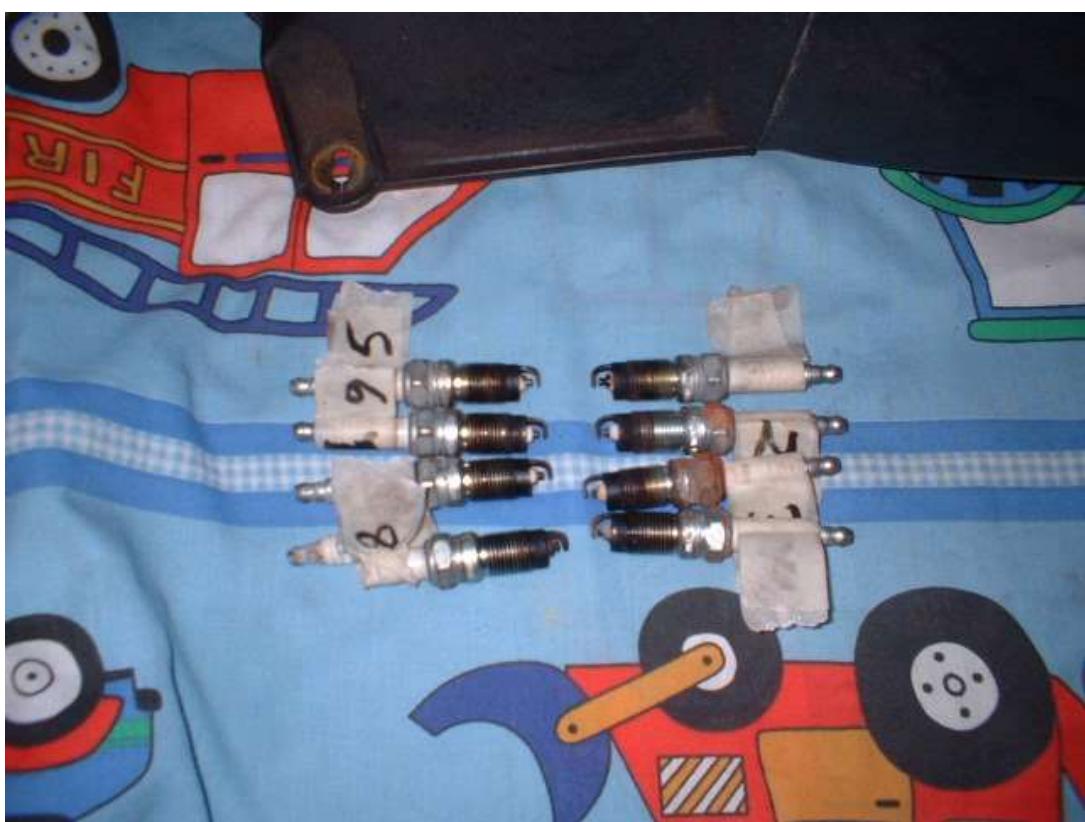
Most were in good shape, but 2 had very close gaps compared to the others. Number 8 looked and smelled of a misfire. That also correlates with the corroded top of the plug and the corresponding corrosion in the HT lead.

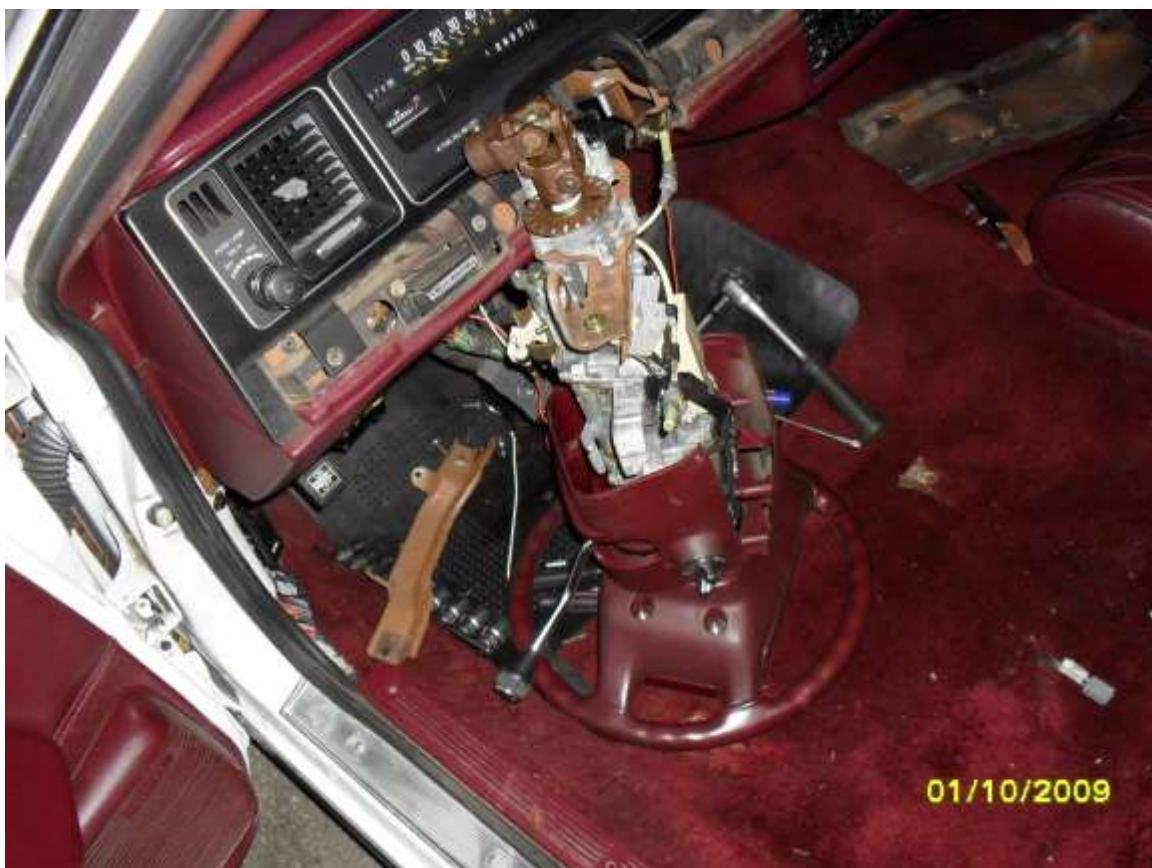
Stuck my head under the dash to check out the parking brake mechanism and removed the under dash panels. Then spotted that the steering shaft UJ where it attaches to the intermediate shaft was loose.

It didn't look right, so out the steering column came.

I removed the UJ and turned it round and refitted it. Then put it all back. Perfect now.

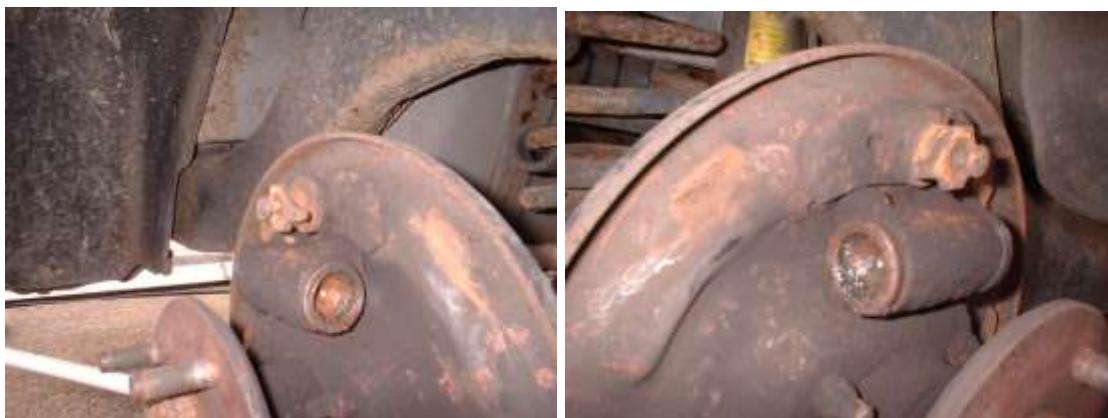
Anyway, shoes are recent but the cylinder looked like this

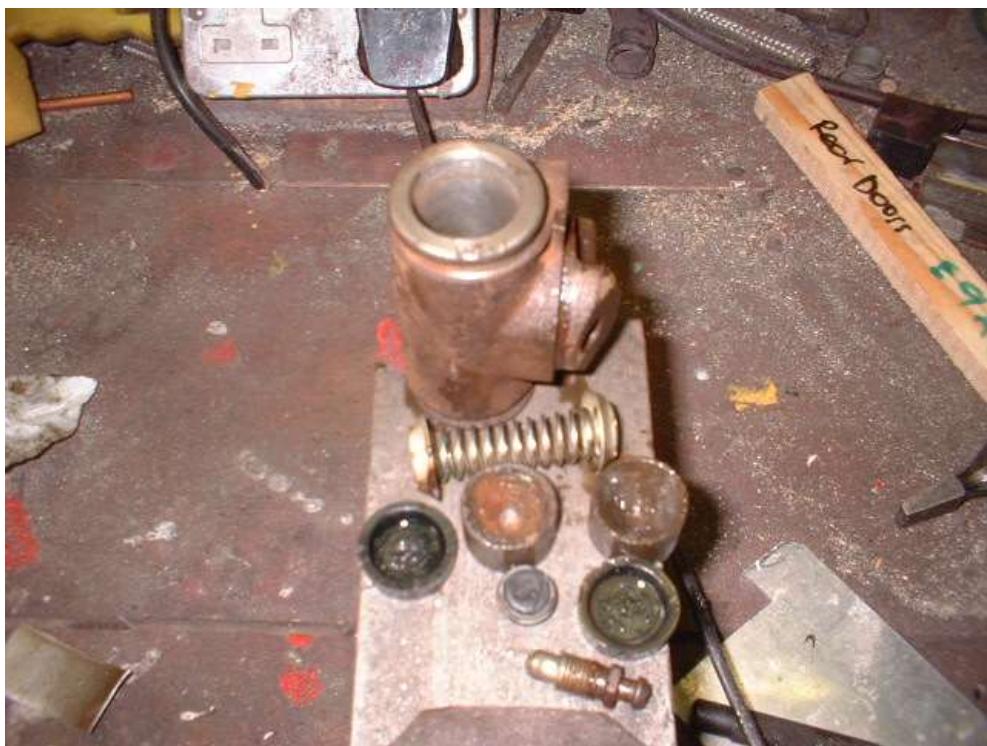
So removed to bench (lines okay) and stripped out. LH piston seized.

Honed bore out and put back together.

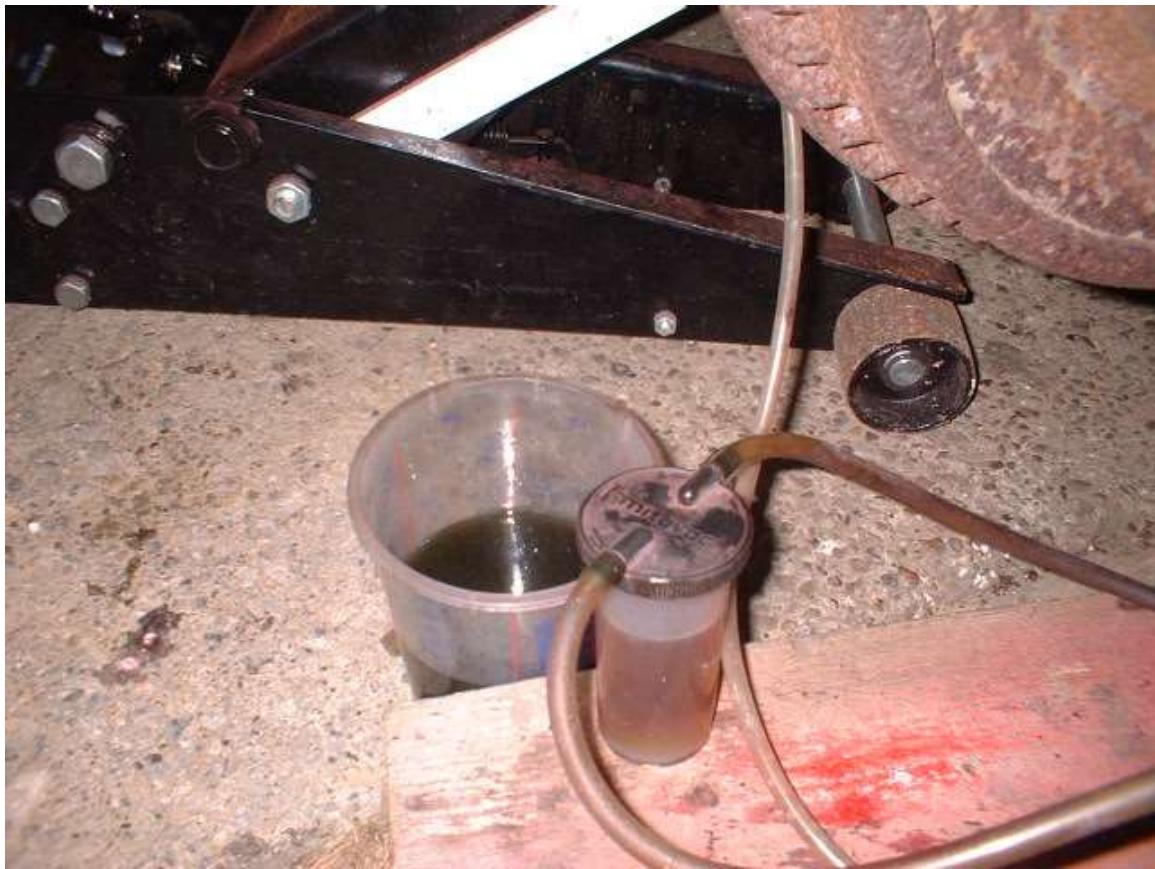
Have a look at the fluid that cam out, compared to what went in!

Looks like LHM fluid!! Luckily it's not!

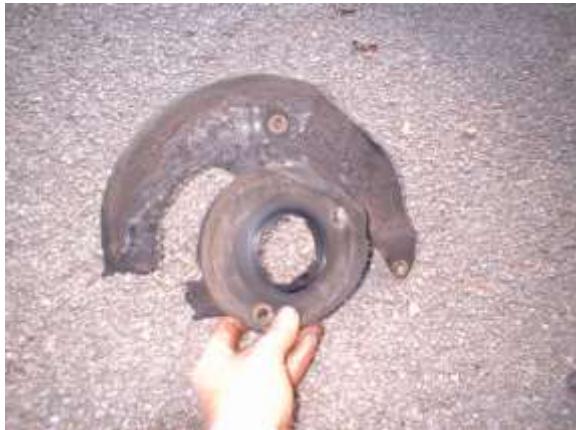
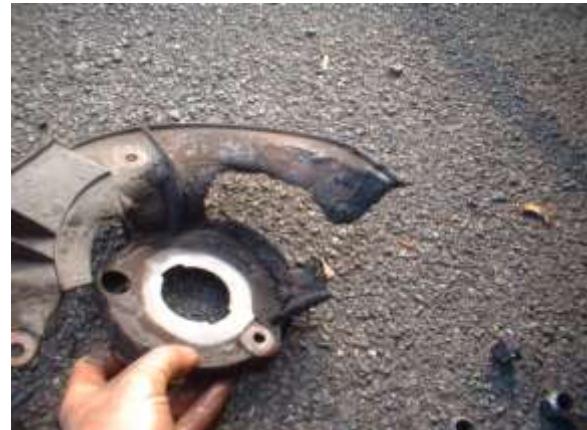
Noticed that the dust shield was in a bad shape, So removed caliper and hub/disc and removed remnants of shield. The shield is plastic and has seriously melted! No wonder if the calliper had seized.

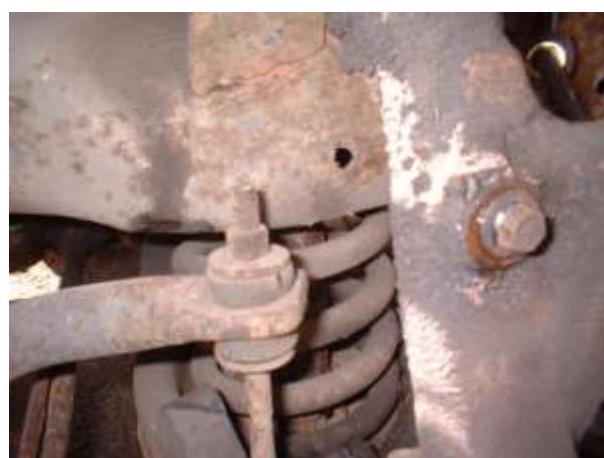
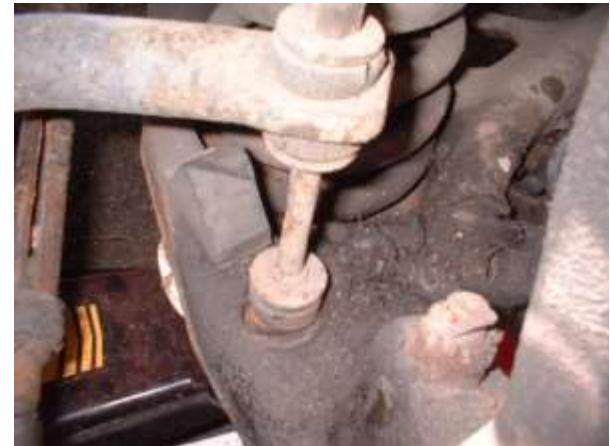
On the drivers side front the drop link bushes are perished and the hole in the lower control arm has worn oval. Needs welding up. Do that soon.

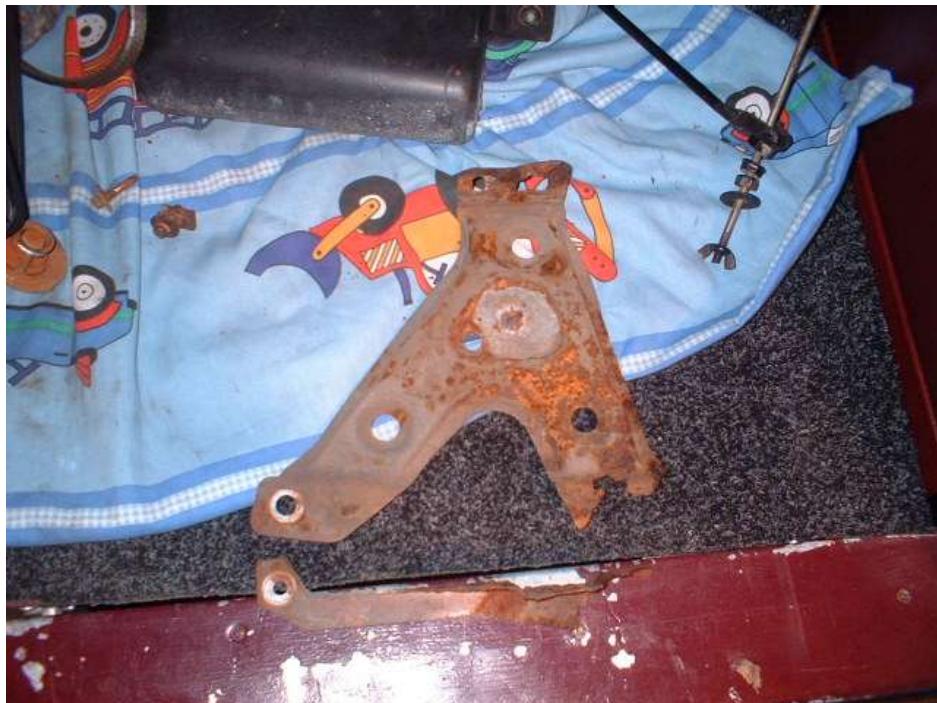
Removed battery and put it on charge on the bench. The battery tray is an extension of the plastic inner wing with a reinforcing metal plate underneath. This is rotten. So took 2 of the bolts out and had to grind away the third. I'll make up another one soon.

Removed battery and noticed that it is sat on the plastic inner wheel arch with a metal support bracket underneath it. This is what it looks like.

Had to grind off one of the bolts because it was rusted in solid.
Need to make one of those.

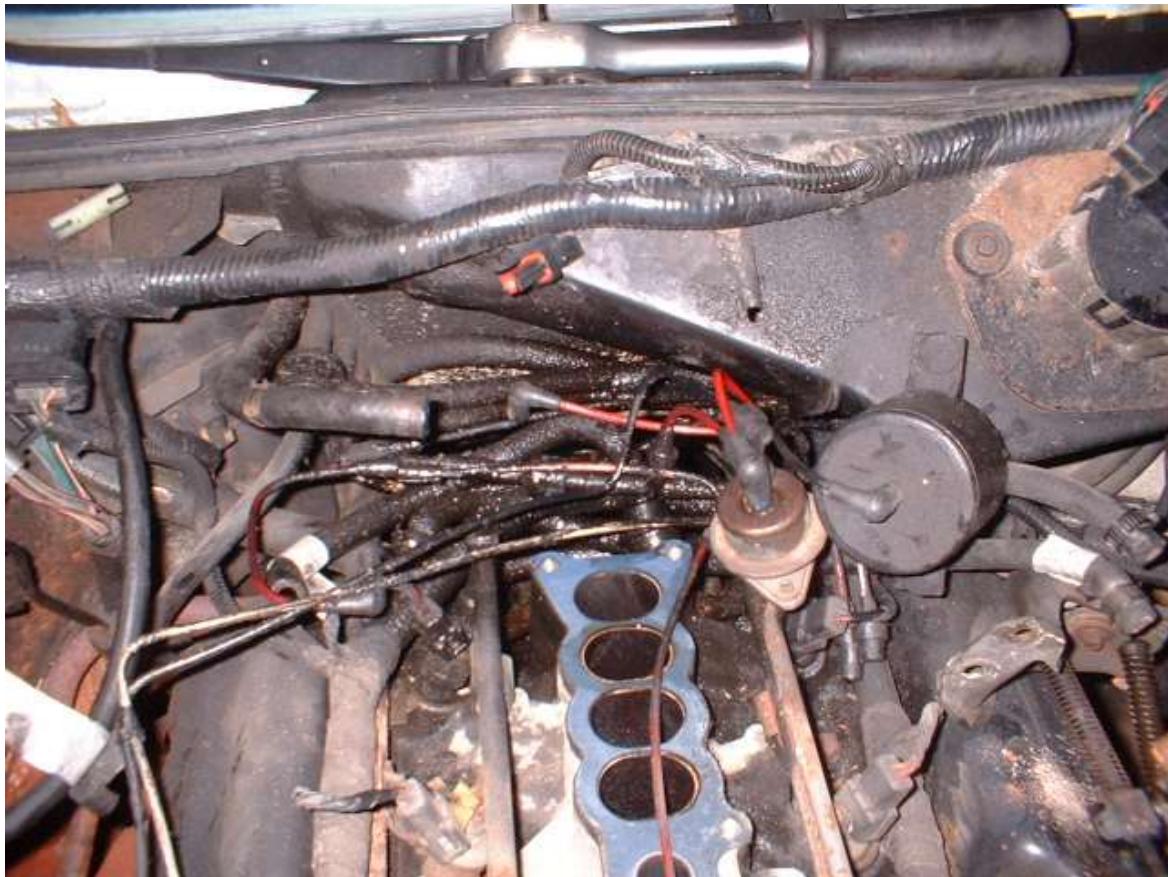
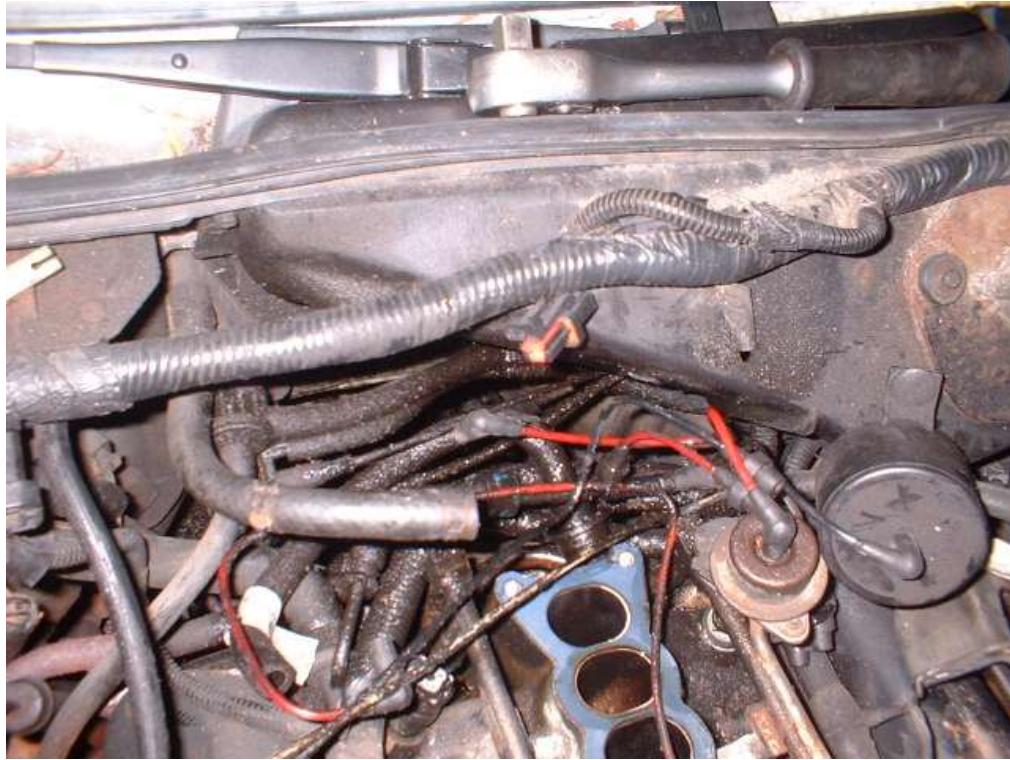
Removed plenum to be greeted with this site.

The PCV valve and grommet have come out of the inlet and the engine is now spraying oil out of the hole. No wonder it is oily. The oil goes all the way down the transmission as well. This is gonna take some cleaning up.

Removed PCV valve and grommet and pipe from the engine and cleaned them all up. Then pulled the screen out with some pliers and degreased and blew through with compressed air. I will order a new grommet tomorrow.

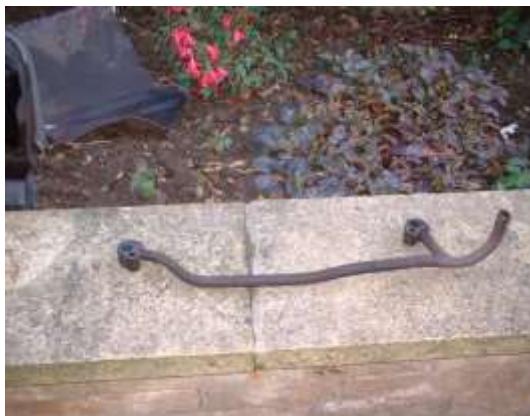
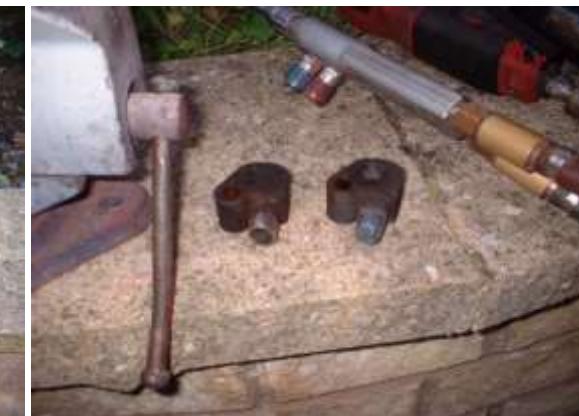
This pipe was cut and the ends welded up and painted black-when in fact I could have just turned them round!

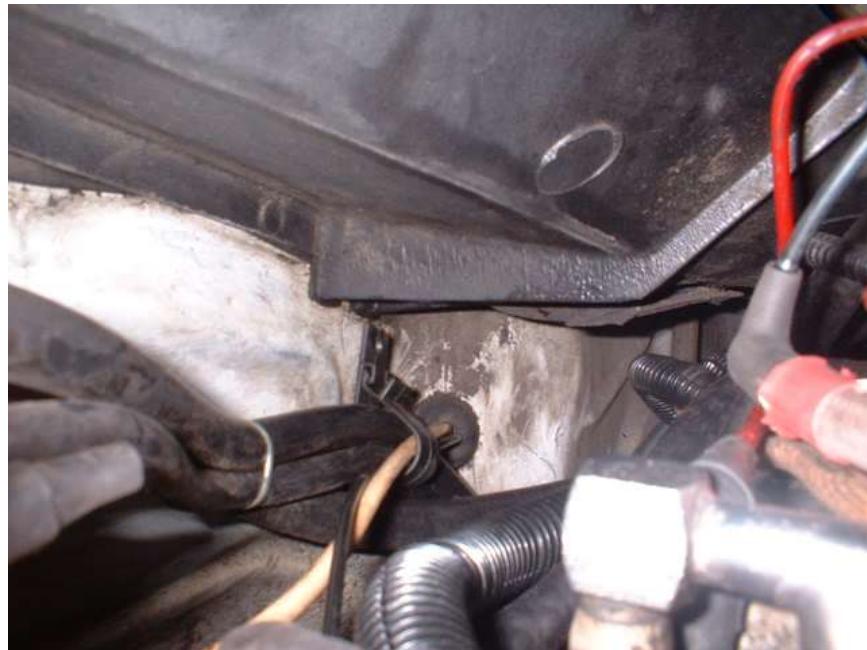
Re-secured the loom up against the firewall

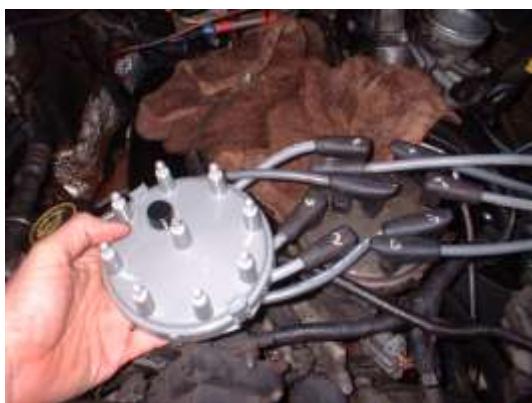
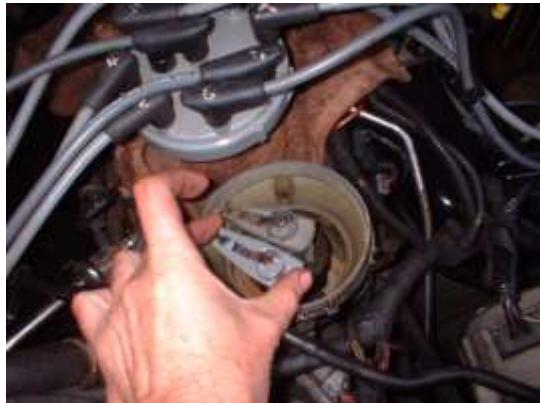
Replaced dizzy cap and rotor arm

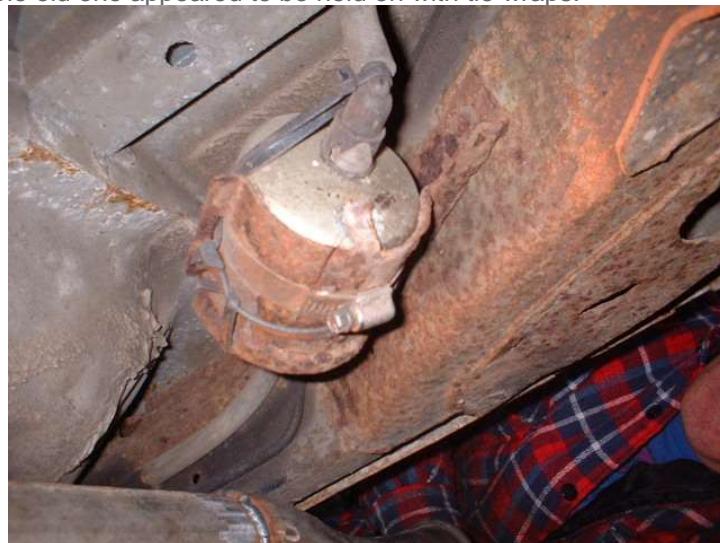
Fuel filter next. The old one appeared to be held on with tie wraps:

But in fact they were holding the pipes on! Why? When it was removed, I could see why. The new one had a shoulder on each pipe where the clips attach and stop the pipes from being pushed off.

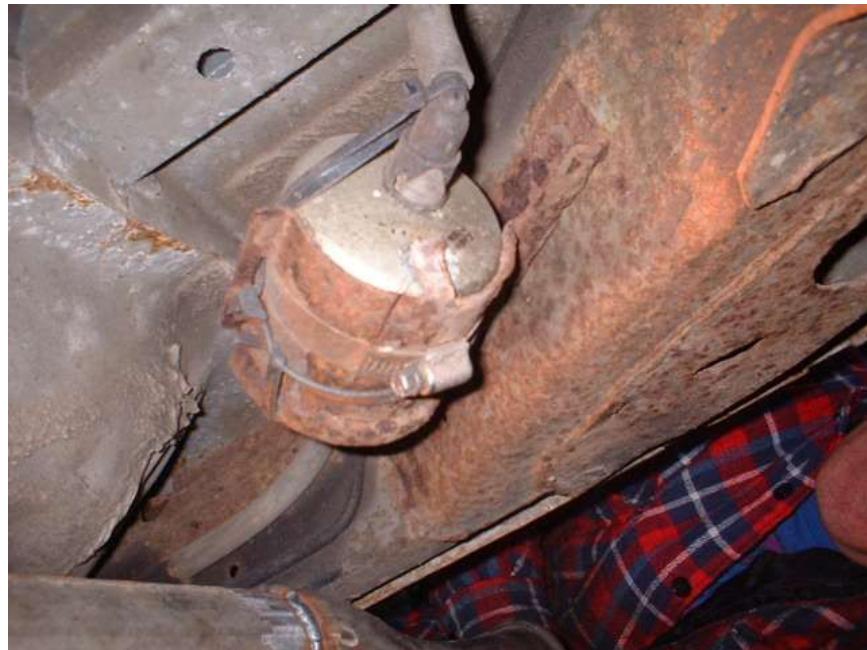
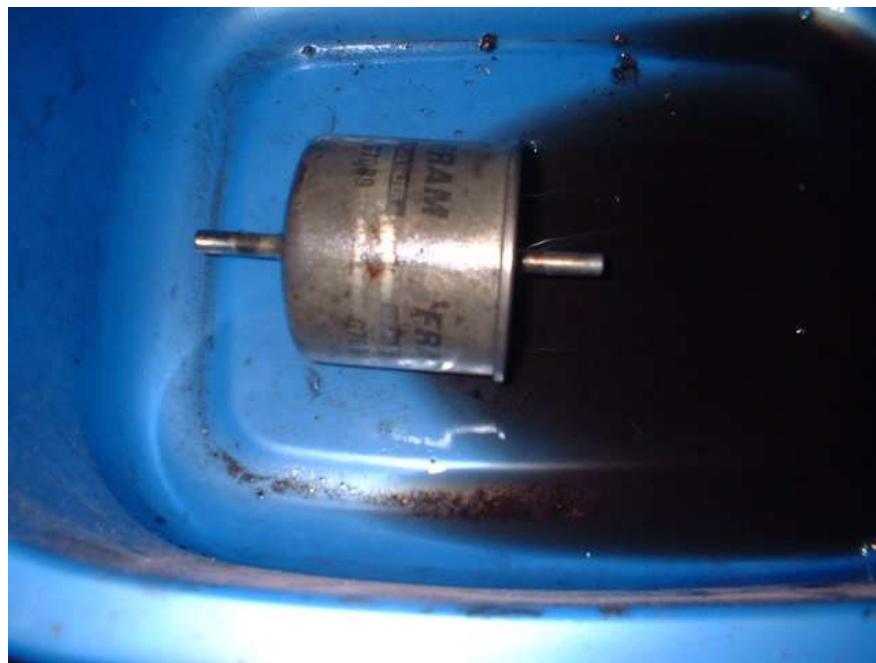
New one fitted securely with no tie wraps! The bracket holding the fuel filter looks well rusty. Might get that off and media blast.

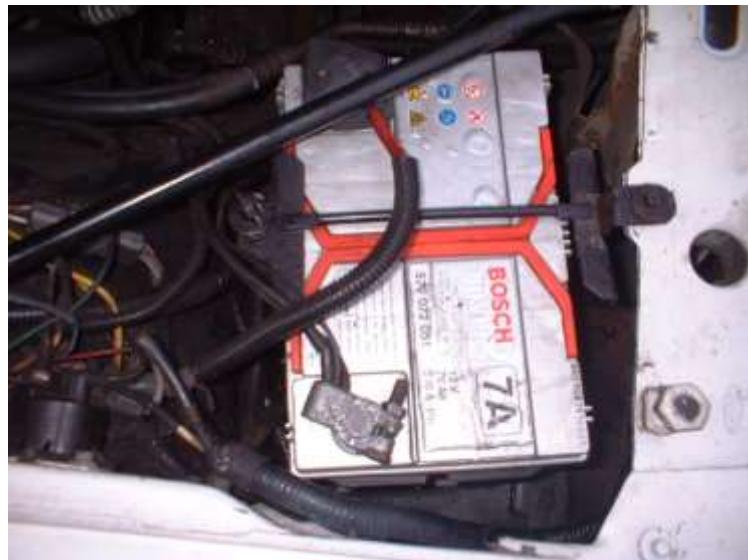
Battery put back and clamped down, then noticed that the battery doesn't look wide enough for the clamp

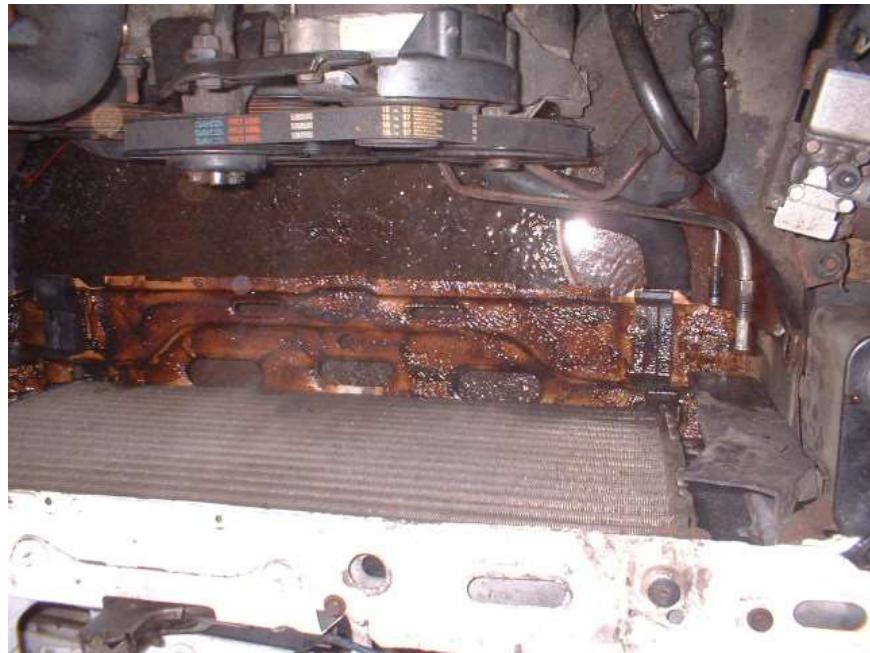
This is the lower radiator panel that is showing signs of light rust. So, a clean up first followed by a coat of dinitrol 3125

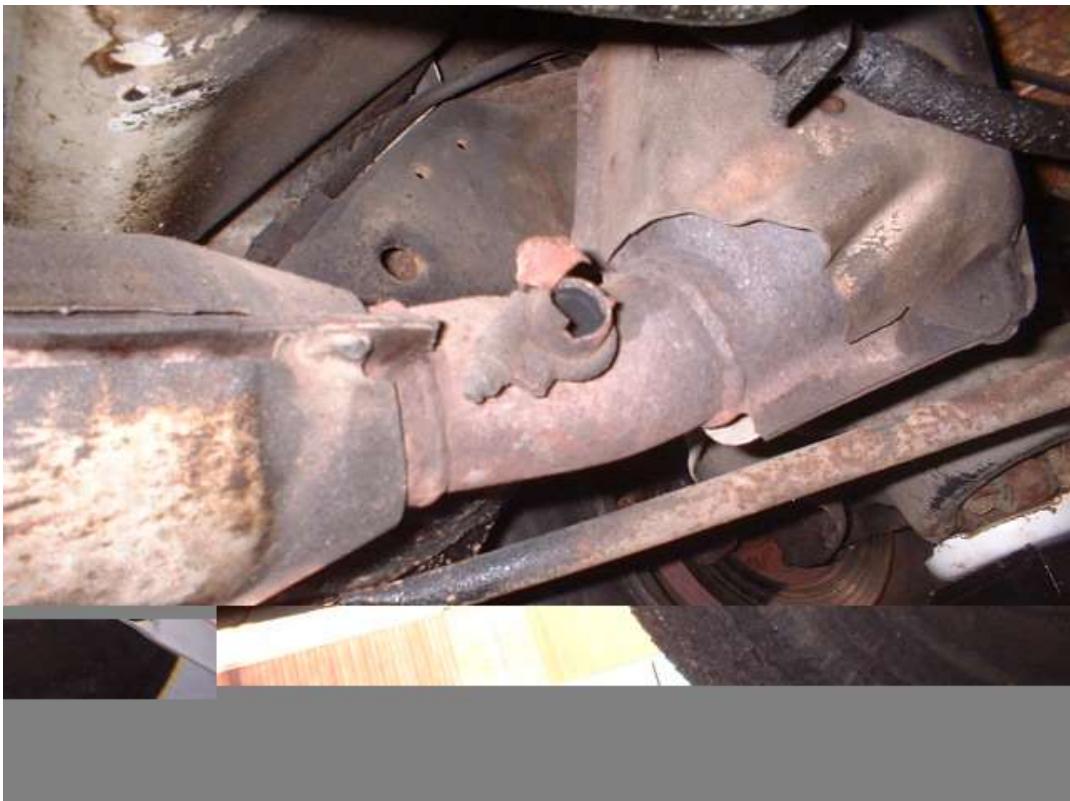
Filled cooling system up with fresh water and 3 bottles of the rad flush. Fired engine up and it coughed and spluttered and ran smooth but with an exhaust blow from the drivers side CAT where the AIR pipe used to be. Weld that up tomorrow.

Heres the view of the offending stub.

Got car up on one side tonight so I can weld up the drivers side cat thermactor pipe stub.

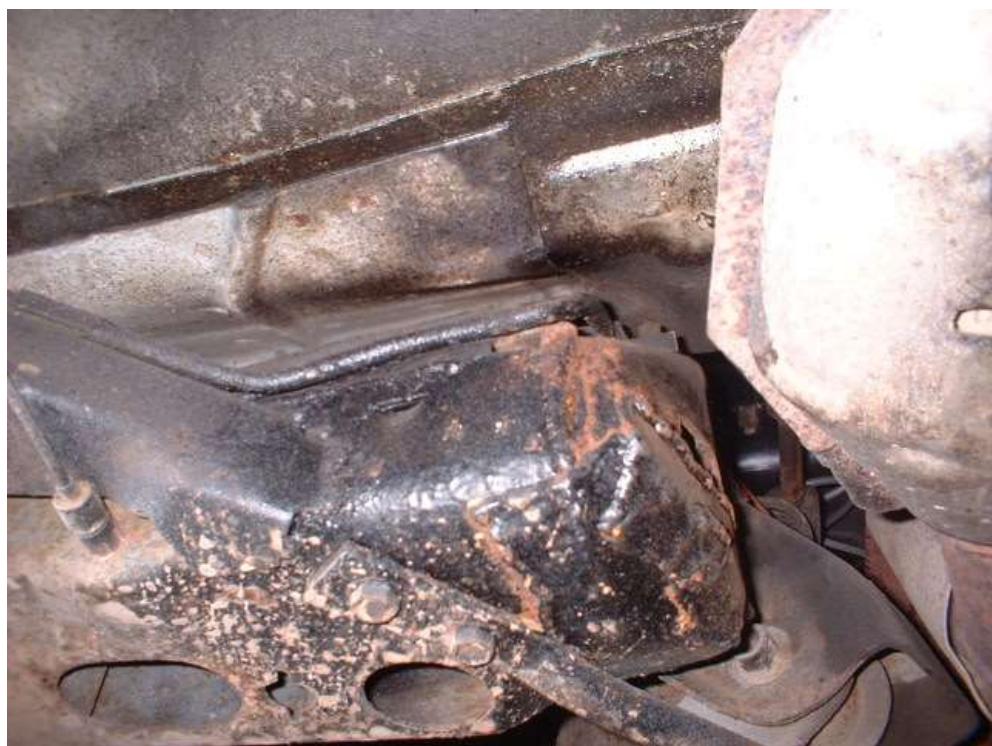
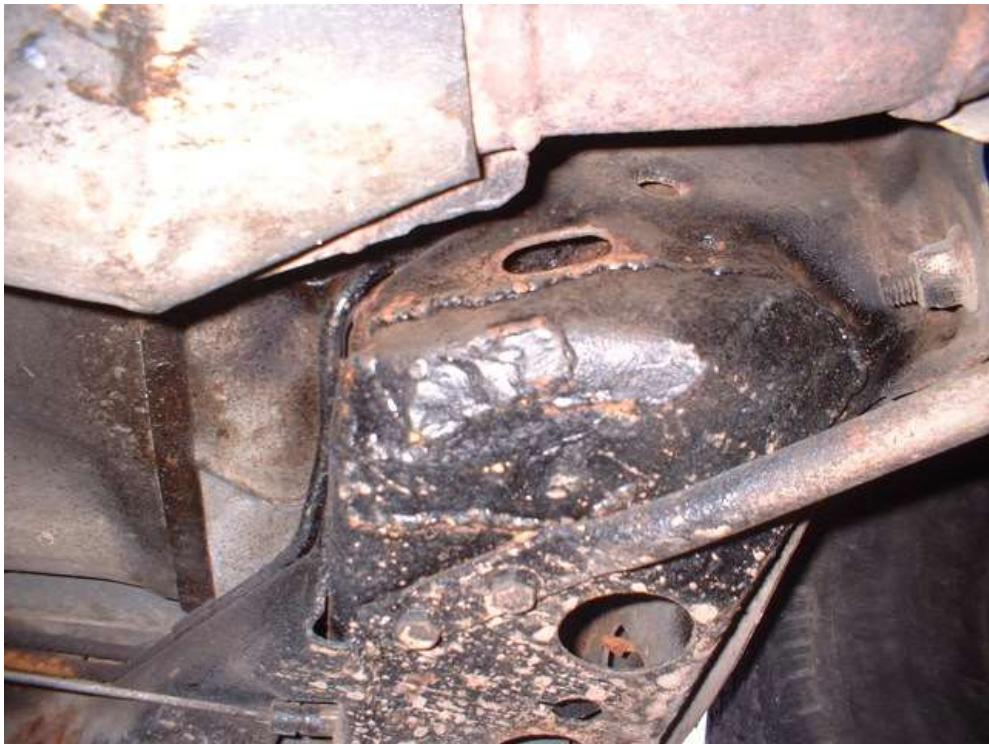
More worrying, while I was under there, I noticed the frame on the drivers side just behind the wheel and right at the side of the CAT was a funny shape and black undersealed.

Inside the section is packed full of rust debris. So someone has welded it all up and not cut out any rot. Just plated over the top. This needs sorting out asap and properly. Over to the other side then and the hammer went through that one as well-but no where near as bad.

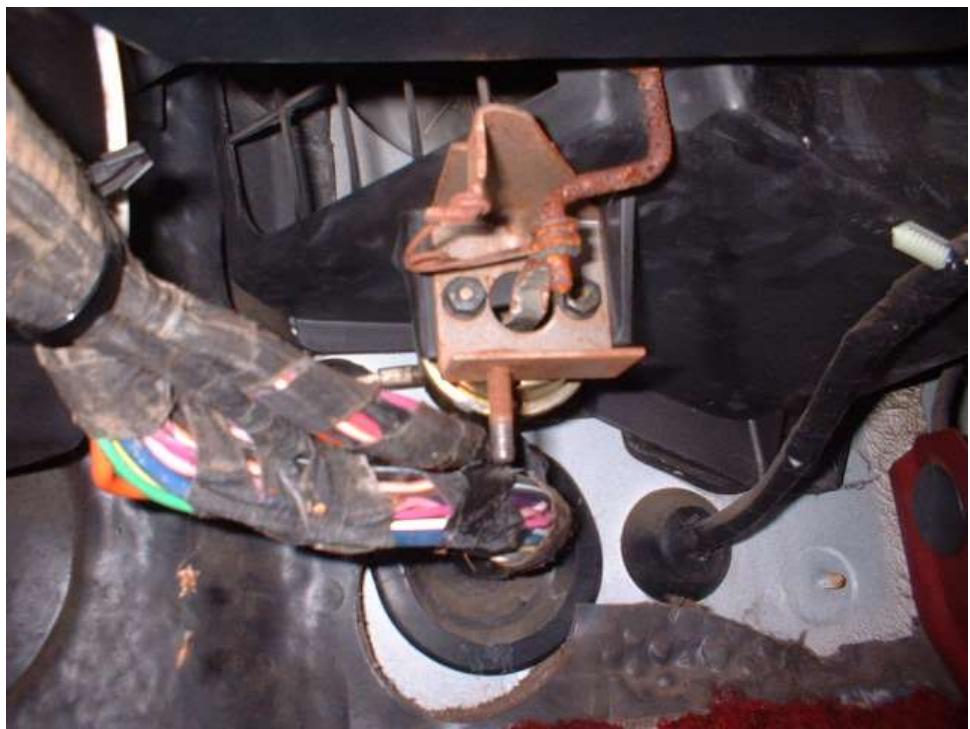
While I was under there I noticed the heater flap/door linkage was corroded and stuck.

Joint dismantled and lubed. Immediately the joint was freed the flap door moved over its full travel. Put back together but now need another one way washer. An M10 nyloc nut wedged on in meantime.

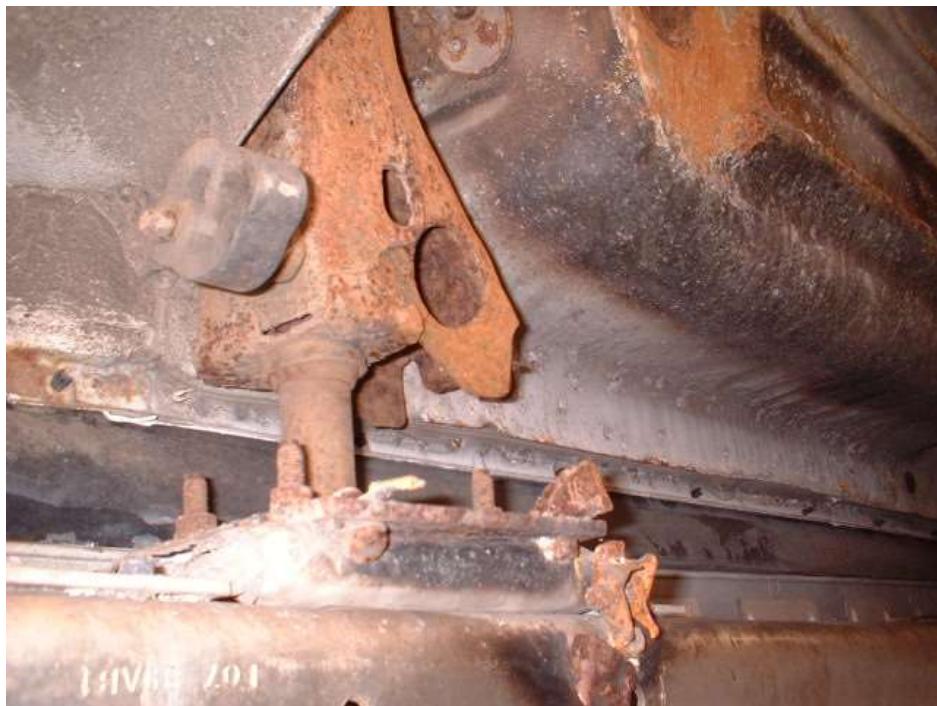
Where the grommet is under the trunk floor, I have managed to put the hammer through it!
