Project Big Ford

Ford LTD Crown Victoria LX Country Squire

September 2009

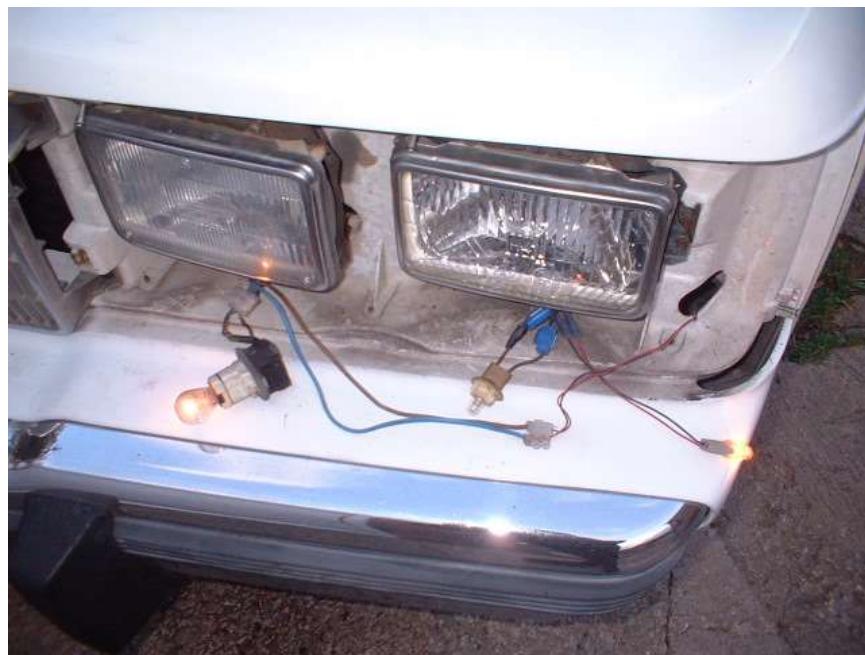
Removed the light unit from the front right and was greeted by a carnage of wiring mods!

That domino block and the blue scotlocks will have to go. The flashers are wired across the front of the car and wired to the amber leds on the side of the wing. The bottom corner light fitting is not used so I will get that working and remove the leds. All other bulbs replaced by LEDs as much as I can.

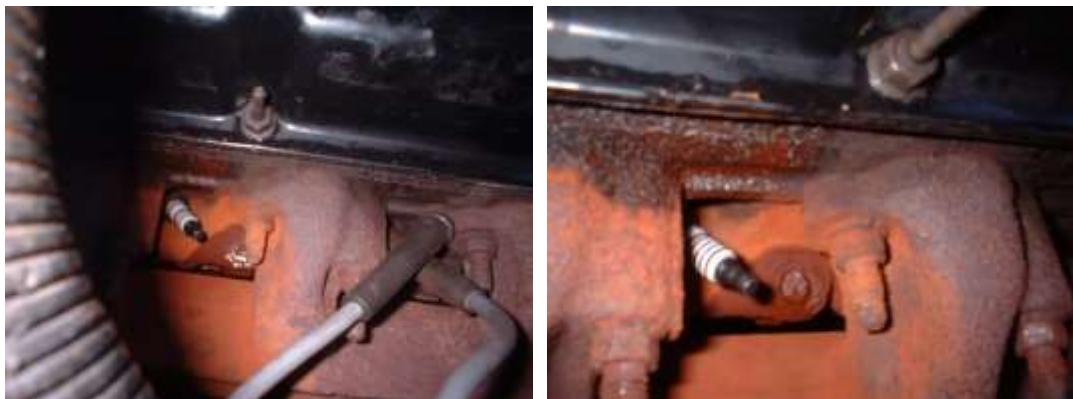
Then noticed an antifreeze puddle under the car. Almost below where the brown staining is.

Had a closer look up there and spotted the leak

That's a sheared off head bolt! Well. I said I wanted a challenge!

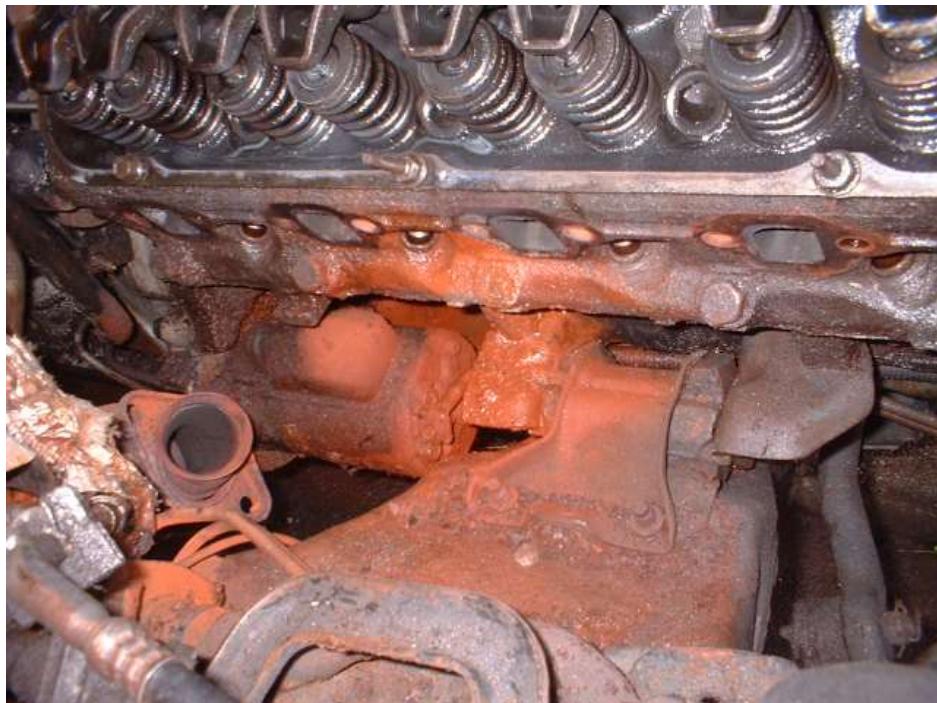
Removed manifold to see the starter absolutely covered and corroding away.

Removed top cover off starter and it had just started to rot through with the coolant being sprayed on it. Media blasted it and fibreglass matted the hole up.

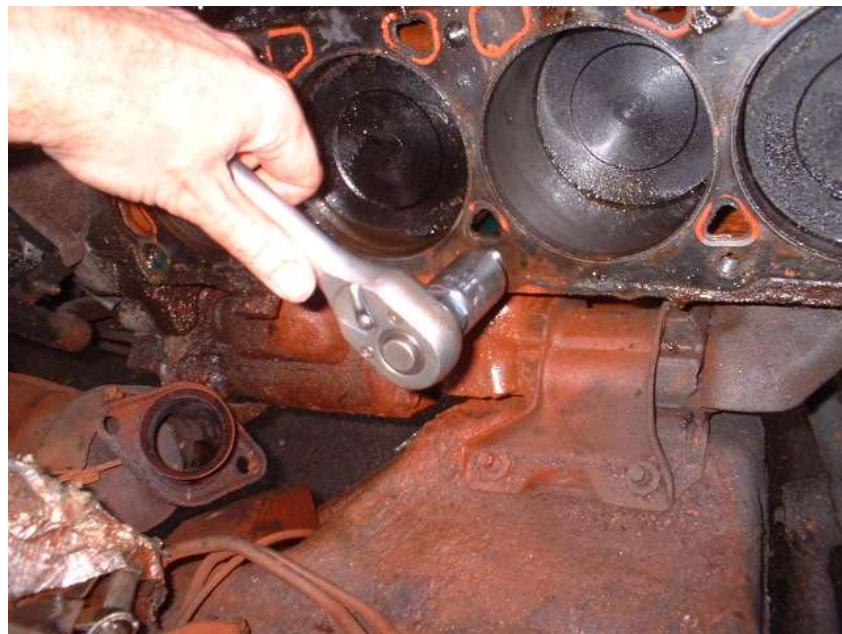
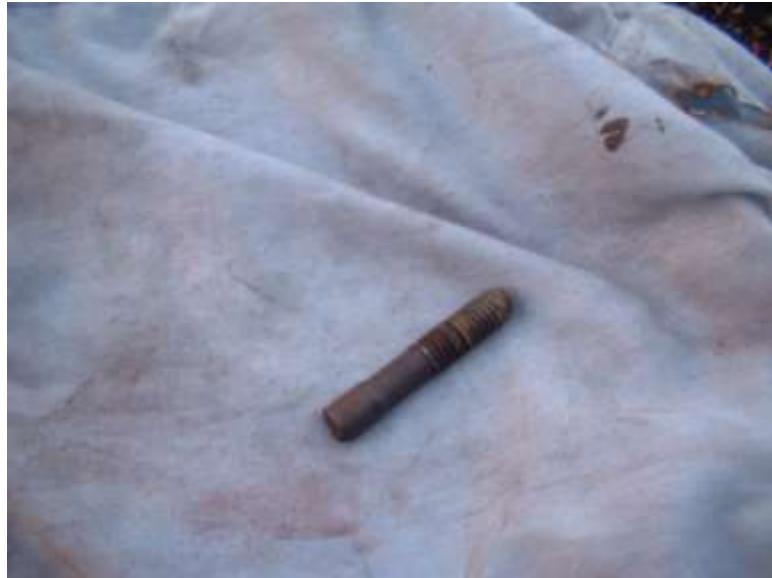
Borrowed some stud removers. Didn't need them because it came loose easily. Still don't know why it sheared.

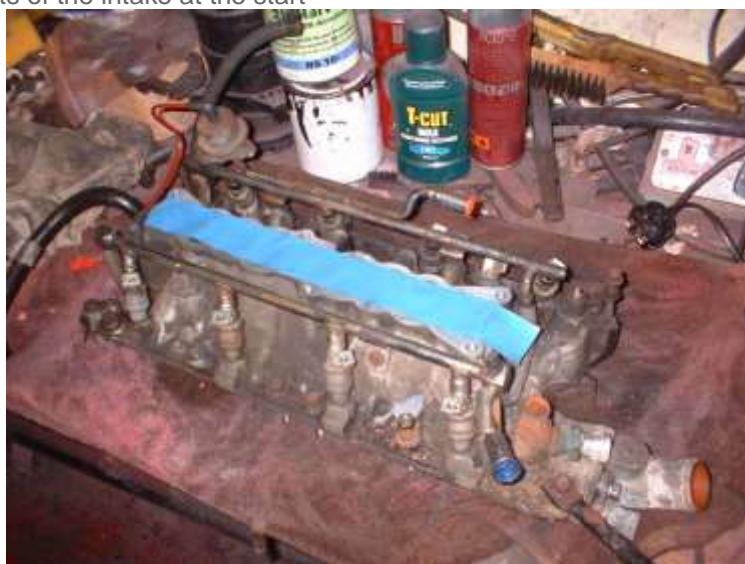
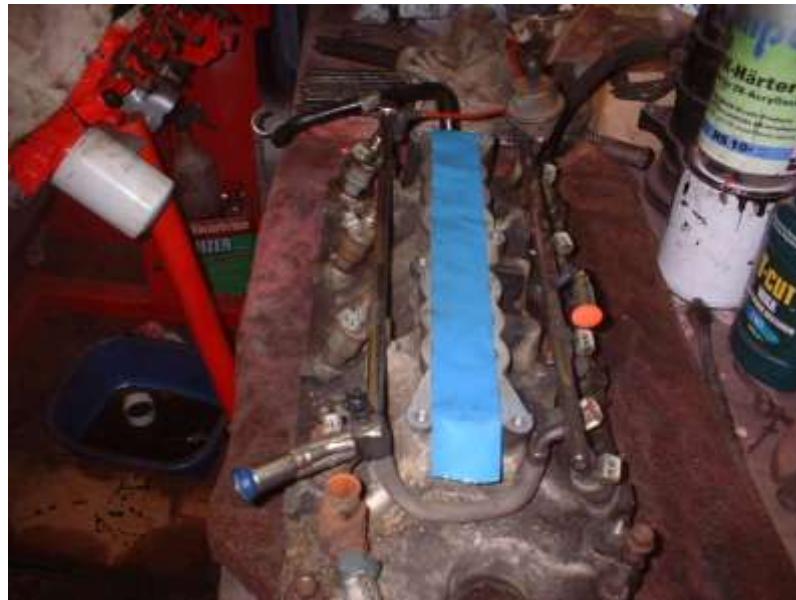
Heres a few shots of the intake at the start

Managed to strip down the inlet, but not before 3 injectors were stuck solid in the intake. Managed to release them but not sure if they'll work again!!

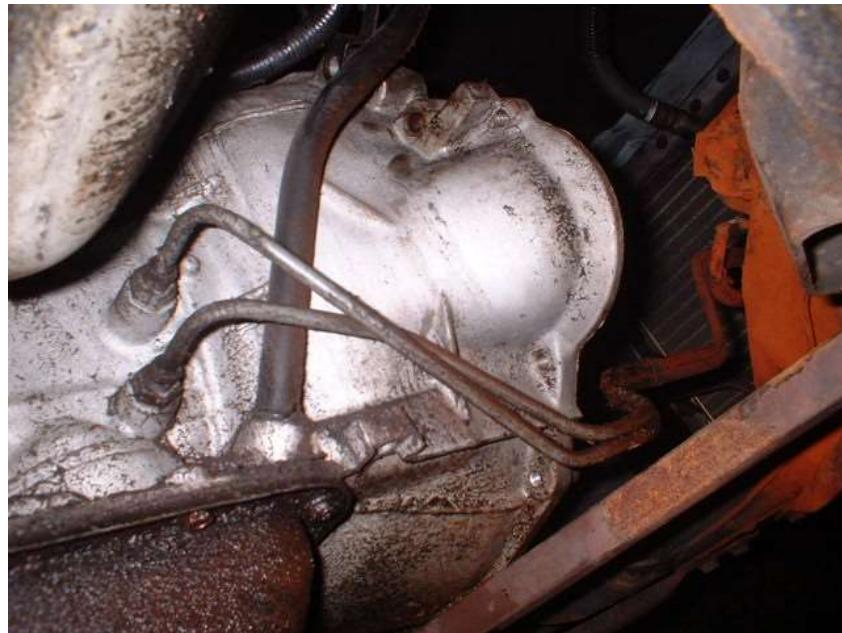
Heres the pipes.

Had to cut through the top one because I couldn't shift it. I'll replace them with copper anyway.

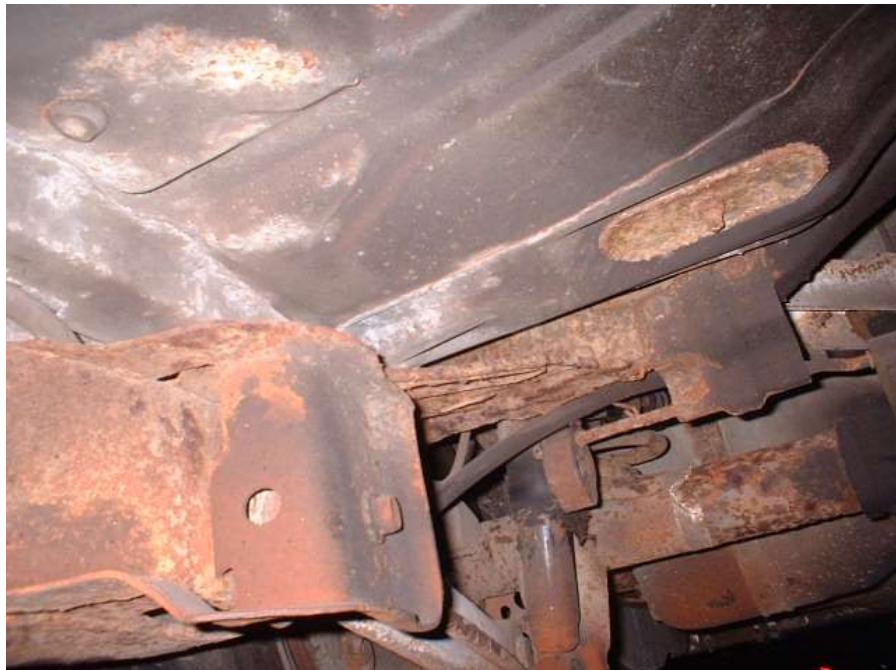
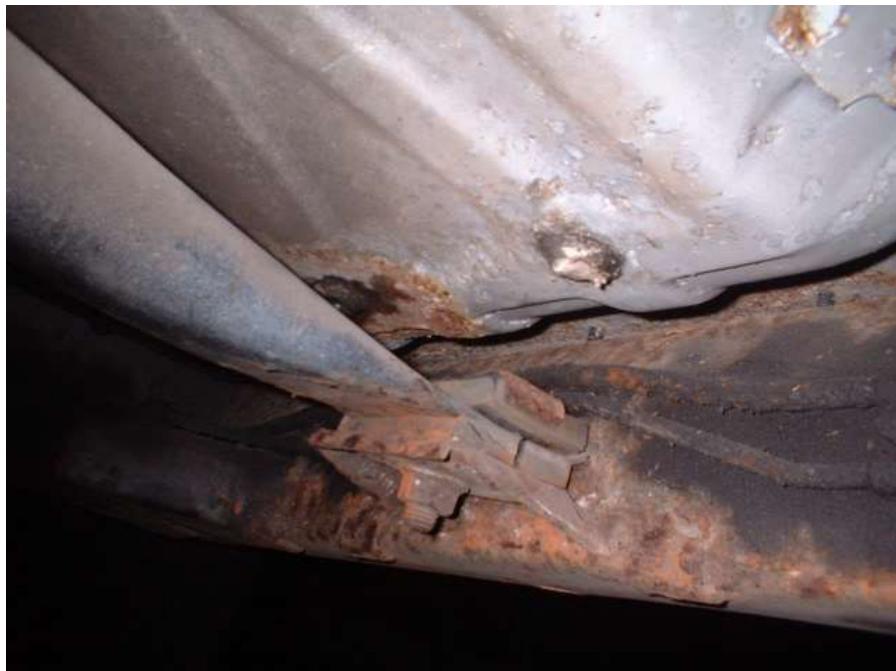
The frame is very rusty under there, so it's a good job its coming out.

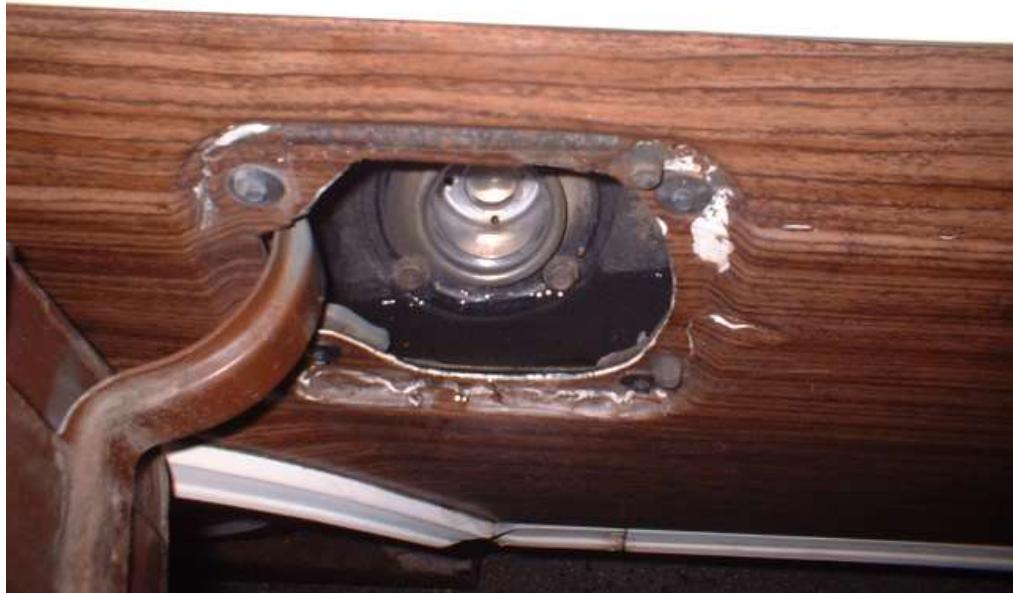
Loads of water build up in the filler neck. May have to put a drain plug and pipe in there eventually.

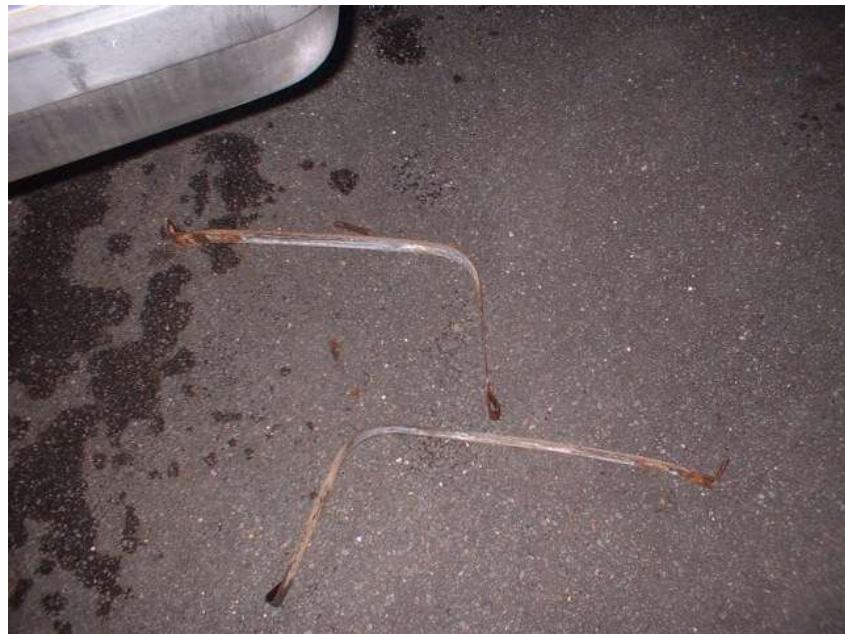
Rusty fuel straps

Mixed up some deox c and put one end of one strap in one container and the other in a bucket.
Power steering pump in the bucket as well.

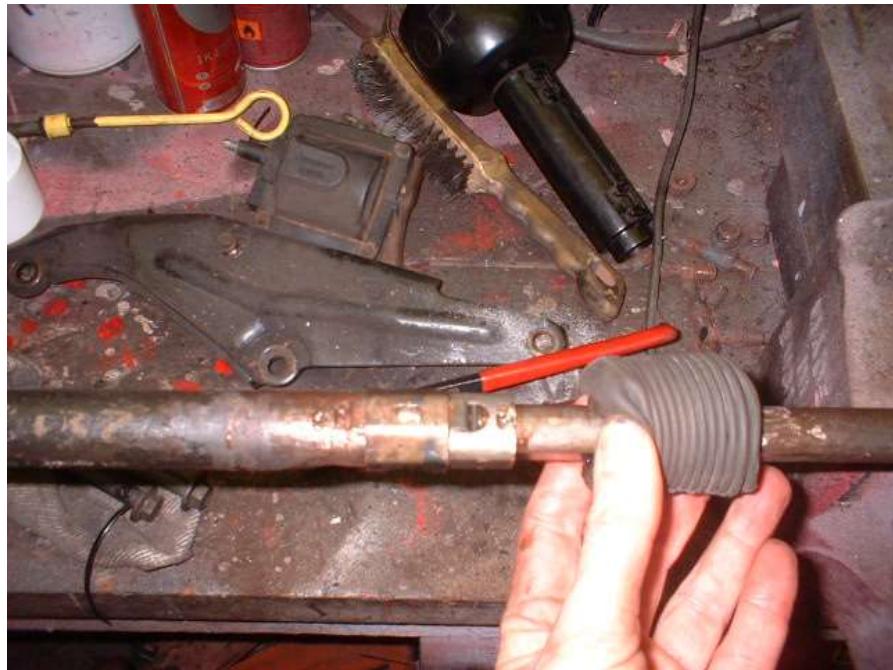
Removed steering intermediate shaft (had to unbolt steering box because the sliding joint wouldn't slide!)

Freed up on the bench though.

Cleaned it up, re-oiled and sealed it all back up.

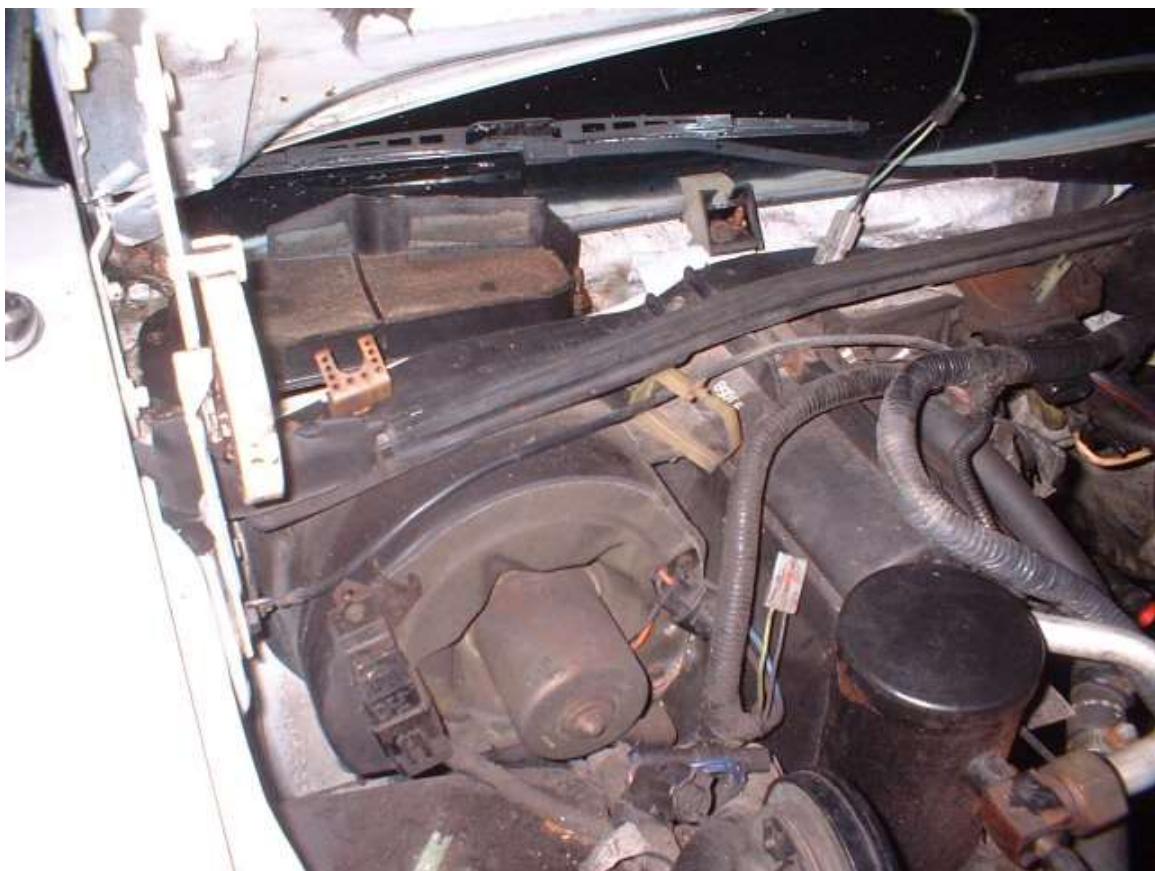
Found the drain hole just under the heater box. Looks like water runs under the cowl black plastic vent and drips into the heater and exits through a hole that has a rubber flap on it. I will remove the cowl vent and seal it down when I can get the bolt out!

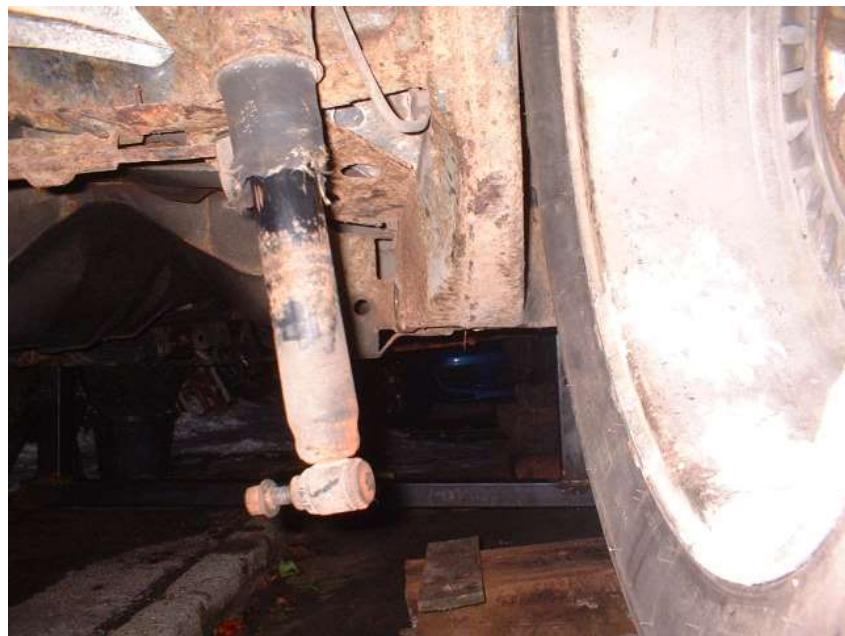
Rear axle removed on my own! Top arms and shox left attached to frame.

Rear right shock looks sad!

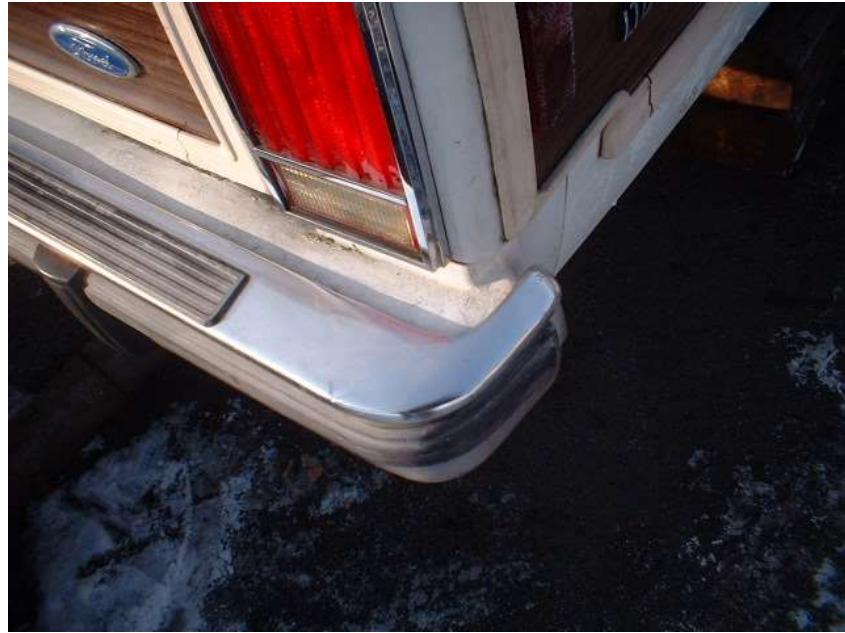
The rear bumper seems to sit too far away from the car with a filler panel inbetween.

I may remove that panel and put the bumper closer to the bodywork.

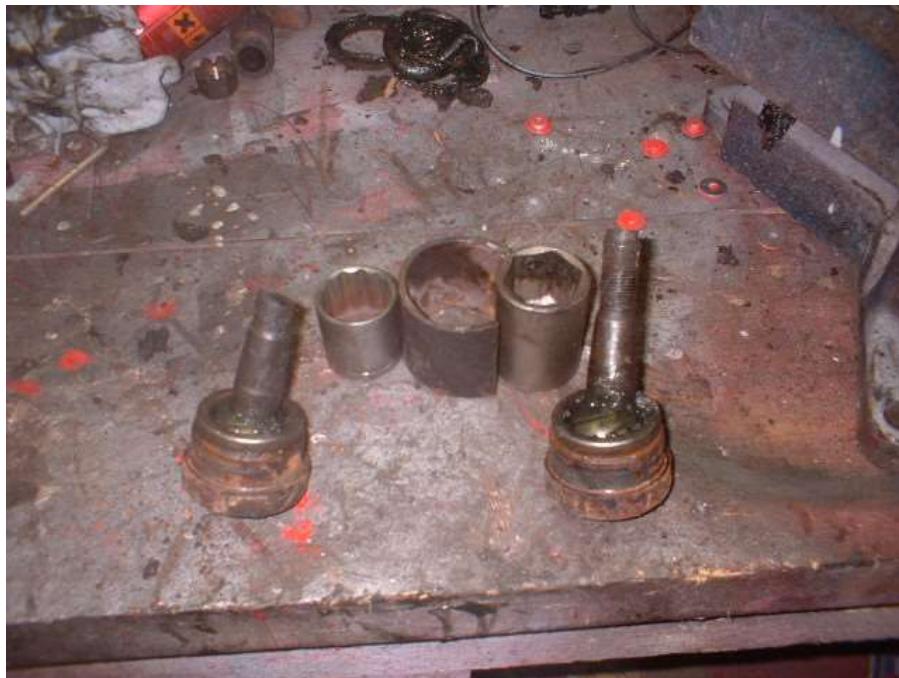
One ball joint was very loose, but the other wasn't too bad. But they are both going into the bin anyway.

US Automotive phoned and 2 upper ball joints and 2 lower ball joints (only 1 lower in stock – other to follow). And 2 drop links. Also left them with finding me some frame to body mounts.

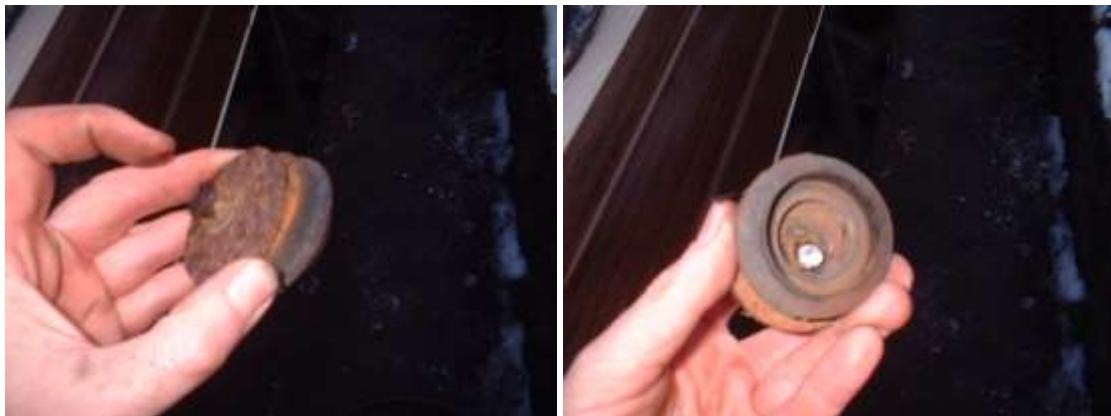
Managed to remove the 2 front frame bolts, then decided to see what the others do. All came out except for the back left that spun the captive nut. 2 behind the front wheels (one on each side) sheared.

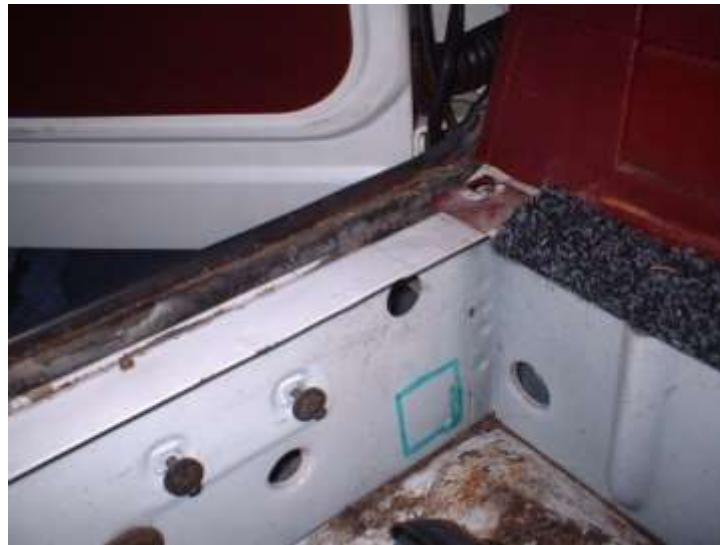
I will have to cut a frame bolt access hole in the back left corner. Heres the spot in green pen

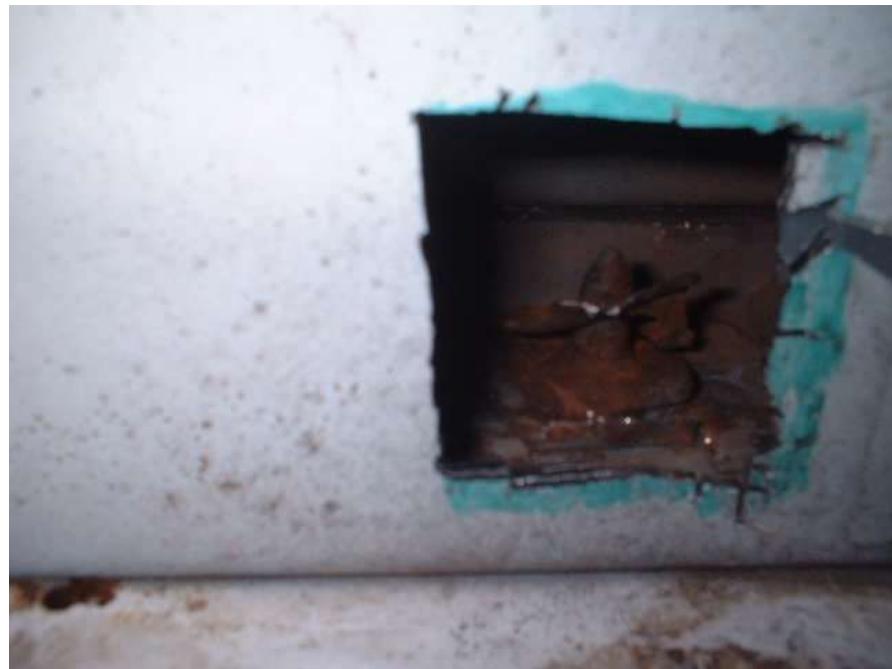
Cut the access hole out and soon saw that the threaded plate was spinning inside the cage. So I cut across the cage and held it with an adjustable. The bolt then sheared. Not good, but at least its off.

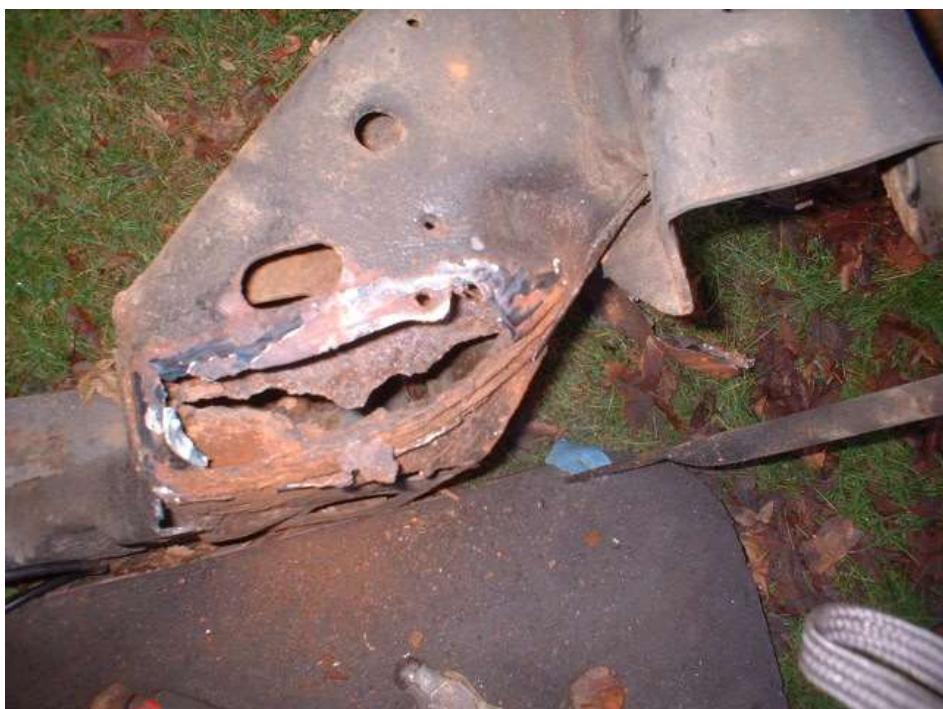
Outer plate removed to reveal true state.

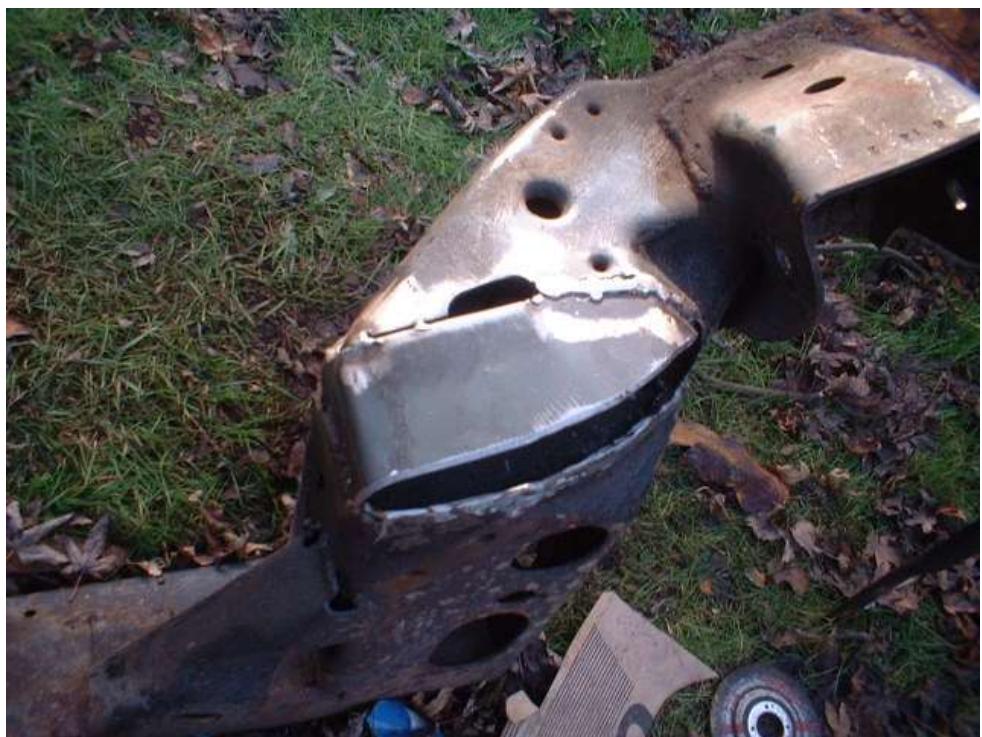
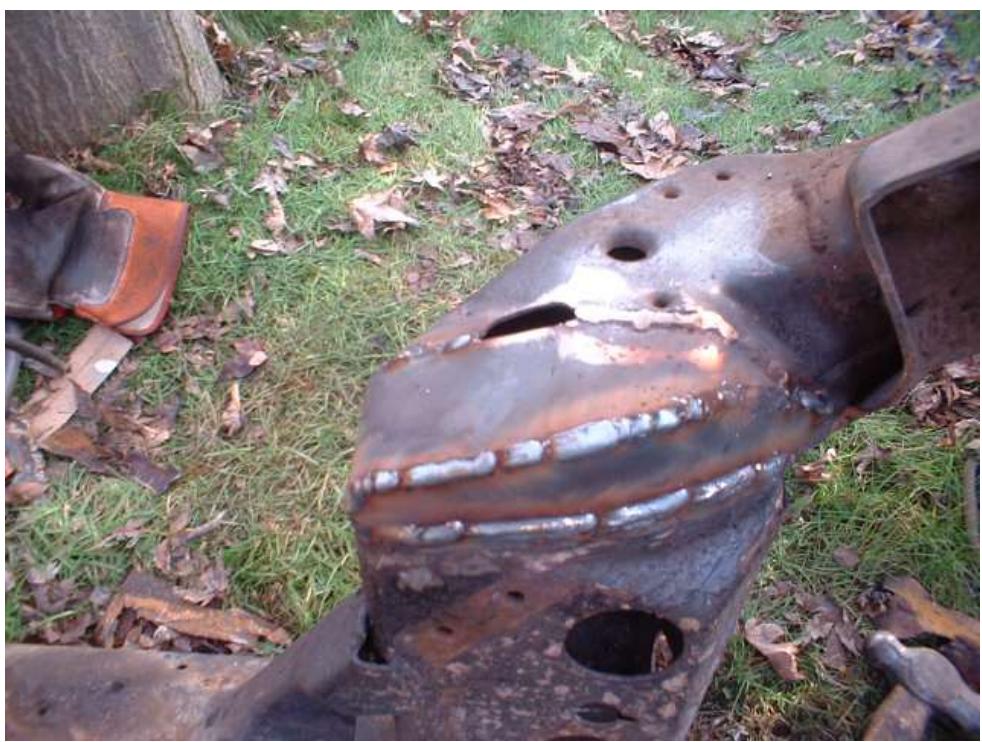
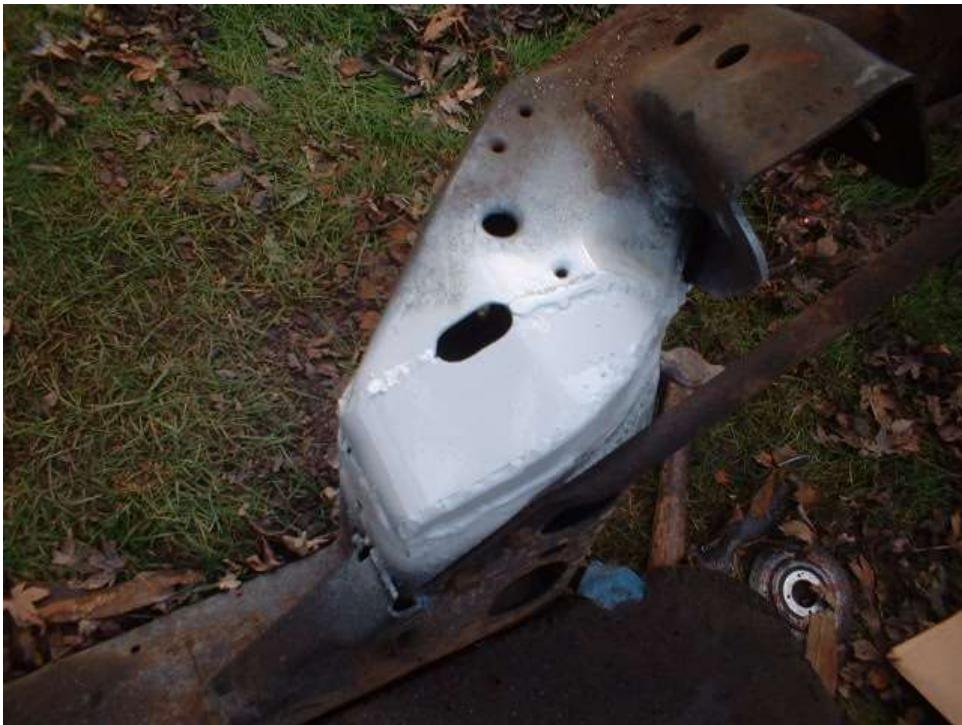
28/12/2009 and 30/12/2009
Started to cut out rusty steel from the frame corner

The other side is just as bad so Jay came round and we moved the frame to the other side of the tree and turned it upside down.

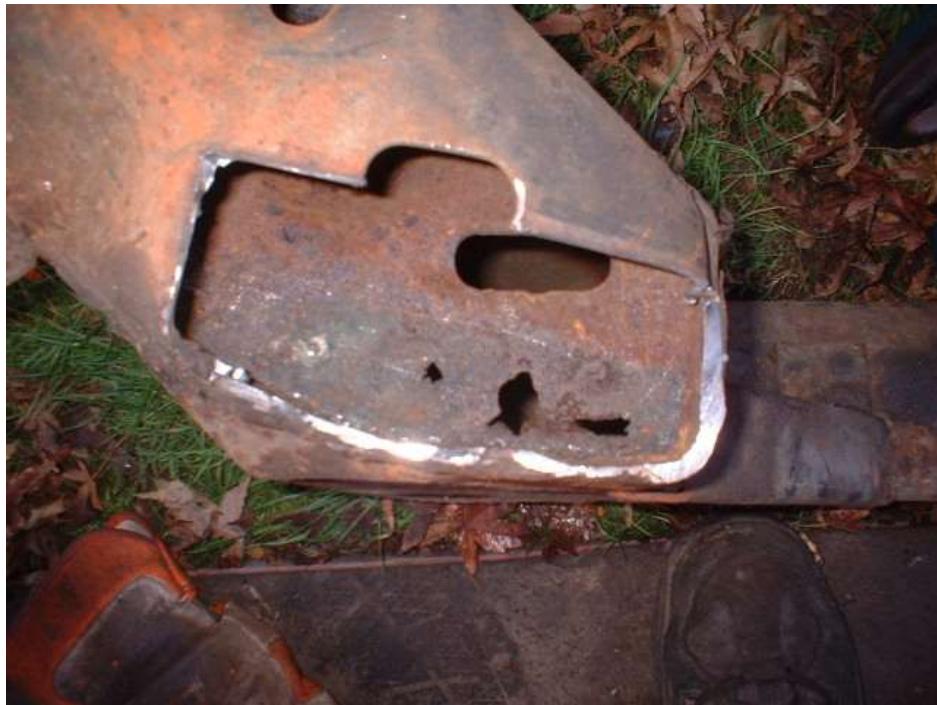
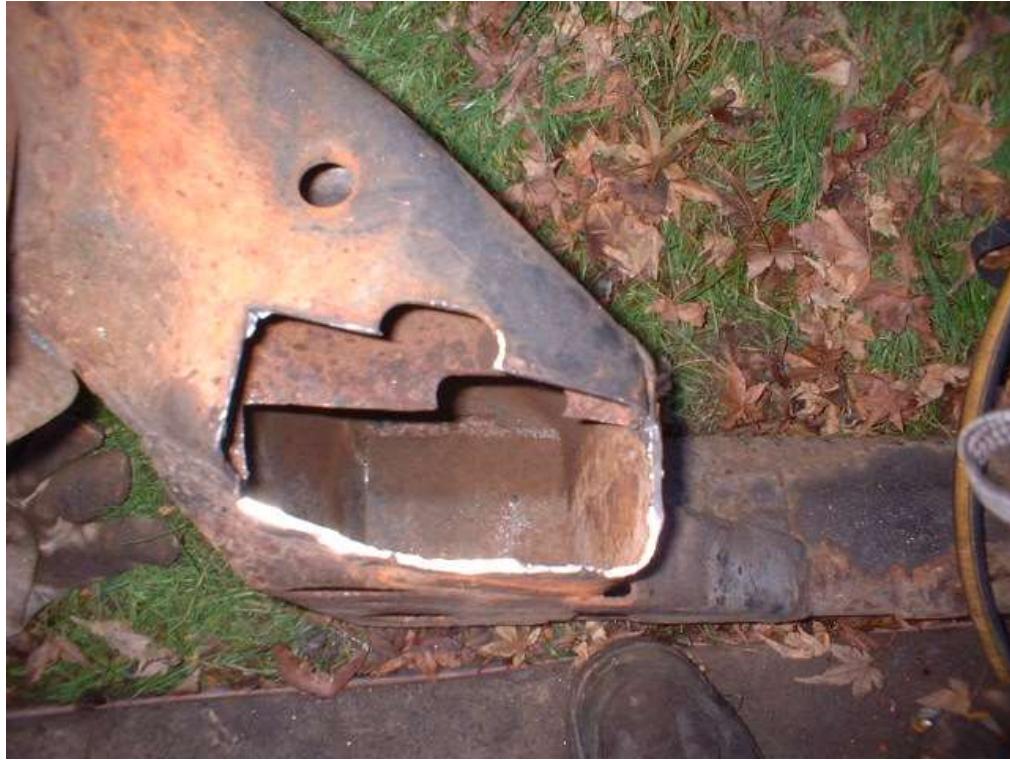
Clear day, so I cut out the other side, which didn't look too bad. Wishful thinking eh?

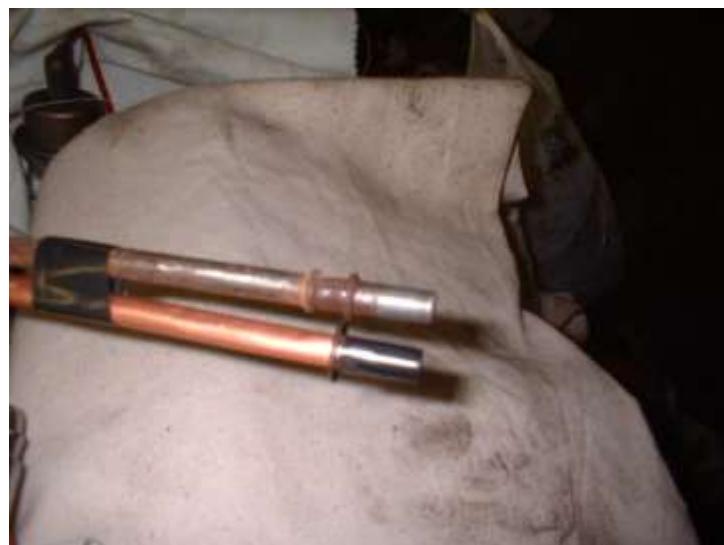
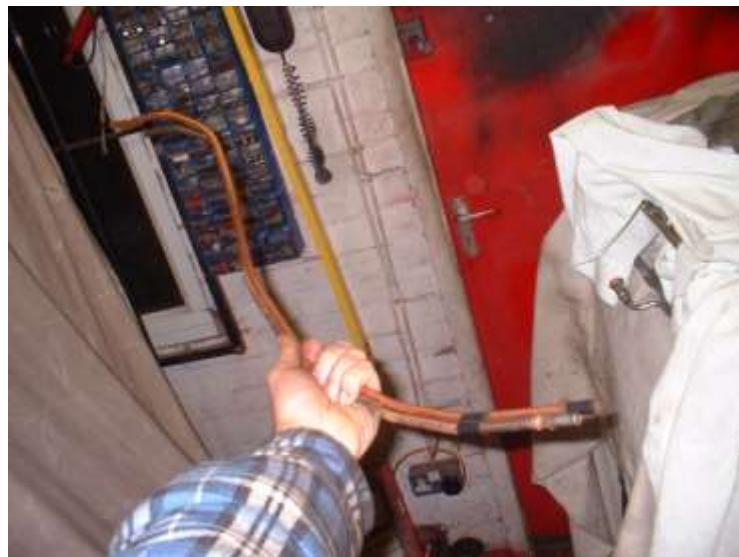
Spent ages trying to figure out a way to make the replacement fuel lines. There's no way I can exactly match these. I've got to find a way to reproduce the stop on the pipe to prevent the connectors pushing off under pressure.

Fuel filter back first. I have cut the steel line off just after the flexible fuel filter line and slightly flared it. Then slipped an 8mm fuel pipe on it. Then bent up a section in copper and slipped a one way circlip on the pipe to copy the stop.

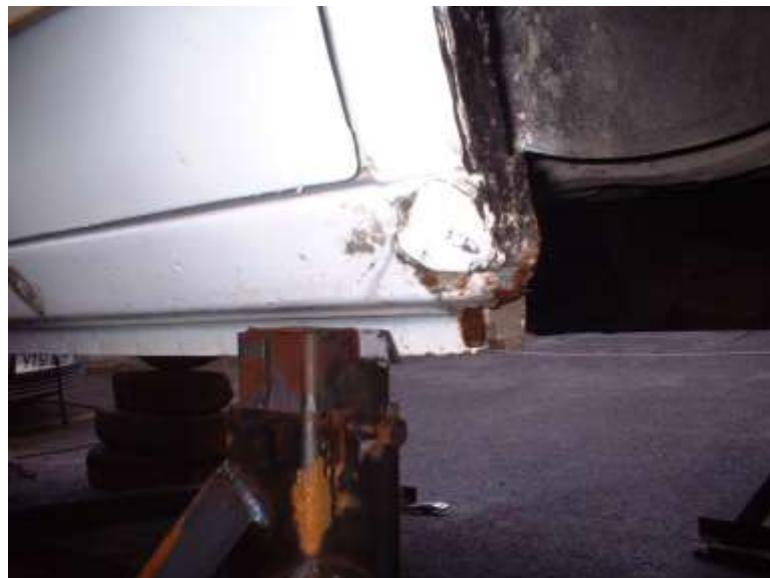
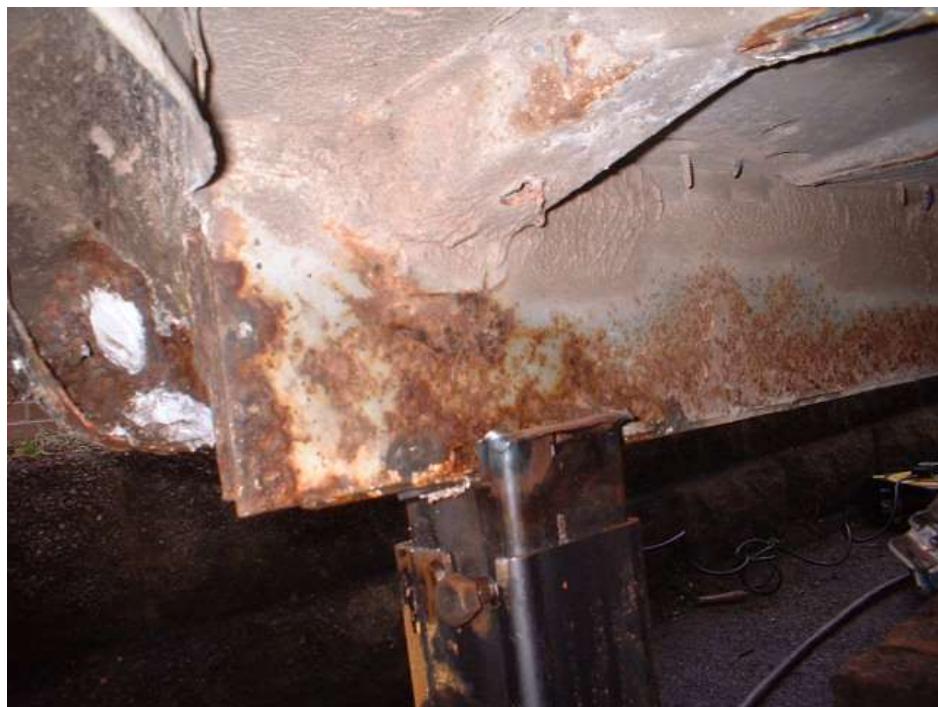
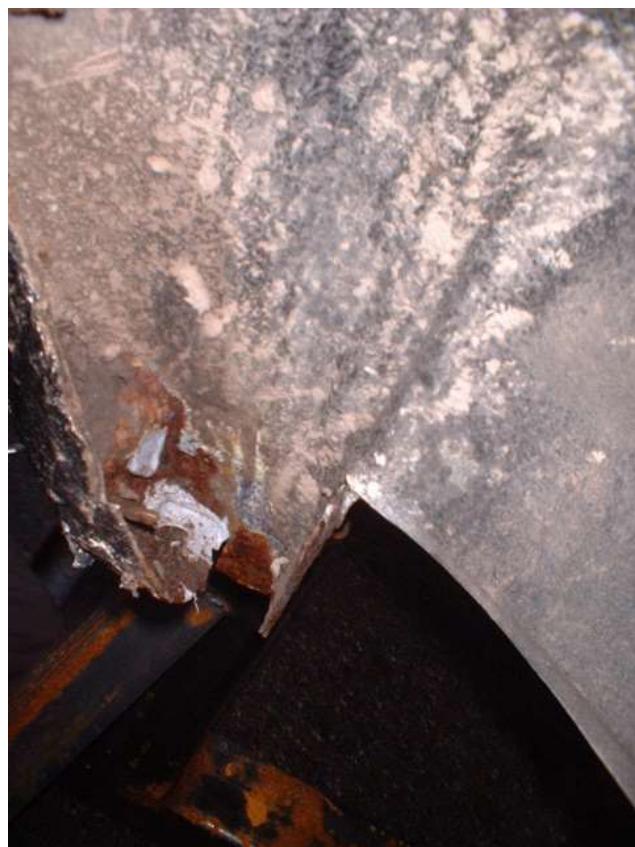
Started on the rust at the back of the sill on the drivers side

The outer sill is almost unmarked but the inner has gone right at the back.

Heres a bunch of photos that show what has been removed. I had to remove the outer sill section for about 12" or so, but it will weld back.

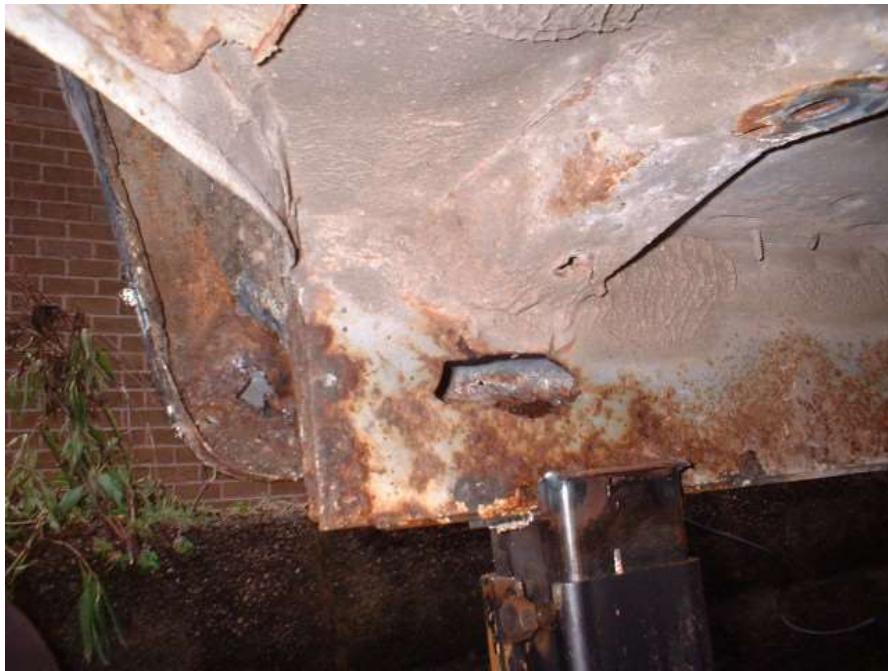
Then put my hammer through!

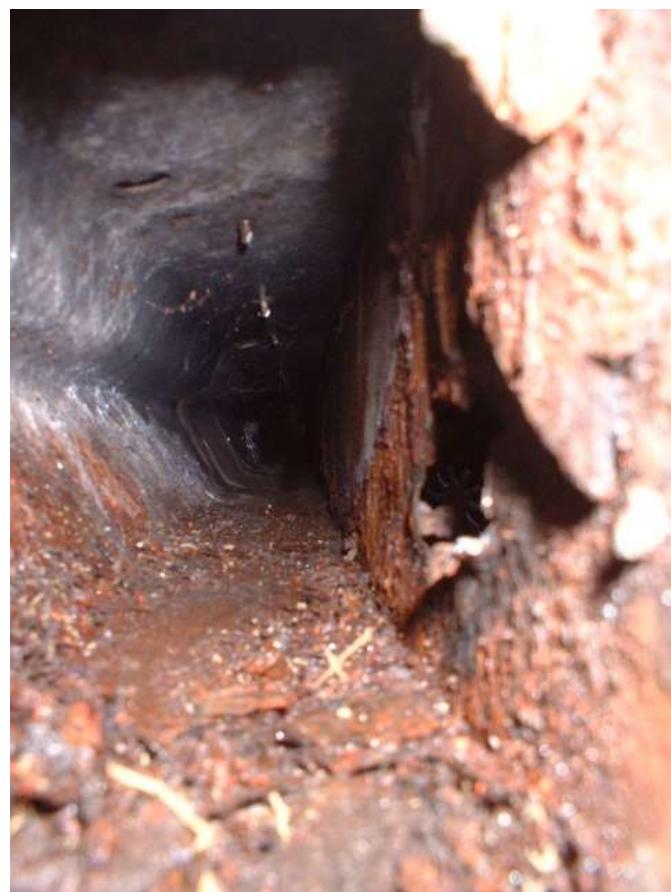
Heres a view down the sill. Looks sound further down but a bit dodgy at the front!

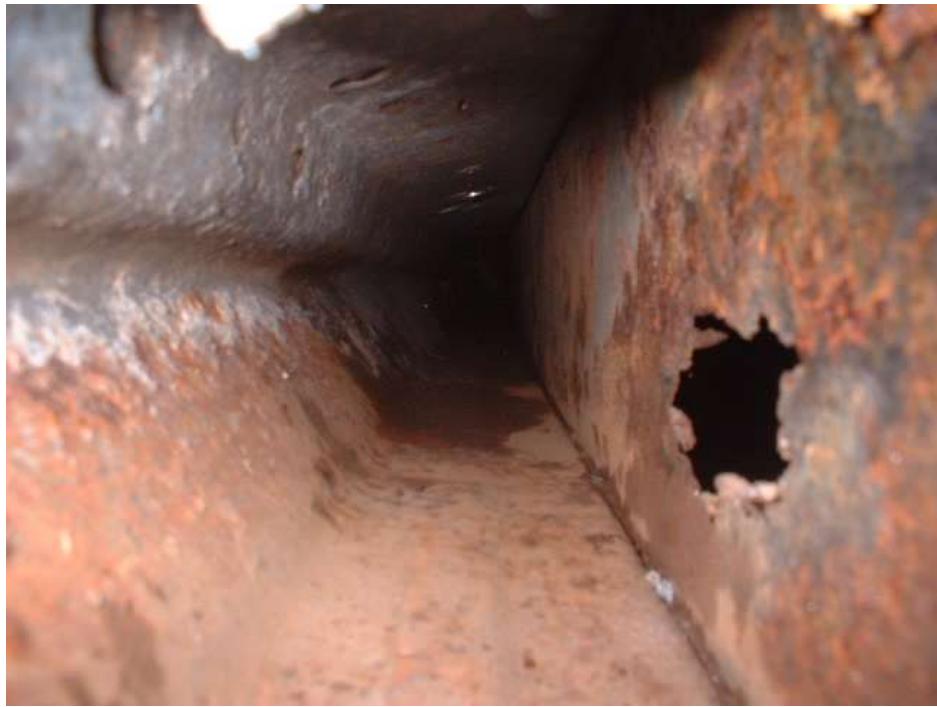
The sills are galvanised and in good shape. A good coating of dinitrol 3125 will hold this forever.

Here it is cleaned out and dried.

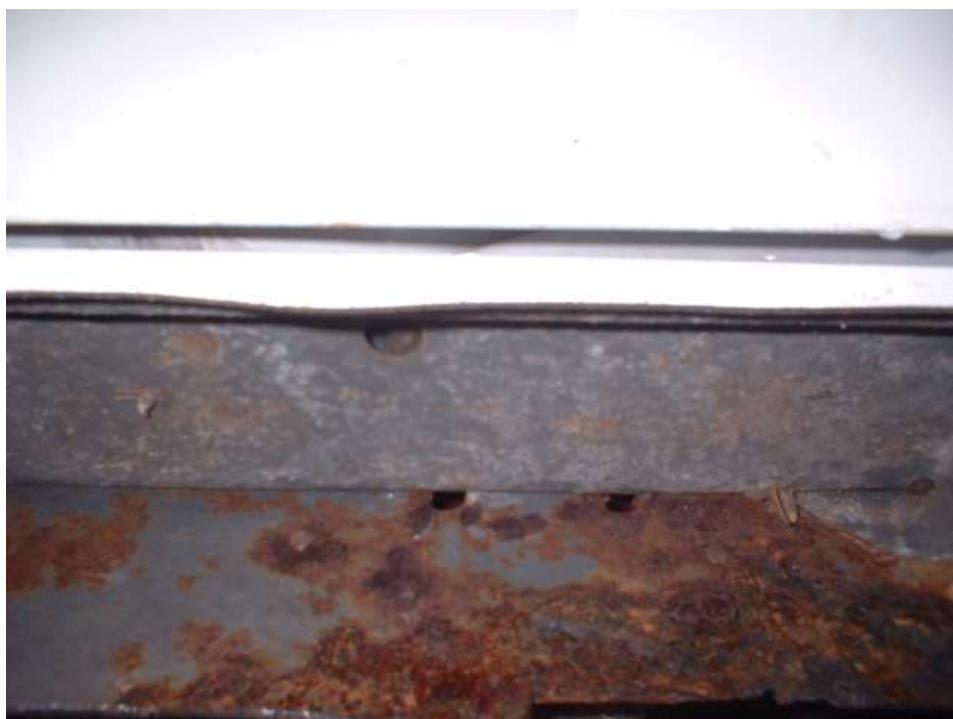
Heres the rust inside at the top

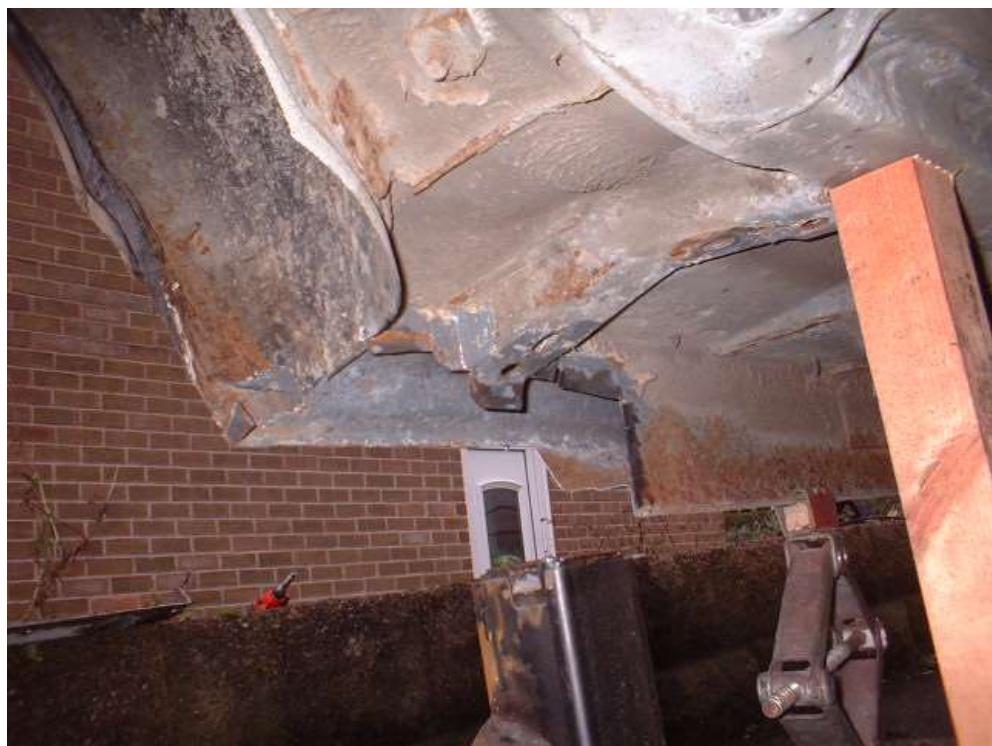
More cutting

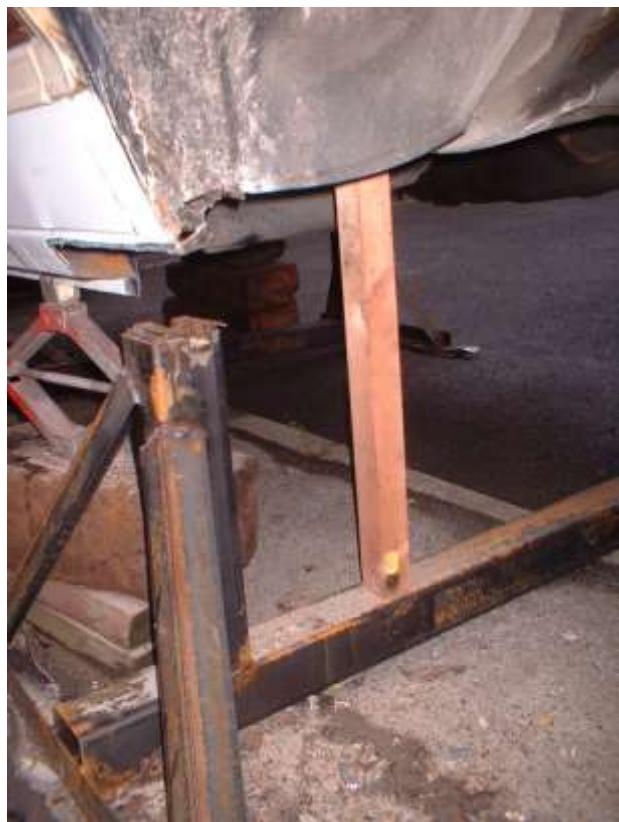
Here's my wooden support!
