Project Big Ford

Ford LTD Crown Victoria LX Country Squire

September 2009

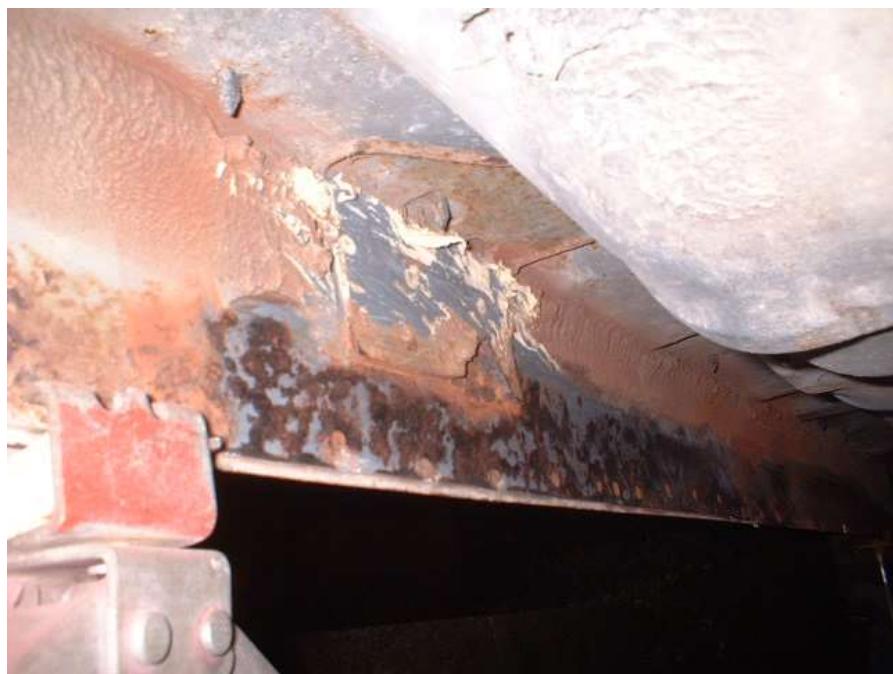
I removed a lot of the rust on the inner sill earlier in the week and spotted the seat belt reinforcing panel was a bit rusty. So that will have to come out.

Heres the removed rusty panel and the associated panelwork under it.

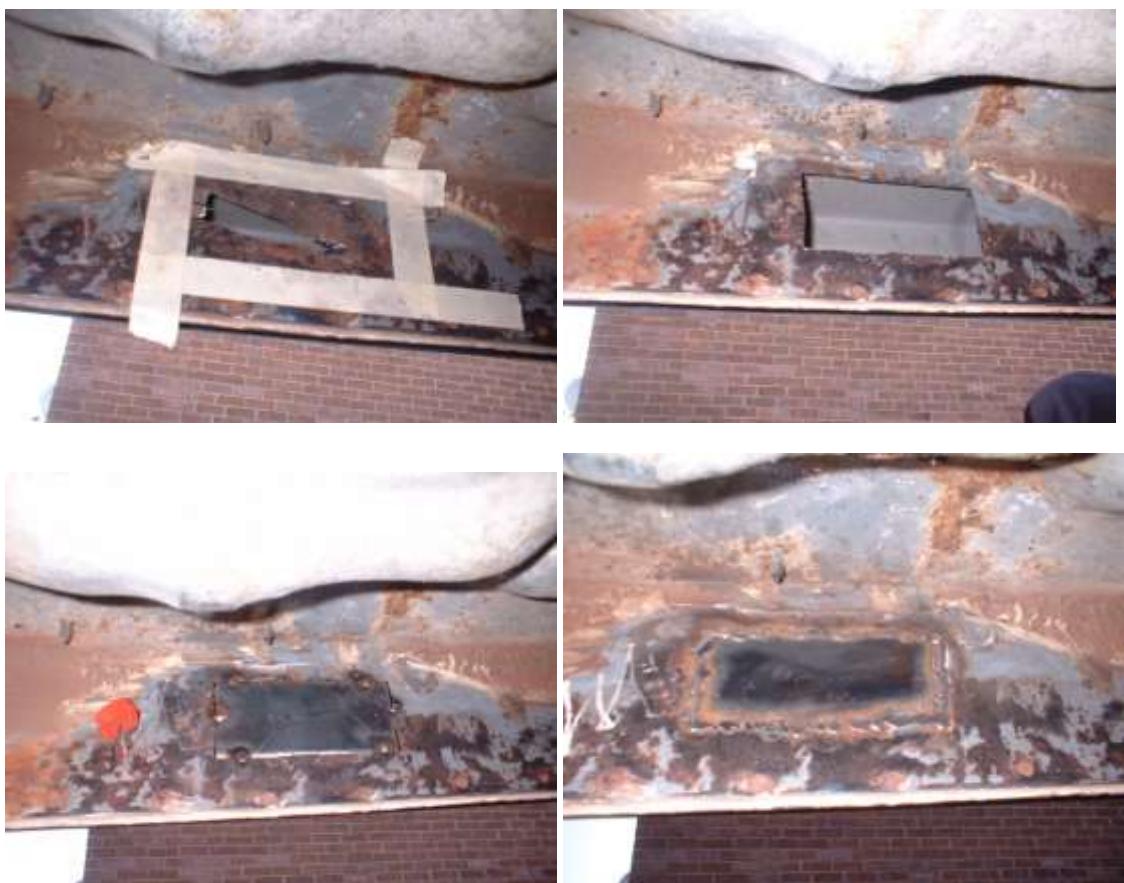
Heres the inside view of the holes drilled to remove the plate

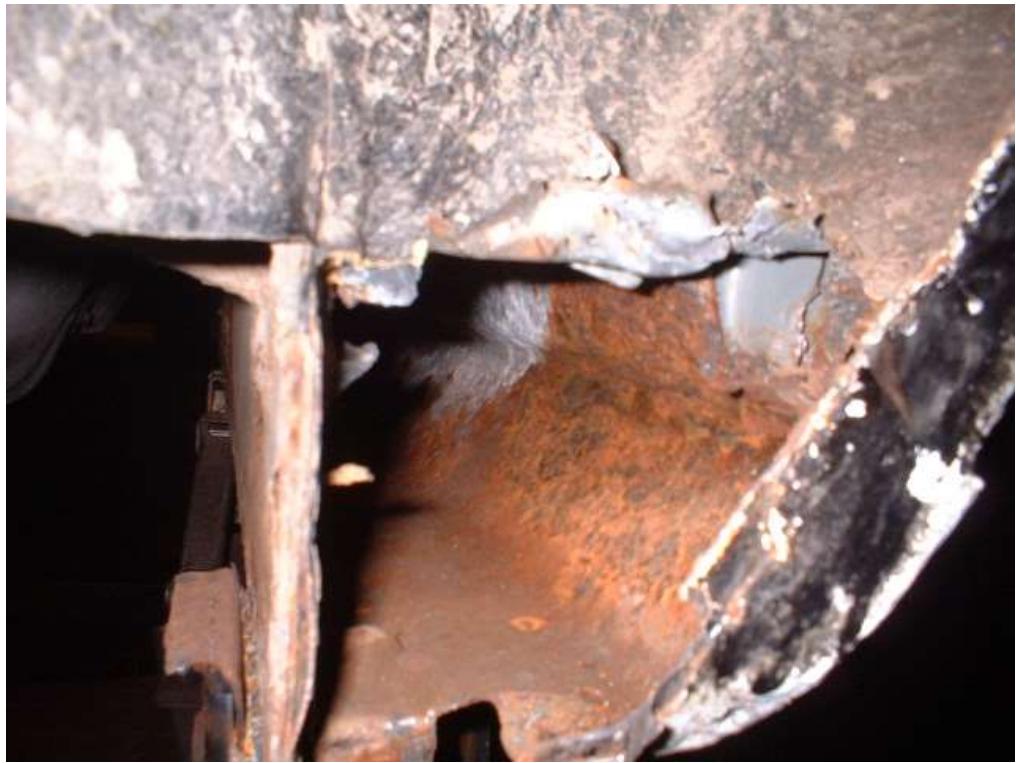
Supported the pass side and started investigating the rot. Not good.

It has gone further up than the other side and further down the sill. Absolutely loads of rust came out of the sills when I drilled 3 1" holes and blew compressed air down.

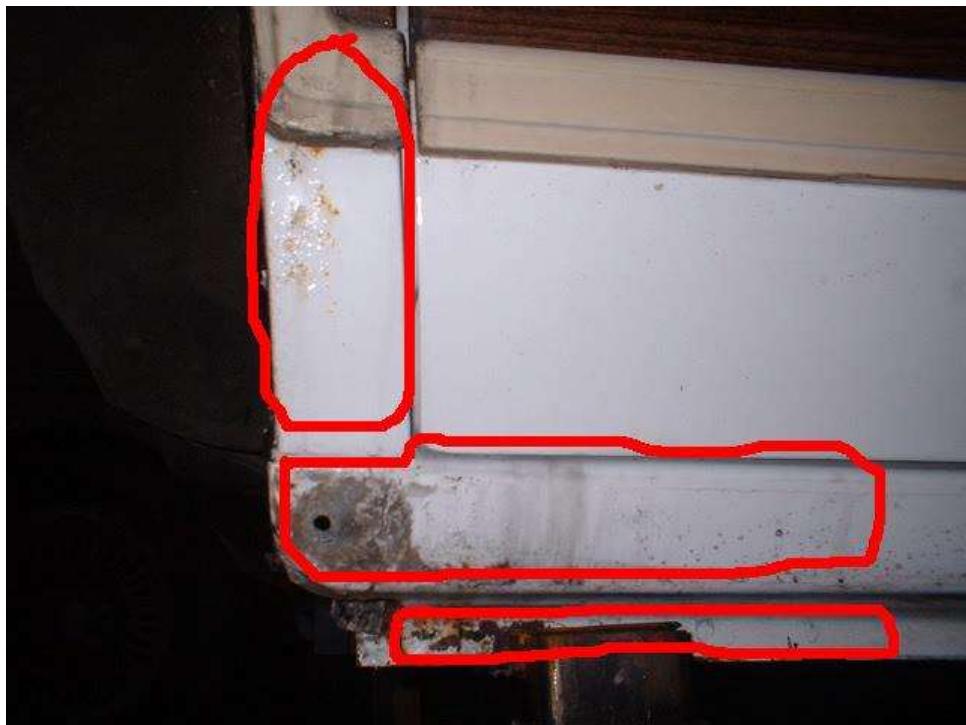
It is rusty in these areas

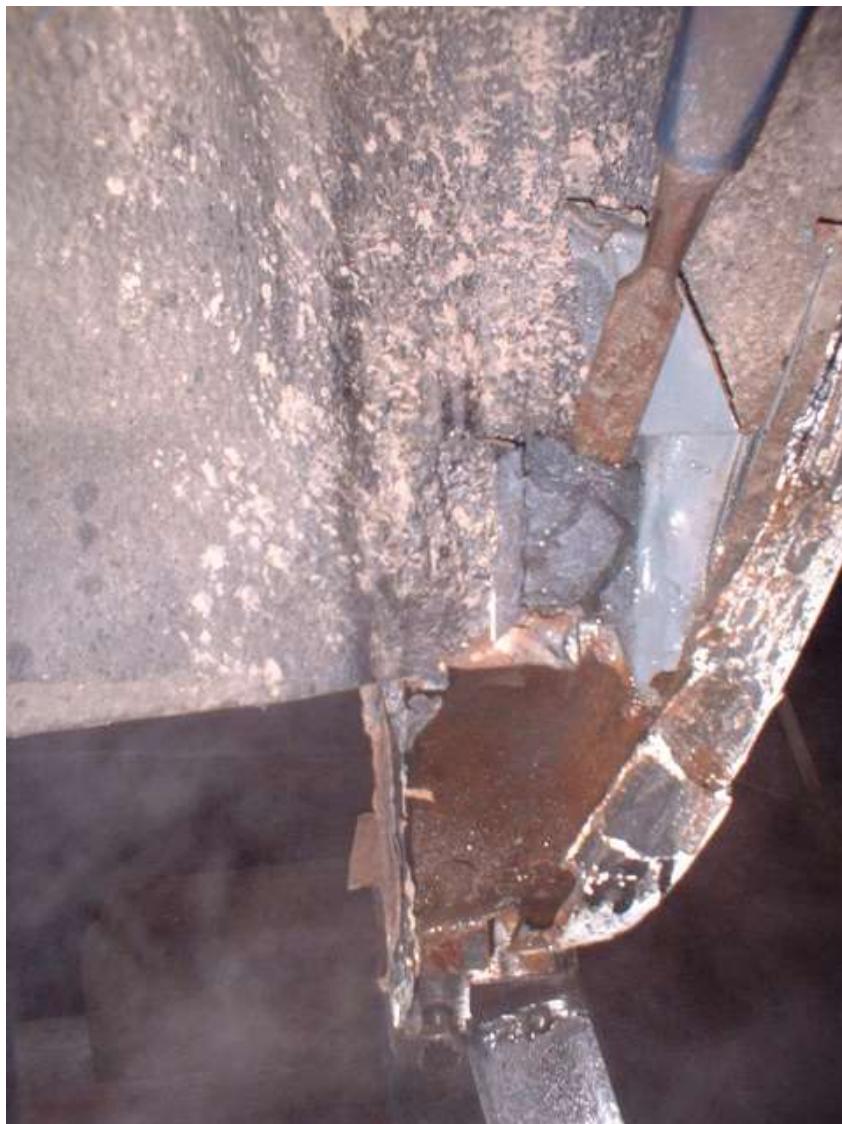
The first panel cut revealed a piece of black foam that was saturated with water. This had obviously run down into the sills and started to corrode them from the top down. Heres a photo of it being squeezed with a chisel.

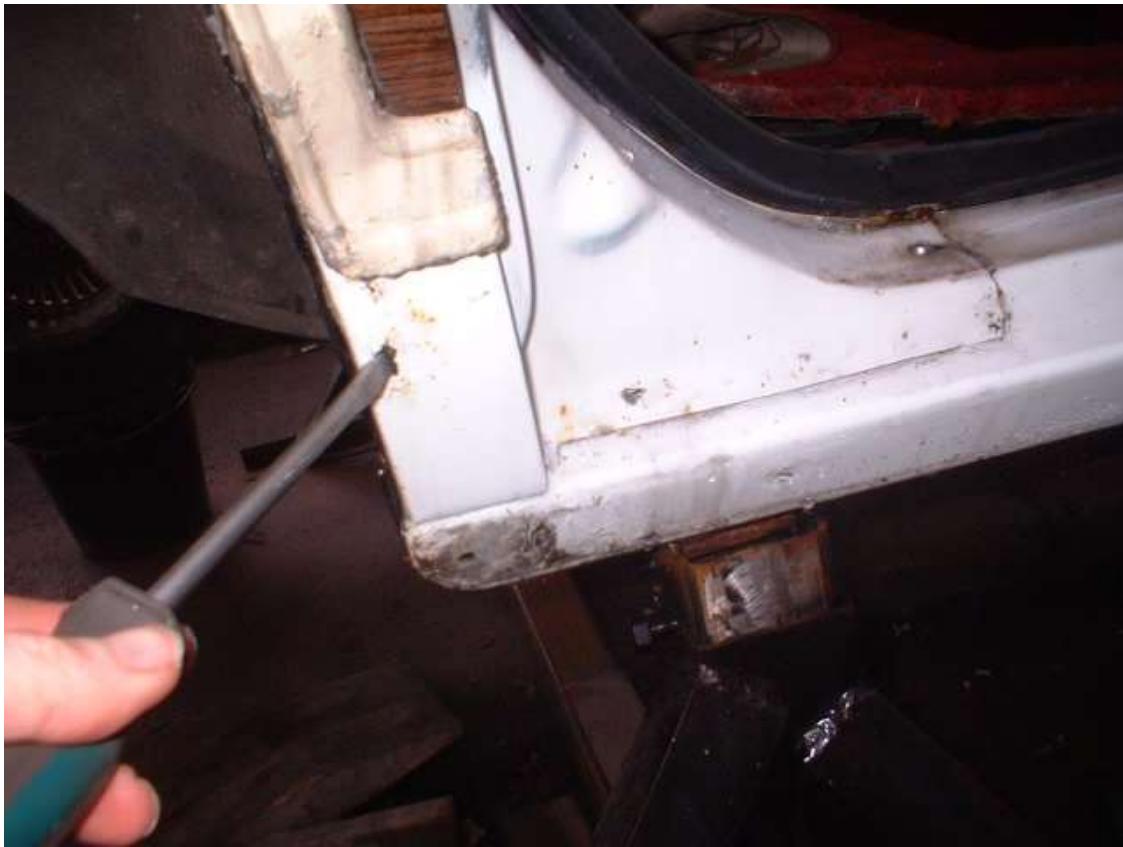
More corrosion here

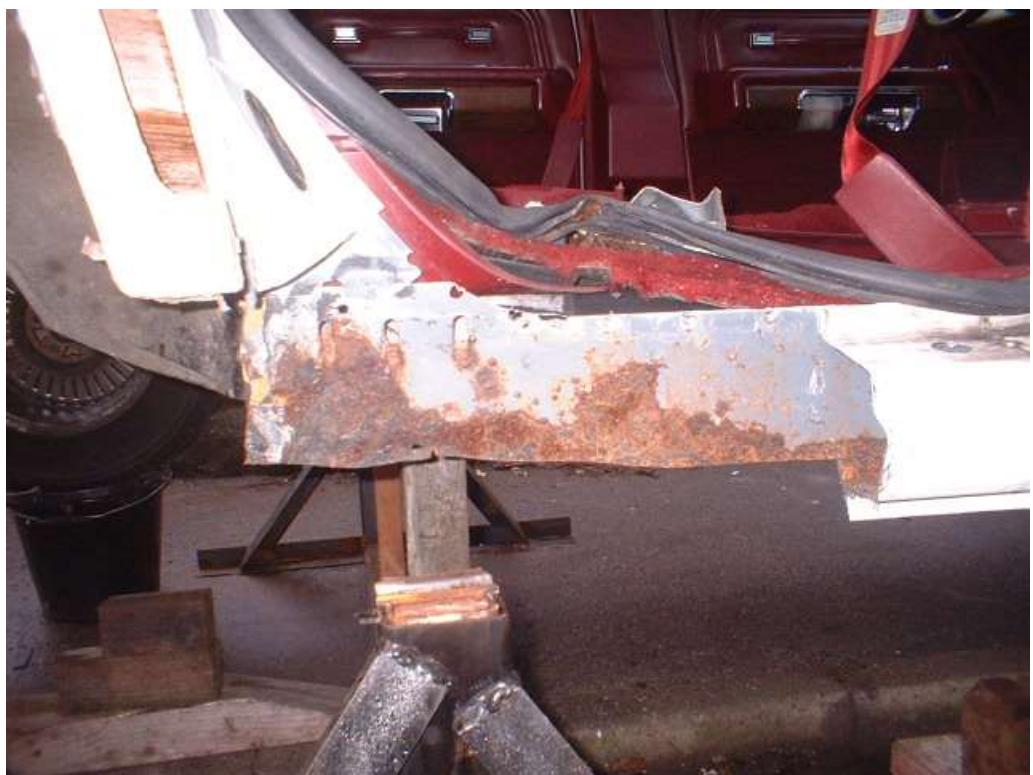
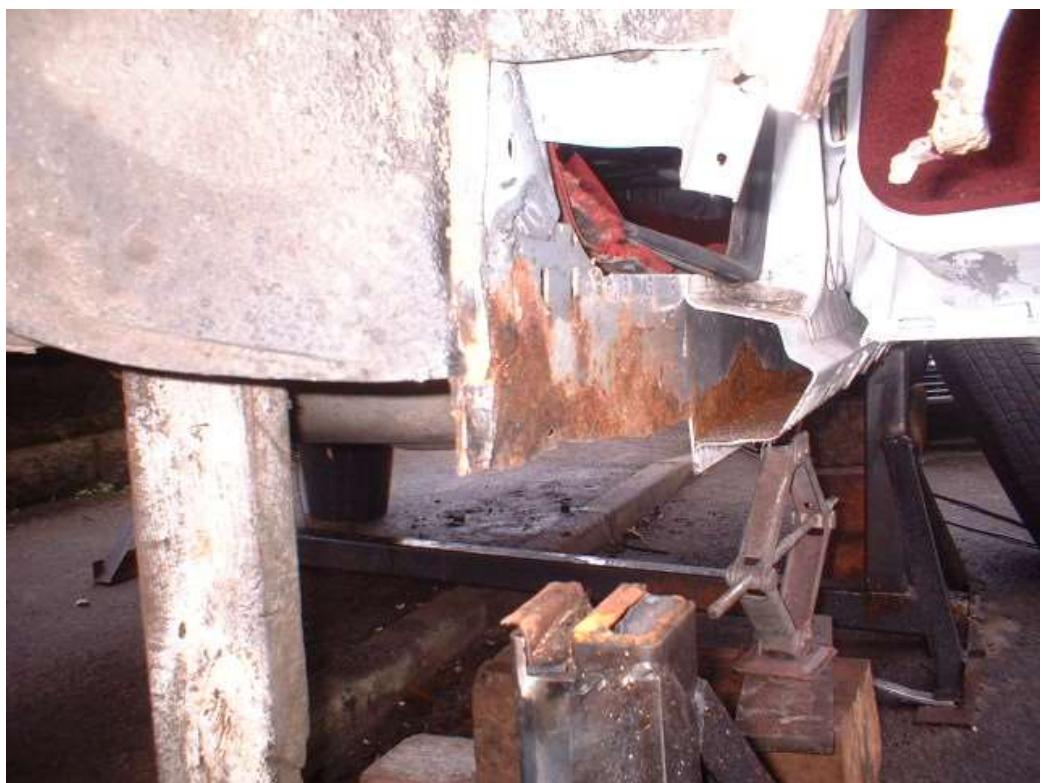
Still more to cut out then

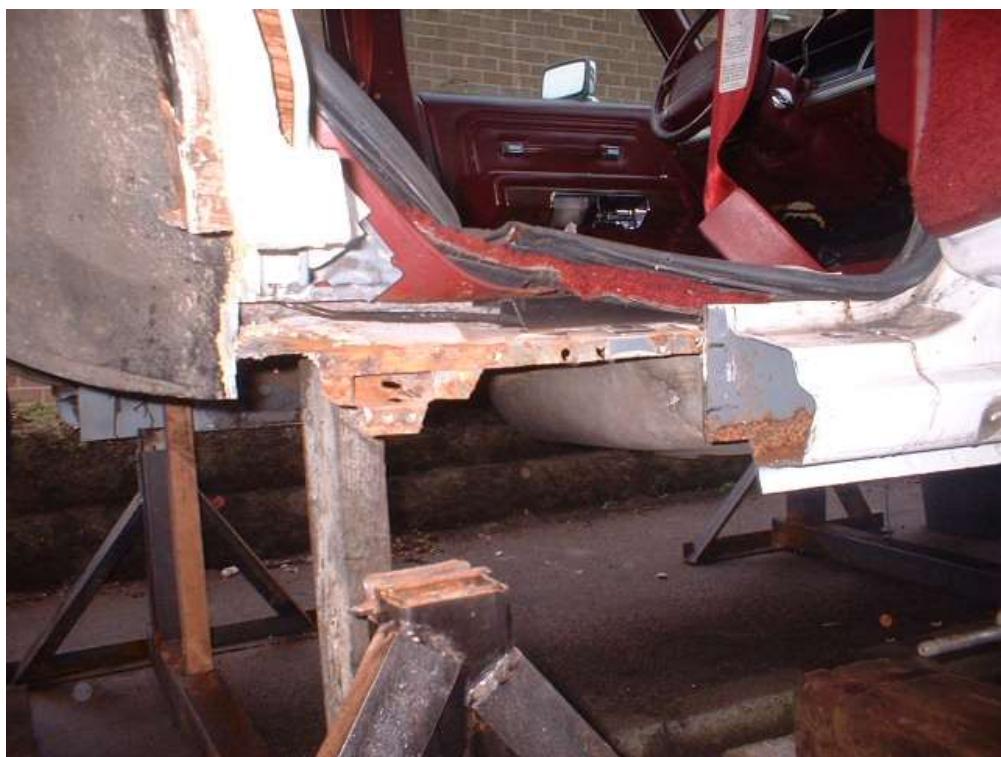
Finally back to good steel.

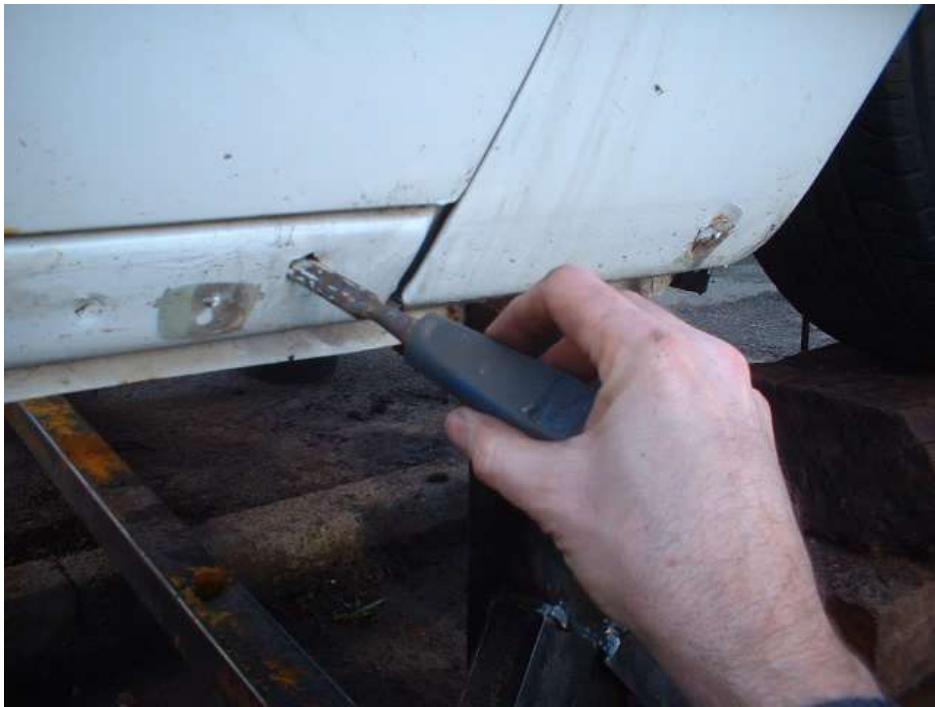
Drilled out all the spot welds on the bottom of the passenger sill to about 6 inches from the front. Then put my hammer through it! Some more welding to do then!!

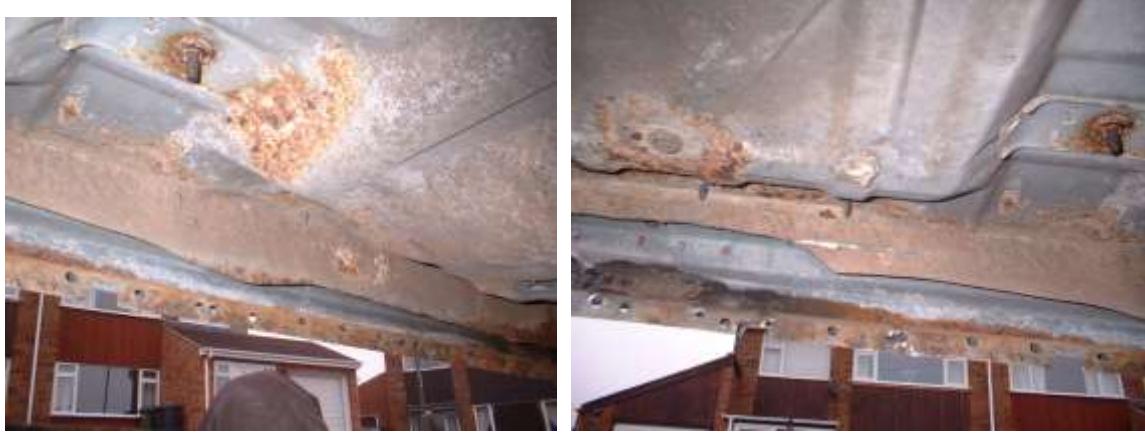
Cut the bottom off the inner sill to reveal a rusty outer sill but not too bad.

It is very close to the front wing so I will cut the inner sill back further and then blast the heck out of the front section. It then may need properly repairing when the car is running again.

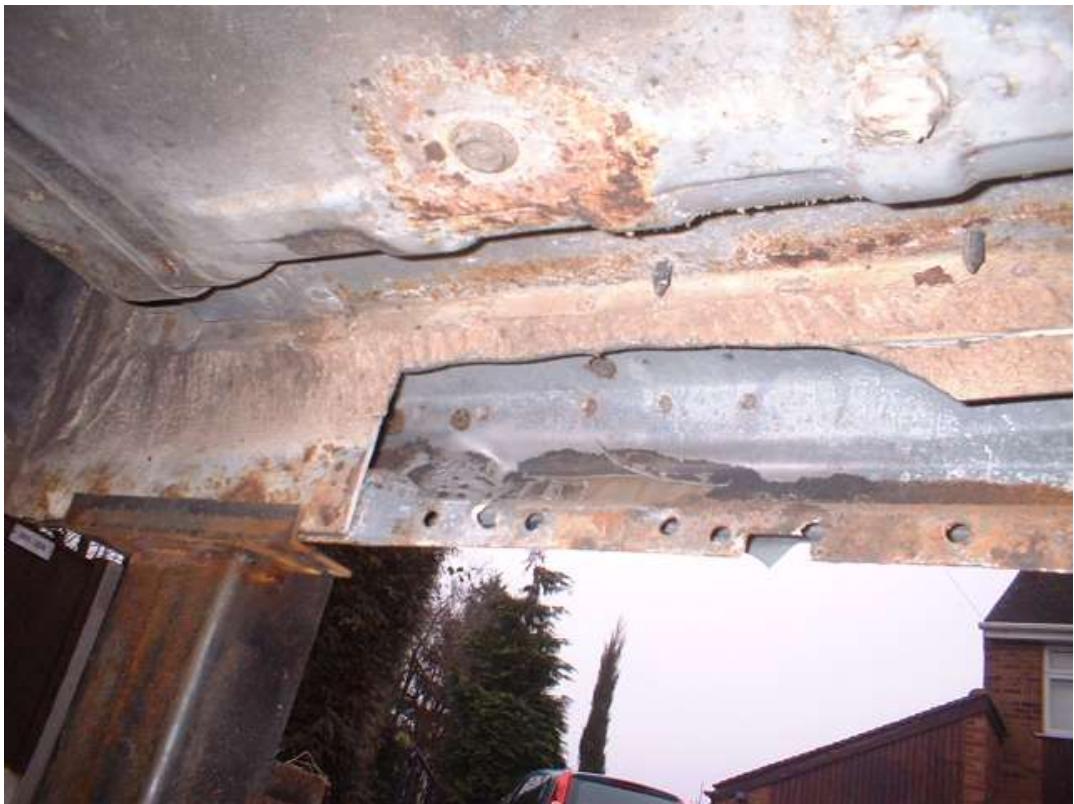
Cut further forwards towards the stand and removed a further section of inner sill.

Lots of scaly rust inside but I can't cut further back because the stand is there. So I'll media blast into the front as far as I can and then rustproof and tackle it again when the frame is back on.

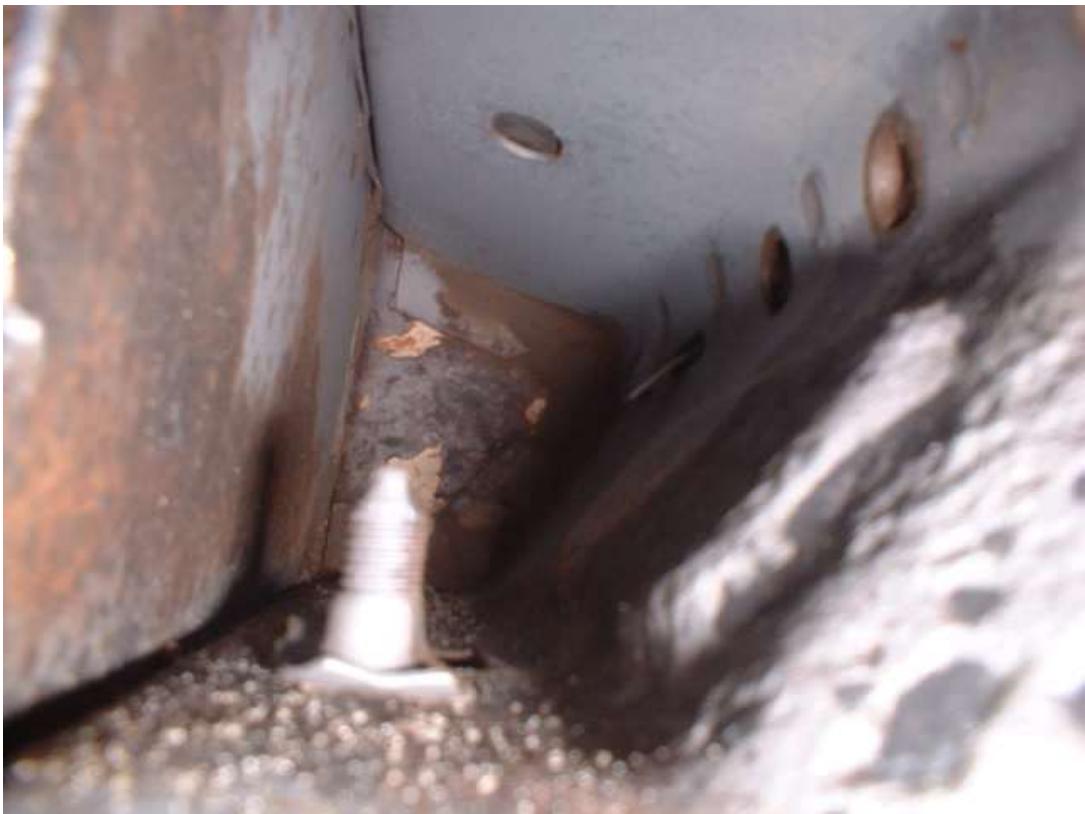
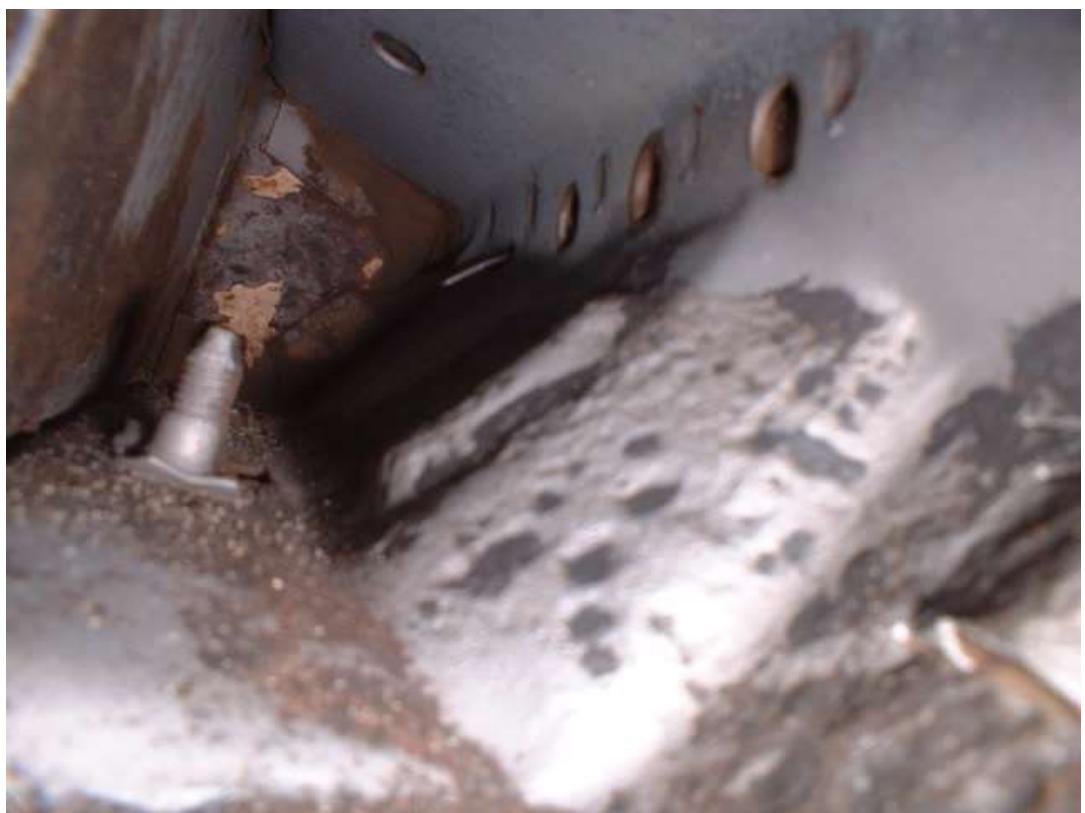
Heres a view from the inside looking in

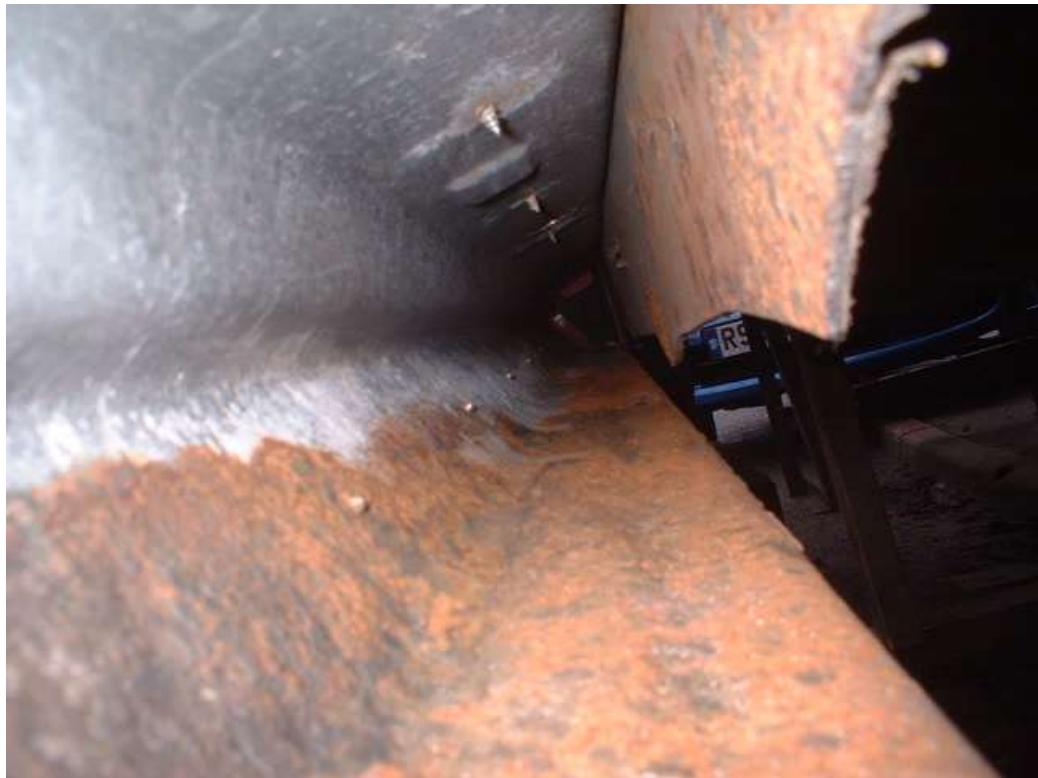
Here's a view down the other way

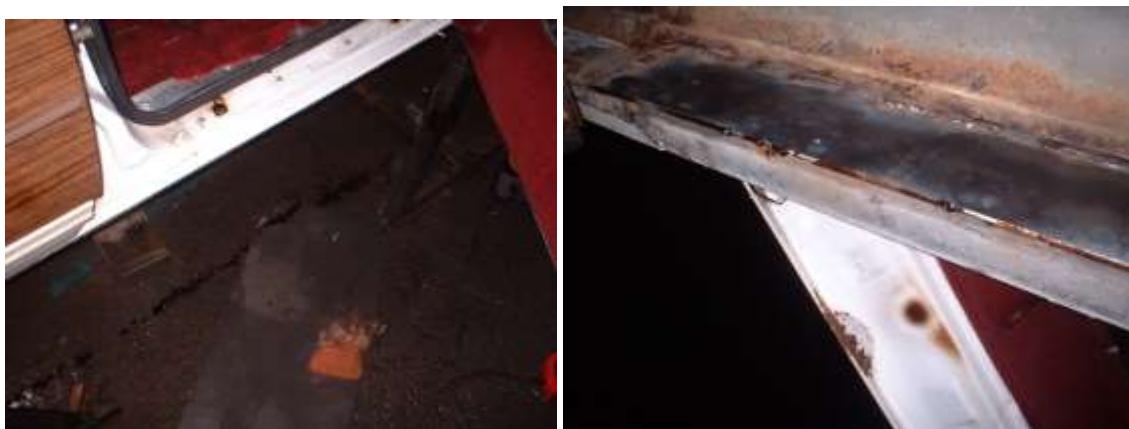
Now I can see the rusty patch on the underside of the passenger door. Sort that out later.

Then sprayed 3125 inside the sill and heated it up with a hot air gun until it ran into the seams and dripped out

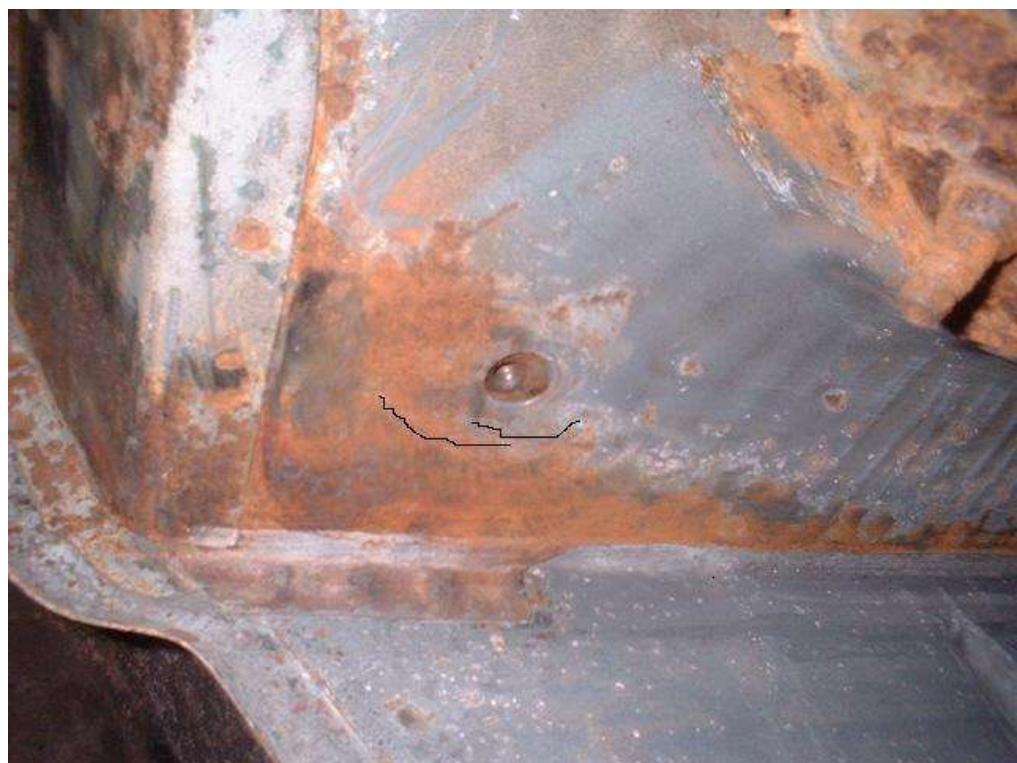
Here are some fatigue cracks on the frame mount (highlighted in black)

Need to weld these up.

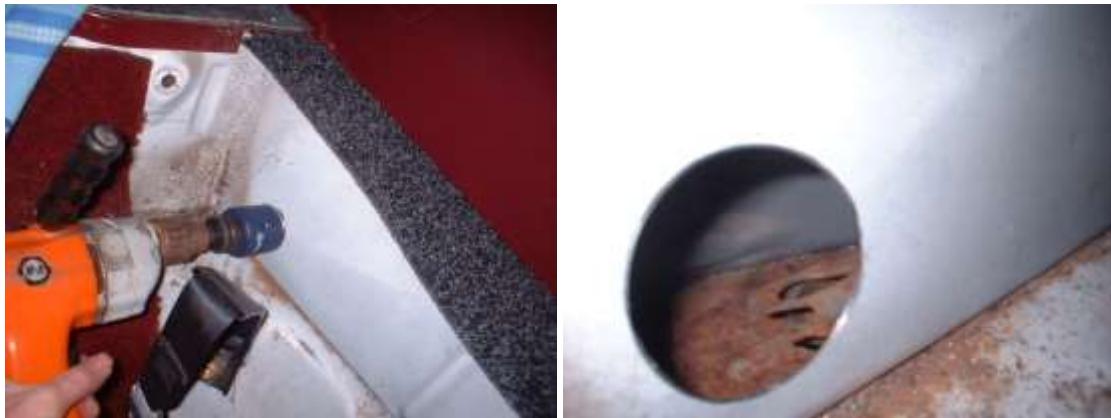
First attempt at not quite in the right place

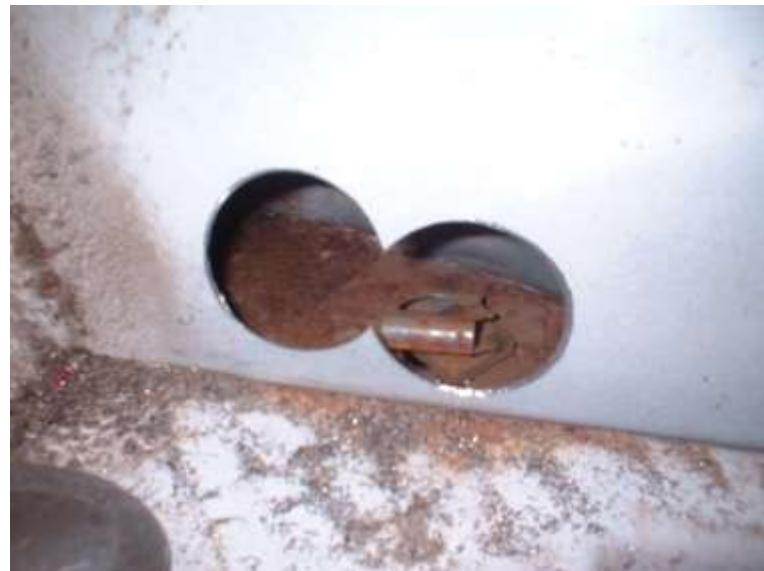
Now I can see what's happened. The captive nut cage has broken free on one side and has bent upwards. The threaded nut has dropped out of the bottom! And there is plenty of rust. So it looks as if the panel will have to come out to assess the damage.

So another hole drilled

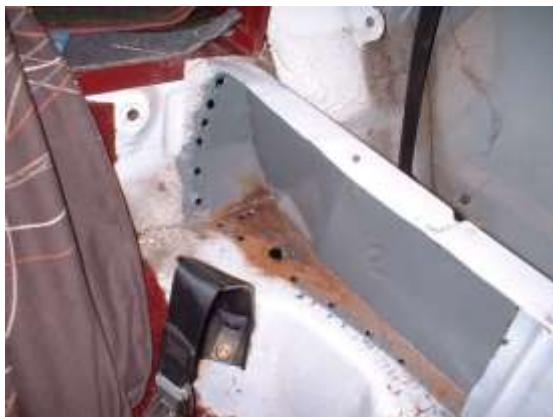
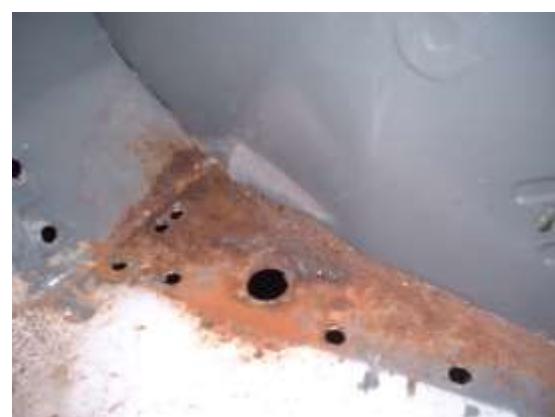
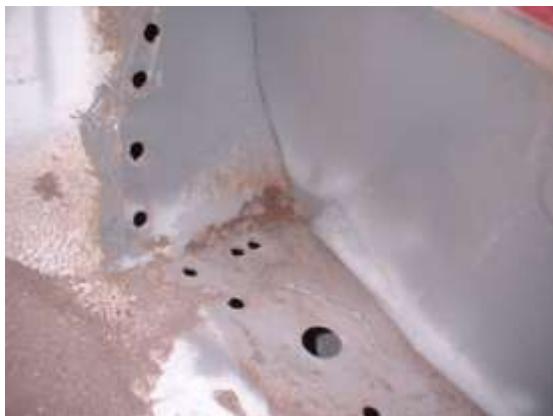
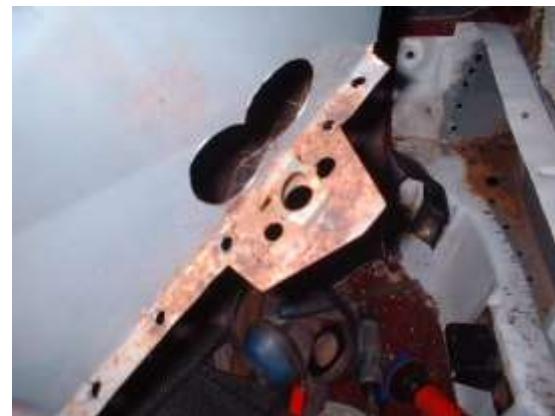
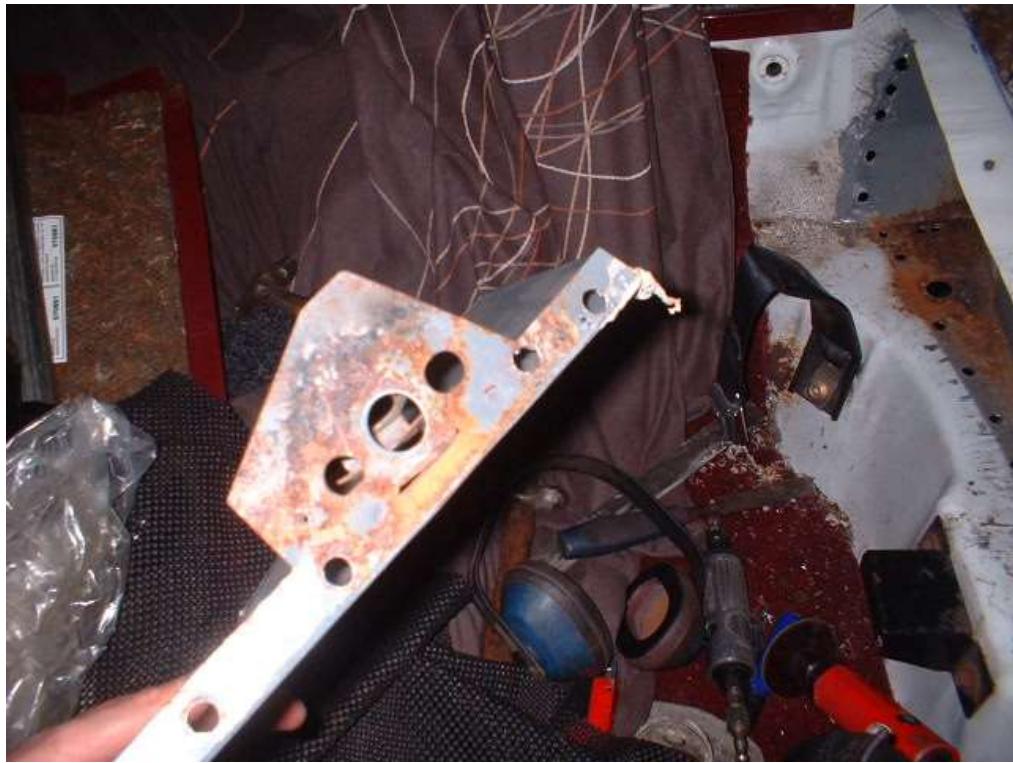
Removed the panel to have a look

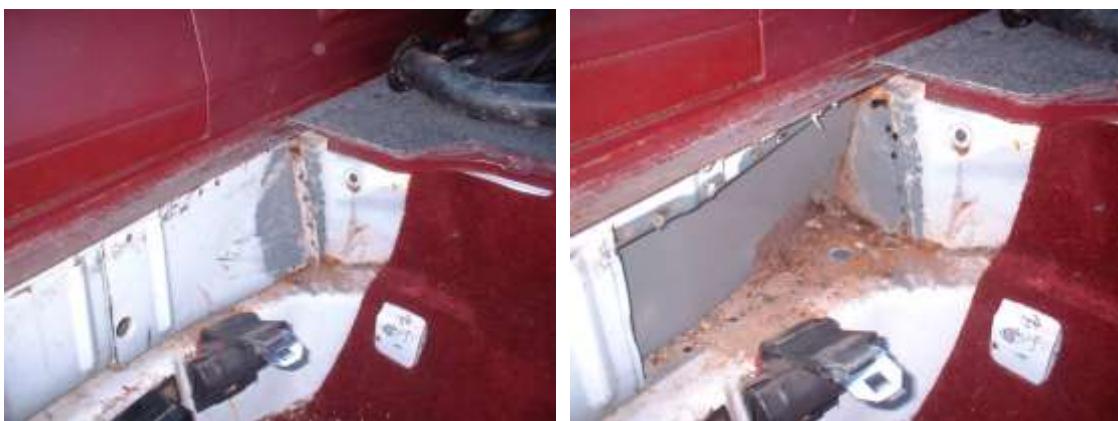
Here's the panel back left about to come out

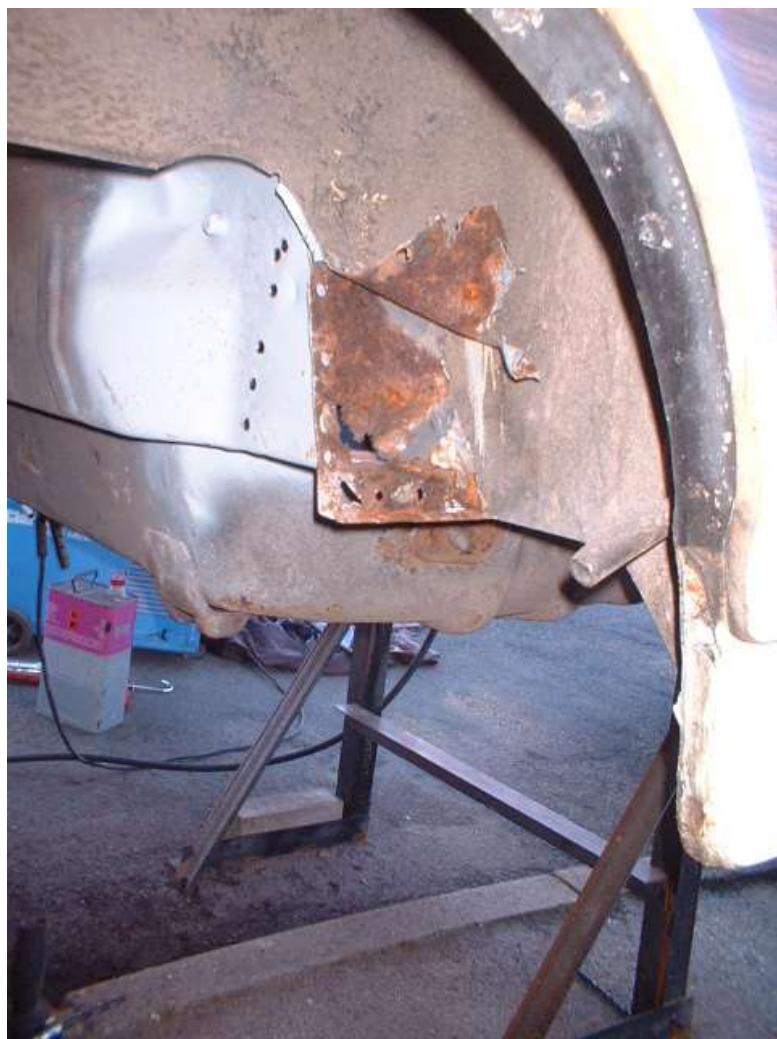
Heres the other side of the panel to show how far the rust has travelled

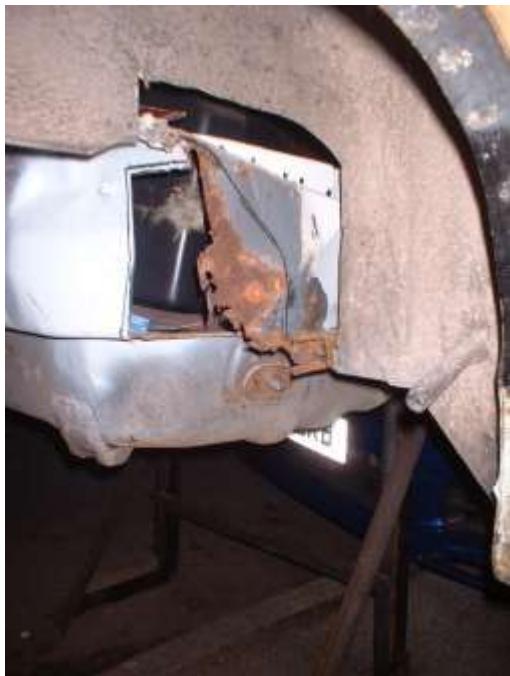
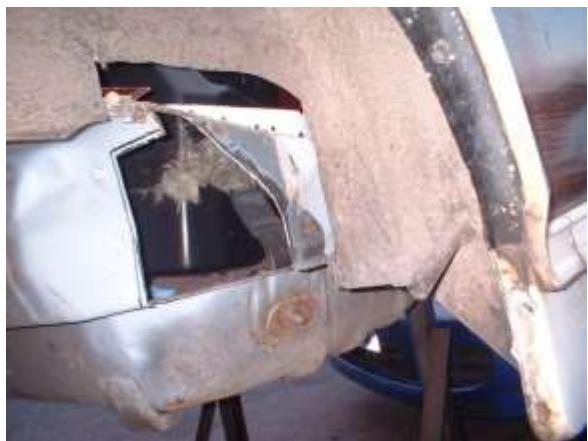
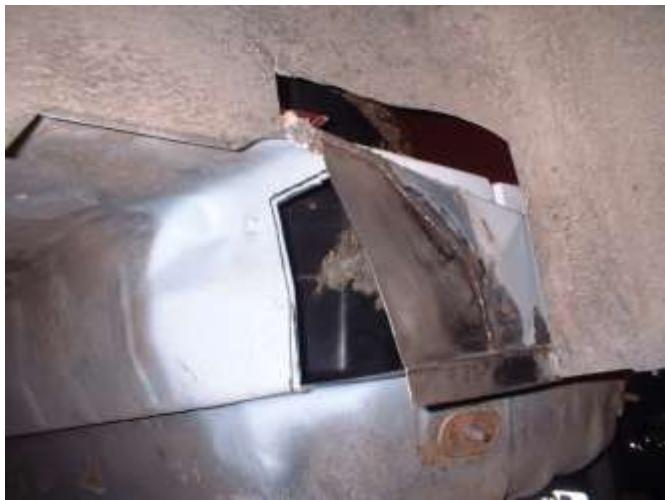
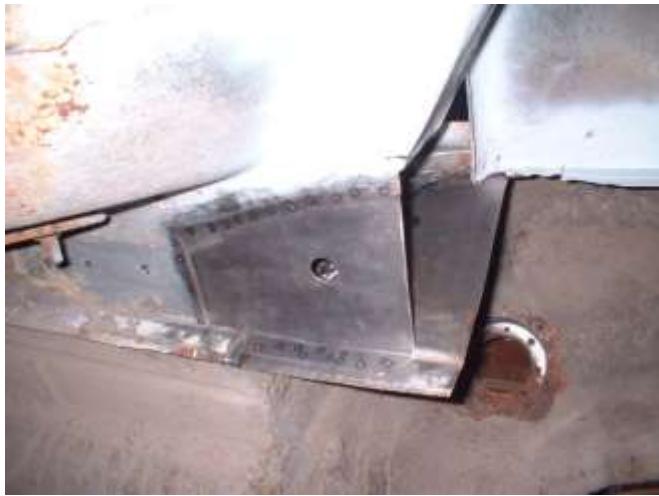
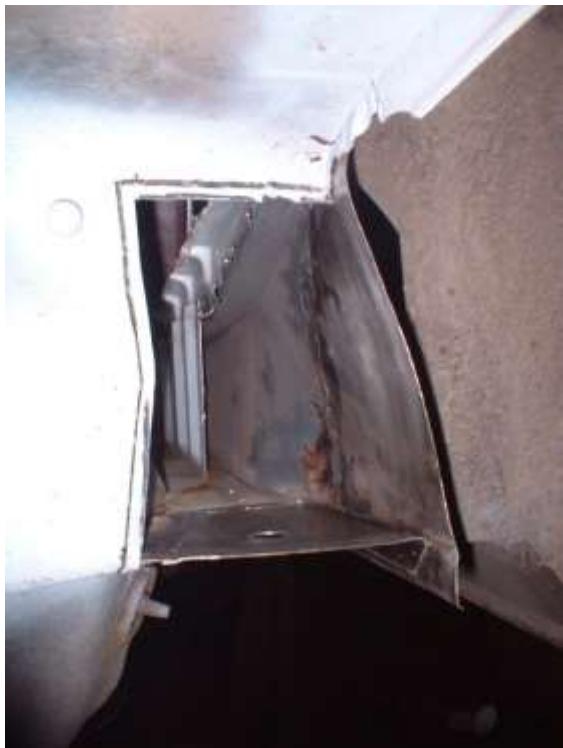
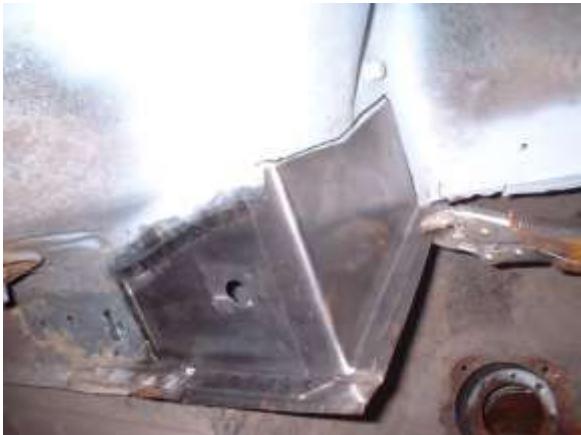
Had many hours reconstructing the above corner

Heres a few photos to show its build

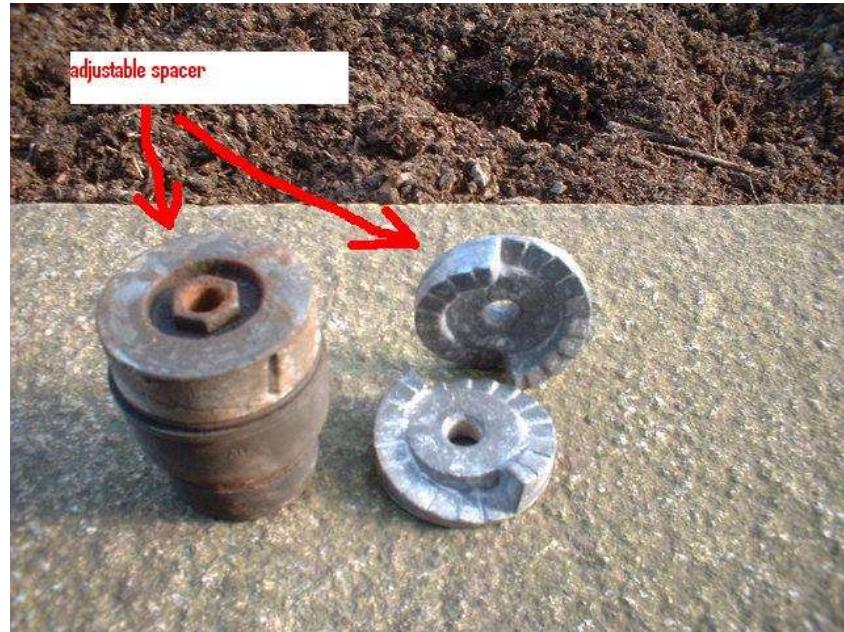
Then I remembered that I have to reuse the spacers with the front core support to frame mount. As I was prepping them, I got a surprise! They are in 2 halves!

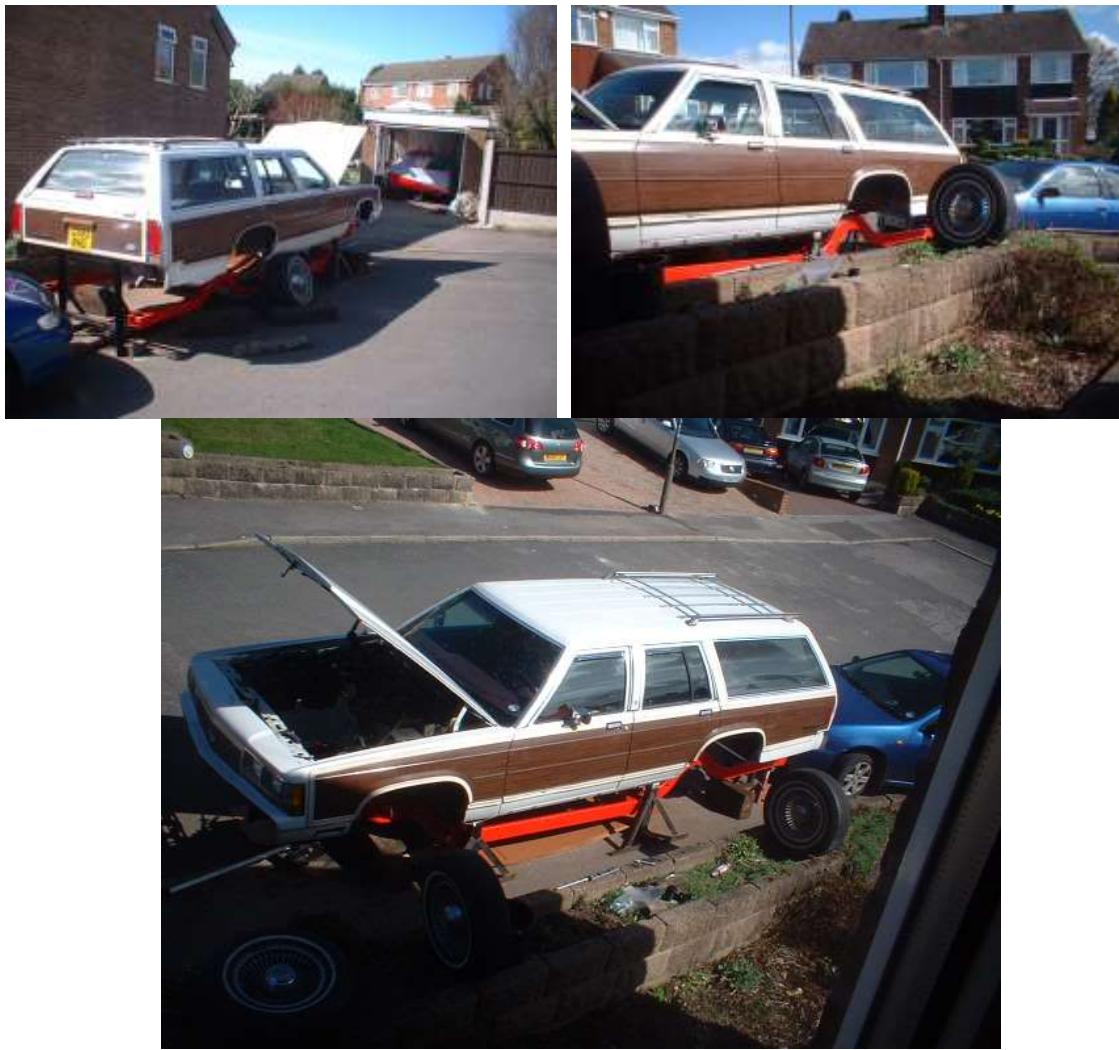
Gradually I raised the frame up and bolted it in. Two of the washers were too big to go through the holes so I had to cut a slot to get them in.

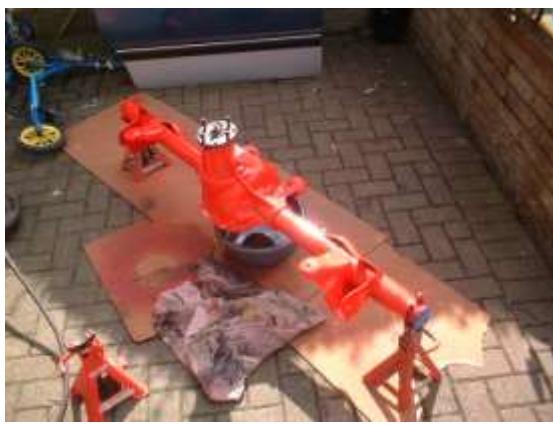
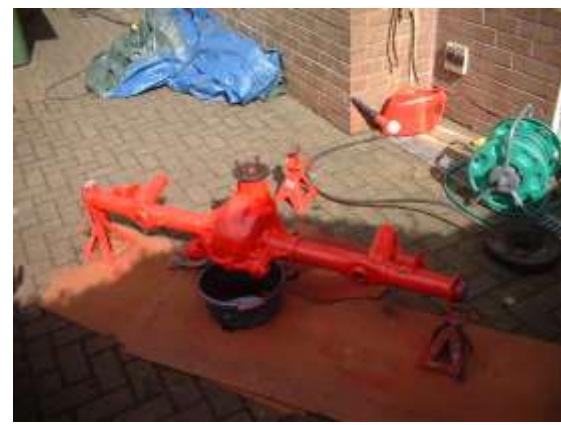
The axle fell off the stands and split my bowl which was full of gear oil!!! You can see the split in it in the right hand picture!!

Axle painted with 2 good coats of smoothrite red and a further coat sprayed on for good measure!

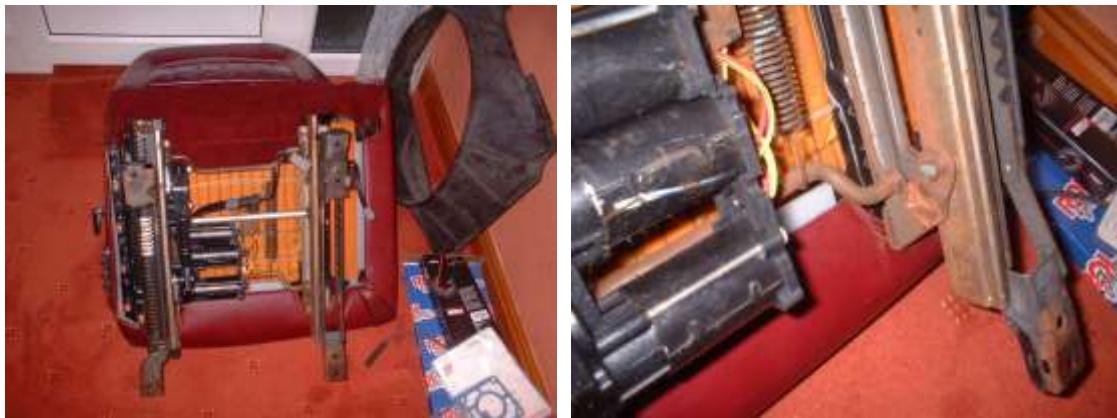
The reason for the groaning and non operation apart from tilting side to side weirdly came obvious.

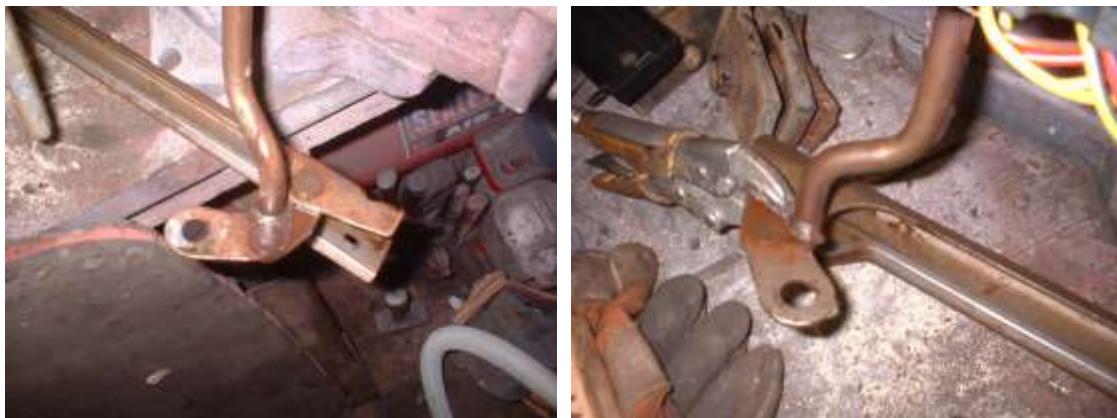
The weld had broken. But why? After dismantling, all the swivel joints on one side were seized solid. So solid in fact that hitting them with a hammer wouldn't shift them. A flame and a big lever eventually worked wonders.

Then clamped for welding tomorrow. Damn good job done if this works.

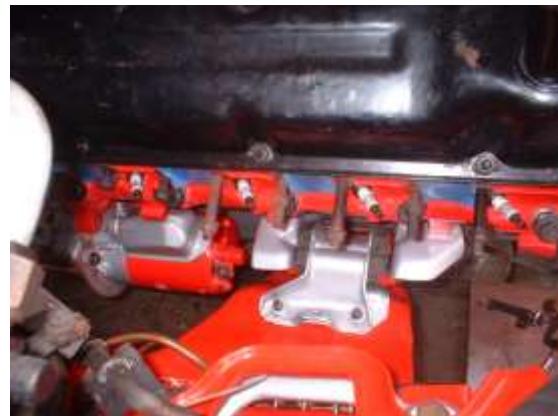
Here's a photo of before and after
