Project Big Ford

Ford LTD Crown Victoria LX Country Squire

September 2009

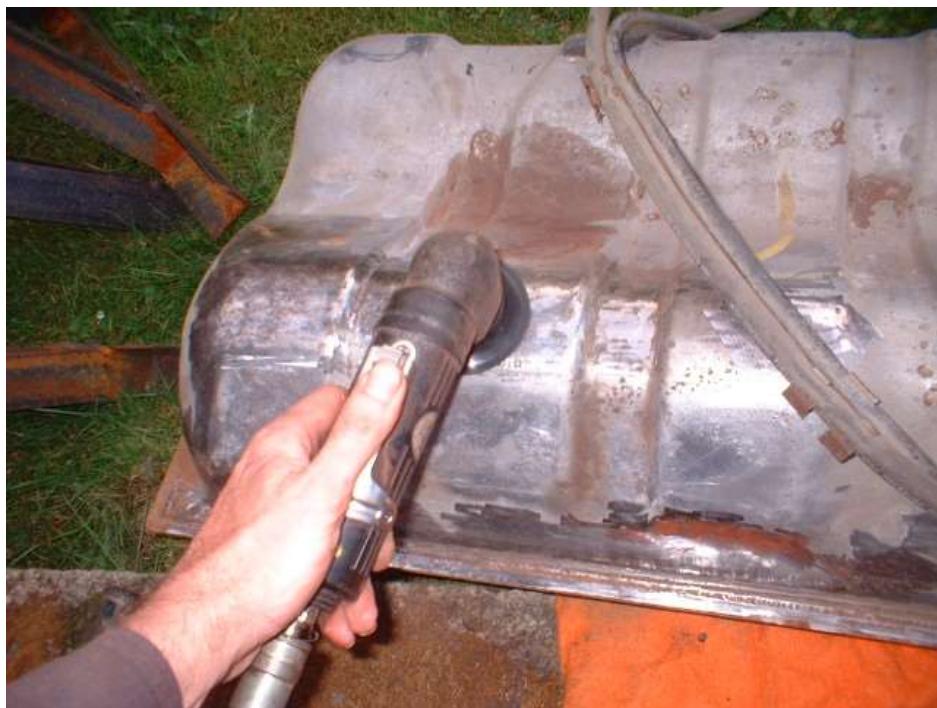
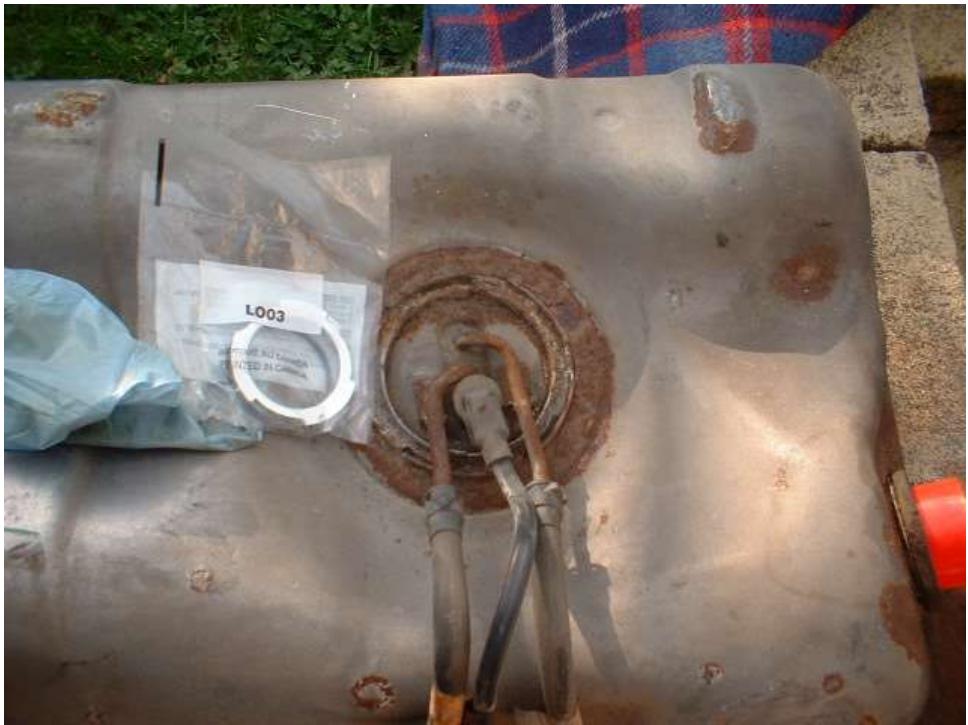
Media blasted the areas around and on the sender unit and fuel pump. Then removed them. I have a replacement fuel sender unit ring and seal, but not a fuel pump one.

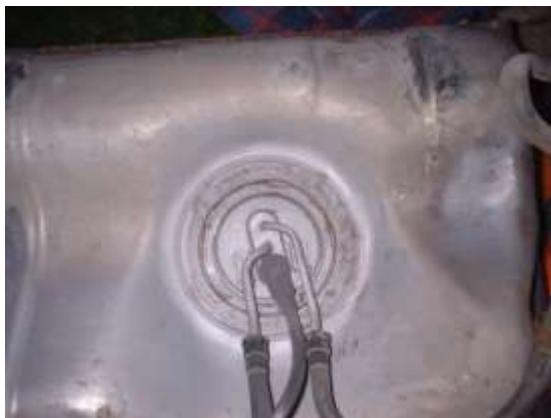
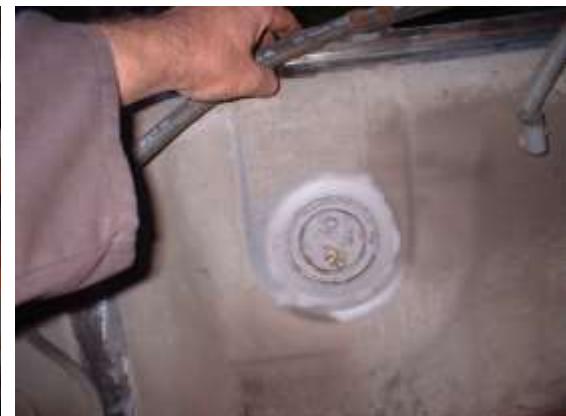
Media blasted the top of the fuel pump and top of the sender unit.

Areas under locking plates rustproofed, new O ring and plate installed on sender unit, old o ring and blasted lock plate put back on top of fuel pump.

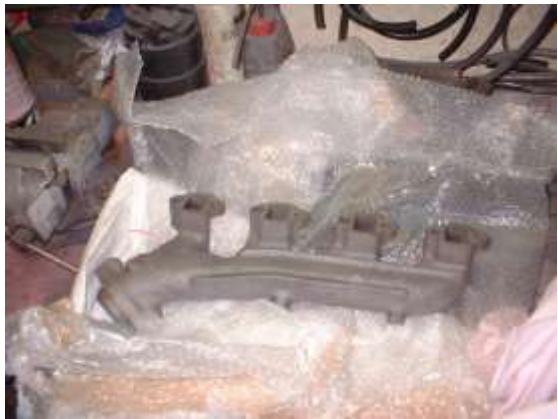
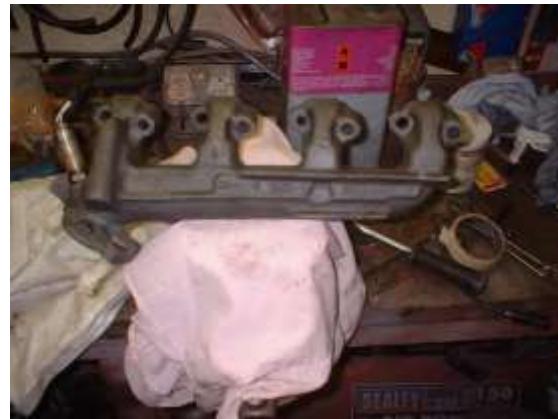
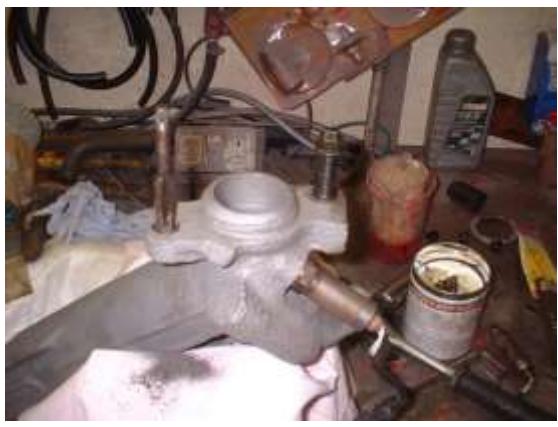
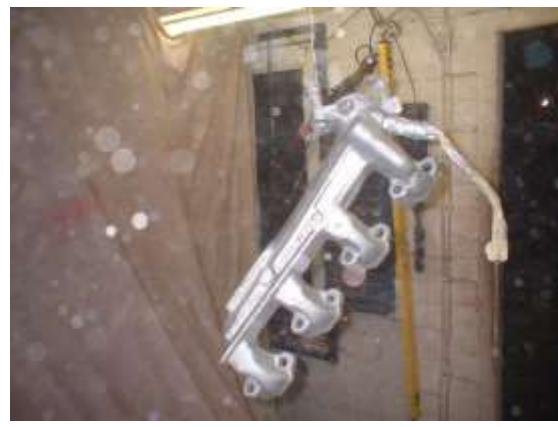
Stuart media blasted the exhaust manifolds for me again, and I retapped the threads and restudded them, screwed in the O2 sensors and sprayed them with silver high temperature paint from Halfords.

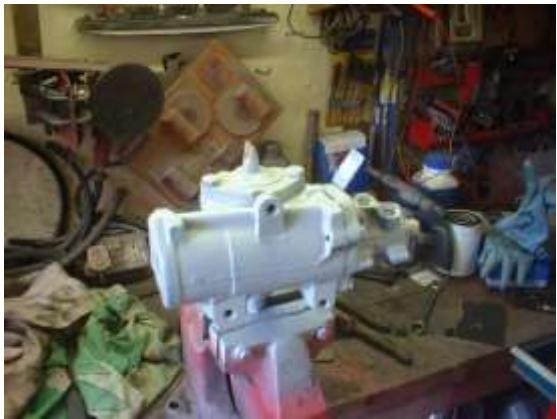
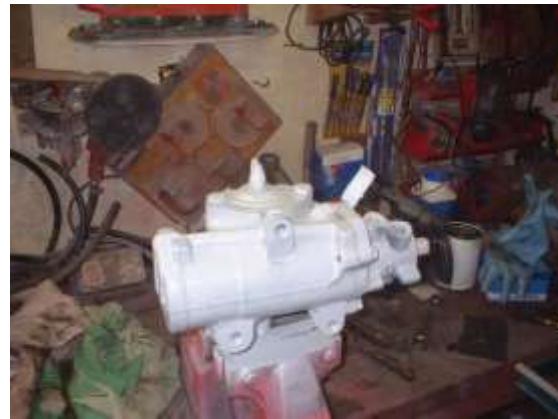
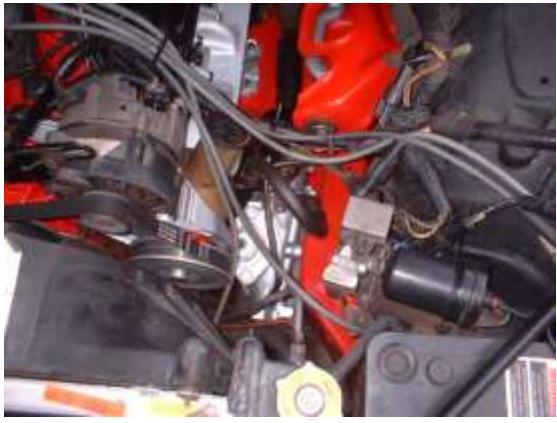
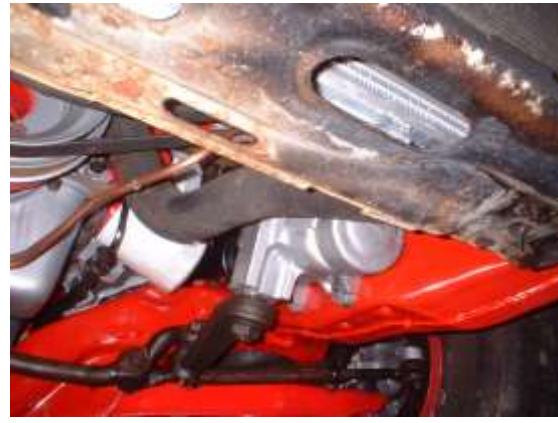
Heres an interesting find. It looks as if the pitman arm has been changed before and someone has had trouble pulling it off and ground it off! You can see the grinding marks here.

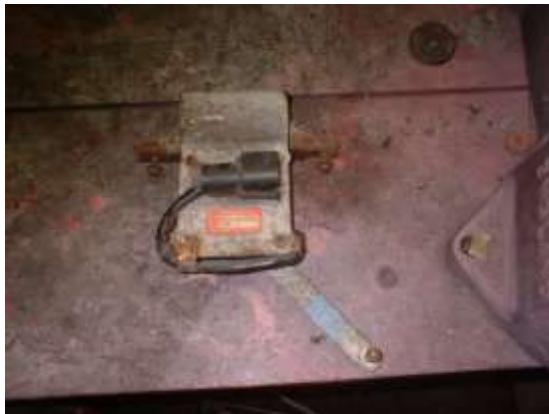
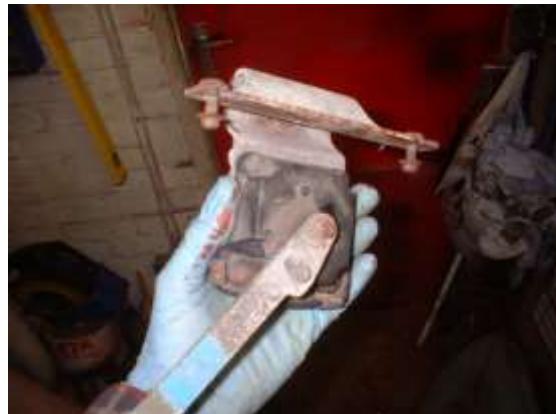
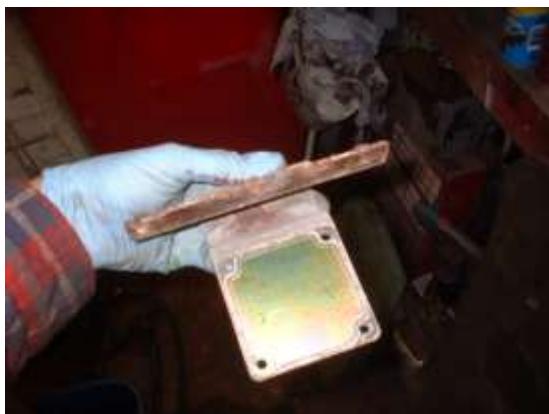
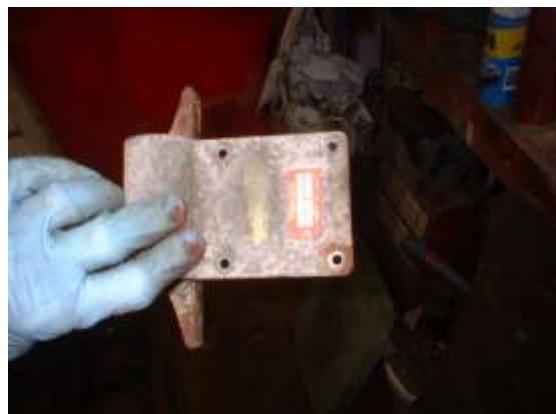
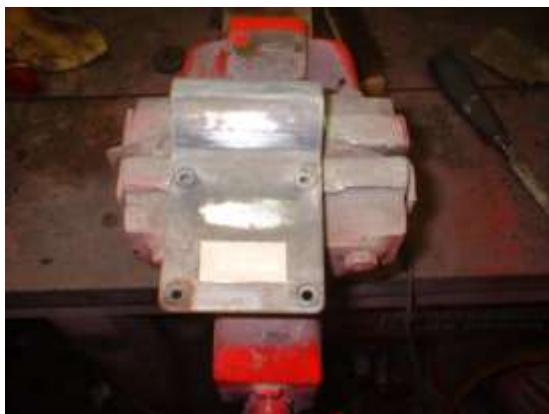
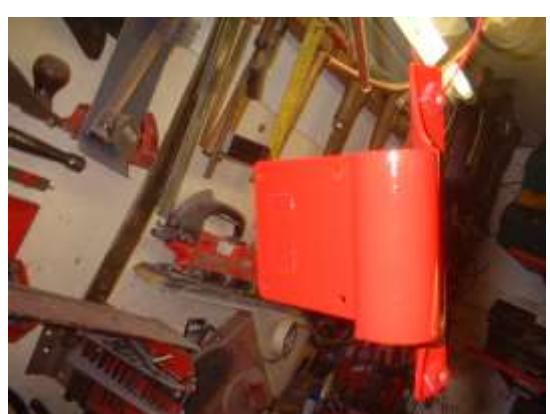
Cleaning up the rear self levelling sensor was interesting!

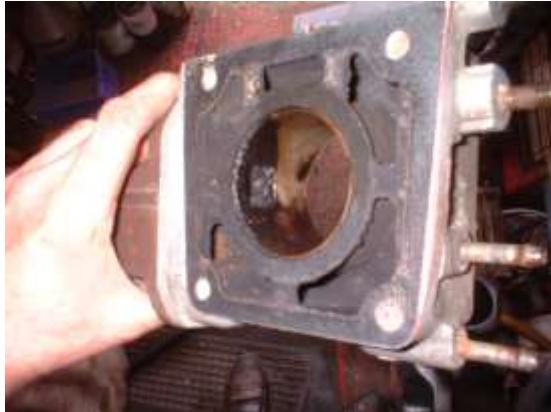
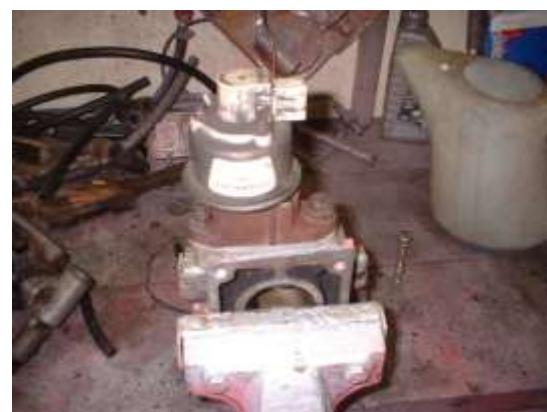
Stripped out throttle body and cleaned the IAC valve (was clean anyway) and the EGR valve that was coked up bad. Took the opportunity to grind a bit off the top of the clevis pin on the throttle valve cable.

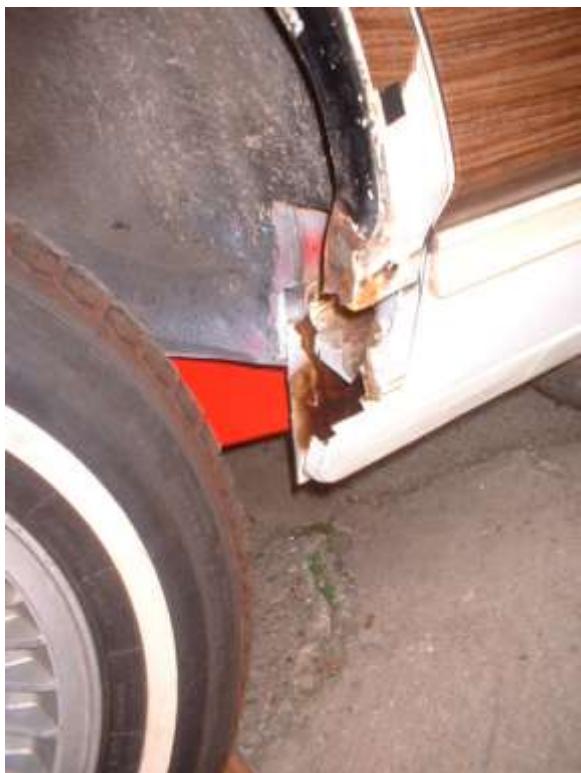
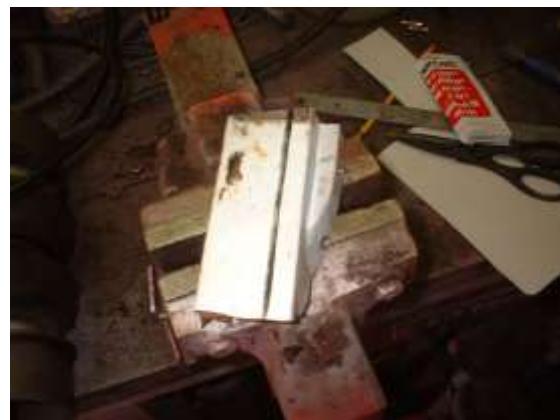
Now I need to do a bit of cosmetic welding before the MOT. Lets start with this. And the panel that I removed 7 months ago

I will cut along the black line and joggle a new section in.

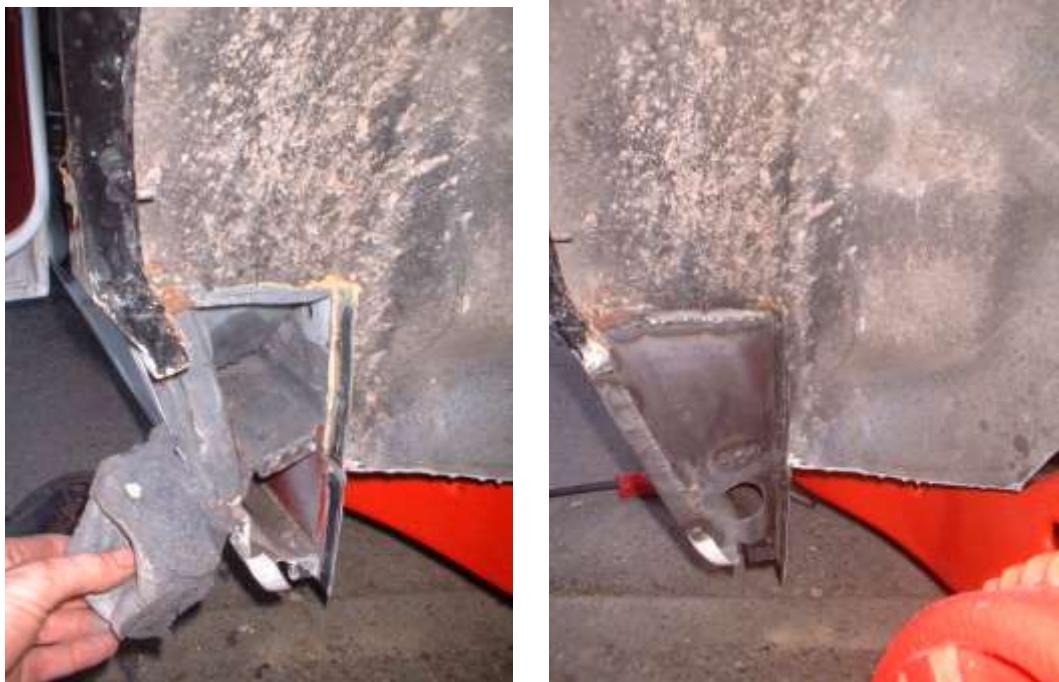
Same thing repeated on the other side. There's the sponge stuff that causes all the water to be absorbed.

Then painted white and a grommet glued in to stop water entering (after a serious rustproofing dose though).

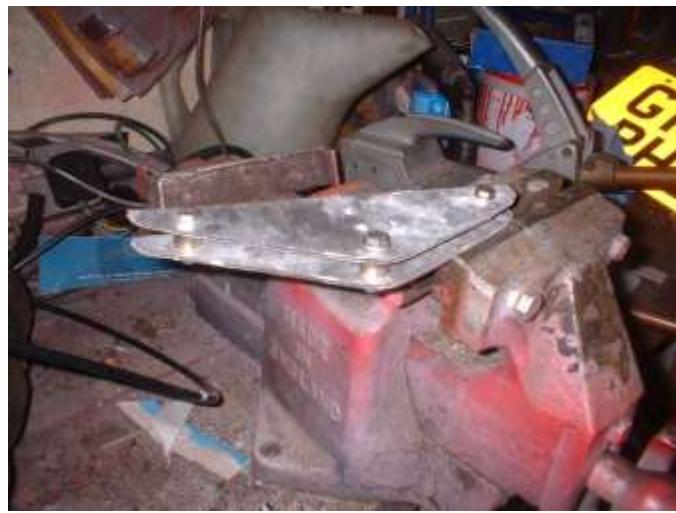
Installed in the line and it all works!! So it looks as if a wrong cable has been fitted at some point.

Handbrake next. Lets make up a tensioner and see what happens.

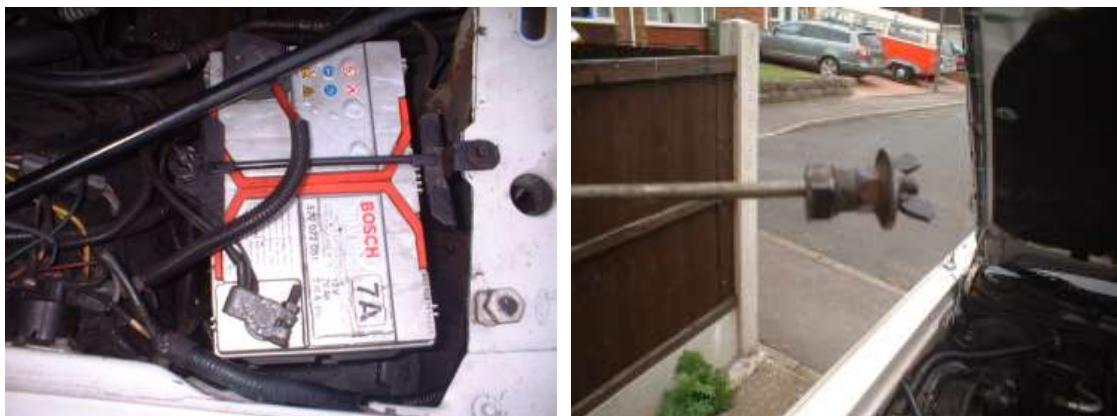
This is the old battery clamp that is too wide, and the spacer bolts!!

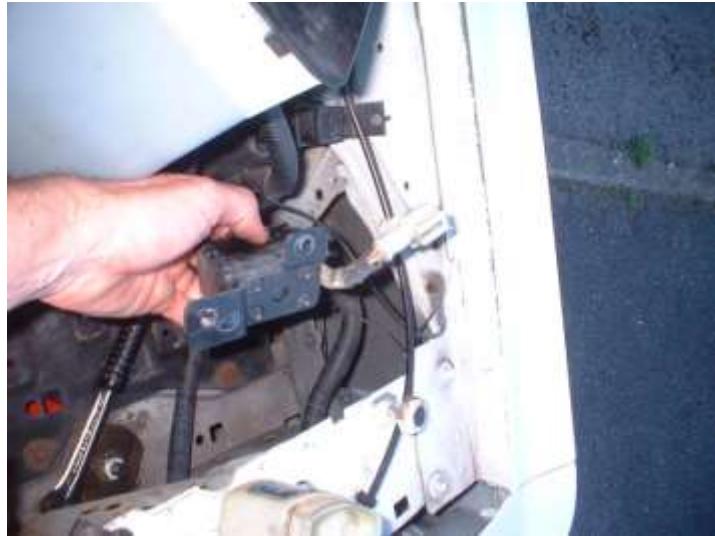
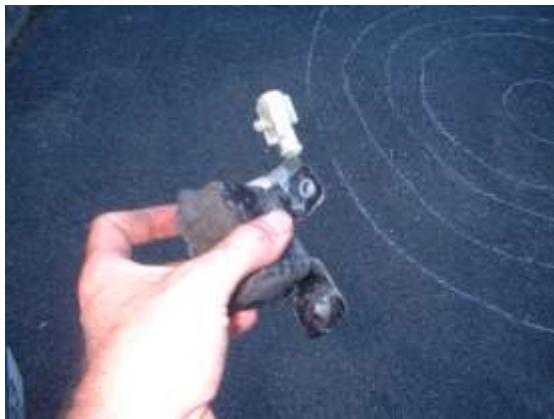
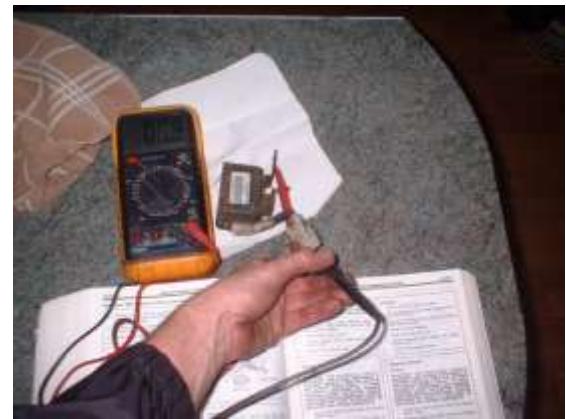
First 3 photos show the 2 side front sensors being checked. Both okay but slightly rusty. All mounting points de painted, vaselined and bolted back down to clean metal.

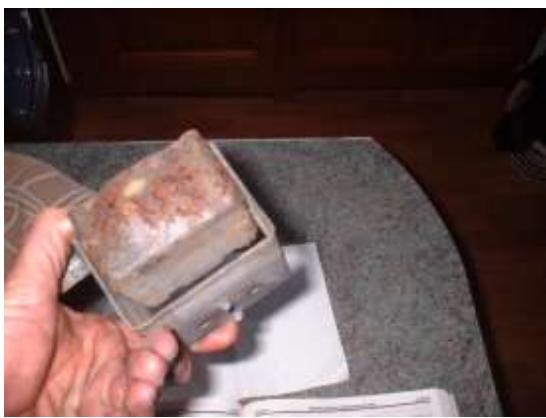
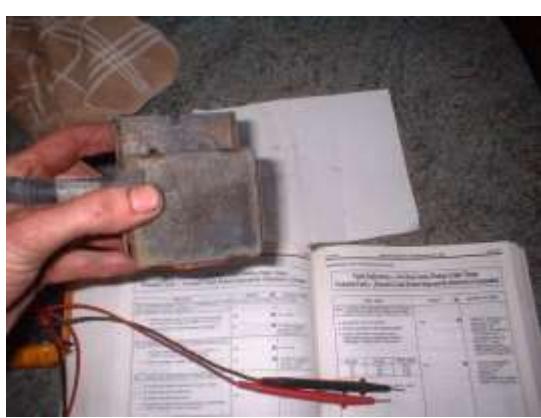
The next photos are of the sad looking front sensor that is seriously rusty! Also didn't check out with the multimeter. Read open circuit. Whats the chance of getting one of them!

Luckily Justin McCarter on the crown vic forums has one he took off his car and has offered it to me for just the shipping! As long as it works. I have PM'ed him the test procedure and await the results!

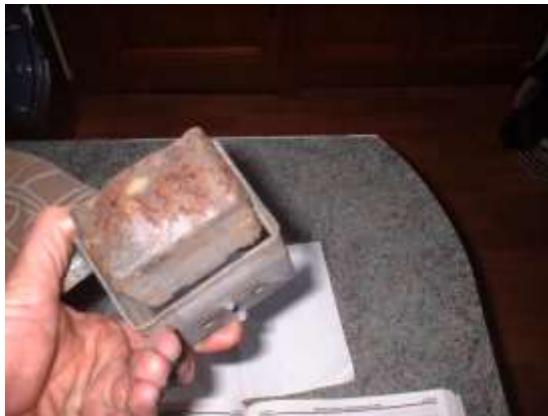
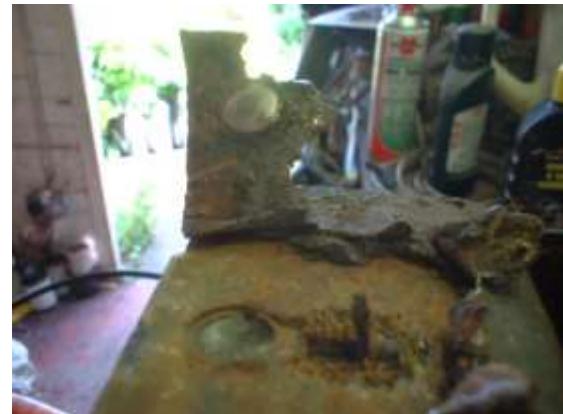
Heres a shot I took earlier on of a seriously corroded front centre sensor.

The silver circle in the RH photo above is a rivet that should have been connected to the remains of the wire that is sticking out! So that is why the airbag ECU was detecting no earth through the circuit.

First.....that code 8 for the airbag circuit front sensor, has now reappeared and turned into a code 9! Perhaps the heat from the soldering iron on the little bit of wire that was left has affected a solder joint on the PCB buried in the protective covering. The resistance across the firing circuit resistor is way too much. It was okay before the soldering. Whatever has happened either needs further investigation by trying to dig away at the plastic, gel covering, whatever its called. Bit like an archaeological dig-a bit at a time and with a lot of care OR loose the airbag and all associated components and wiring completely. 1990 airbag technology is a bit dated and worrying.

So I soldered a wire to the little bit that was left and secured it back to the case with a self tapping screw.

Then fully rustproofed (dinitrol 3125) and installed.

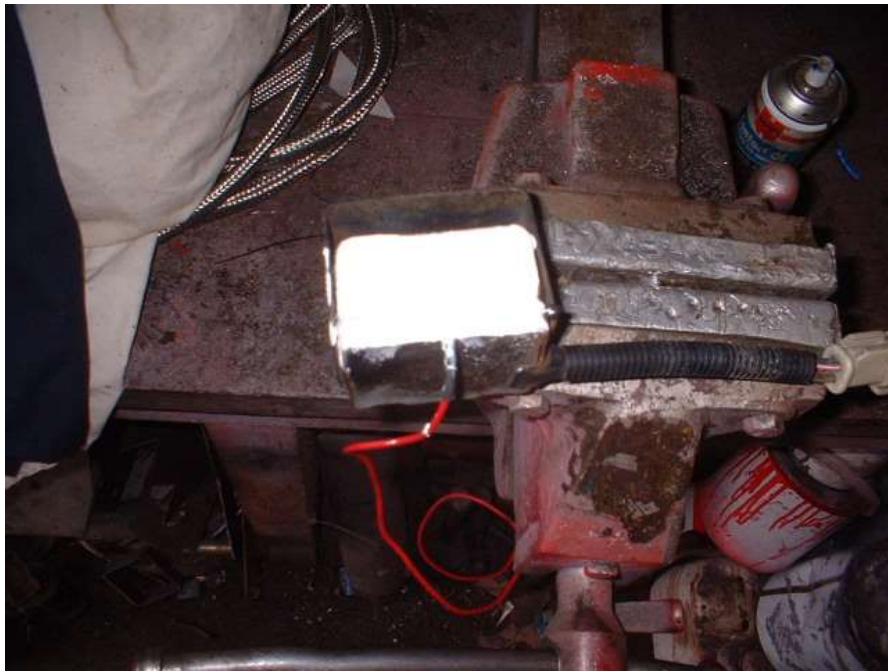
The white stuff is a sealant to try to prevent it all happening again!

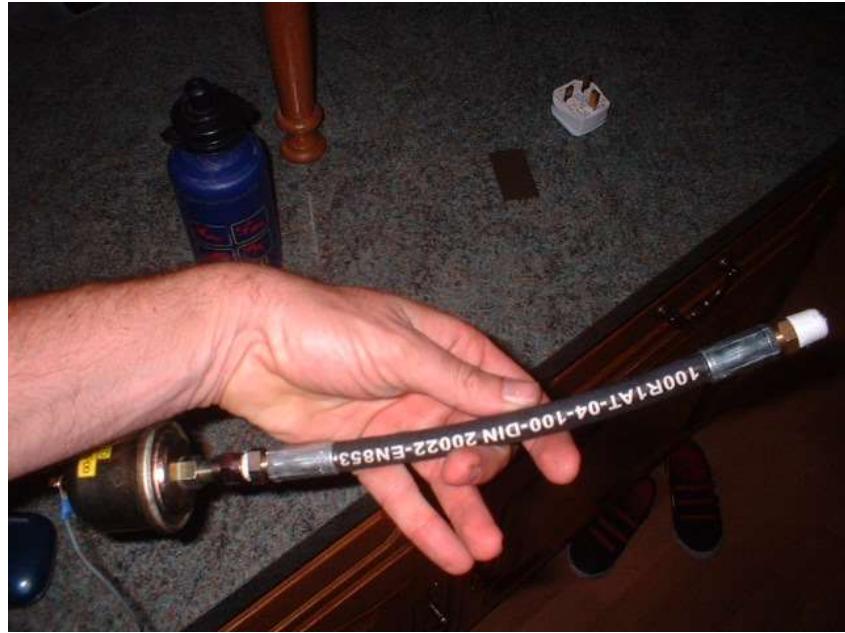
Secondly and more serious was the appearance of the oil pressure warning light after a run and a thoroughly warm engine. According to the manual that's 6psi or less - oops!. No problem, perhaps a faulty switch on the block. So, get an oil pressure gauge, make up an adaptor hose and wire it in temporarily.....

Fire it up and what do I see? 40 psi with a cold engine and 10W 40 semi synthetic oil. As it warmed up I kept an eye on the pressure. When fully warm, the pressure was 5 or 6 psi. As I blipped the throttle the oil pressure went up to a max of 25 psi. Now call me a perfectionist, but that ain't enough. The engine doesn't rattle or smoke or misfire even when idling hot, but it doesn't inspire confidence!

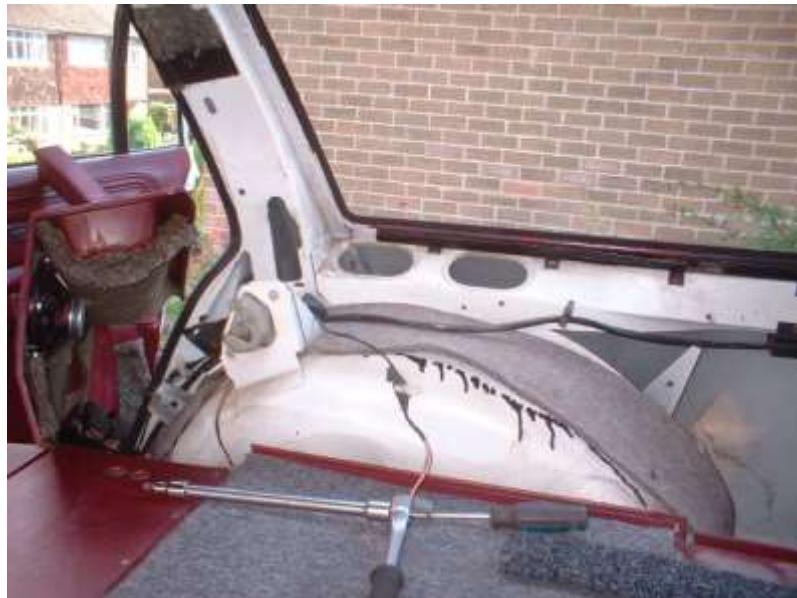
Heres a view of the inner wheel arch joining the outer quarter panel. Notice the rust starting to show through.

If the car was repainted, it wouldn't be long before that ate its way through. So I am going to remove the outer half of the inner wheel arch and try to detach the inner wheel arch lip from the outer wheel arch lip cleanly. Then reshape, media blast and repaint.

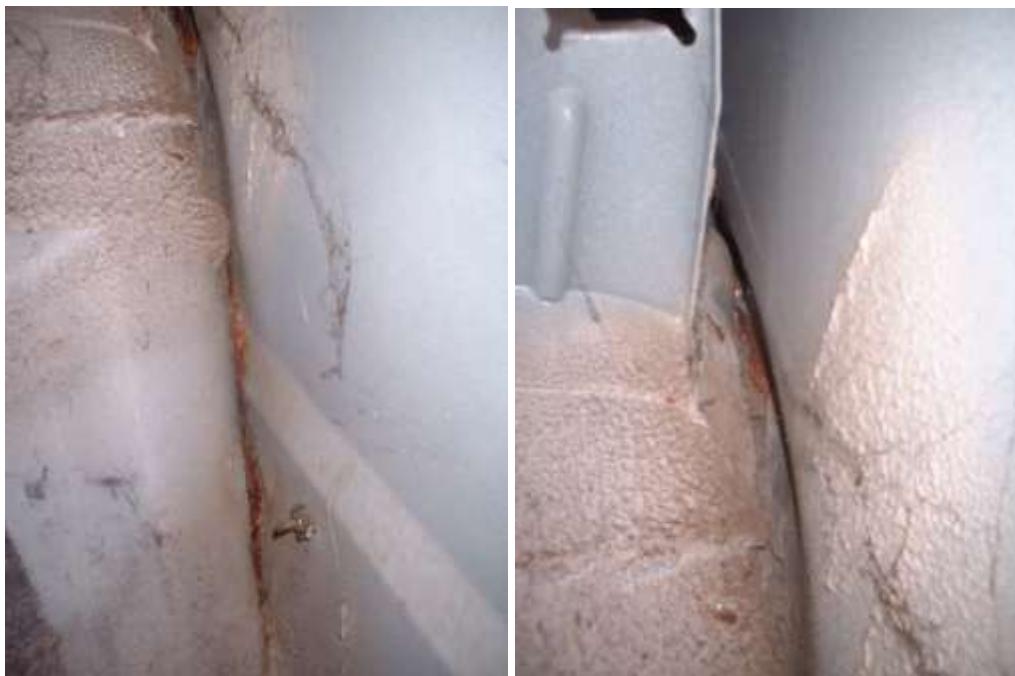
This is the bracket on the drivers side that the rear seat back bolts to and pivots on. That is rusty and will be removed and remade. One of the speed nuts (as we call them) has already rotted through.

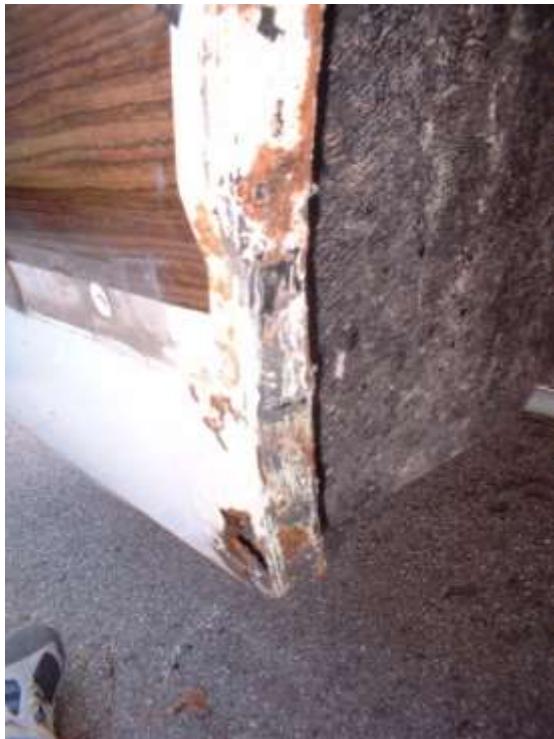
Heres a view of some rust bubbling through at the bottom of the wheelarch towards the back.

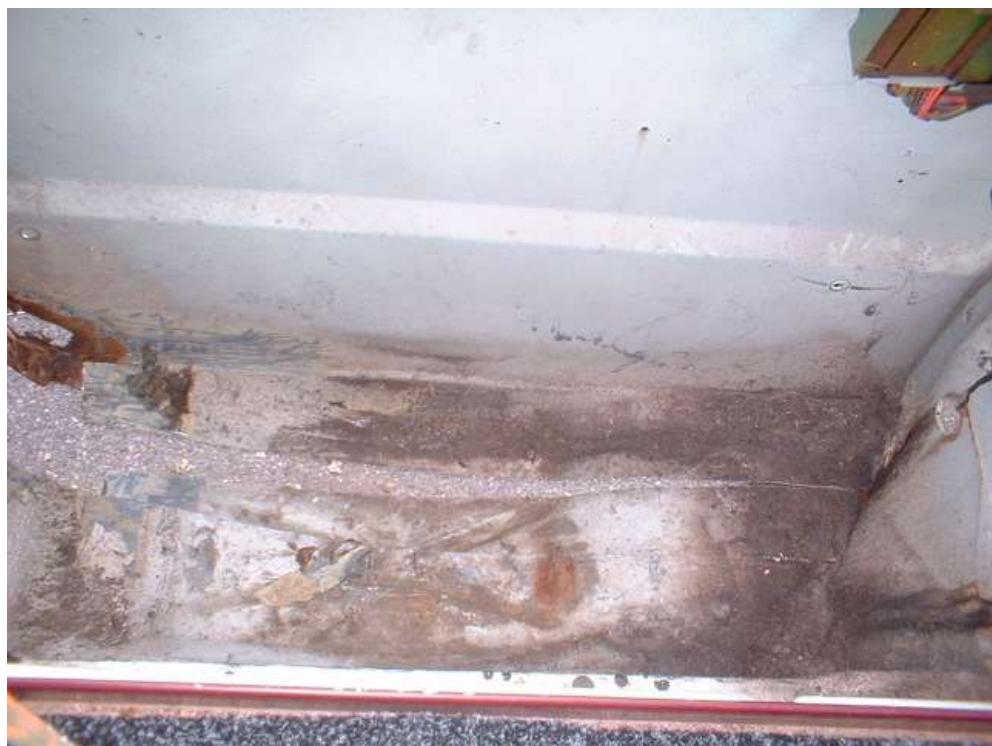
Heres the old spare wheel well with a cut or 2 in it!

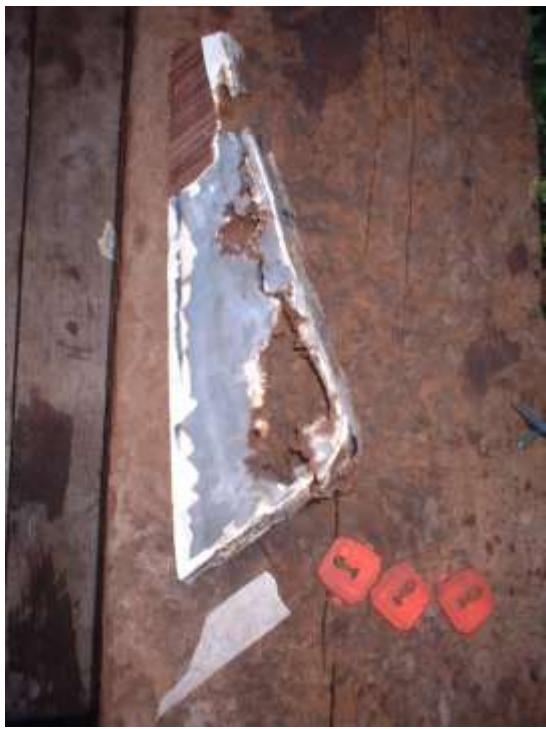
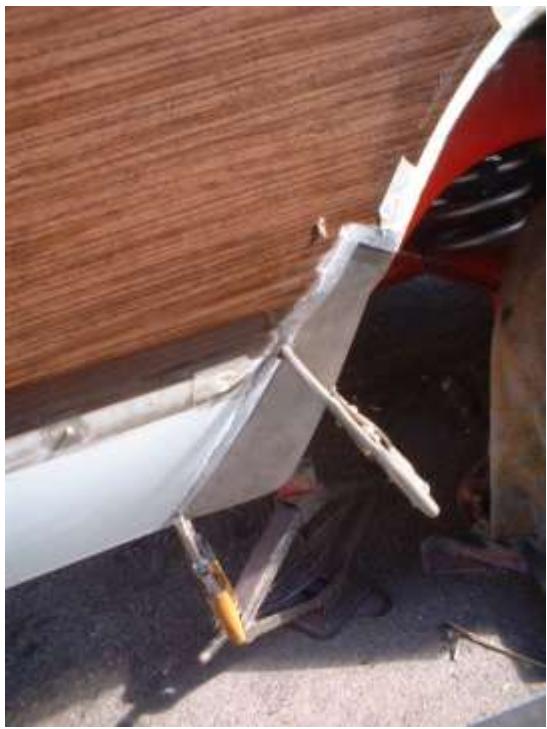
Heres the card template for the rusty corner and a black line where I am going to cut.

The task was to repair the rust corner of the wheelarch, finish the panel replacement where the spare wheel used to be and try to weld some holes up.

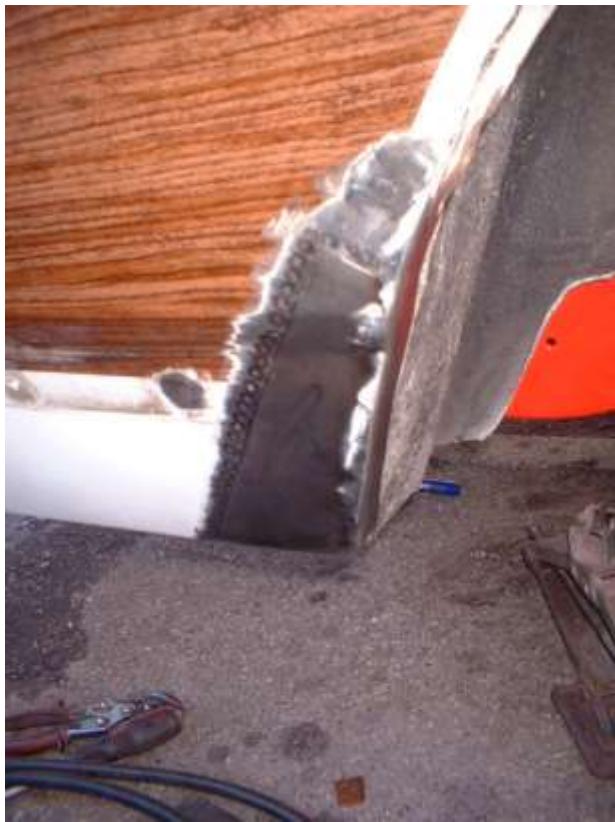
12/9/2010
Cardboard template for bottom panel made

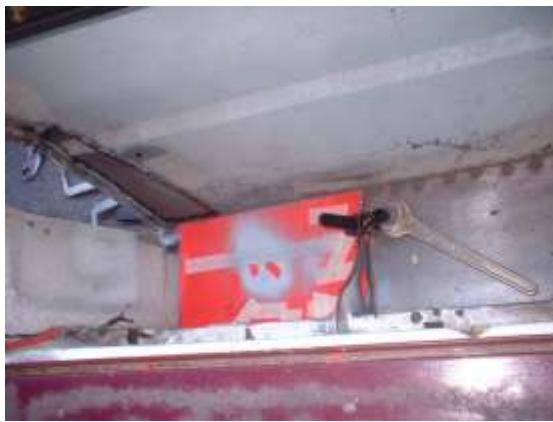
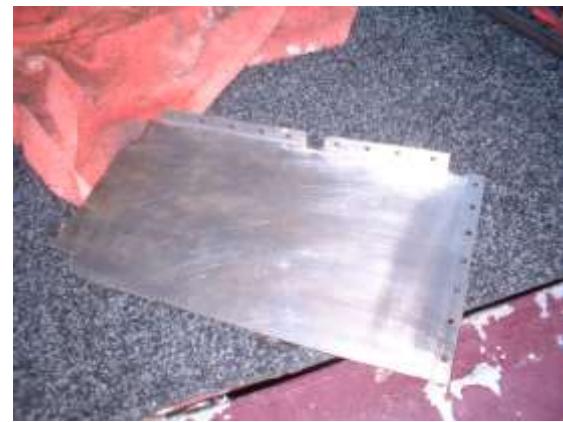
Card templates made for bottom corner

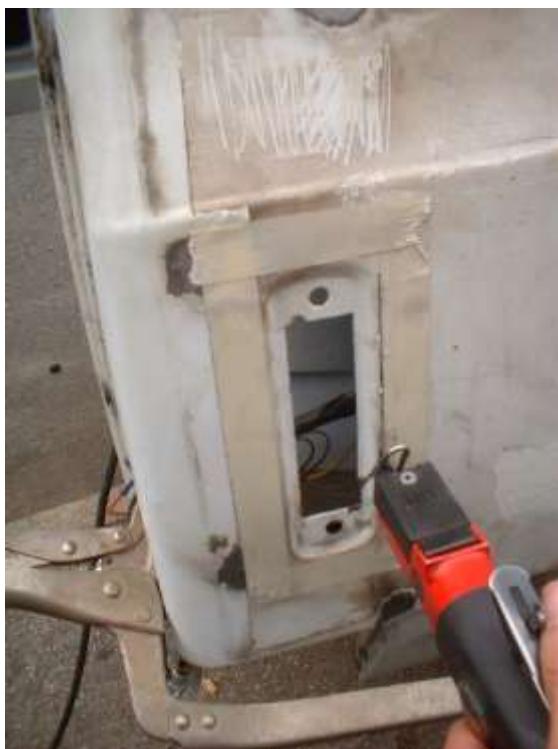
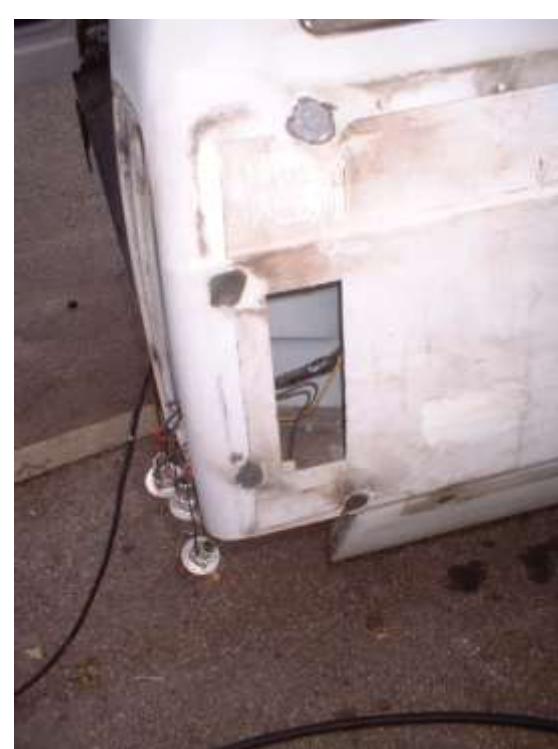
Light panel cut out for welding up

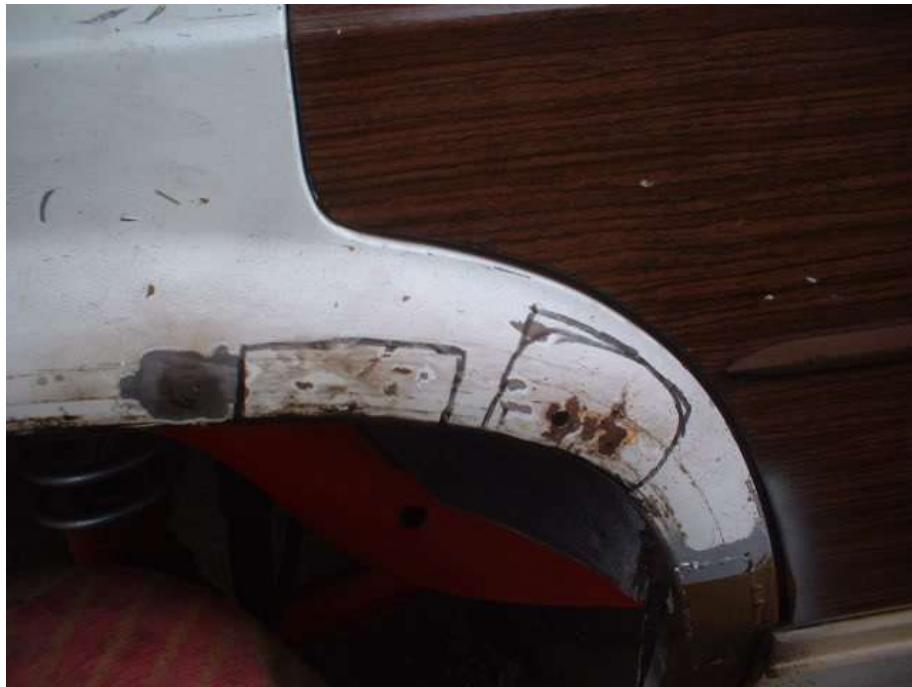
I need to finish the welding on the passenger side, so its rust removal time.....this time the outer wheelarch

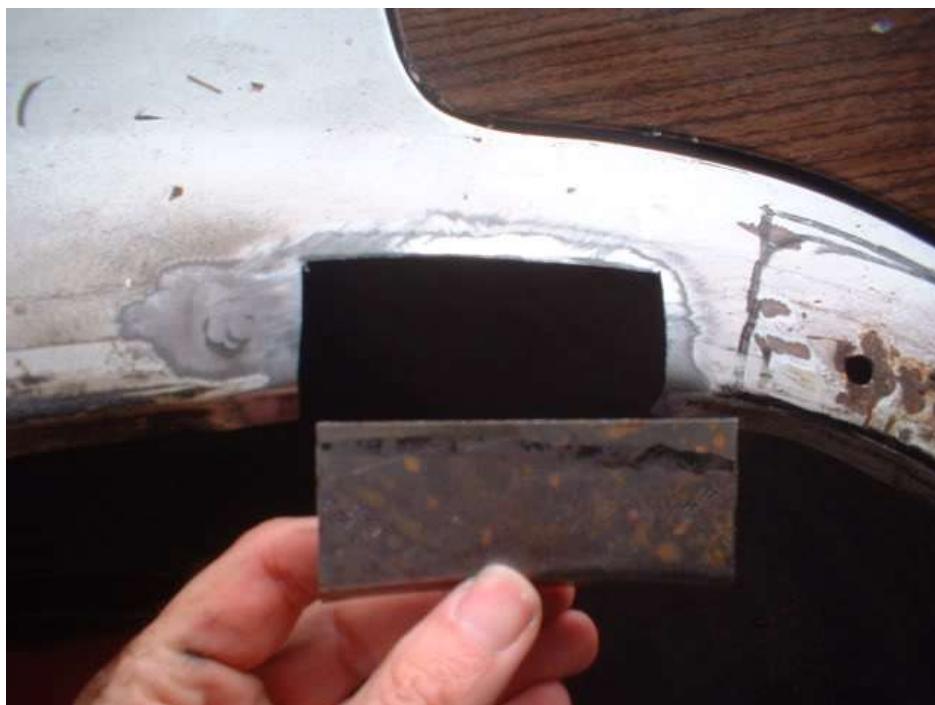
You can see the bits that will be cut out.

If I hadn't removed the inner arches, this would never have been repaired properly and would soon breach the new paint. We've all seen this before - a rust repair that keeps on coming back. Well this one won't.

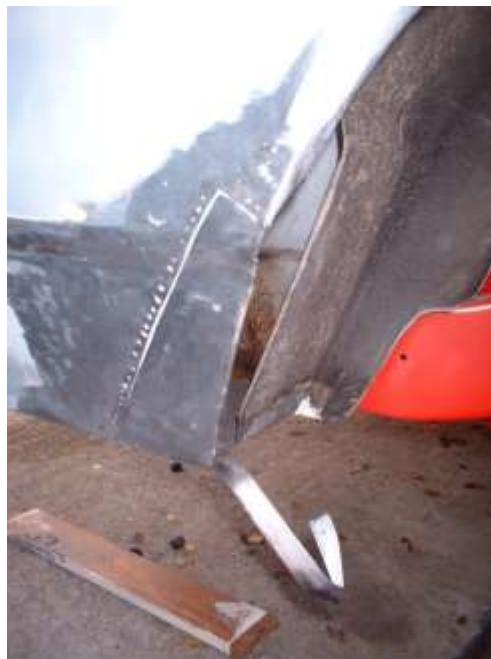
Couldn't get the lower repair panel flat with a skim of bondo, so after a bit of investigational work, I found out that the wheel arch lip I welded in was slightly out of shape (not curved enough), so I had to cut the lip out again, reprofile the panel and then weld a new lip in.....

Heres the lip cut out.

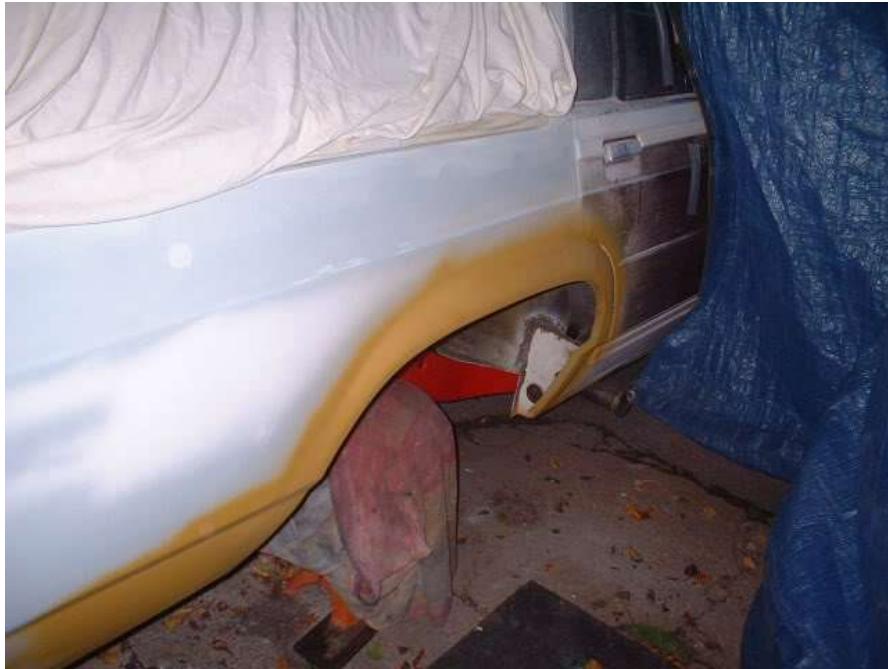
After loads of bondo skimming, panel beating sanding and priming, we come to this

But I am not happy since the shape is wrong and the creases not sharp enough. I will weld in the inner wheel arch first and then deal with that later.

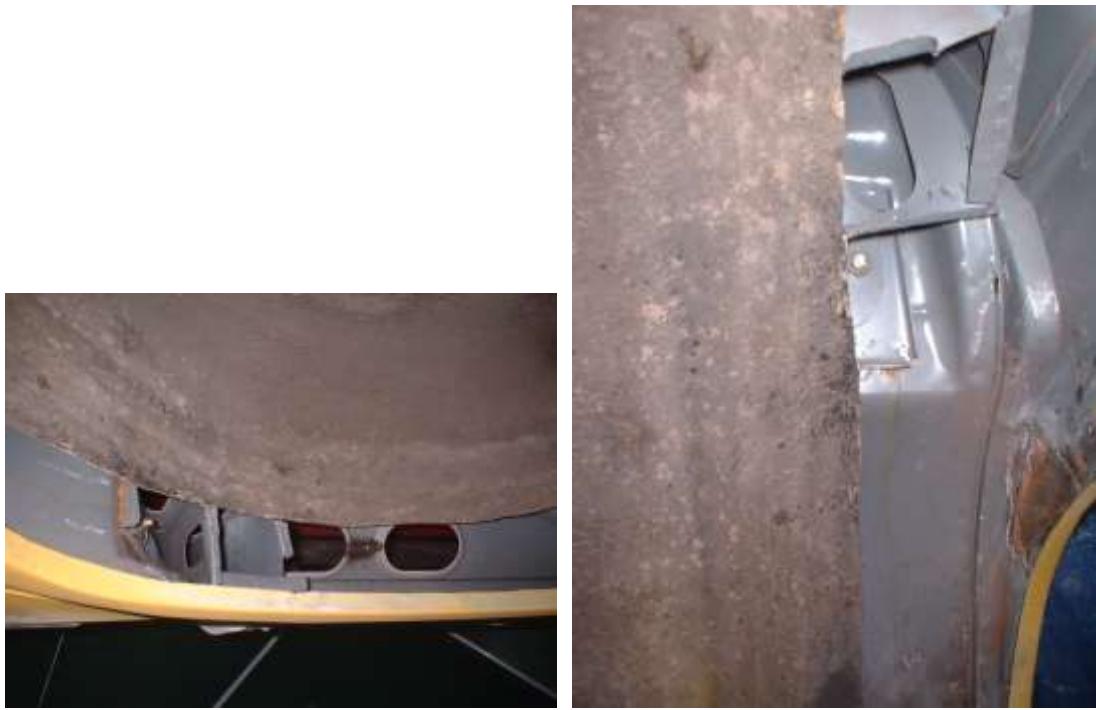
Heres a couple of views of the inner wheelarch structure cut out and new flanges bent ready for the new inner section. Notice the accidentally cut upper panel that my air saw went through by mistake!! Welded back together though. Don't tell anyone.

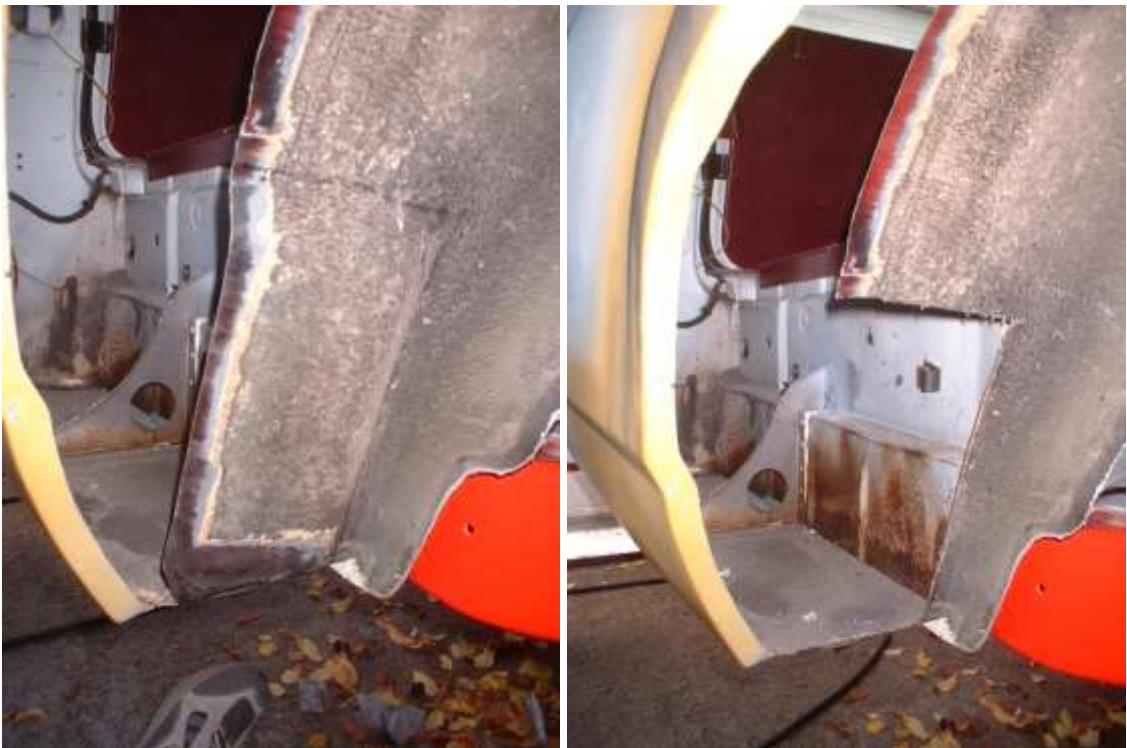
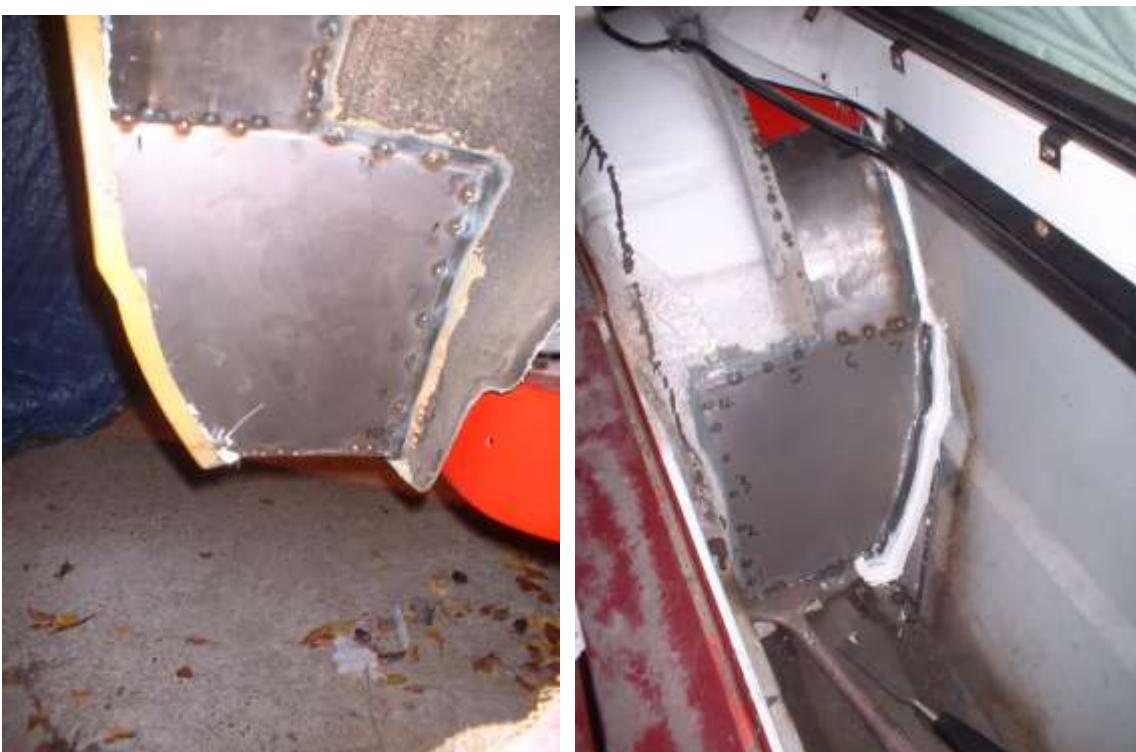
Heres a strange ugly bulge in the rear of the inner arch that needs to go. Notice the black marker line where it is going to be cut

The numbers are there so Callum can hold it down with a screwdriver while I weld from the other side!
