Project Big Ford

Ford LTD Crown Victoria LX Country Squire

September 2009

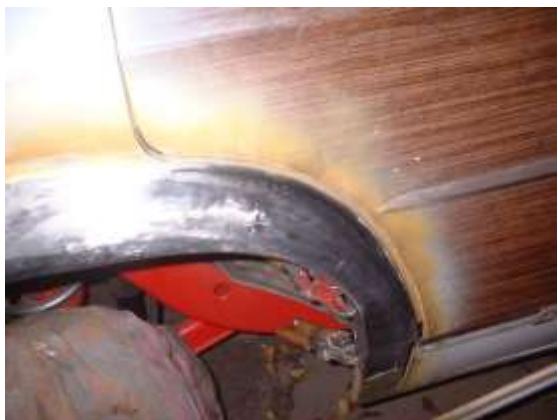
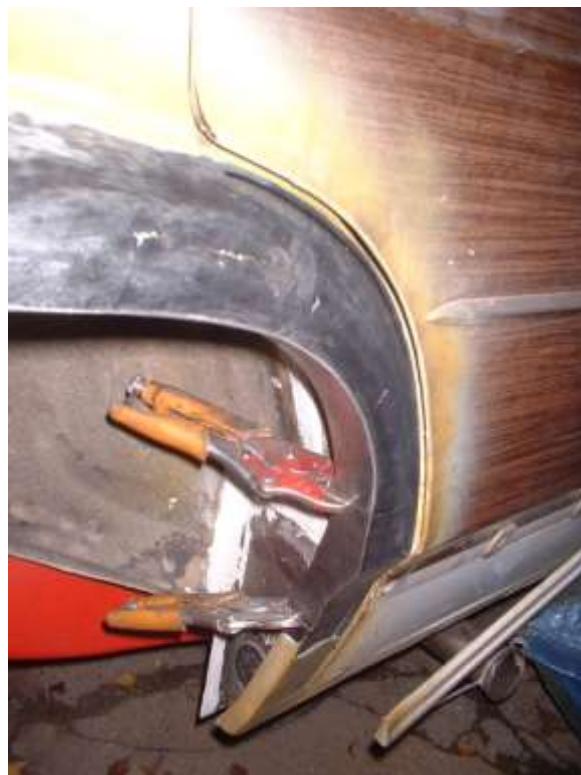
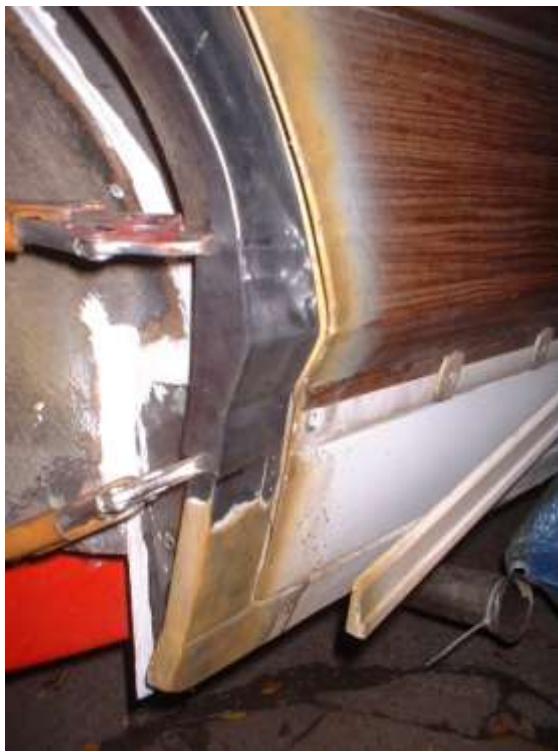
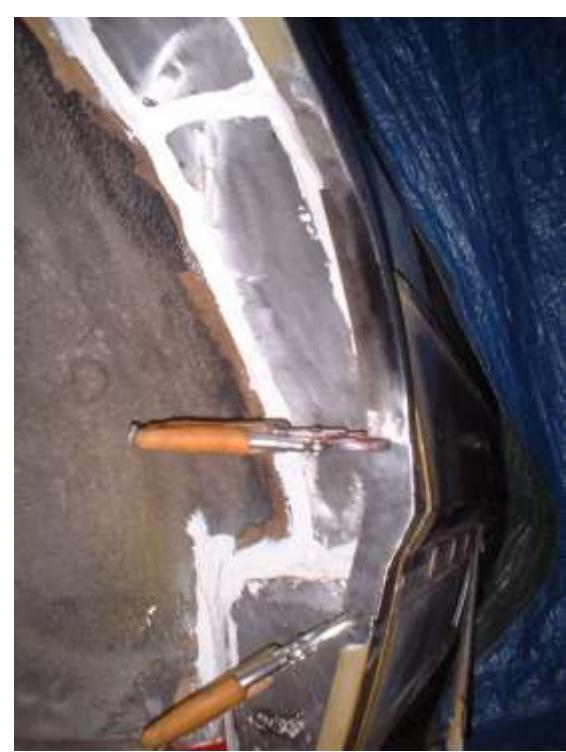
Heres the wheelarch in as close as I can get after about 4 hours tapping!!

Anyway I decided to remove all the bondo and paint I put on the wheelarch and try to panel beat it all into the perfect shape without using any bondo at all!!! This meant cutting out and rewelding some of the patches I welded in before! Including the wheel arch lip from the top of the arch forward.

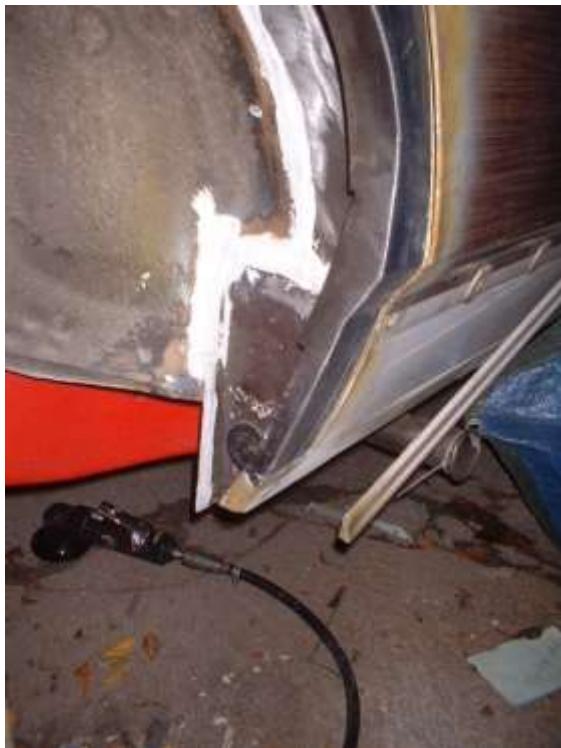
As you can see, I had to remove and reshape the creased section just behind the door.

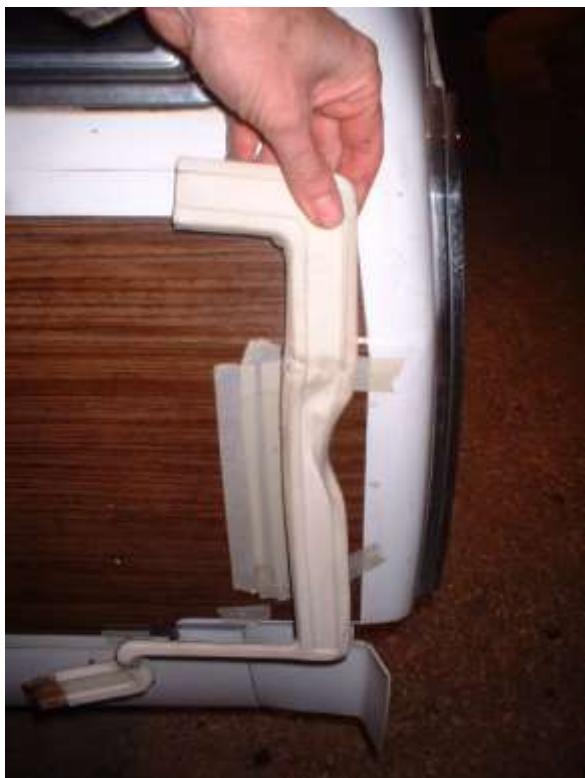
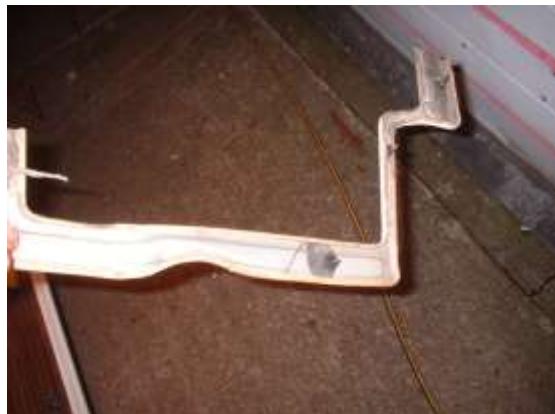
Now when I bought the car, the owner said an exhaust shop had reversed the car into something and damaged the trim around the marker light. He also said the panel had not been damaged.

Heres a photo of the trim just after it was taken off

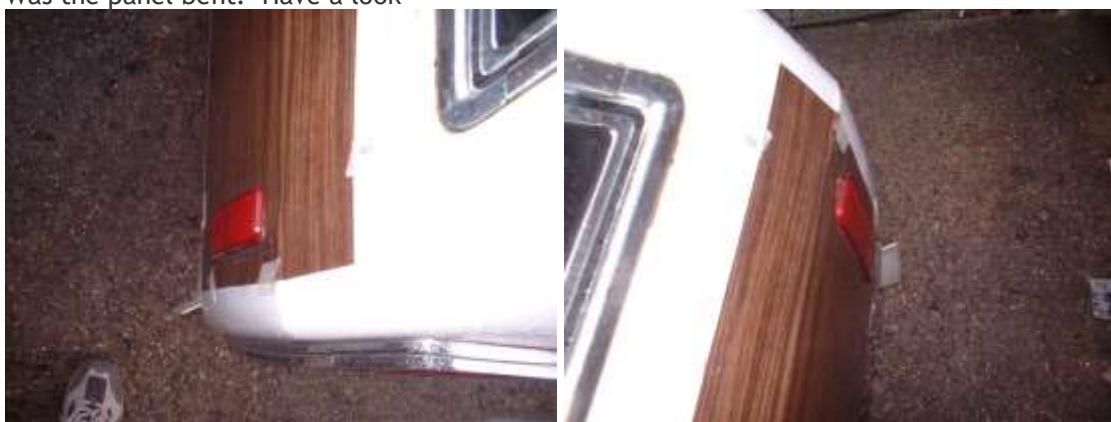
Was the panel bent? Have a look

You bet it was! Difficult to tell from the photos, but it was crumpled around the marker light and the body crease line.

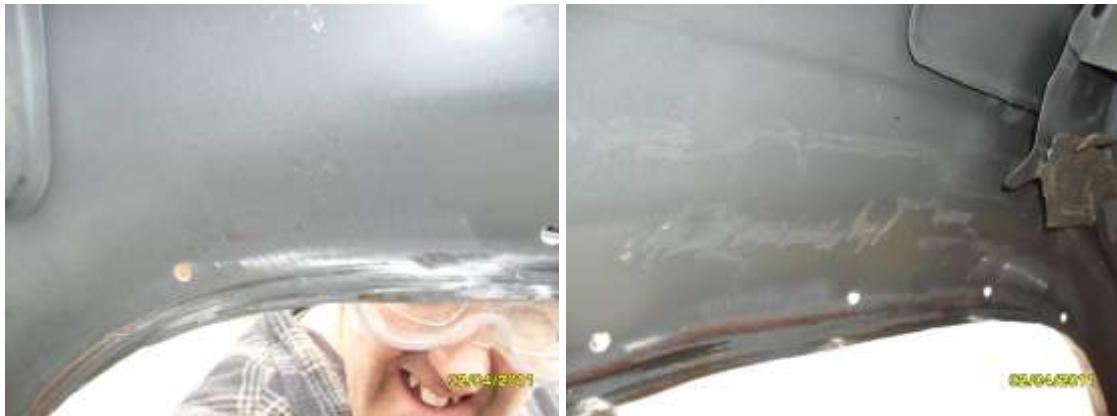
Today (Saturday) I cut out the remnants of the inner wheelarch lip and look how good the inside lip is!

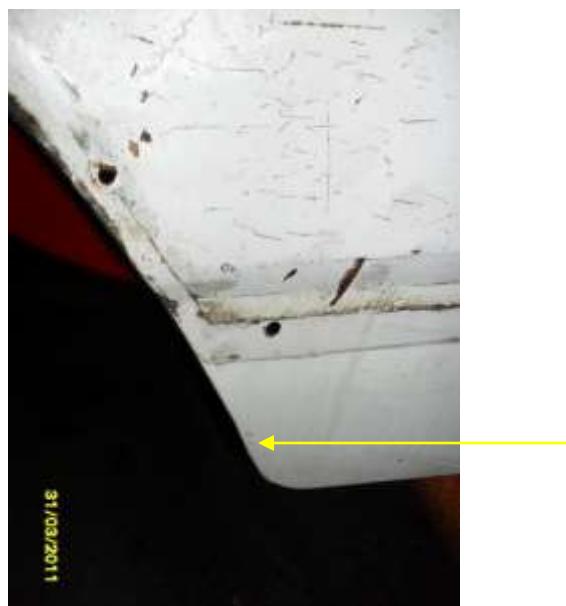
The lower quarter corner behind the rear wheel looked good apart from a small bubble

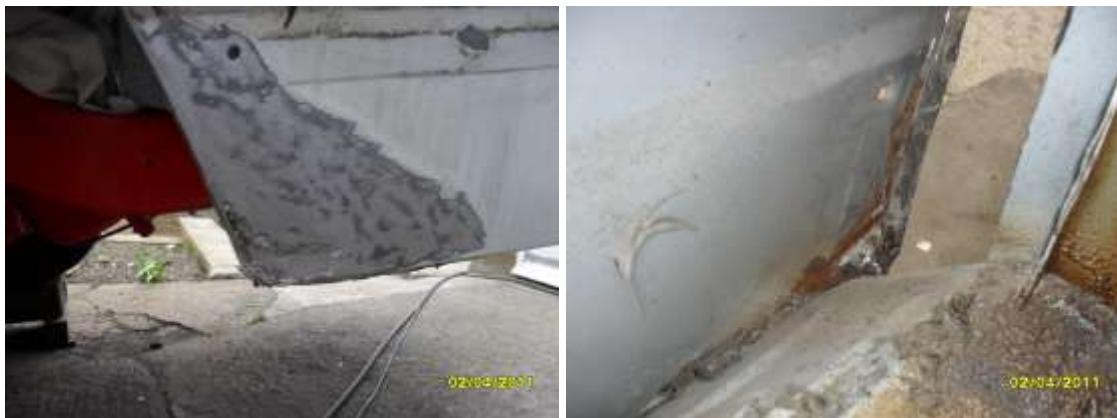
When ground back this is what we had

Metal marked for cutting out and new patch clamped and spot welded in

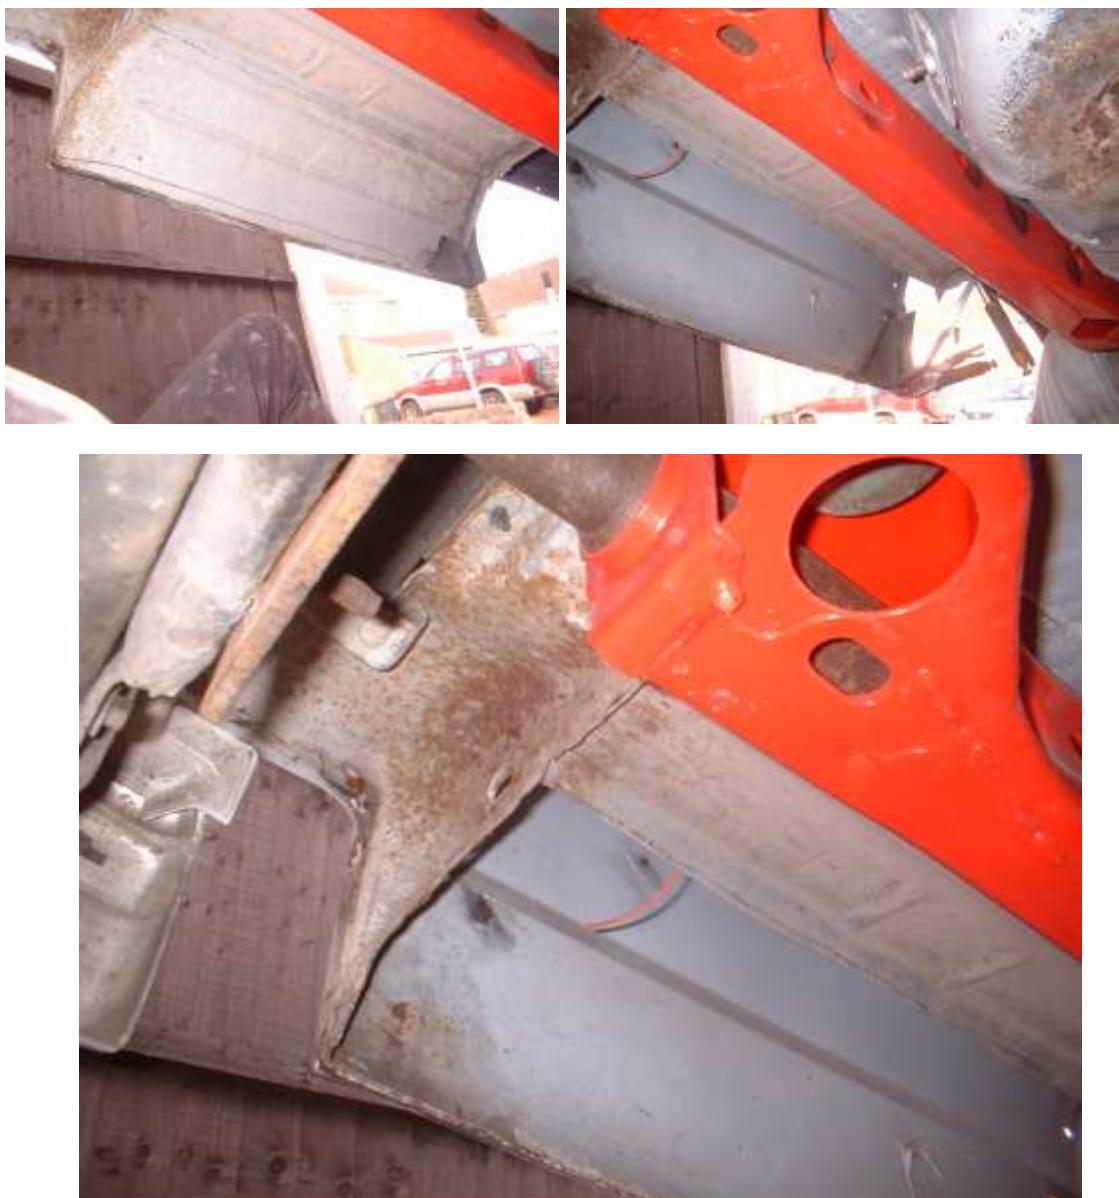
Inner section at the rear marked for cutting and removed

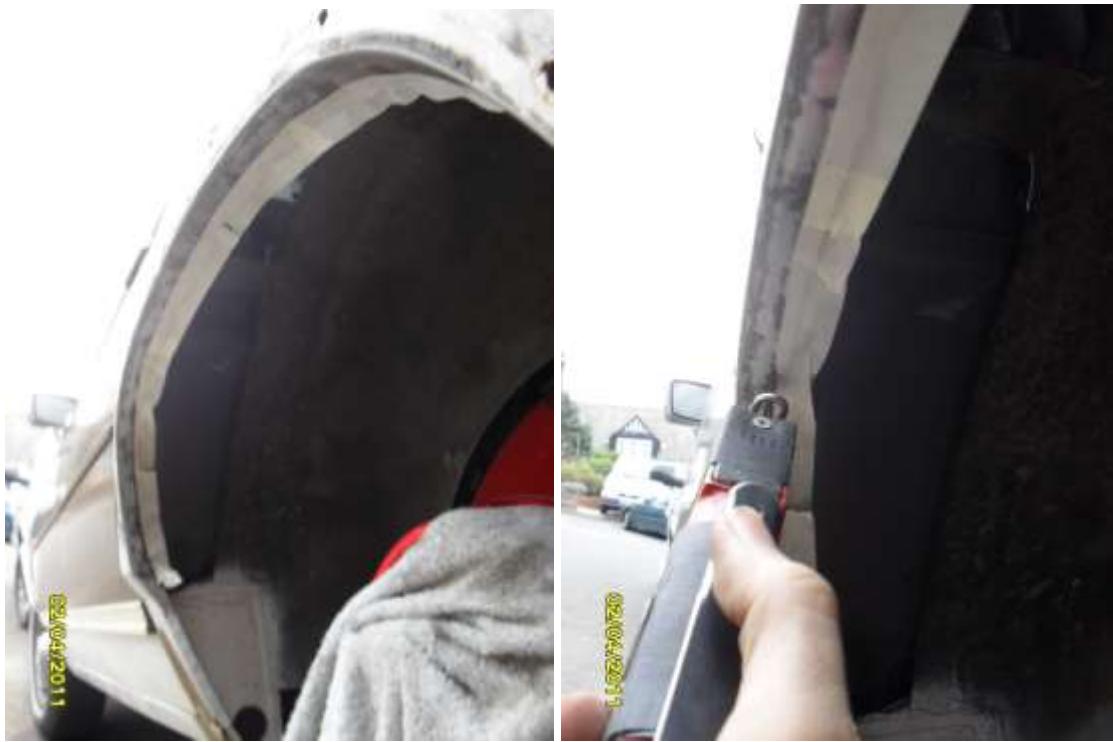
Wheelarch lip reduced in width

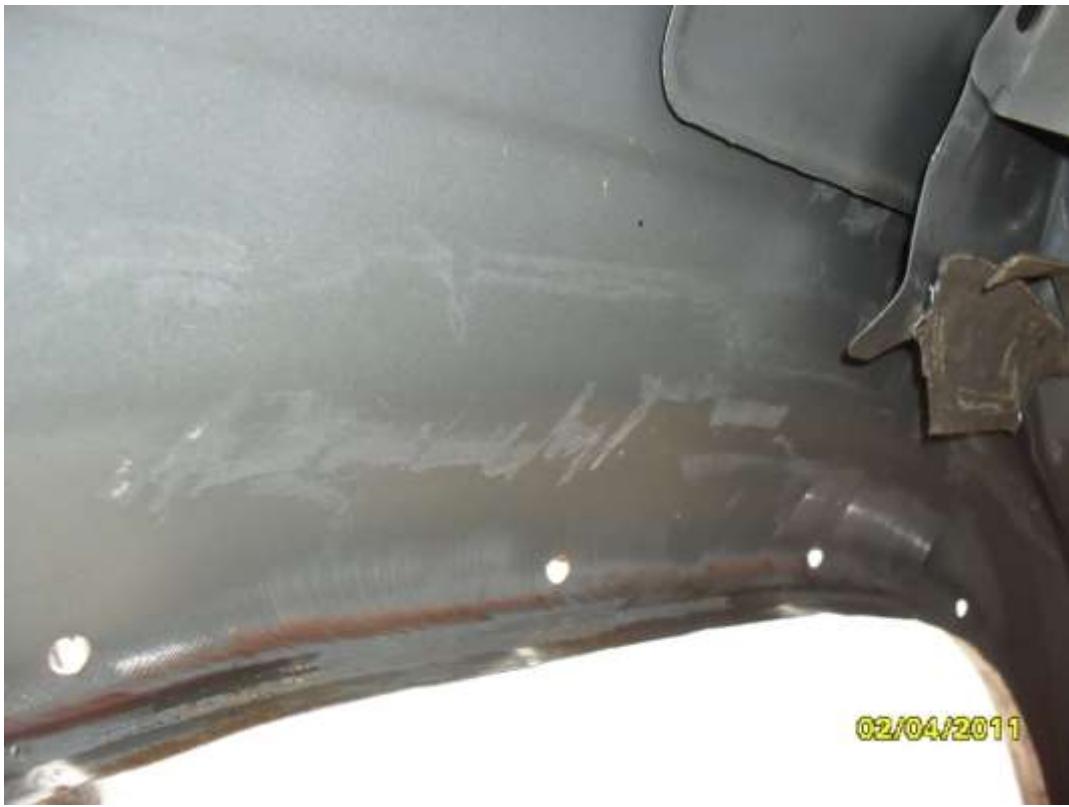
Now the inner wheelarch is out and down to a single skin, lets have a look how rusty it is on the inside lip

Absolutely immaculate!! Wish the other side had been like that!!!

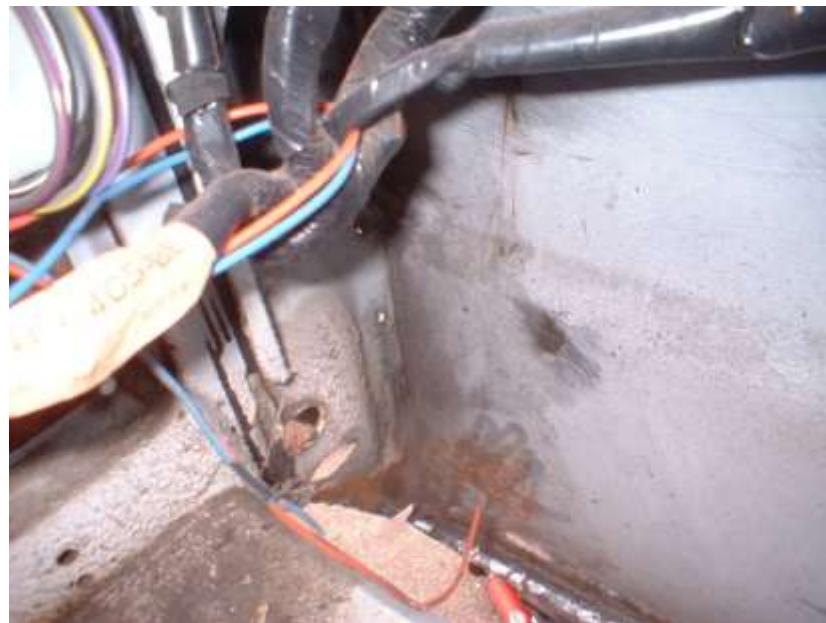
Look at the rust in the bottom corner here...

Thats now been shotblasted clear.

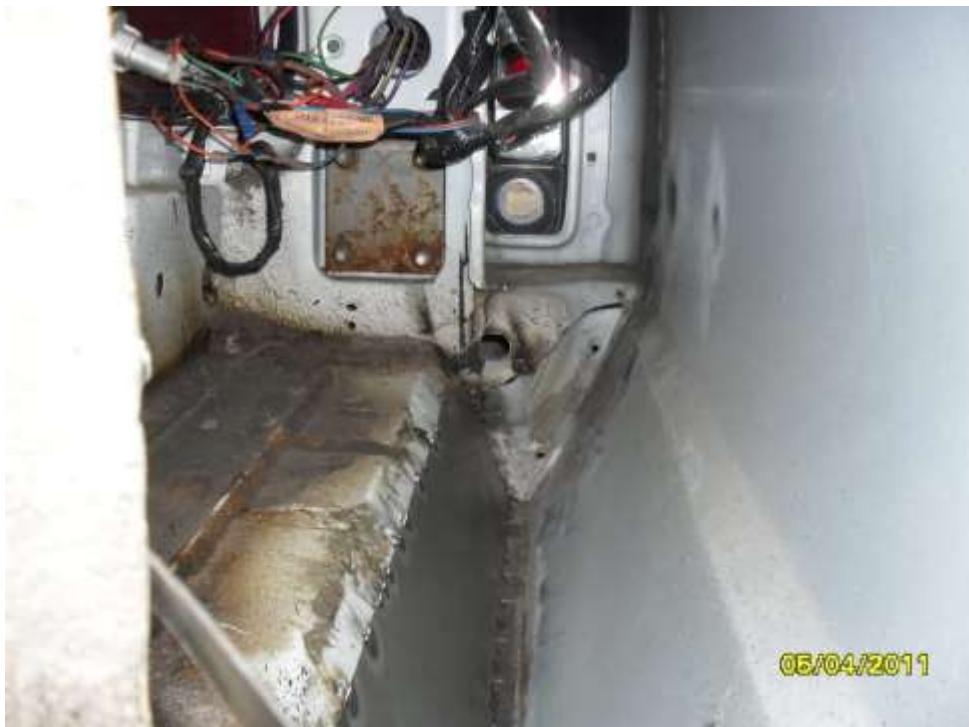
Look, no rust!

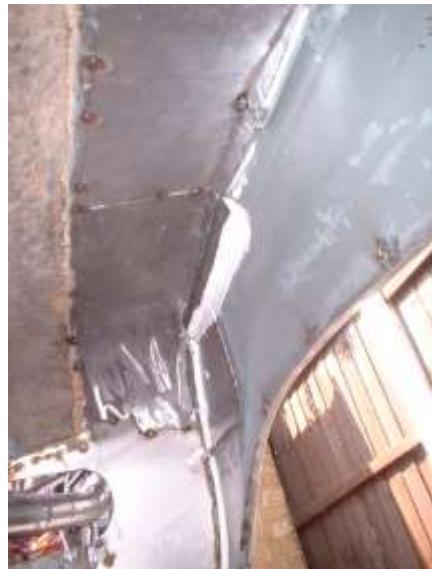
Heres a view of the inner arch tack welded in. This is the single skin outer quarter I wanted. No rust for me inbetween the 2 layers!

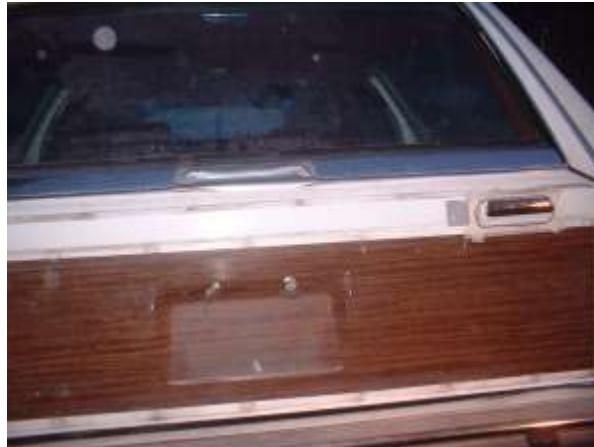
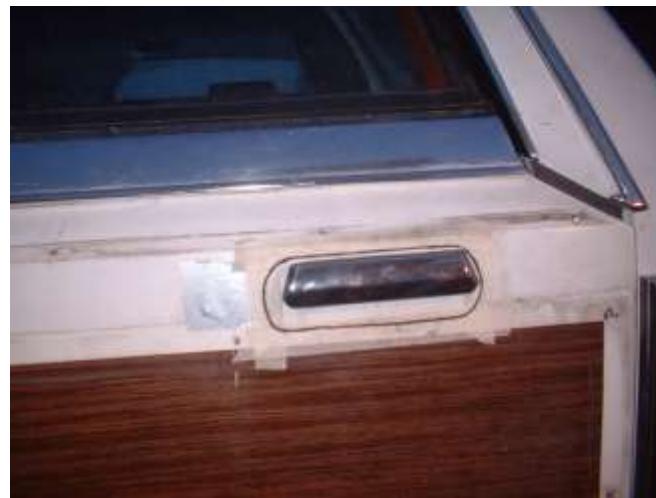
Here you can see the black line where I will cut and weld

Now onto the tailgate. I want it smooth and clean. Just the license plate and illumination. Which means welding up the hole where the hi level brake light used to be and, of course, welding up the handle and lock holes.

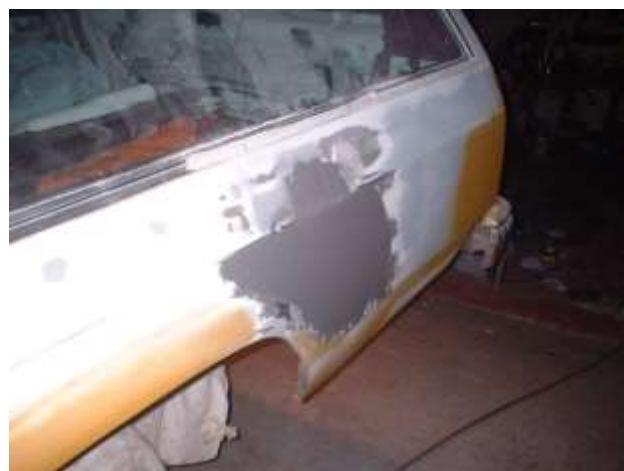
Heres a view of the quarter with a skim of bondo on ready to be flatted

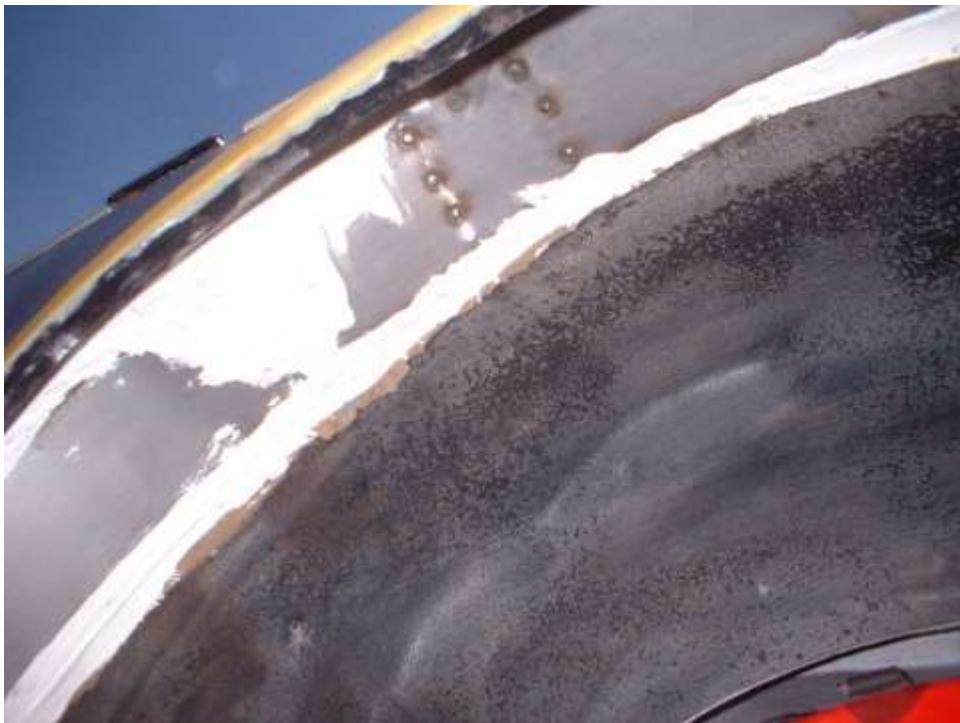
Inner wheel arch fully welded and sealed. Heres an interesting shot looking up from the drivers rear wheel arch

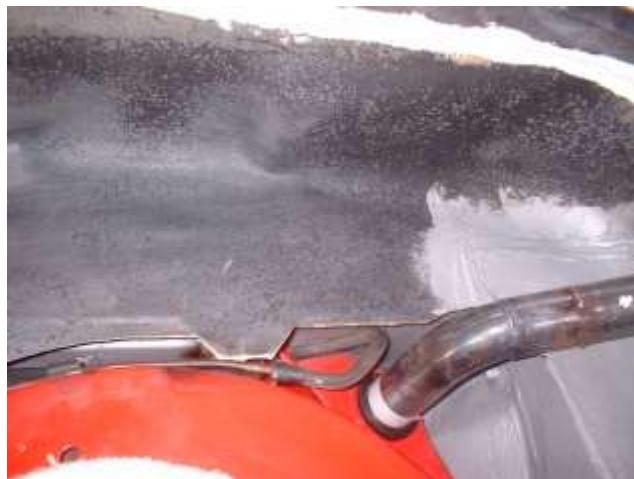
Thoroughly cleaned inner arch ready for the epoxy paint. Looks in fantastic condition seeing as its now 21 years old!

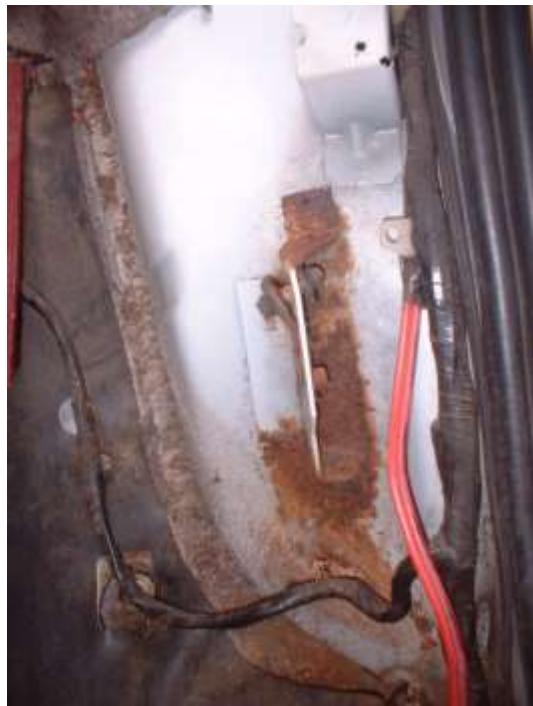
I was prepping the rear wheel arch for its epoxy silver paint and noticed the rear seat mounting bracket that is spot welded to the inner arch was rusty (I had forgotten about it!). So I couldn't paint until that was repaired.

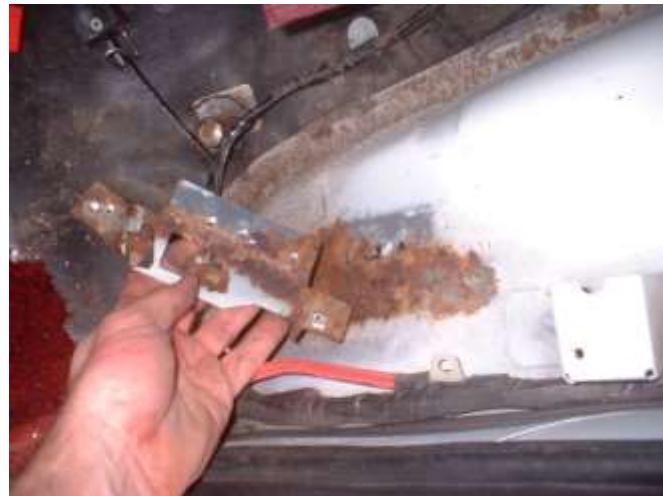
Here it is with the bracket removed

There was a couple of rust pin holes below the bracket that had gone through, so it has to come out

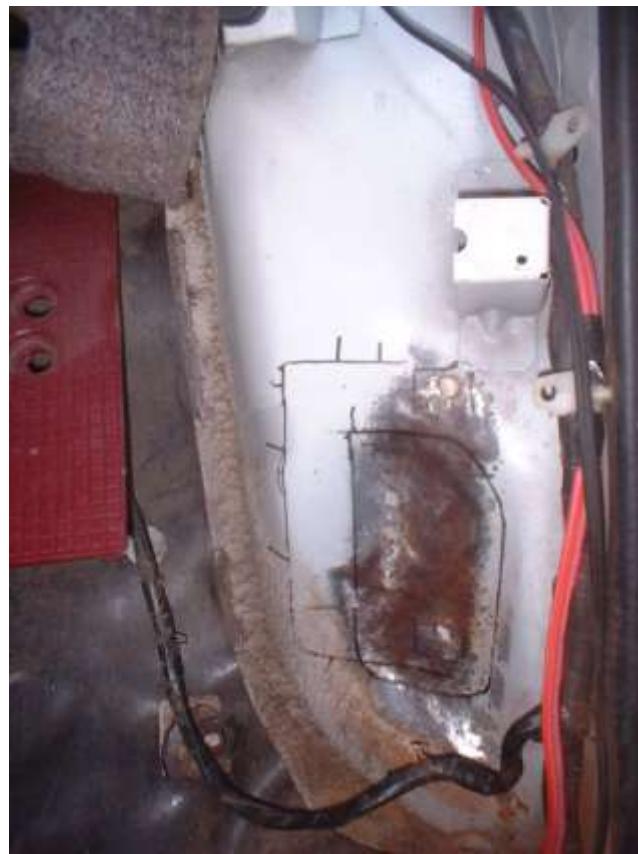
Here the outer black line is a locating mark to make sure I get the bracket back in the right place after the repair, and the inner one is the cut line

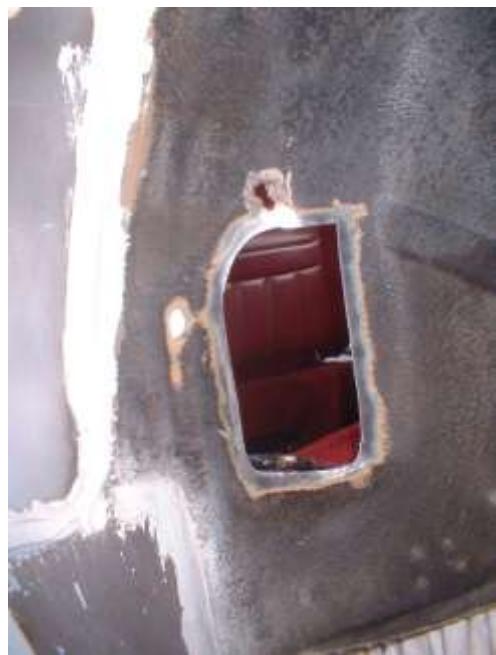
Heres a good view of the rust cut out from under the arch. You can just see the back of the front seat

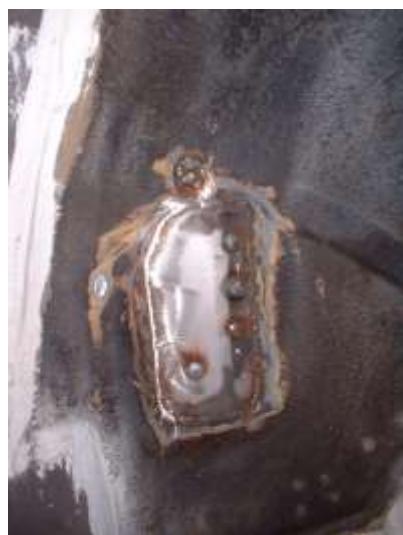
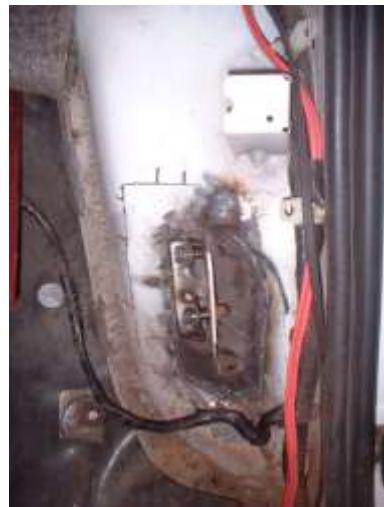
Looks a damn sight better than before.

Bracket cleaned up and welded back in by plug welding from the back

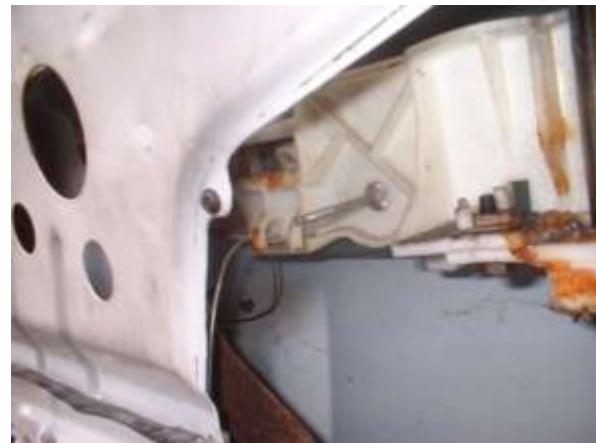
Now heres an interesting sight..when trying to drill out the rivets holding the rear window in I saw this

The rivet centre has failed to break off. I am really surprised that it didn't catch on something on the way up! Or perhaps it did!

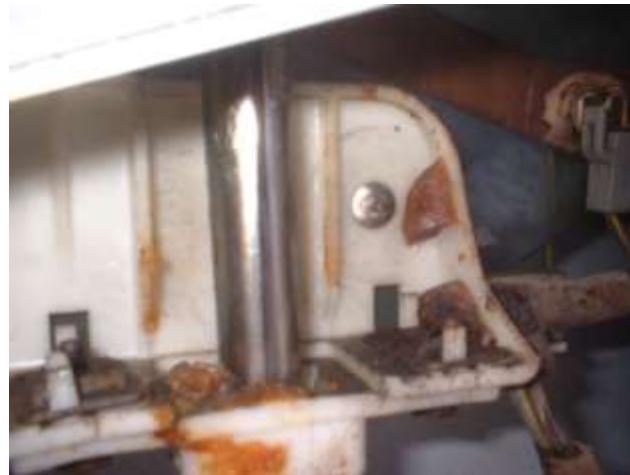
It should look like this

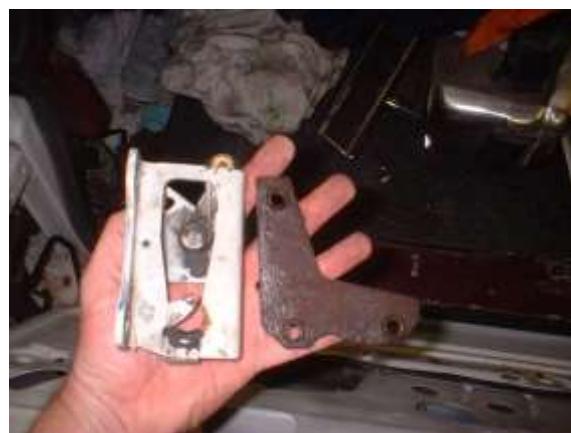
Here it is removed with the rusty plate from behind it.

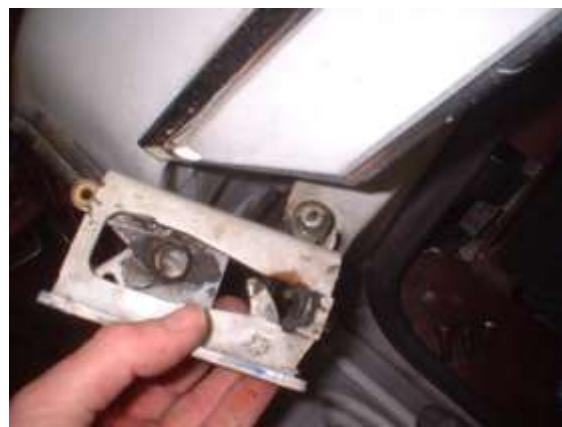
Now heres the wear in it. You can just see the worn rusty area where the roller goes in. It has worn slightly out of round, so I will weld it up and file it back into shape.

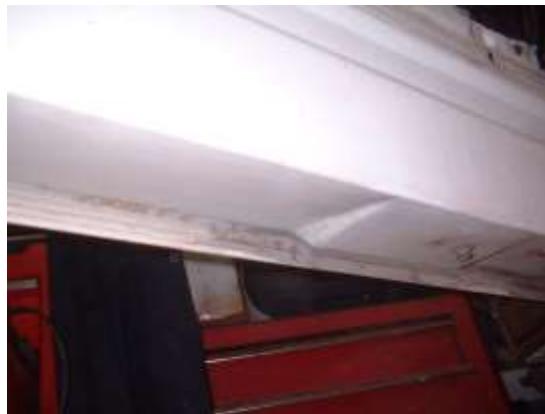
Rust starting to form in the seams. So after shotblasting.....

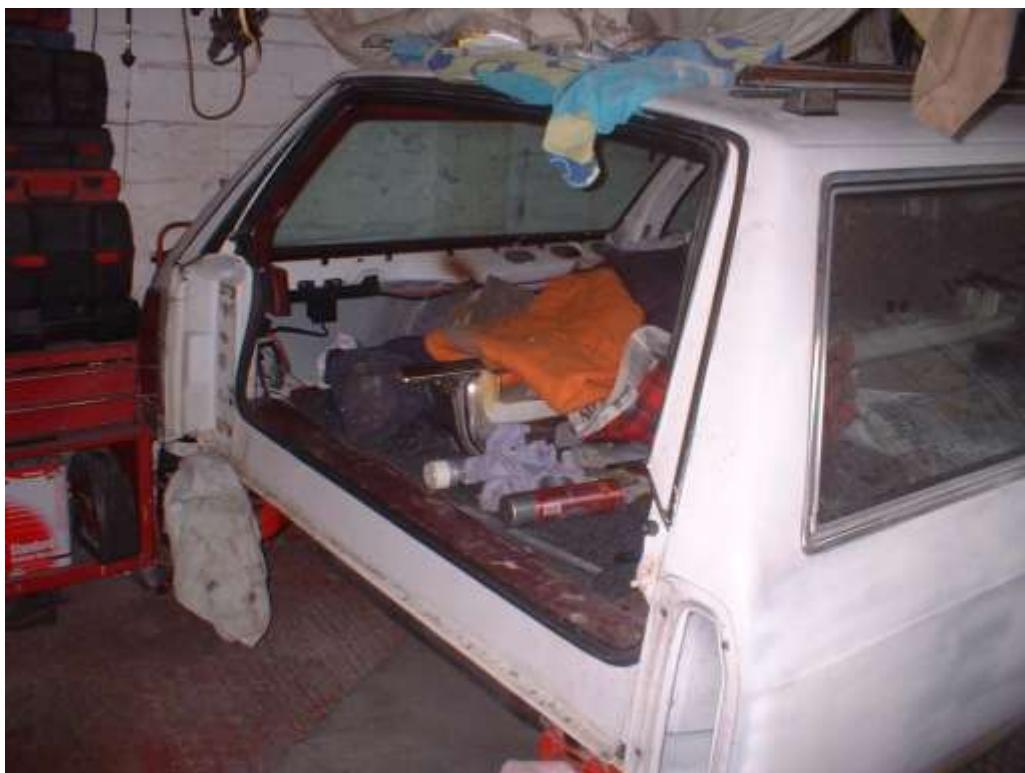
Now its tailgate off time to assess the lower hinge damage

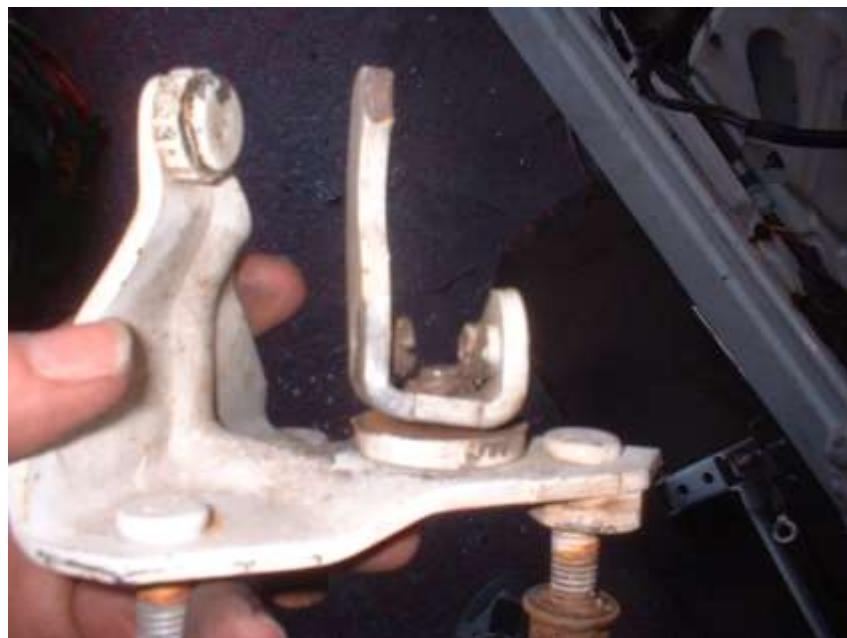
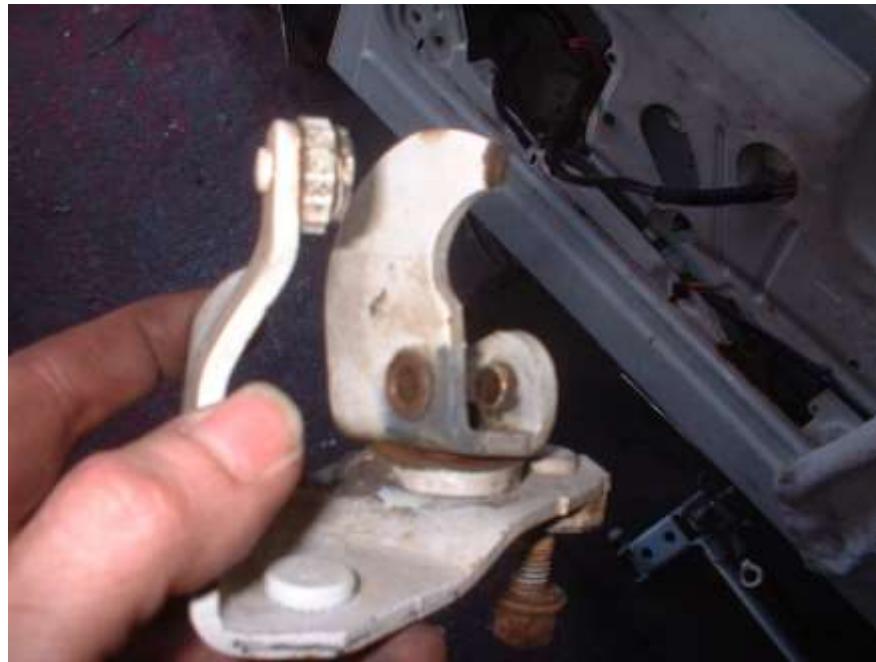
Here it is off to reveal another slight problem

Its actually twisted. Must have been a lot of force to do that.

Rivet welds ground off and took apart then straightened. Didn't realise there was a bronze bush under there. I am going to machine another pin/rivet that is a tight fit in there.

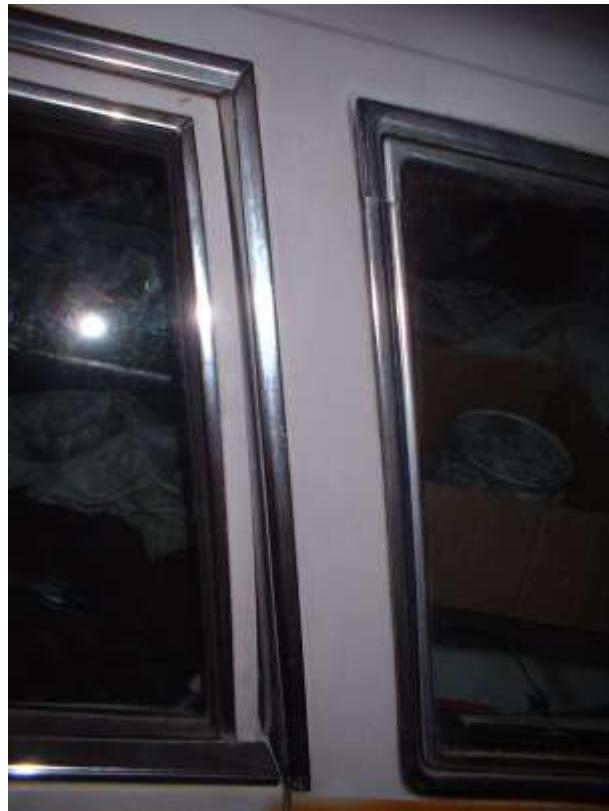
Removed the door and straightened the hinges a bit with a big hammer and put the door back. This time the door gaps are good but the door frame isn't! Top right is almost touching the frame

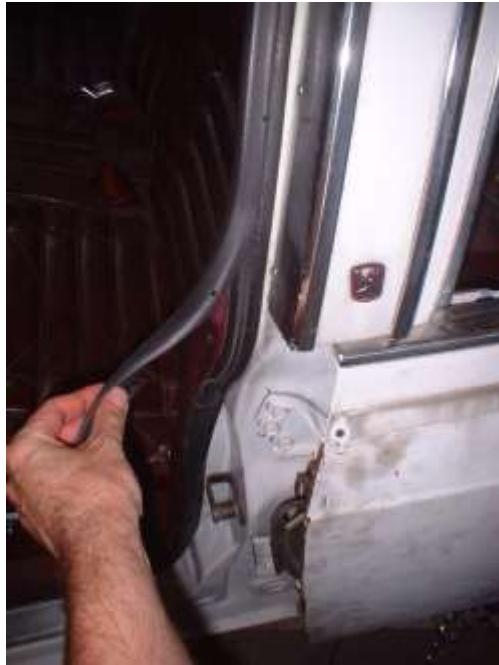
Put a request out for drivers door seal on the forums. Mines a bit torn

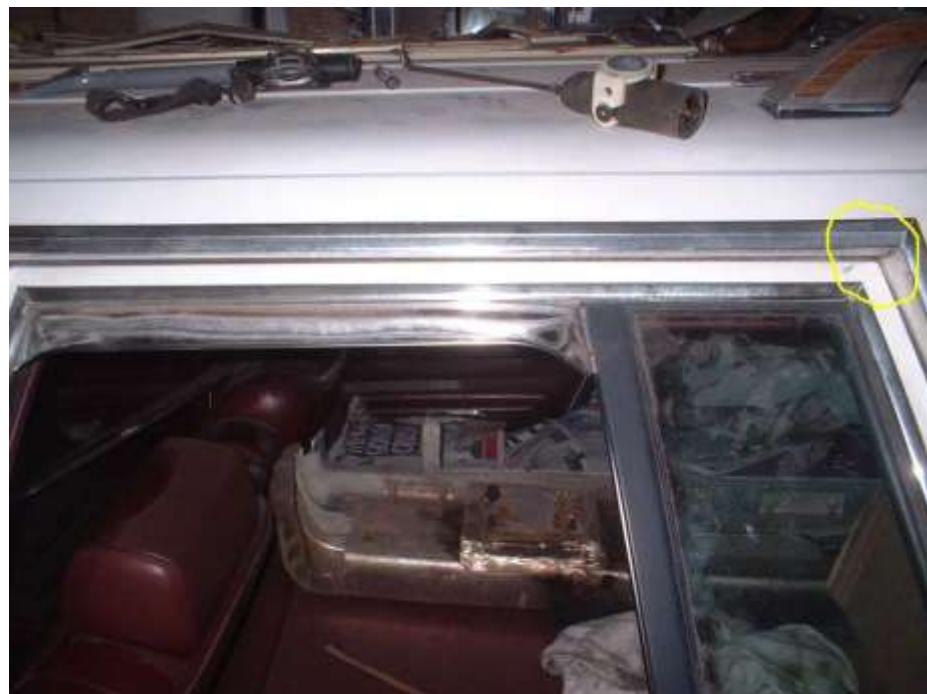
Anyway, its time to make the rear door on the drivers side to fit properly. The main door is now lined up well with the rear quarter and the rocker, but the window frame touches on the top right....

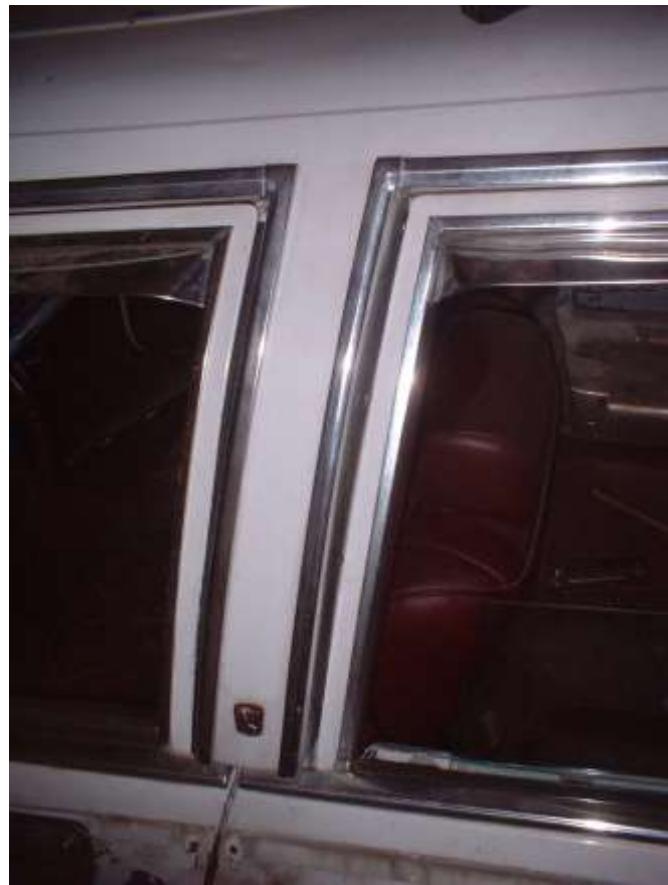
and is too far from the B post on the left.....

So it needs to be moved to the left about 1 cm...ish.

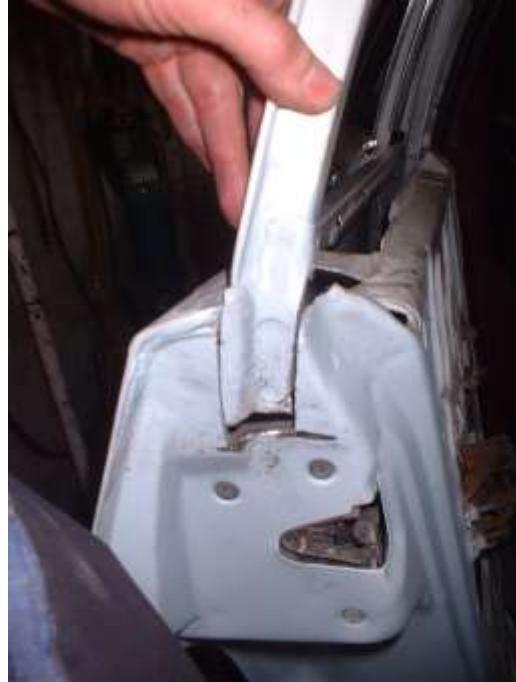
As you can see I am cutting out the frame along with the steel it is attached to and then move it over a bit.

Here it is loose on one side

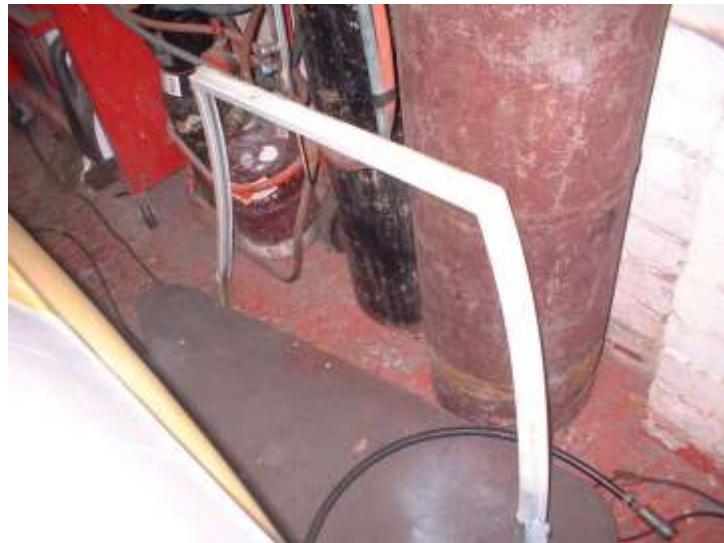
Completely cut loose and ready for prepping for welding

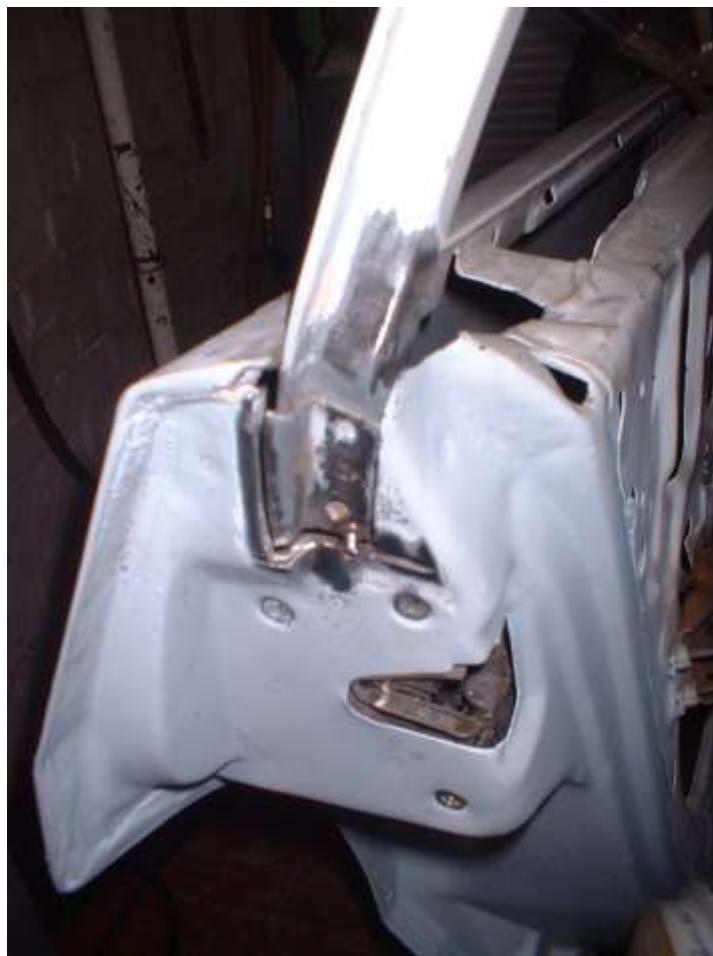
Here it is moved to the left a bit and tacked in. You can see how far it has moved over by the gap

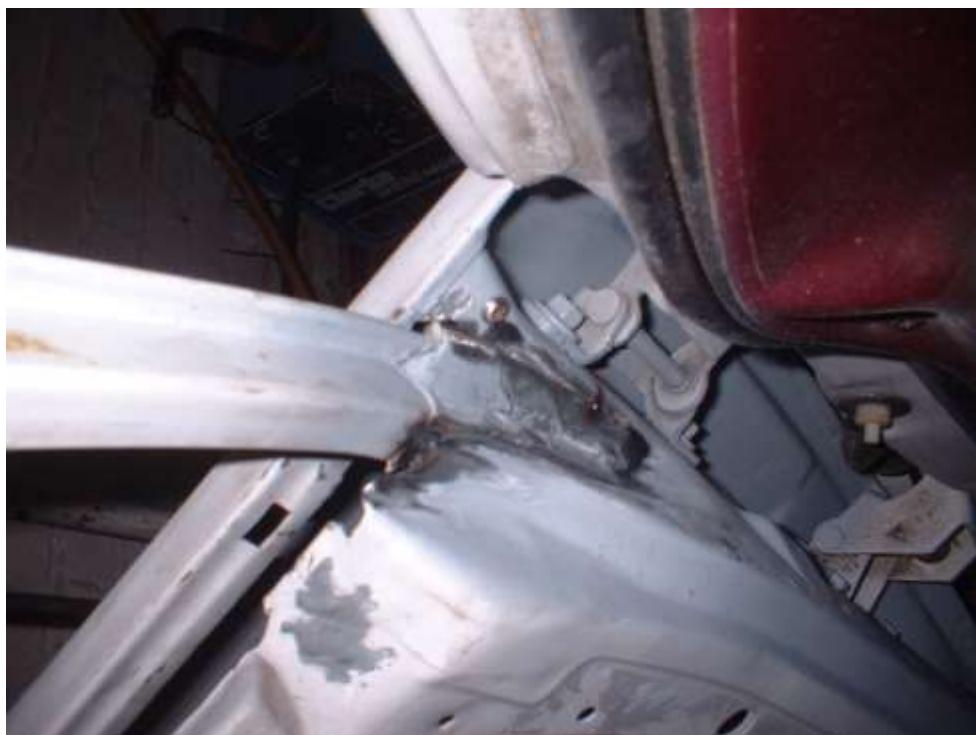
Tacked in the other side

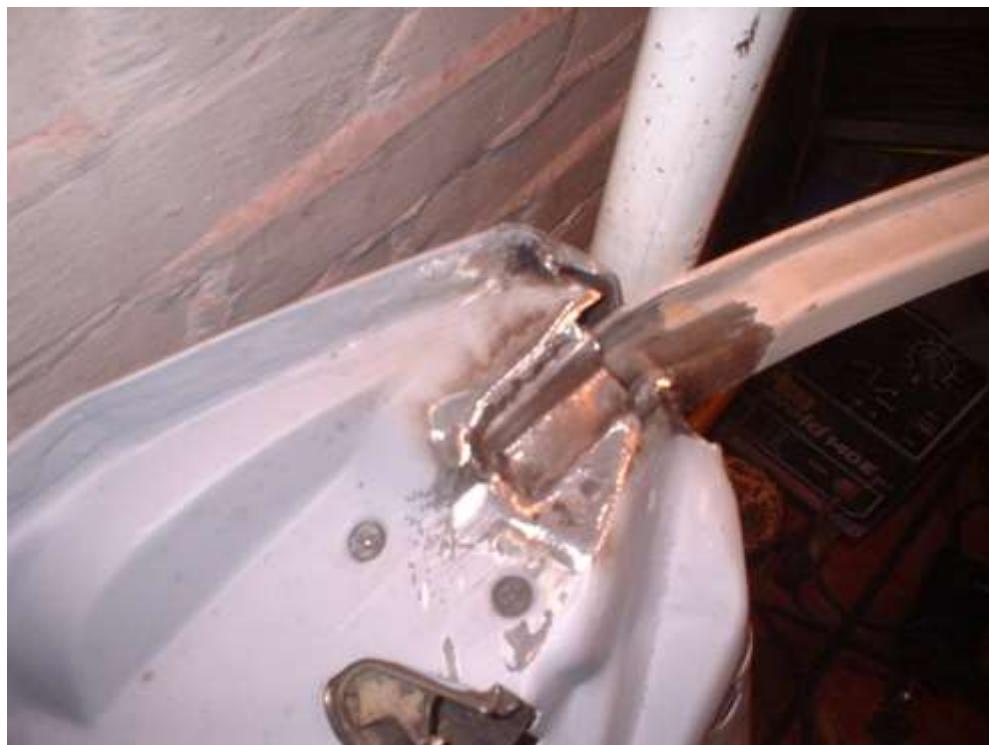
Fully welded

Now need to reassemble the door and move the window runners over a bit and also the dew wipe on the weatherstrip trim that goes on top of the door.
