Project Big Ford

Ford LTD Crown Victoria LX Country Squire

September 2009

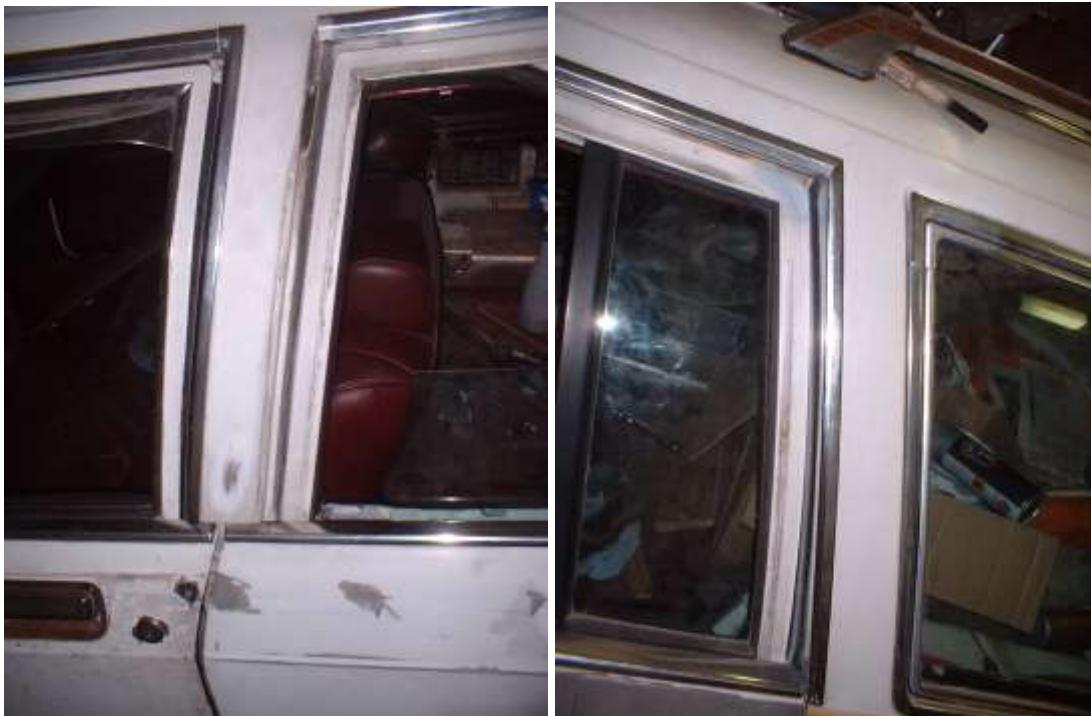
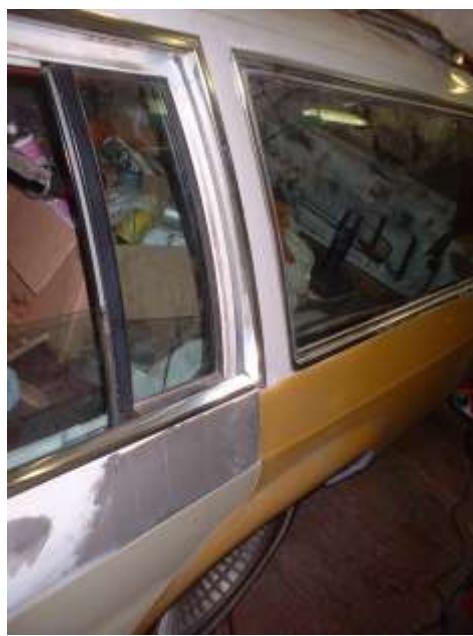
Heres the new gaps

Looks smooth already down the side! Love it.

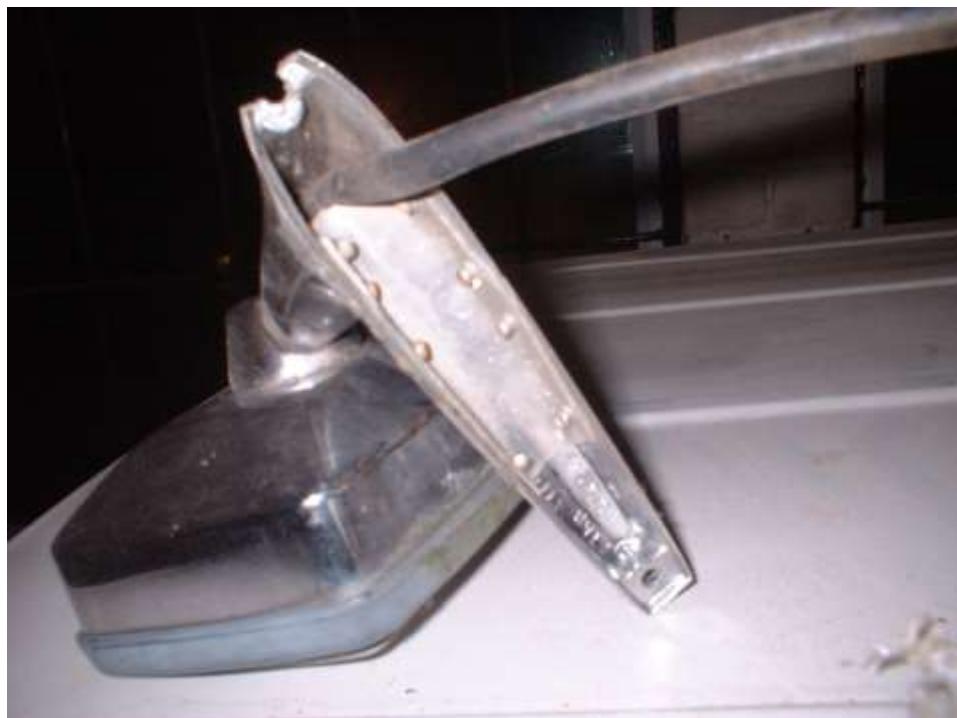
The door mirror will be the next to go the way of the trash! When I took it off it fell apart! Have a look at the repair job underneath the mirror

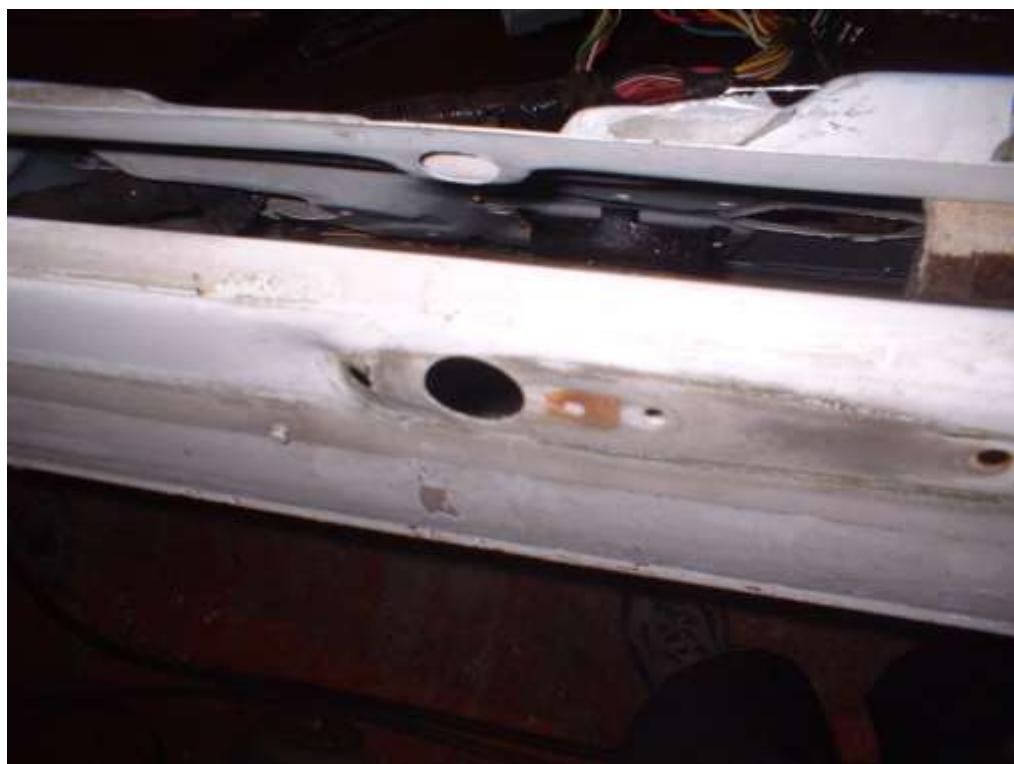
When I looked at the door under the mirror it was obvious that the mirror had been hit and made a good job of bending the door

Its going to be welded up anyway and another mirror moved to a proper position a bit further forward. In fact I may even use the internals of the old mirror and design and build a new outer shell.

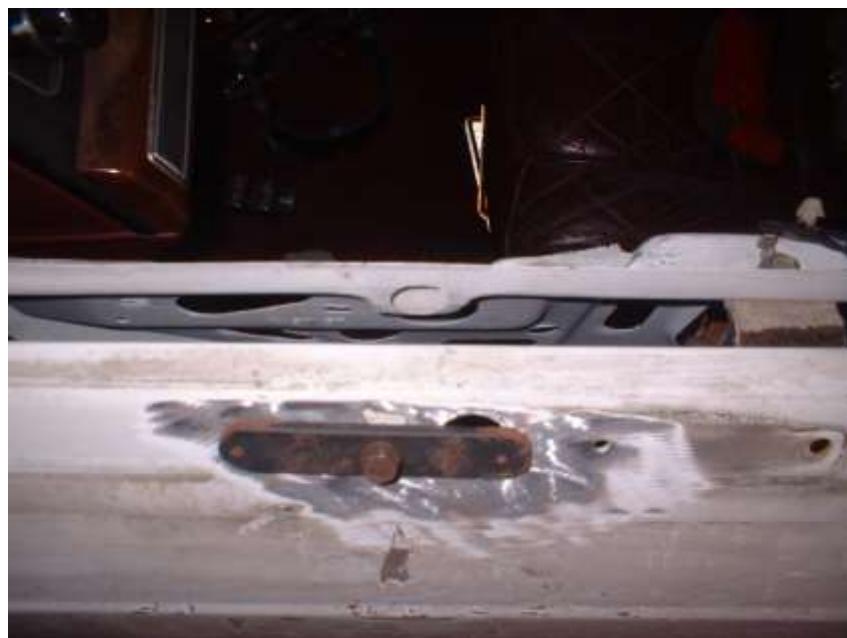
Here is the first attempt at straightening it out. Thick plates and a bolt between them

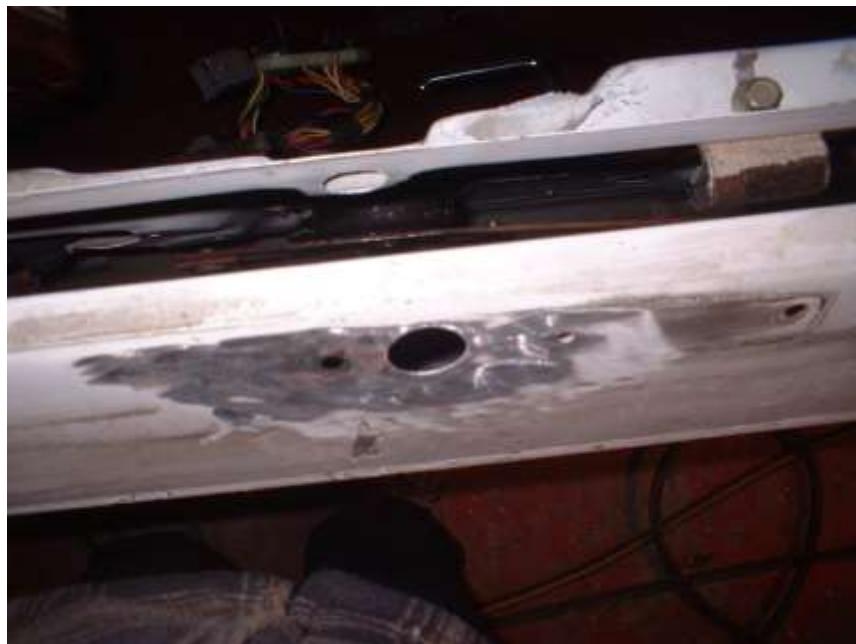
An hour or so later... the straight version

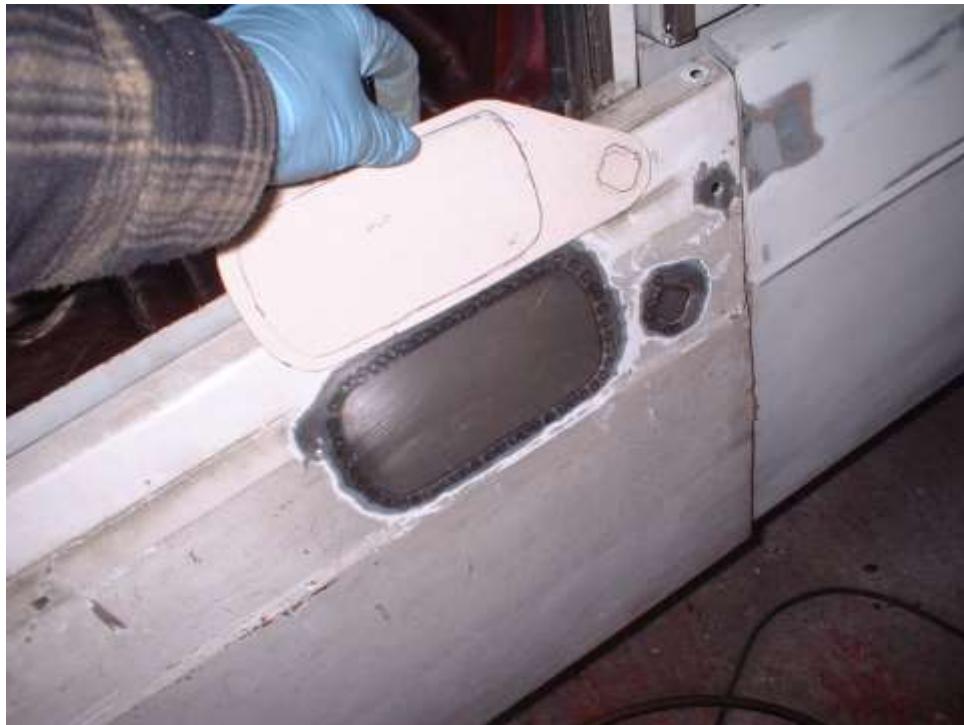
Made up a panel to cover the handle and lock hole in one and spot welded it in.

Just got to MIG weld the back of the lock hole because the spot welder won't quite reach in under the window channel. Then its prepping the rest of the door.

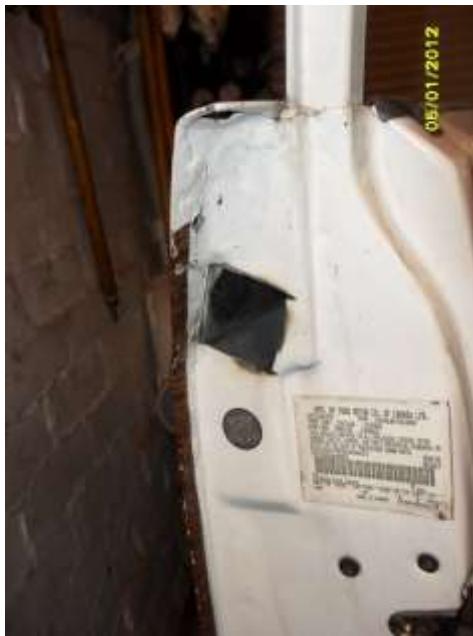
Back to welding up the drivers door. Cut an access hole to get the spot welder in and finish welding the plate in.

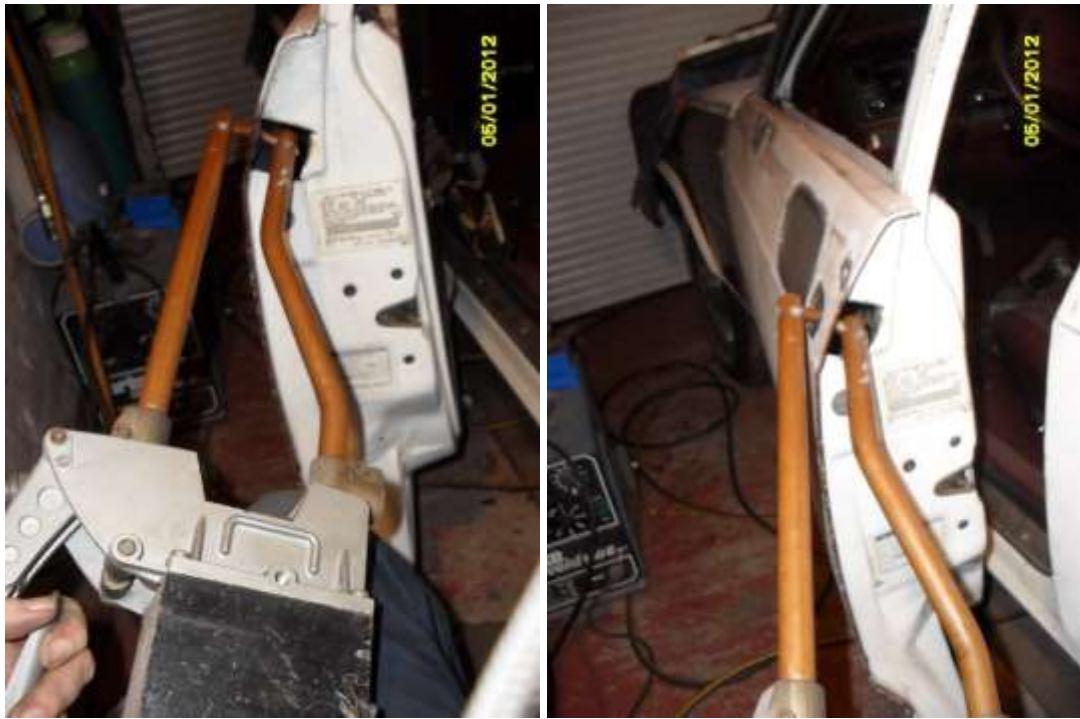
Spot welded around rest of lock.

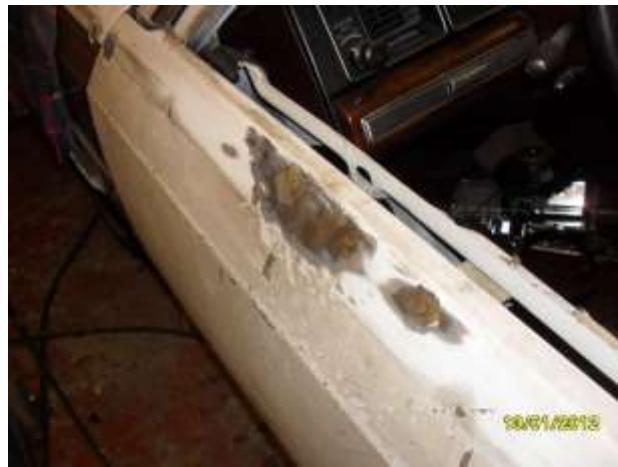
Sealed around the plate with sikaflex and finish welding up the door mirror holes.

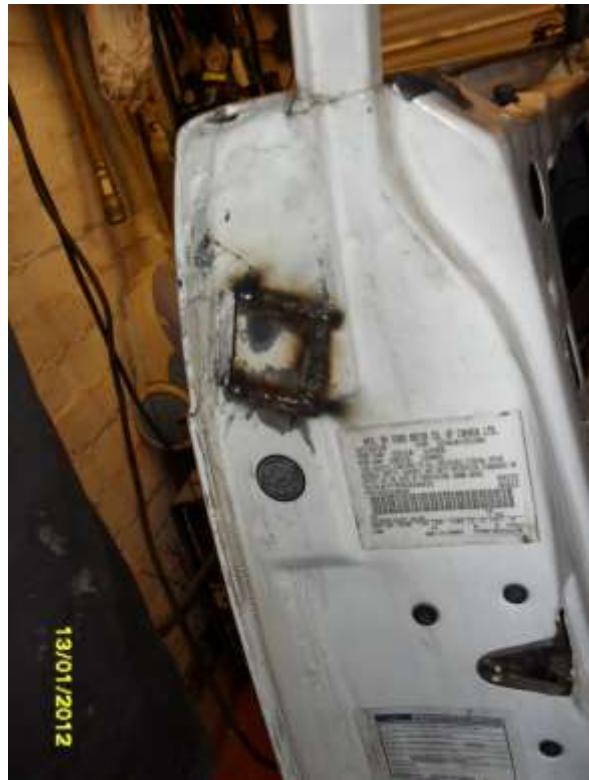
Also welded up the 2 top trim holes and the access hole.

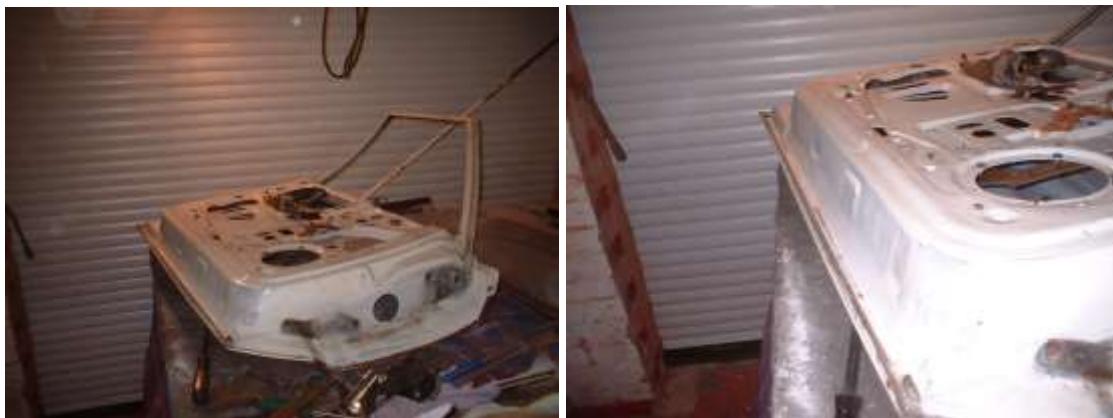
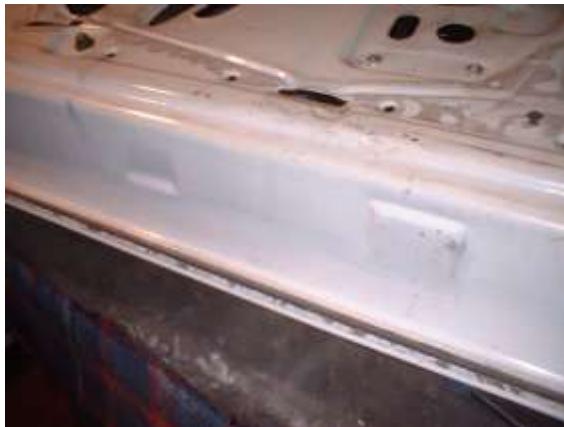
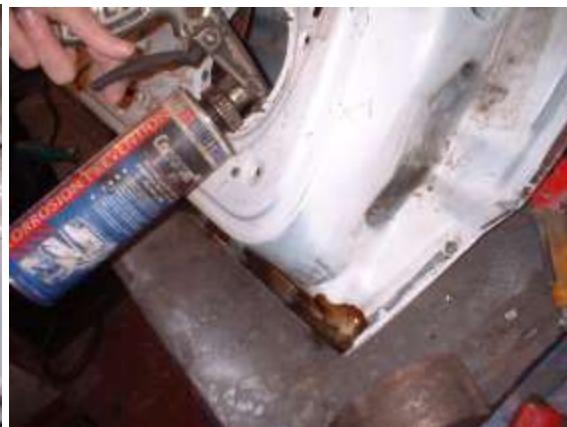
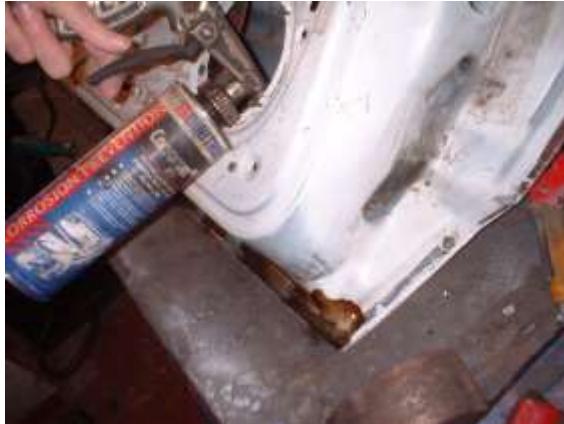
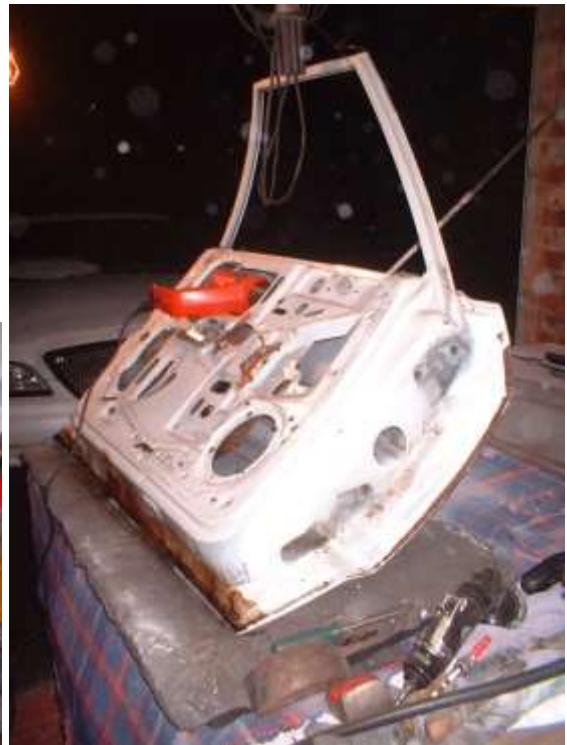
Door put on bonnet on foam pads and final 2 trim holes welded up near the bottom of the door.

Gouge knocked back out as far as possible and the bottom lip peeled back to check for rust.
Then dinitrol 3125'd and crimped back. Now needs the bottom lip straightening and the door
skimming with filler.

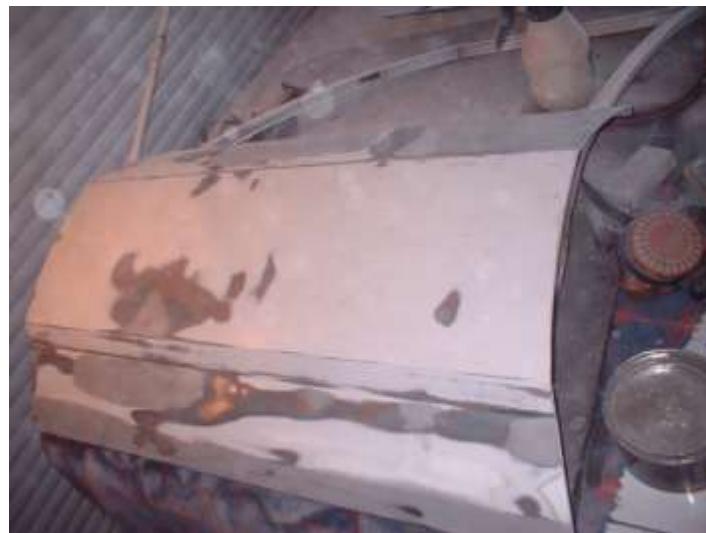
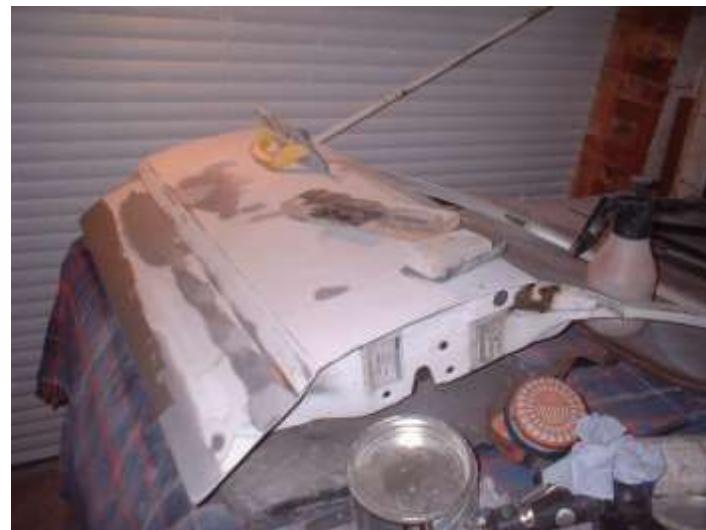
Plan was to finish the drivers door prep. Since I recrimped the base of the door, it wasn't quite straight anymore. A few wobbles so had to be panel beaten flat again and a skim of filler over the top. You can see it here

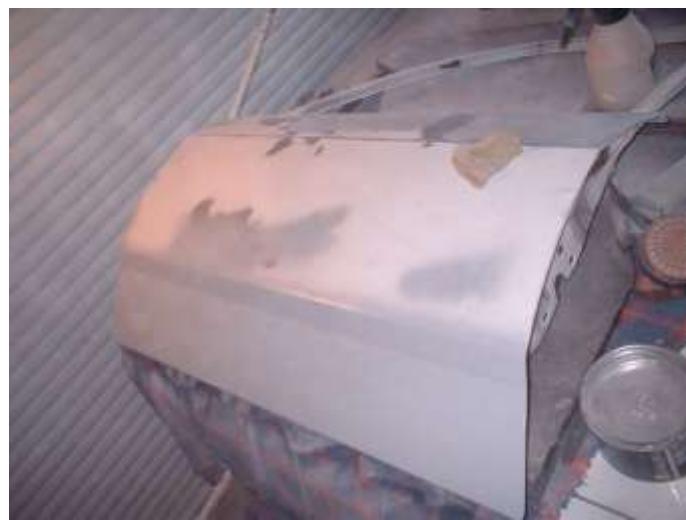
After using my favourite long flat bed hand sander (no machines for me!) and a coat of hi build primer, here we are

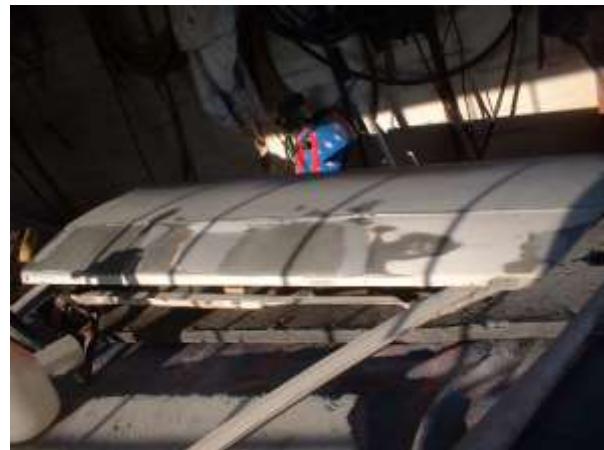
Here's a view of the prep where the mirror and the door handle used to be (good riddance)

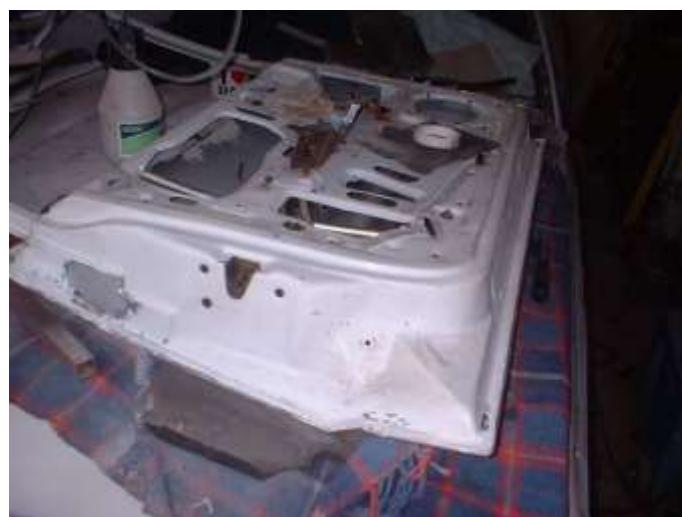
Then door turned over and the panel I welded in to get access for the spot welder filled level and all seams sealed.

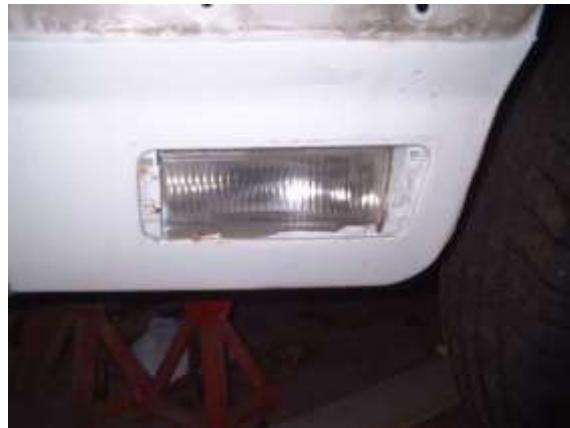
Fender light removed first, but a bit of rust present

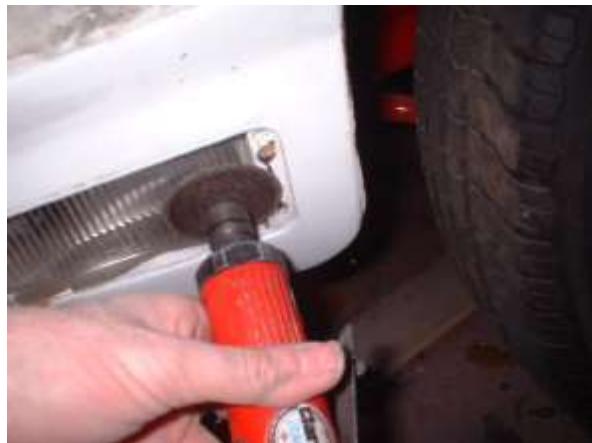
so had to grind one bolt head off.

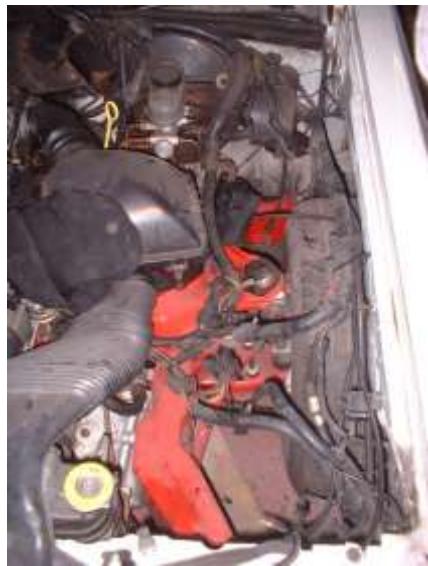
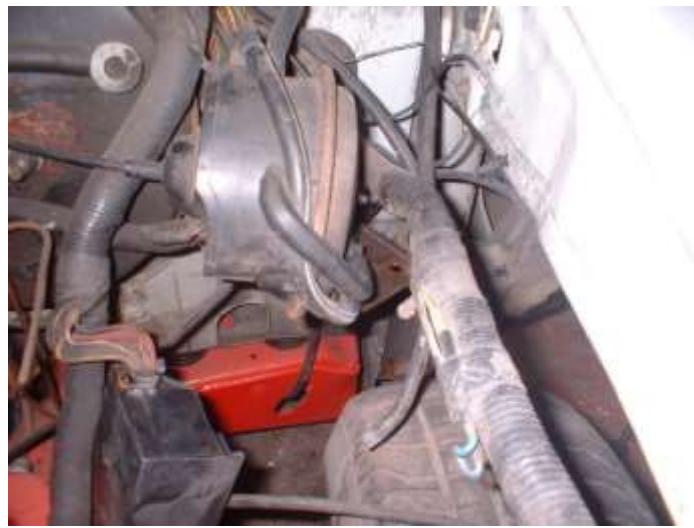
and here it is after. Had to grind one head off holding the inner fender to the rad support panel down here, and sheared a stud under the vacuum reservoir. Both easy to sort.

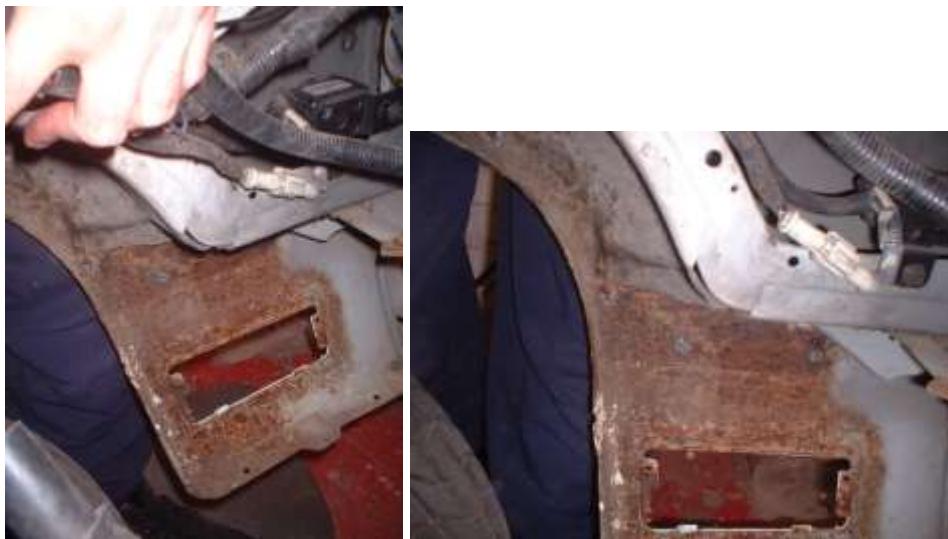
Time to weld in a patch to replace the light that was at the bottom of the fender, but I saw some rust behind there a while ago, so lets have a look

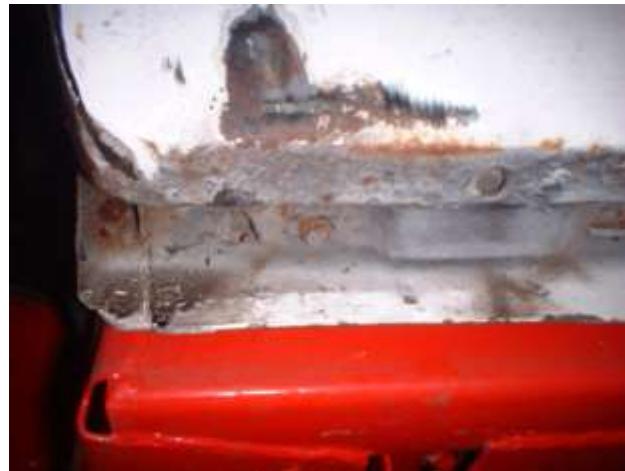
This is the only one that didn't come out. It loosened and then kept spinning. No doubt the captive nut holder broke in half

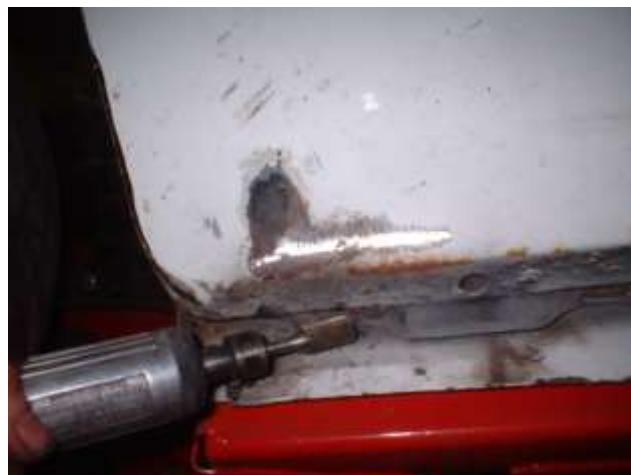
So it was out with my air grinder to grind the head off

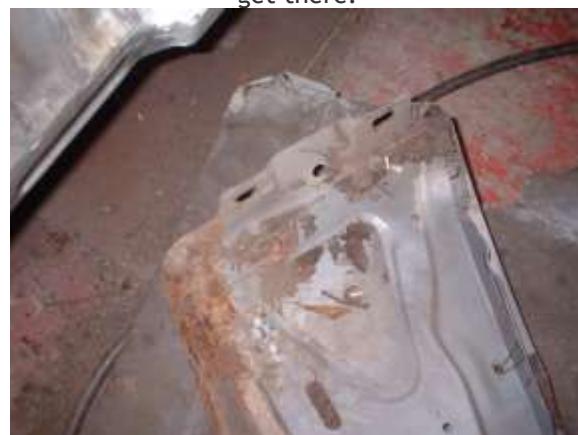
Fender came off but is that the remains of a bulb at the bottom of it?!! How the hell did that get there?

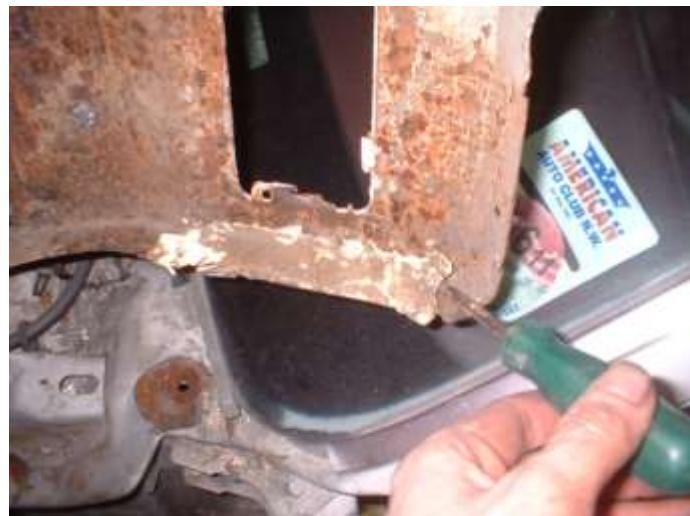
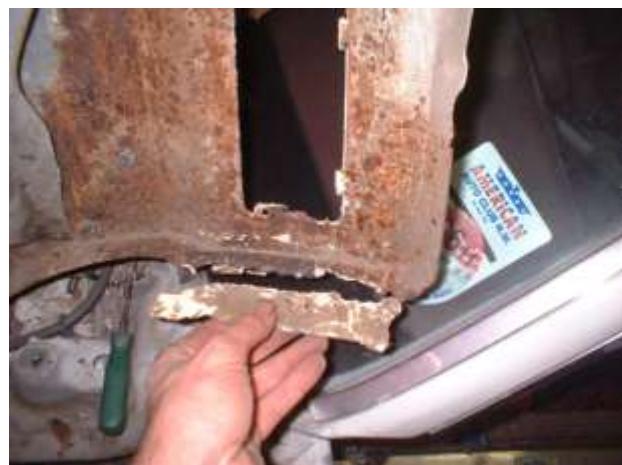
Doesn't look too bad at the bottom, but here's the other side

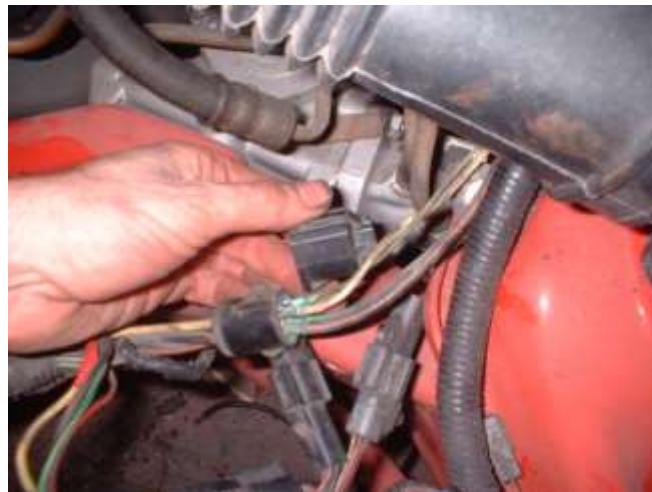
I try to fire the engine up every so often, and today was it. But it wouldn't play ball-no dash

lights or any life at all. Finally spotted this connector that had literally fallen apart! And I had pulled apart a connector where the air compressor used to be. Oops! Started up straight away then.

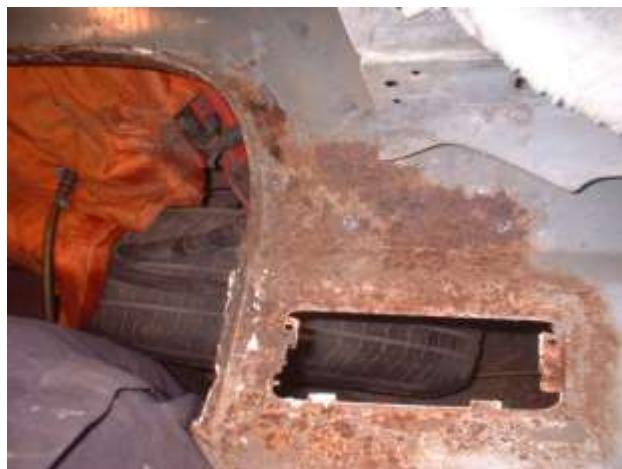
Here's how far the rust goes up the inside of the front of the fender - it reaches up further under the inner skin than I thought.

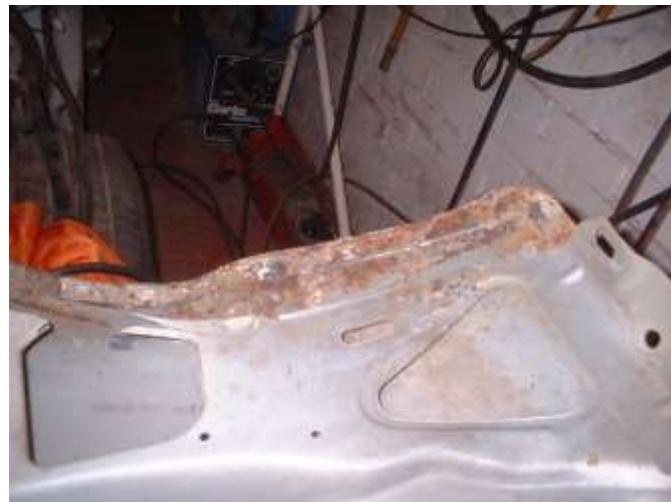
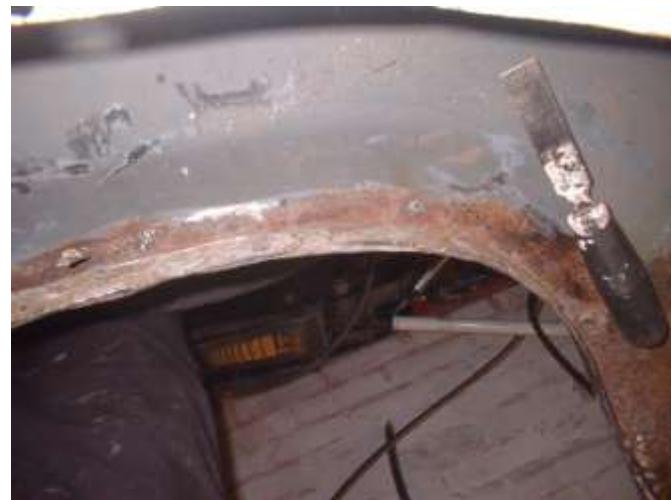
Here's a few views of the fender lip that is left. I now need to remove the inner lip clean from the

outer one by grinding through from the inside and causing little or no damage to the outer

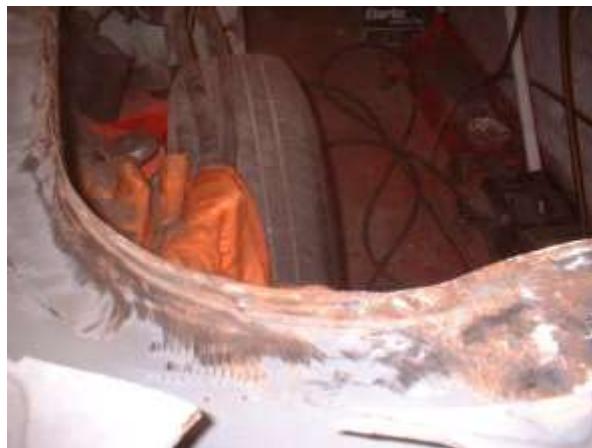
And finally we are all clear

Rust has only gone through in 3 places but I will replace all the lip anyway.

Rather than media blast the whole thing, I am going to use naval jelly(on liquid form) to eradicate all the rust. I am going to dip the fender into a BIG container and leave it for a day or so till all the rust is gone. then the welding starts.

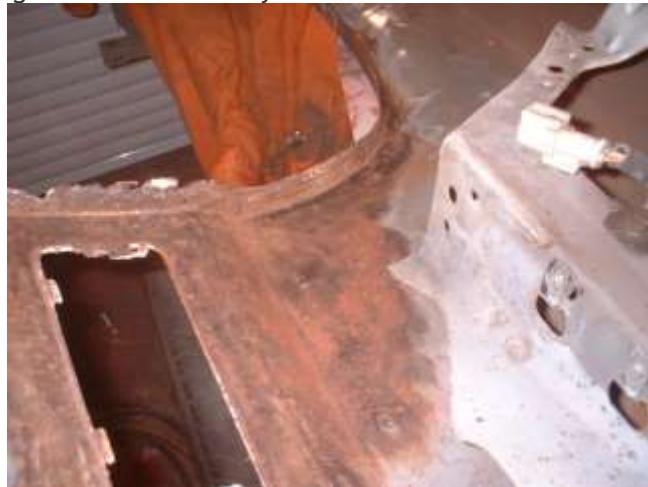
I ran the grinder over the rusty steel and it looks far better than before

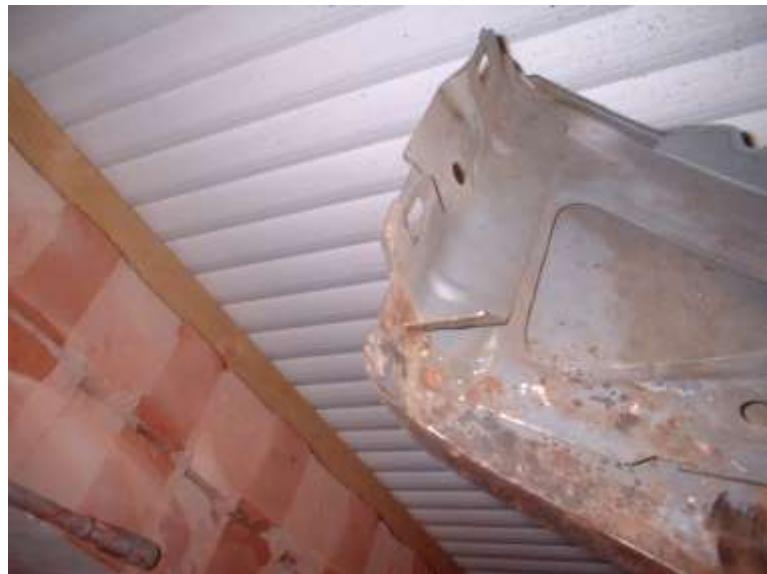
Heres the back lower portion of the fender bent back to check for any rust under there.

Looks okay under there.

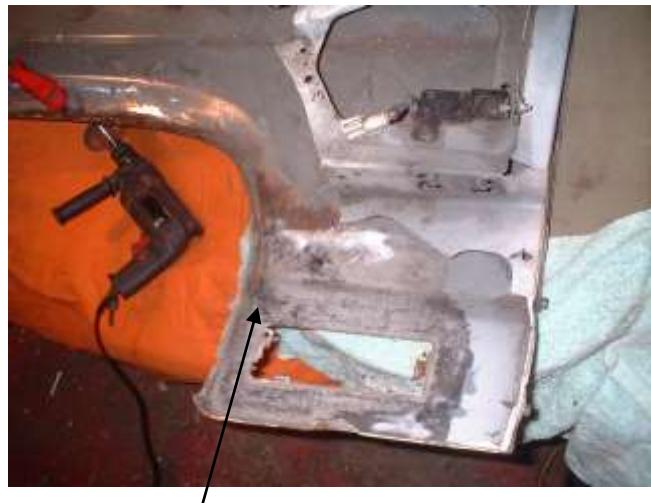
Its just gone through in 1 pinhole here. One spot of mig weld and it will be sorted!!

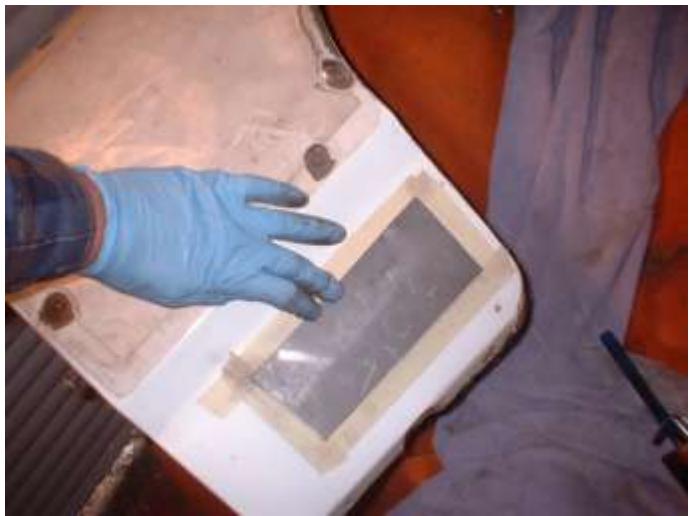
Here is a patch cut to cover the hole

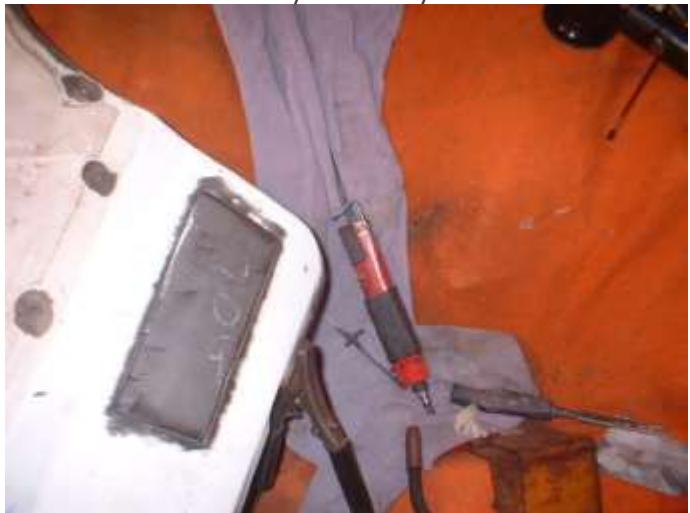
And the hole cut out very accurately for a butt weld

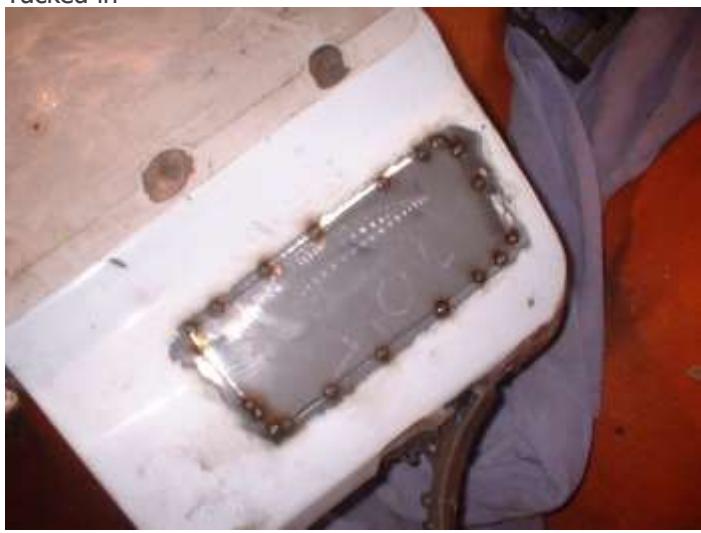
Tacked in

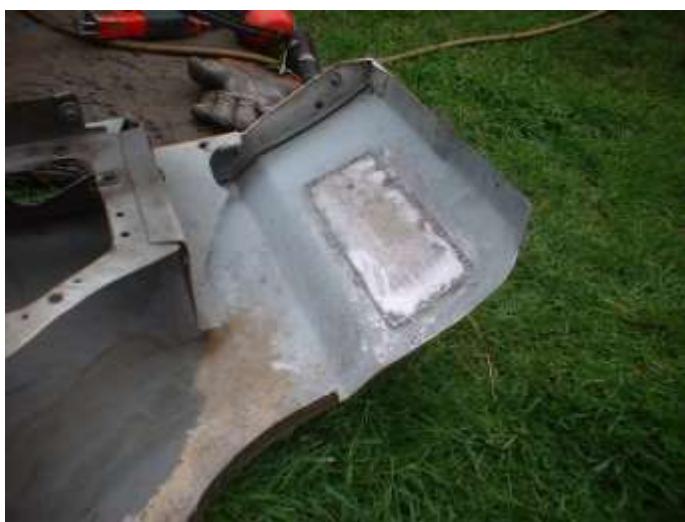
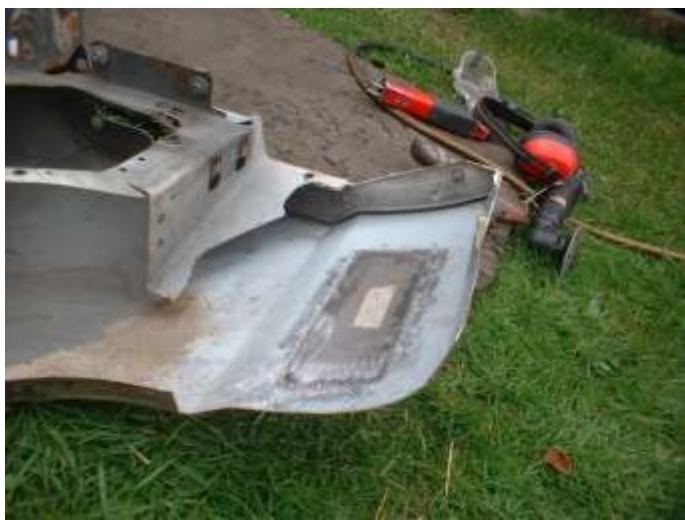
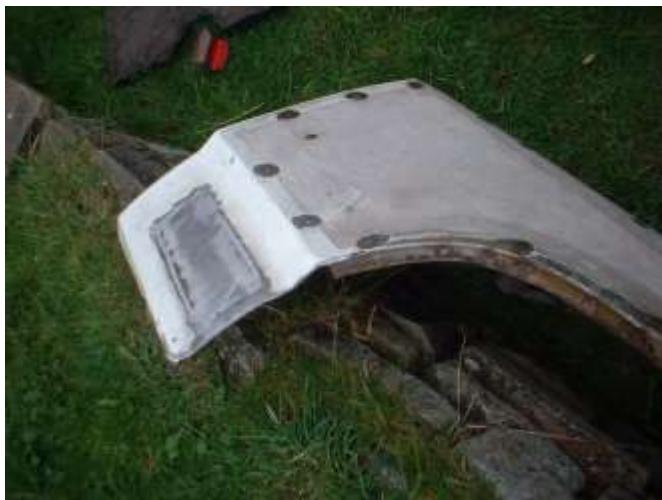
The welding caused slight distortion so I made a decision to replace the weak lip so I can panel beat it back to shape without losing the shape. So, a piece of wood clamped across to keep it all straight and out comes the first part of the lip

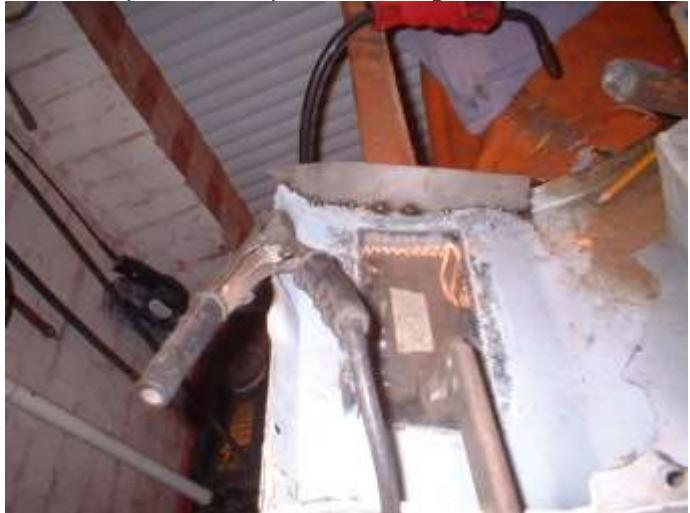
and new lip welded in prior to cutting to width

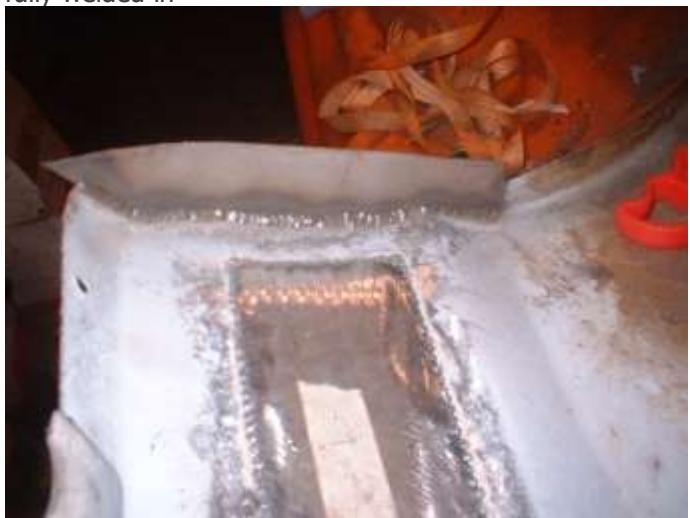
fully welded in

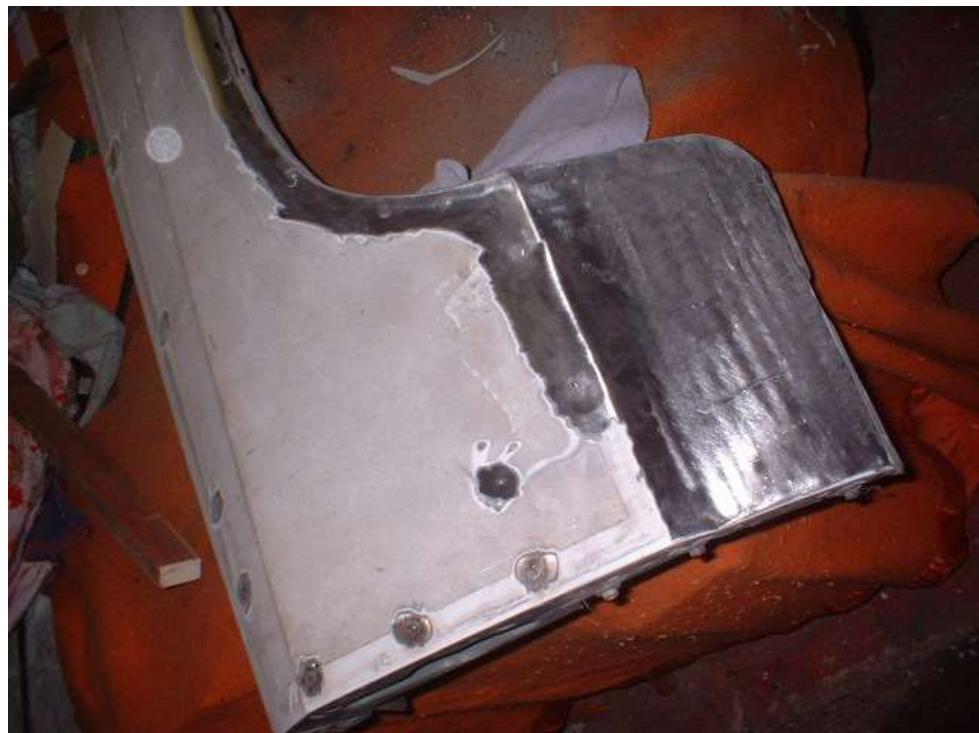
Finished panel beating the lower front of the fender. Perhaps need one more dab of weld at the back in one spot.

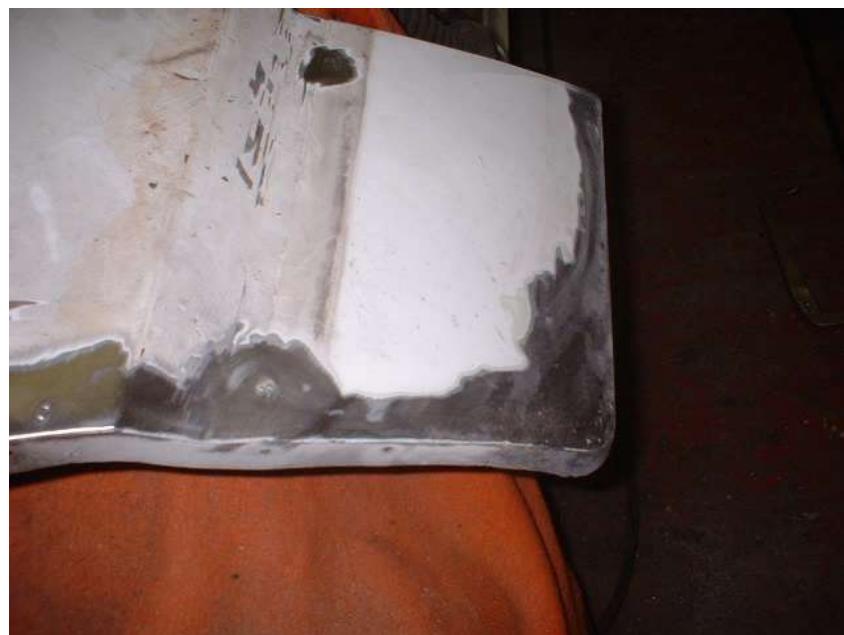
Then took all the paint off the lip and other lower part ready for welding and prep. Noticed that there is some rust pitting there.

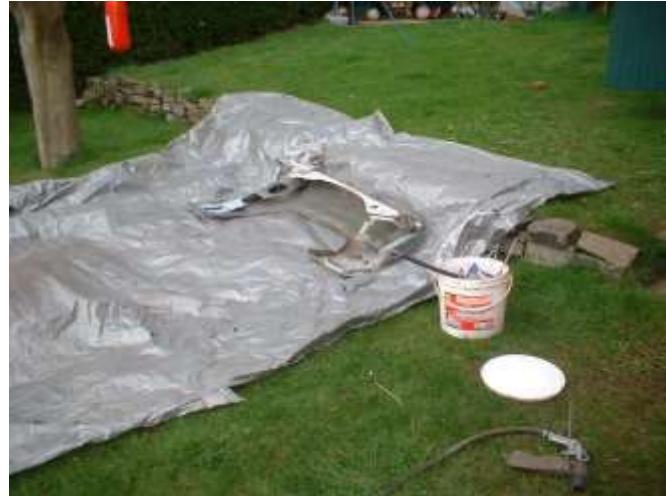
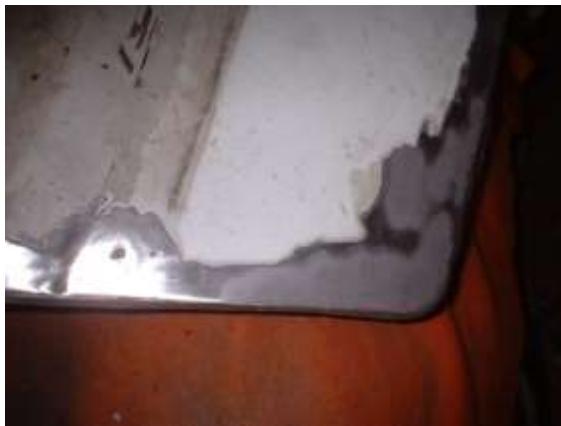
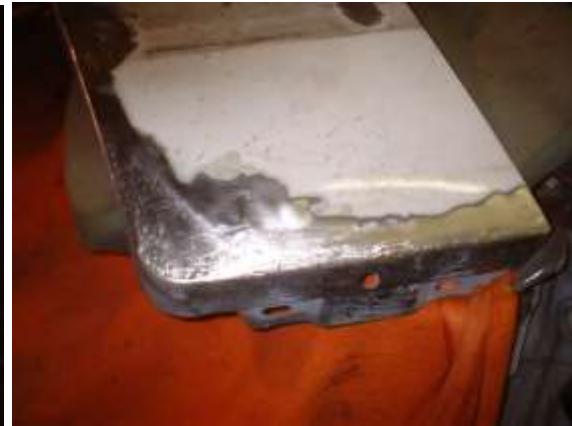
Media blasted the corners and inside lip of the drivers fender.

Then went over the final pits with the die grinder and abrasive bit to really get rid of all rust (right hand picture above).

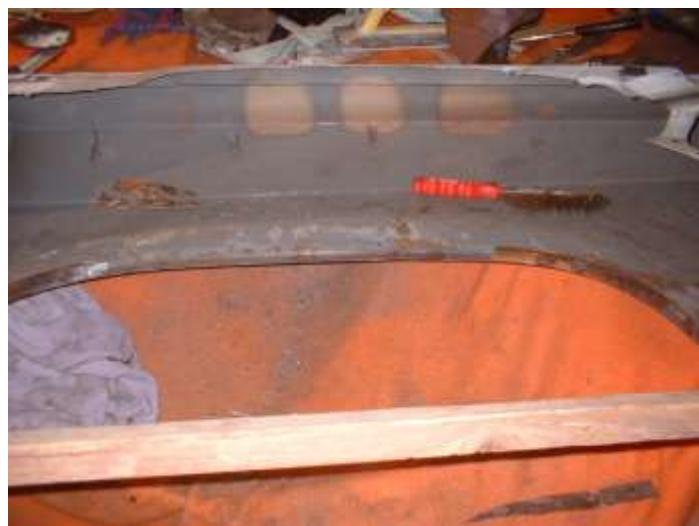
Here's the bad bit cut out

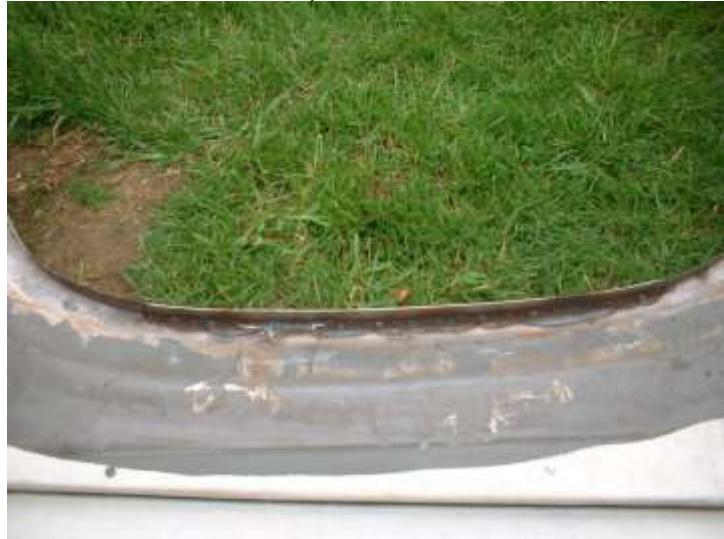
Lip welded in

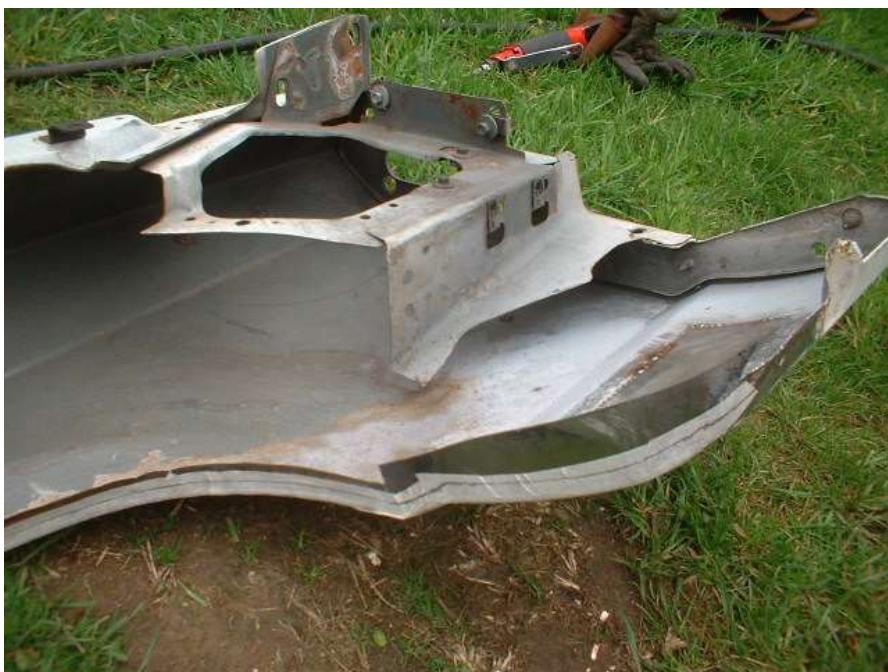
Now its time to reduce the width of the lip. Masking tape on and a pencil line to cut down

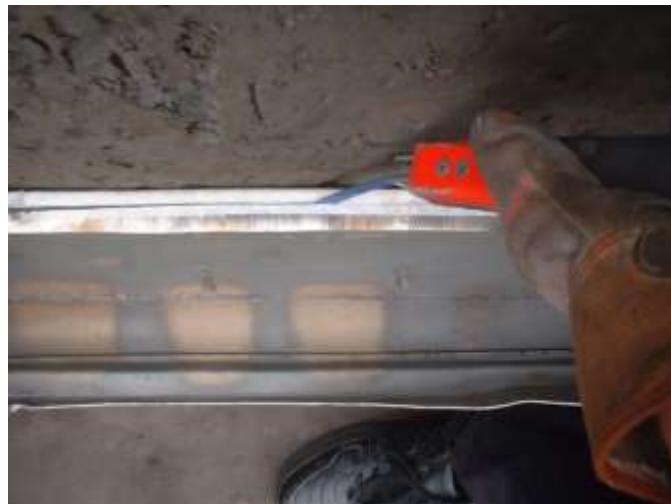
and cutting
