Project Big Ford

Ford LTD Crown Victoria LX Country Squire

September 2009

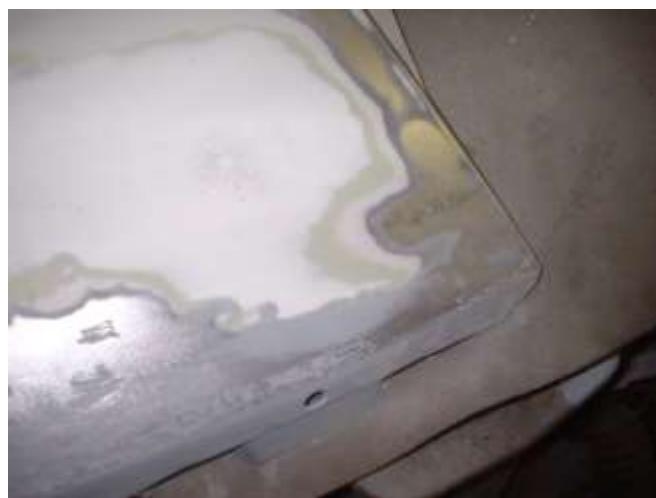
Here's an interesting discovery. Final paint sanding and this line of rust appears through the paint

That would have caused some paint bubbling a year or so down the line.

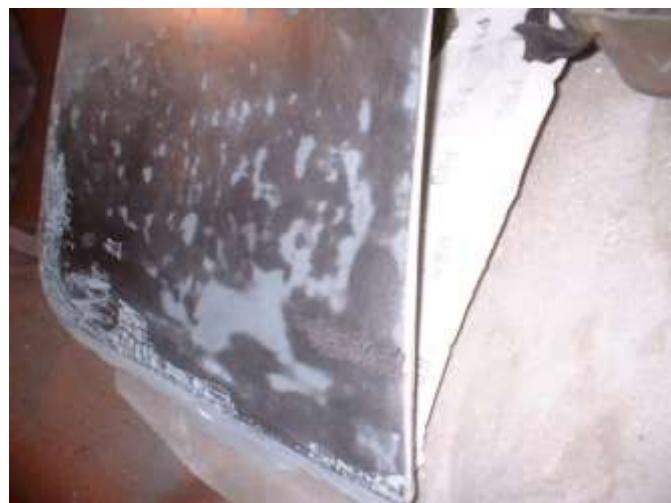
Same line with rust ground out

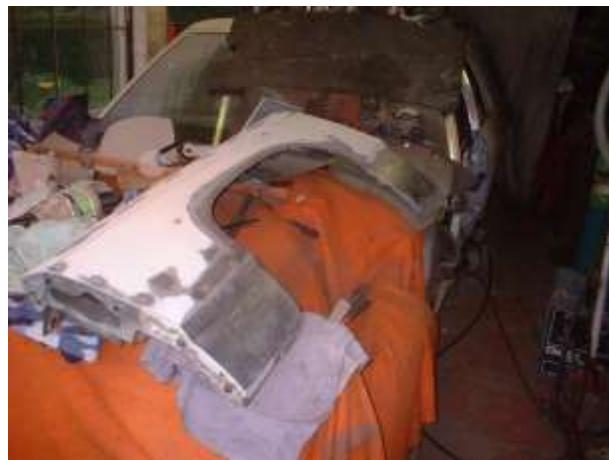
Here is the fender all flattened back and ready for a skim of bondo and primer.

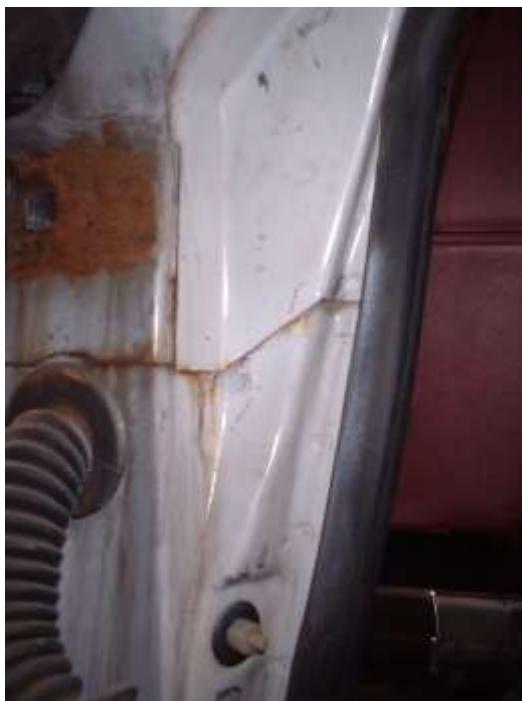
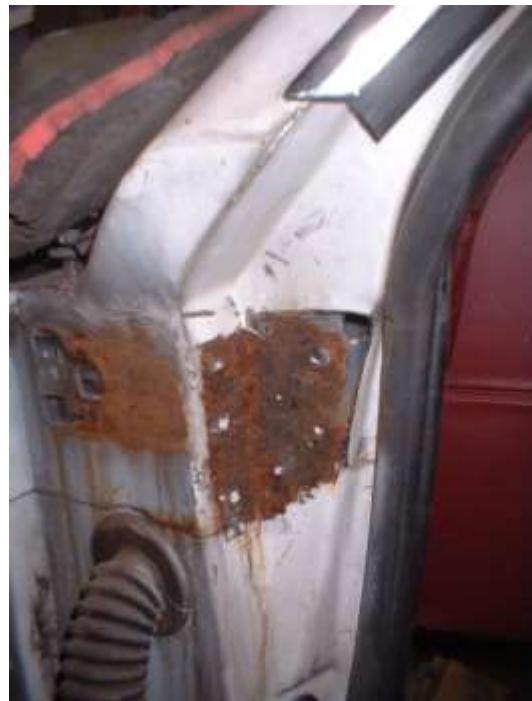
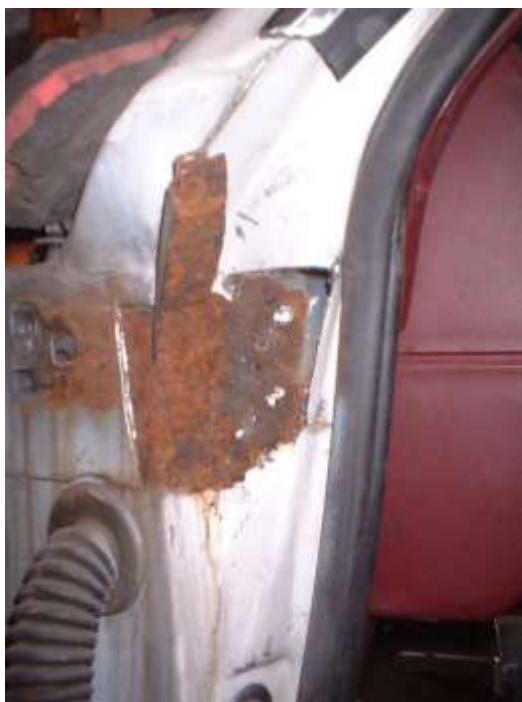
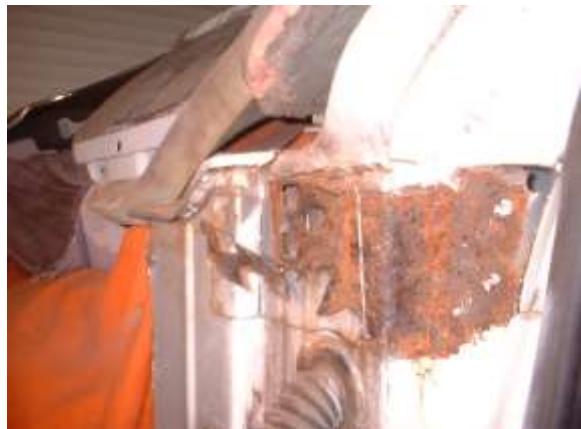
Put a skim of filler over various sections of the fender, and then moved over to a very suspicious looking A post. I am going to peel back the layers to see what is going on.

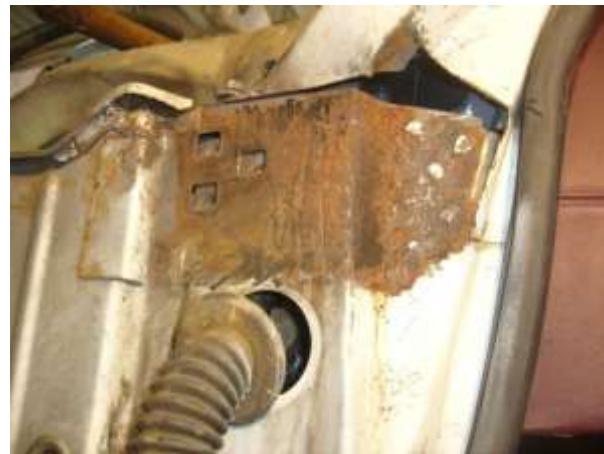
Anyway, finally finished removing enough steel to know roughly why its rusting.
Take a look here

I think the moisture is coming down the A post here as well as creeping around the hinge.

I'm going to have to cut out here and replace this first

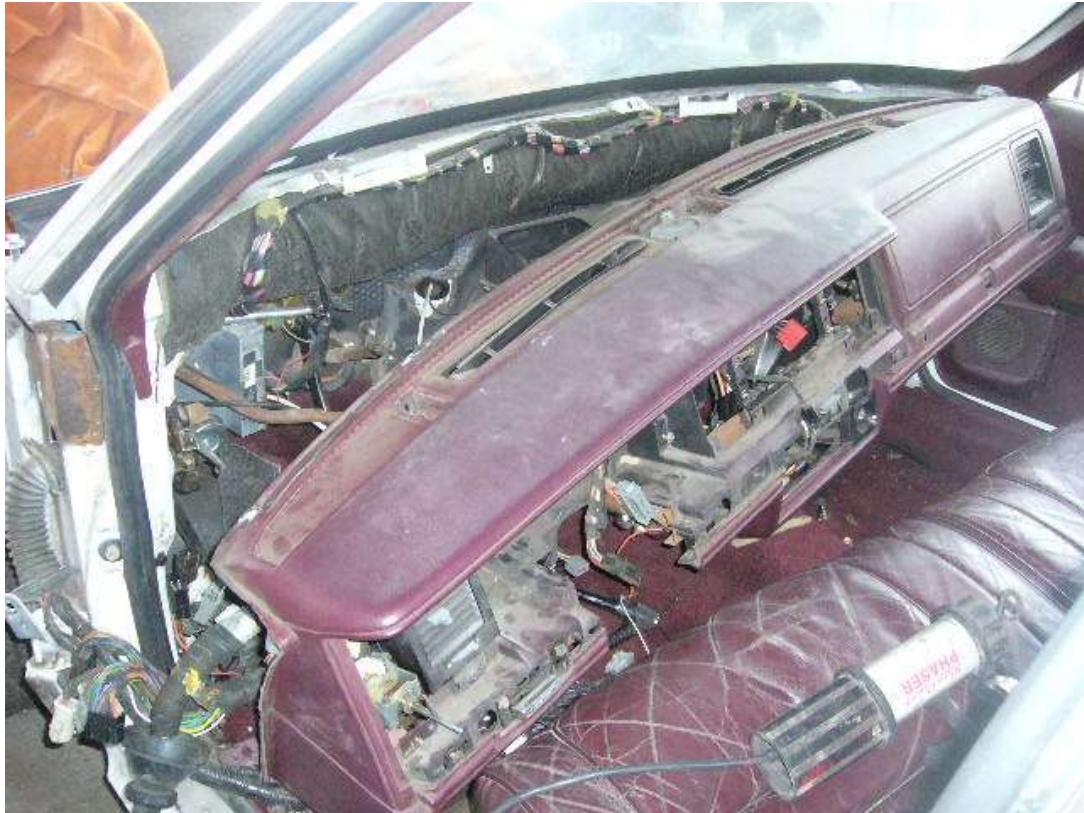
Started to remove dashboard. Took hours but I am stuck on the 2 huge looms going through the firewall. The drivers side eventually came through but the other side goes under the heater box. Here's where we are so far

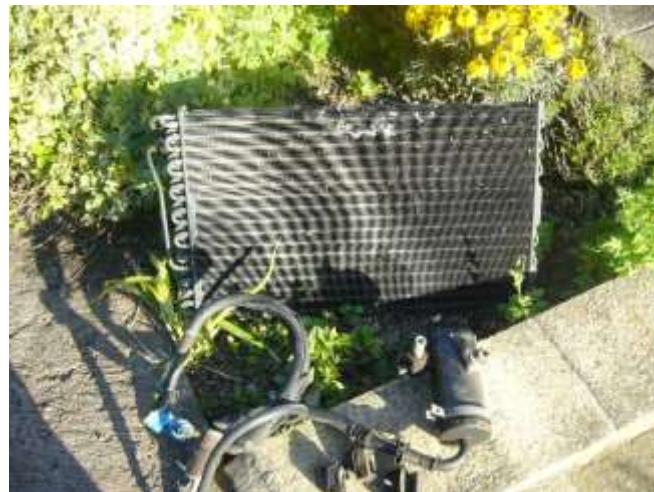
Here's some AC debris that has been removed

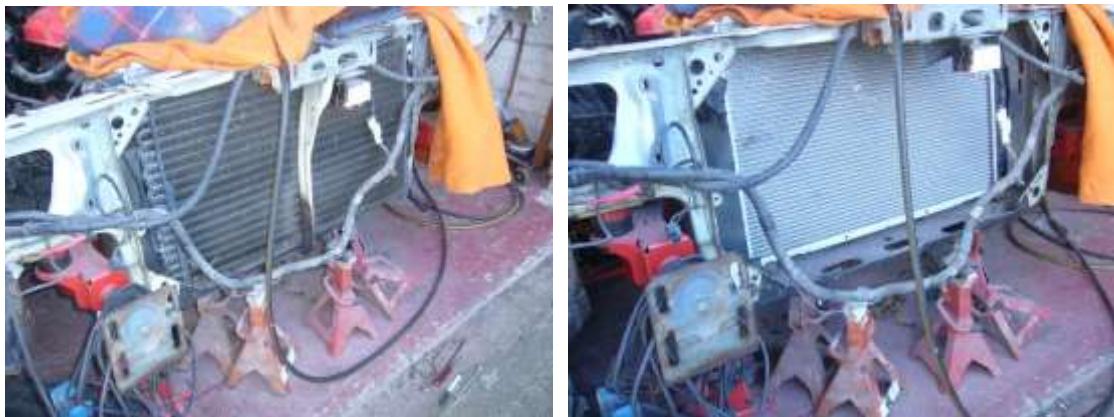
Heres a view of the AC rad still on the car and one with it off

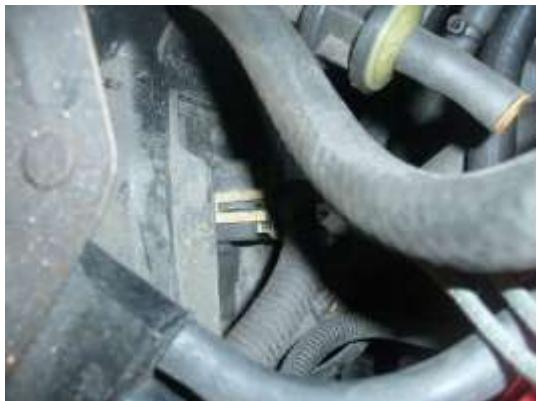
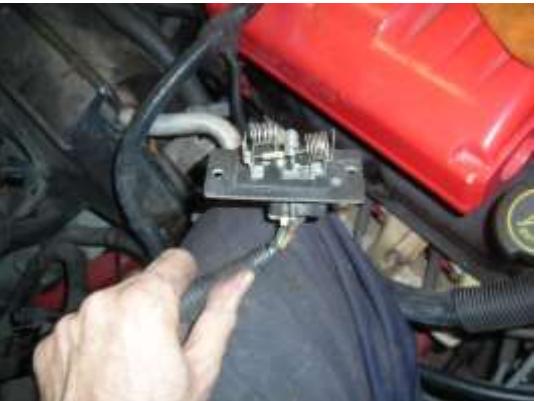
Took me about an hour to remove the fan resistor 8mm bolts here

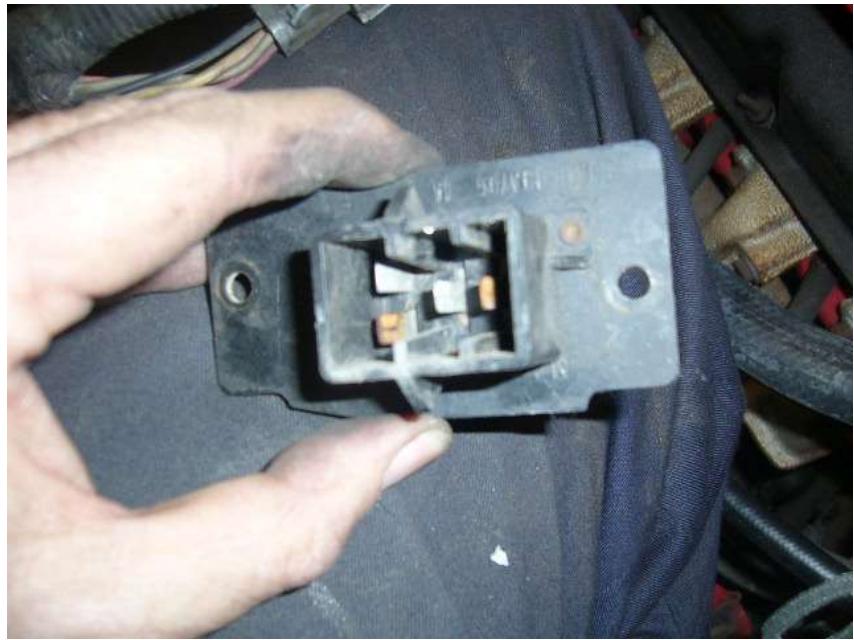
The connector looks like this though - needs cleaning up before it goes back.

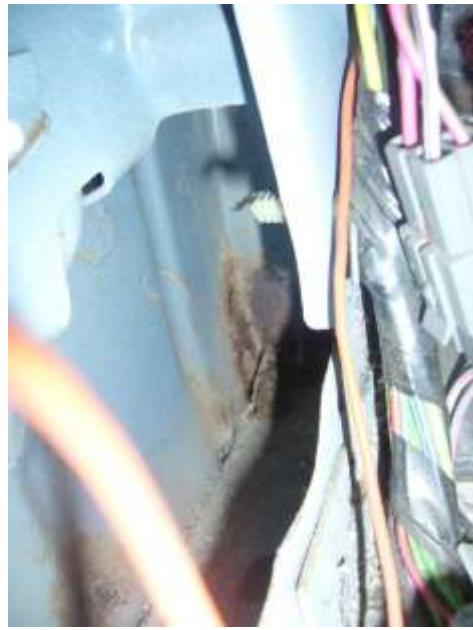
And saw this rust in the corner

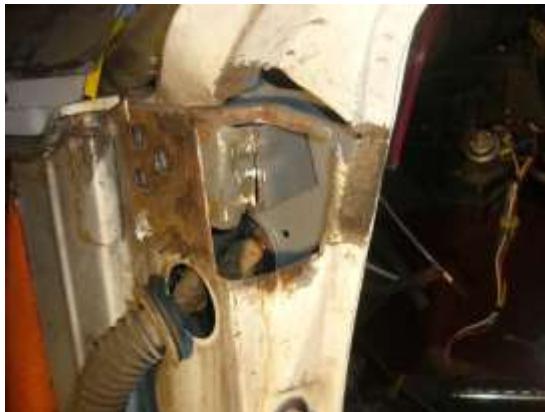
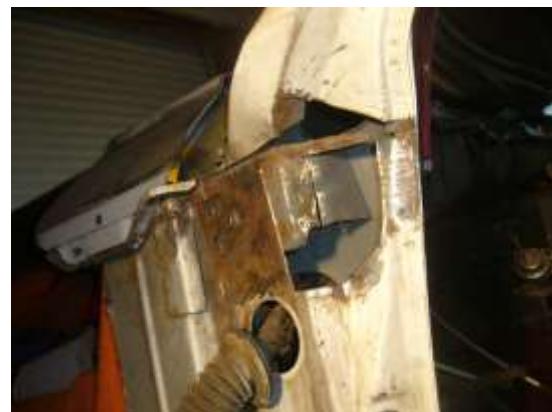
Cut out the final heavy rust on top of the A post and accidentally cut through another plate underneath!

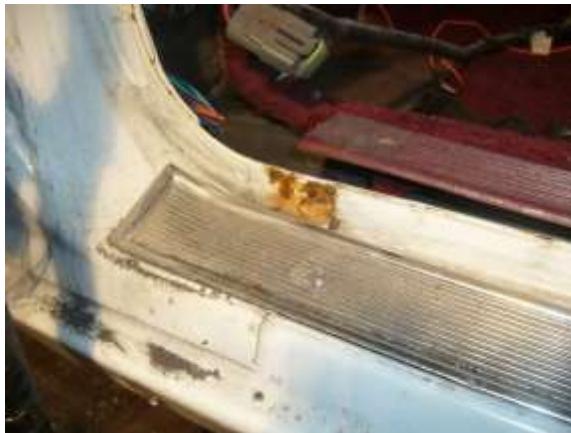
Need to sort this out

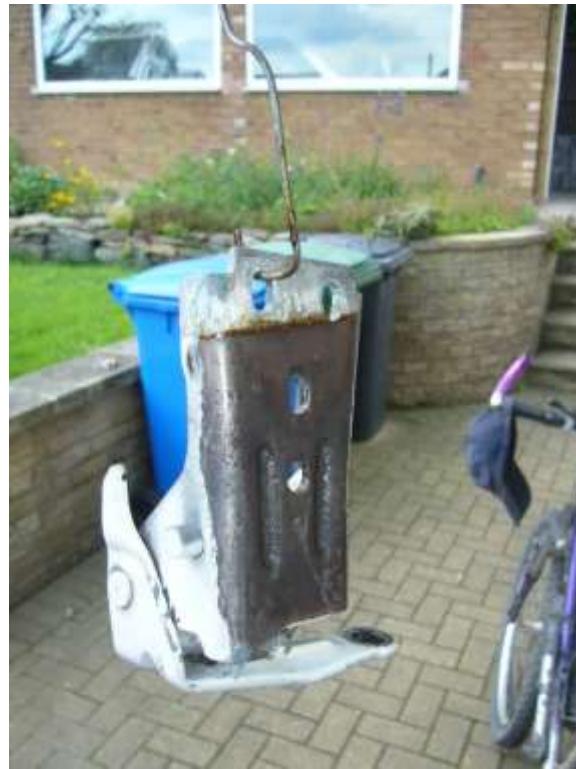
Now top of A post is repaired, the top hinge is a rusty mess! here it is after it has been dipped in acid

I like the tide mark! I left it in for a week because I forgot about it. Oops!

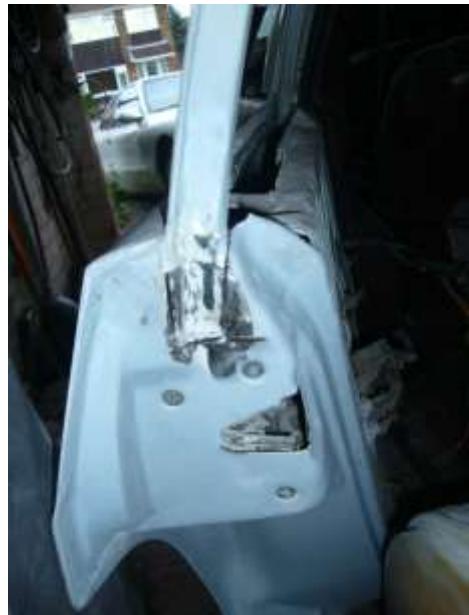
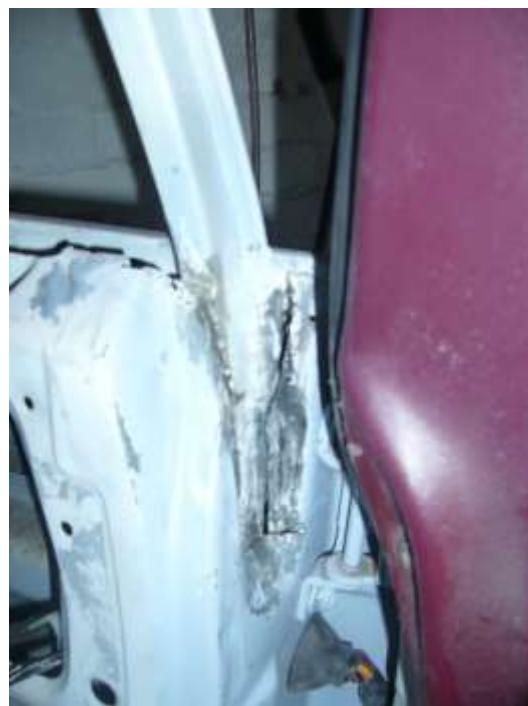
I had to cut the frame clear of the rear door again because it was too far in towards the centre of the car when closed and forcing the top of the door out.

Serves me right for welding it up when the car wasn't fully assembled.

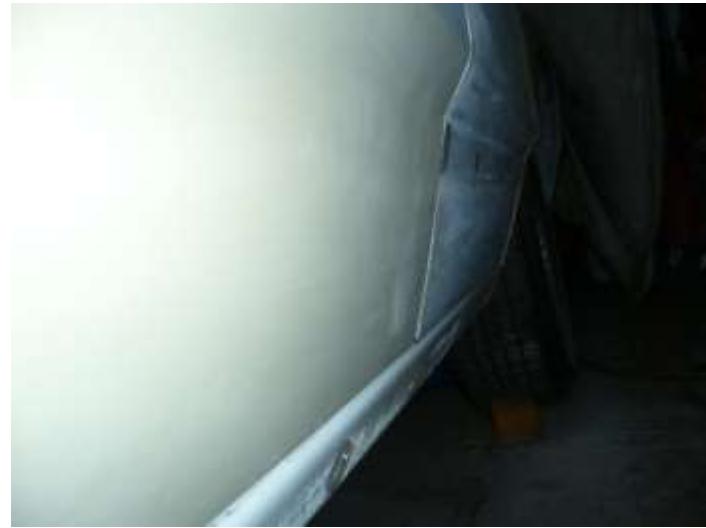
After what seemed hours, we have an almost good alignment between the doors and the rear quarter, apart from here....

The bottom of the rear door wants tapping in slightly to line up, A block of wood and a hammer will do here!

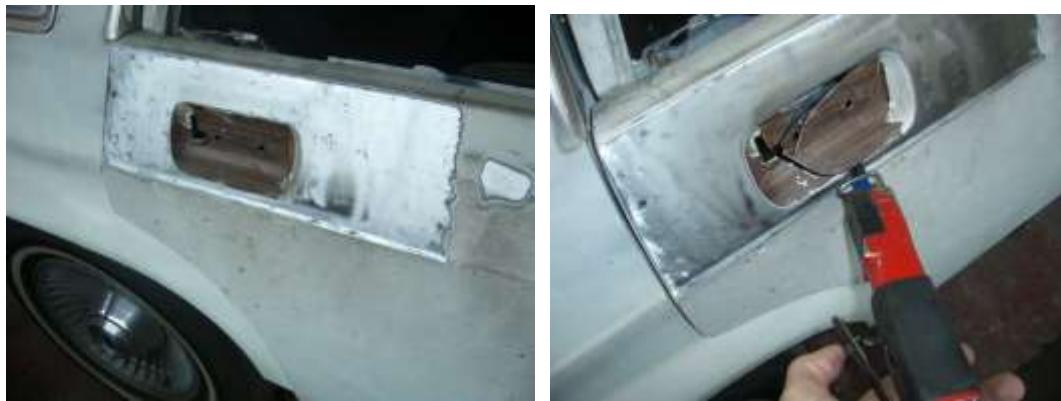
Back to bare metal round the handle area

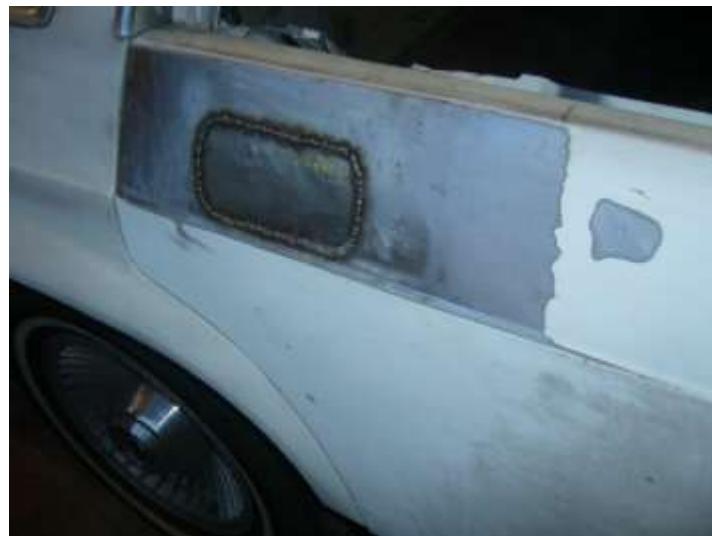
Don't let appearances deceive, there is distortion there that will take a few hours to sort out by tweaking and tapping and levering..etc!

Finished welded over the next hour or two (taking it slow to keep distortion to a minimum

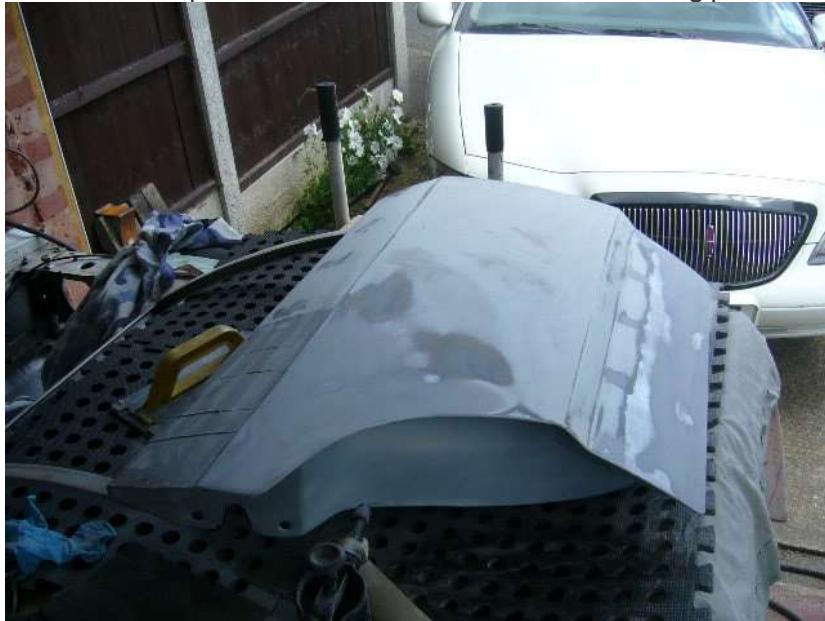
Here's the rear pass door skimmed with filler and awaiting primer

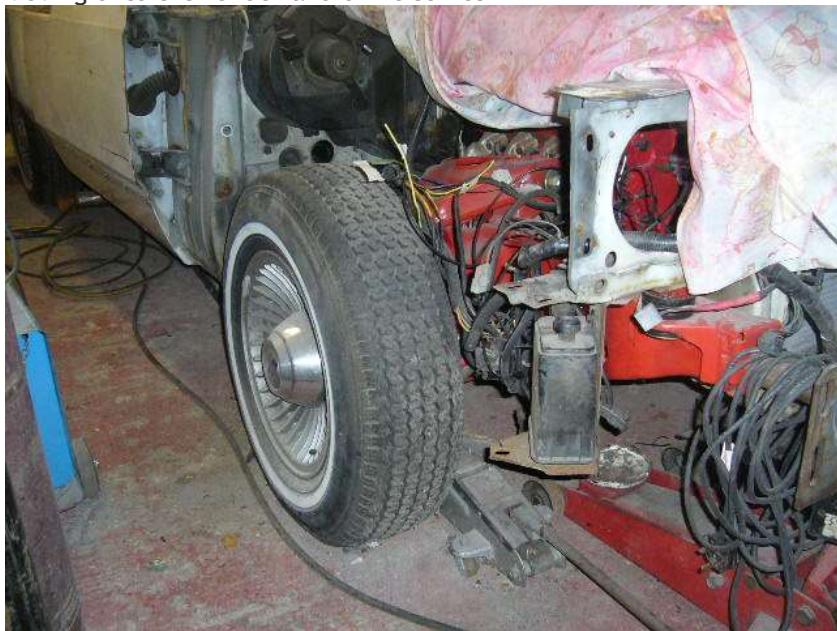
This is a familiar view of rust carnage..

I'm going to cut the hell out of it tomorrow with my air saw!

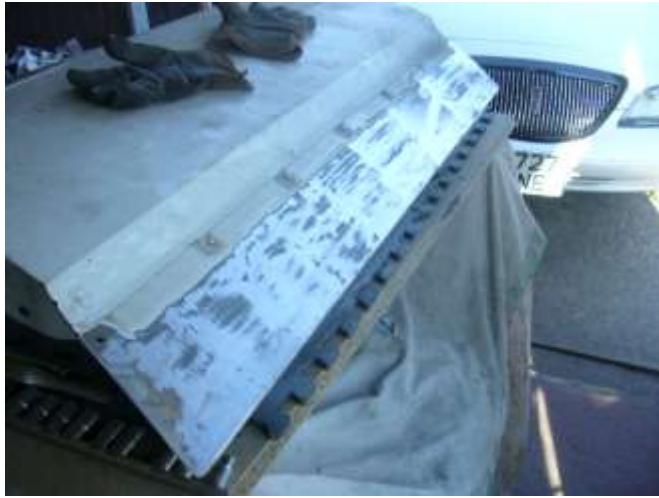
Which is a good job because if you look closely in the next picture you will just be able to see some rust marks that would have bubbled the new paint up.

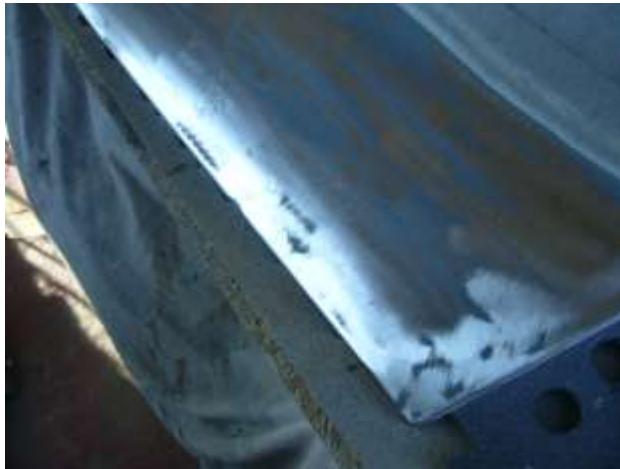
I knew of the underside rust but hadn't seen it for a bit, so door turned round and here is my next job!

Should be simple enough to sort out....lip bent back, rust cut out, a spell immersed in acid and weld in new steel.

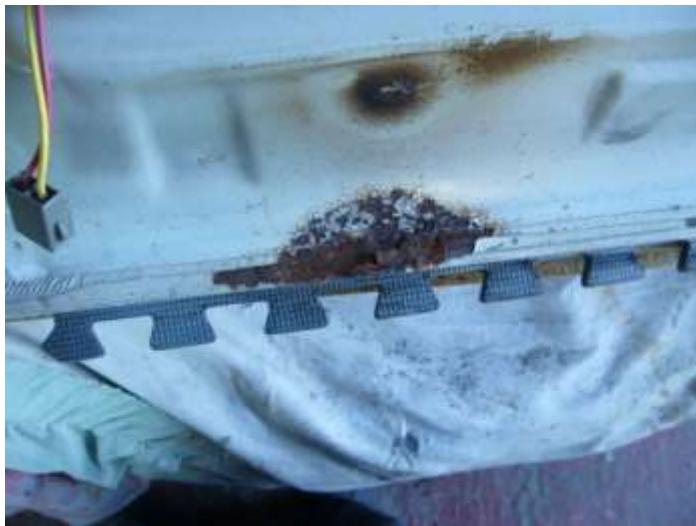
Remember the rust at the base of the passenger front door?

Welded in new sections at the base of the front door where the rust was. Now needs grinding back flat.

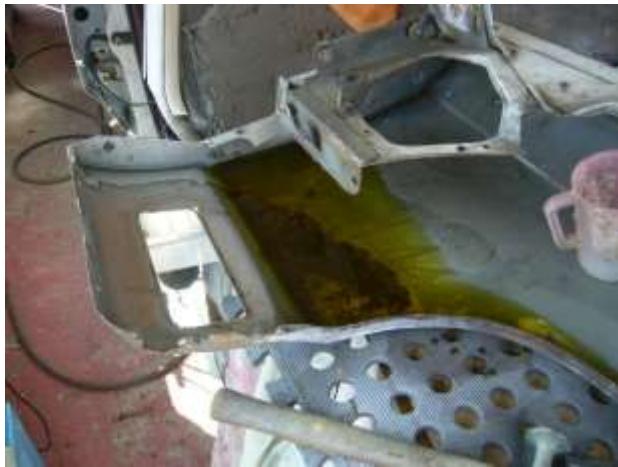
Leave that do do its work and onto the hinges on the passenger A post.
The top one had been welded for some reason. You can just about see where the weld has pulled a lump out of the corner of the A post

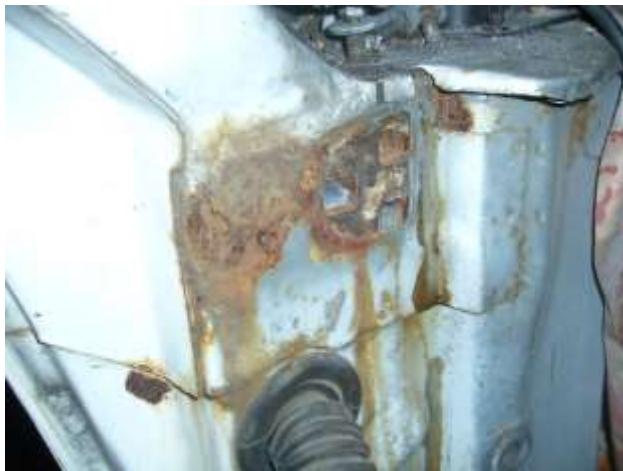
and the corresponding hinge

pity you cant see the lump of weld on the hinge face in the photo very well.

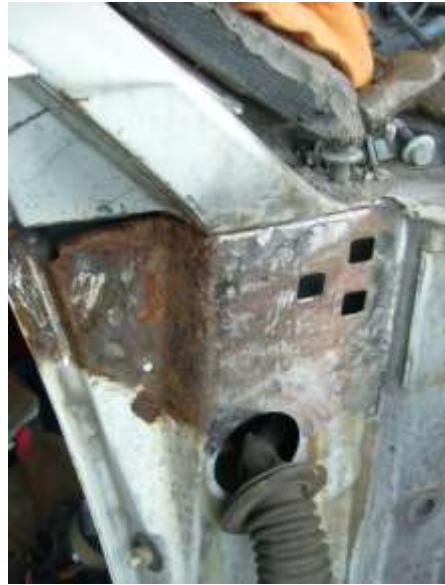
Worried about how deep the rust goes on that corner, so out it comes as one unit

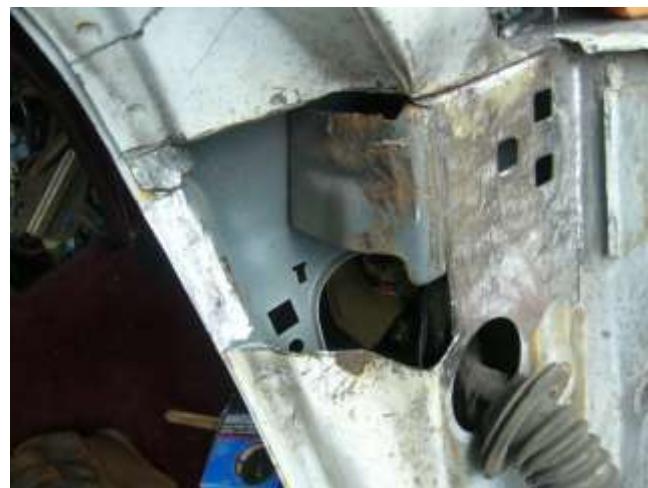
Heres the top of the panel removed

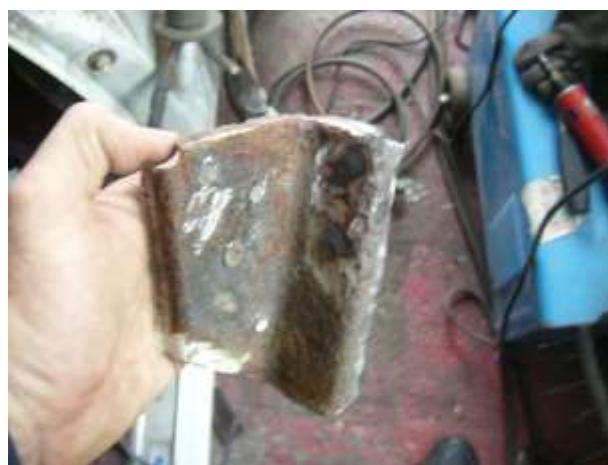
and the other side

Really surprising that it has only gone through in that one area.

New steel going in tomorrow.

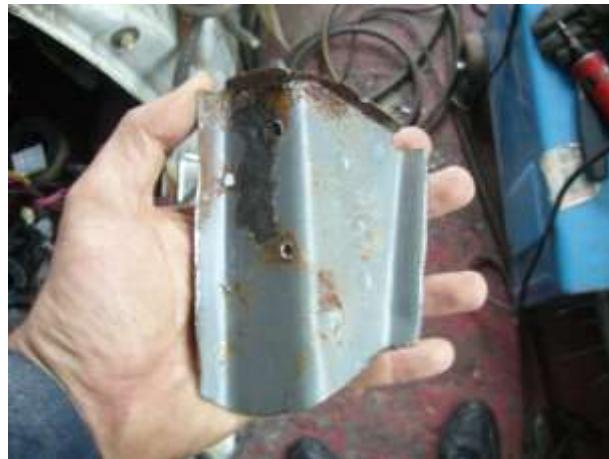
This was an interesting sight. Loads of media from the blasting I did over a year ago.

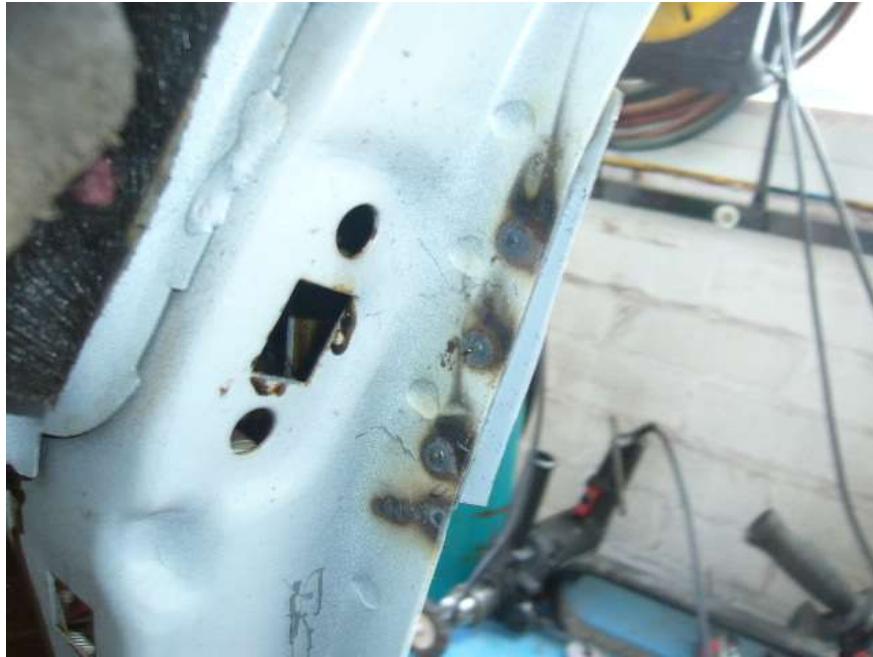
Heres where I think some water gets in to the A post. Here I am levering up the panel at the bottom of the windscreen revealing a gap where the sealant has gone.

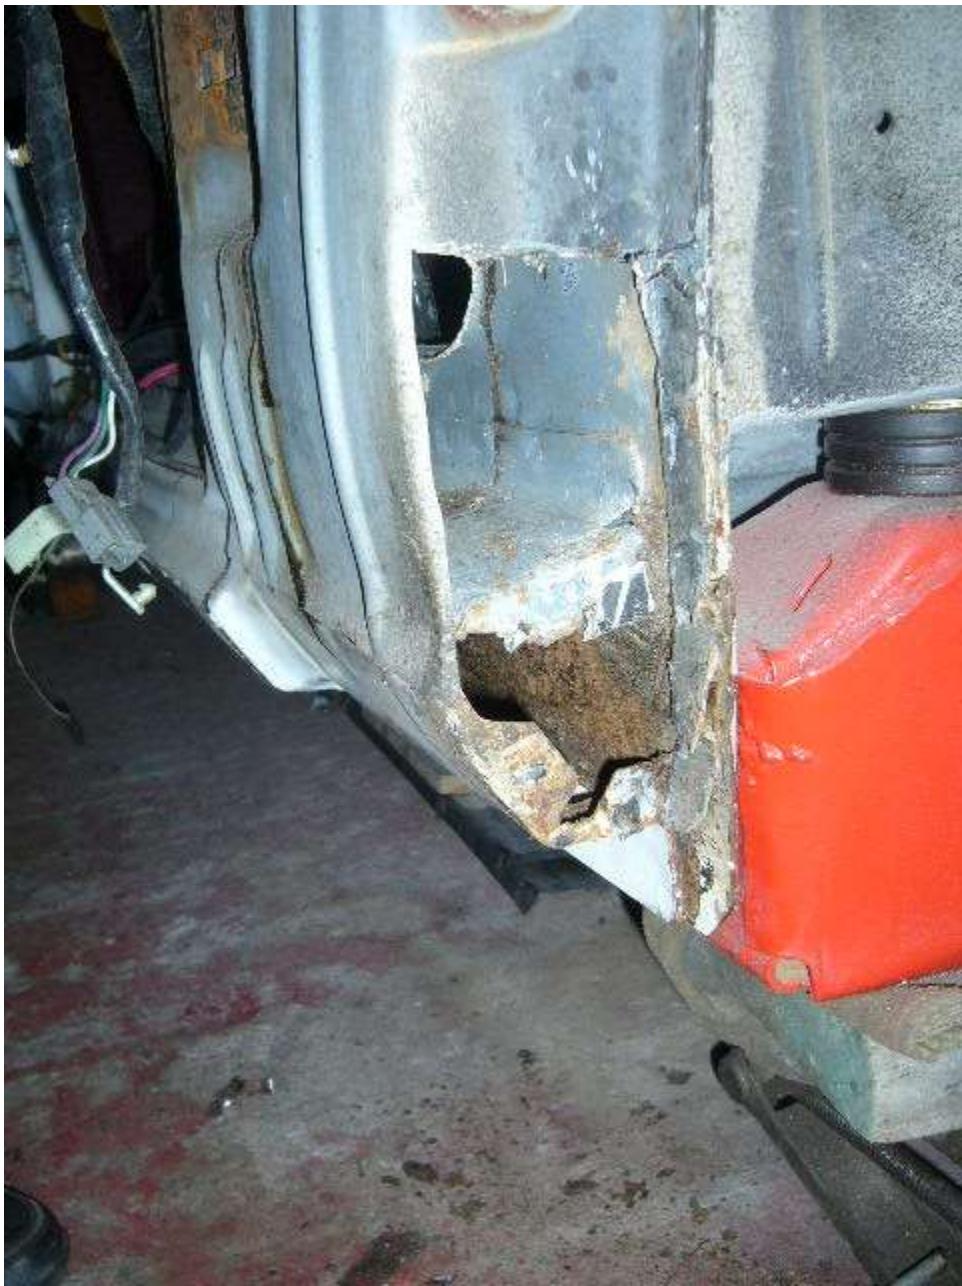
Onto the bottom of the A post. On the other side it was rotted out, so I thought I would cut this side out to check

Looks good this time but the inner rocker has some corrosion on that may need doing.

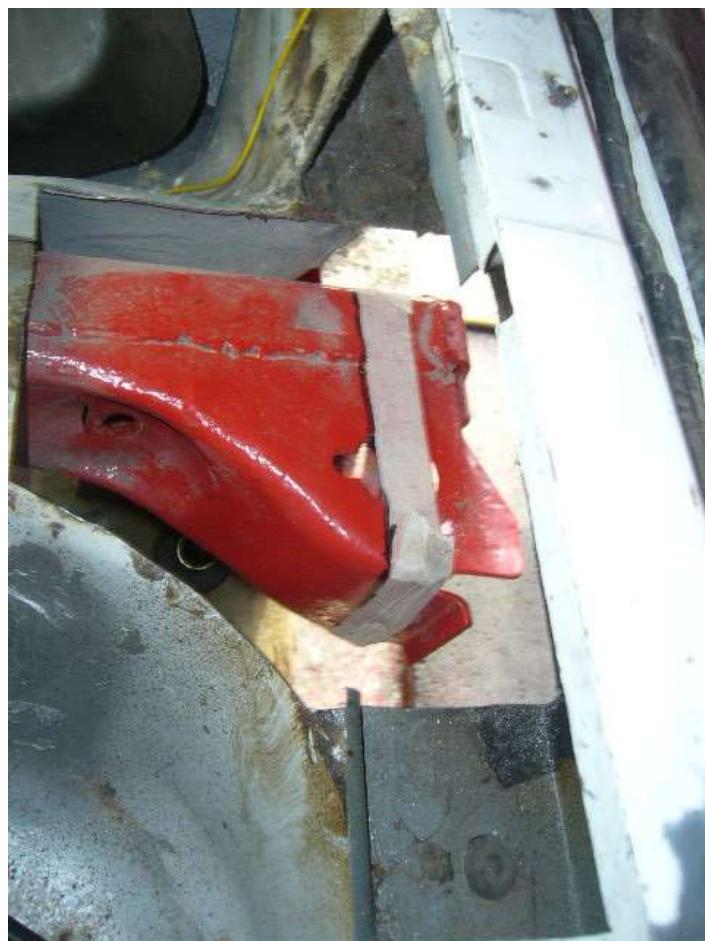
Chassis marked for cutting

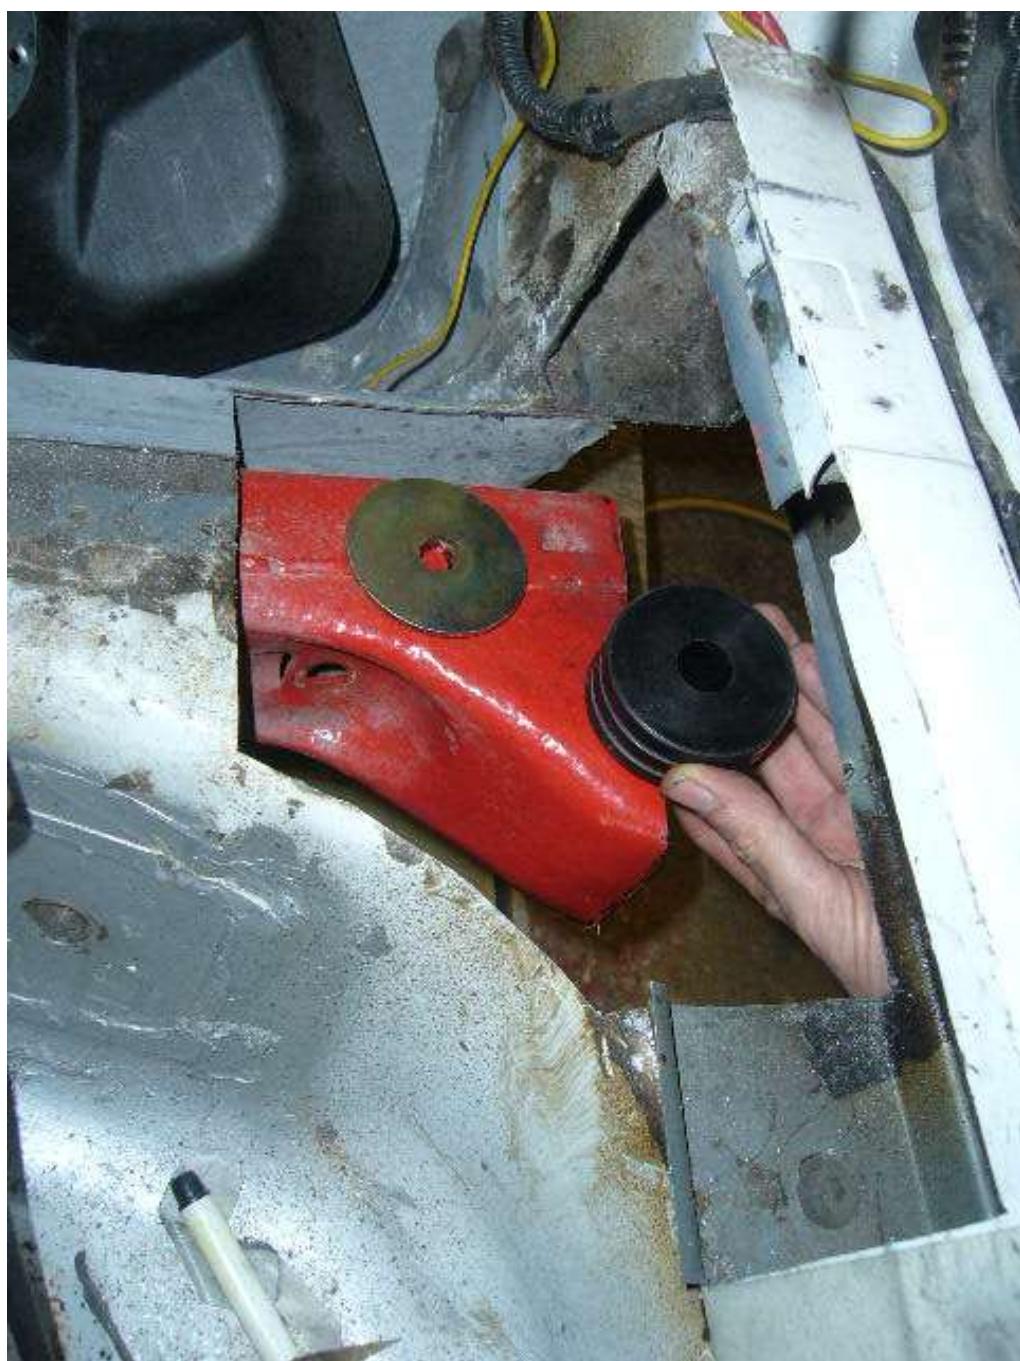
Heres the old mount position compared to the new position

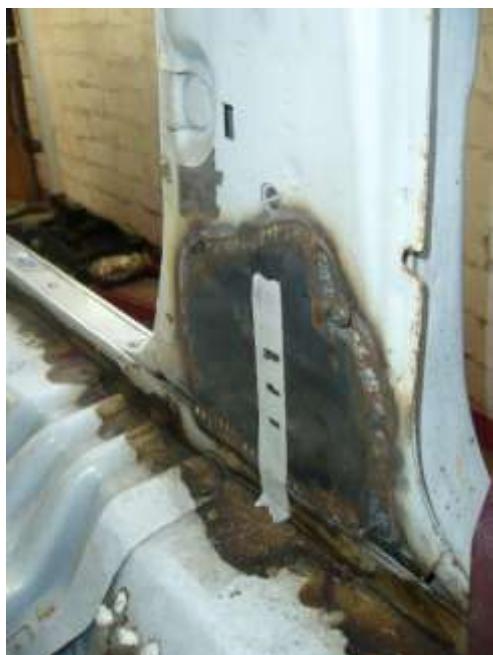
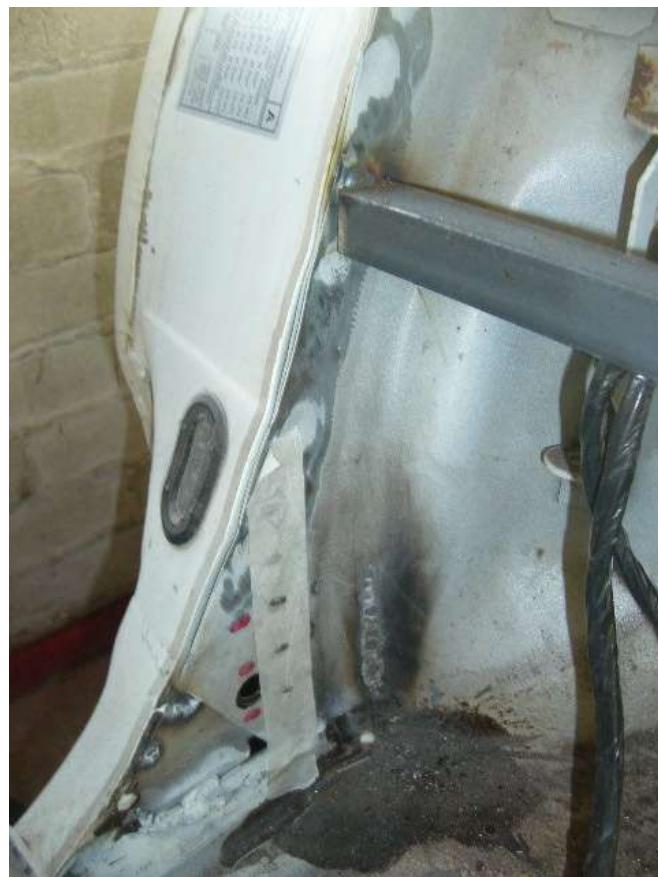
Here is the intended firewall cut - red line you can just about see.

I will cut out the steering column hole (red line) (can you cut out a hole?!!) and weld it back in later.

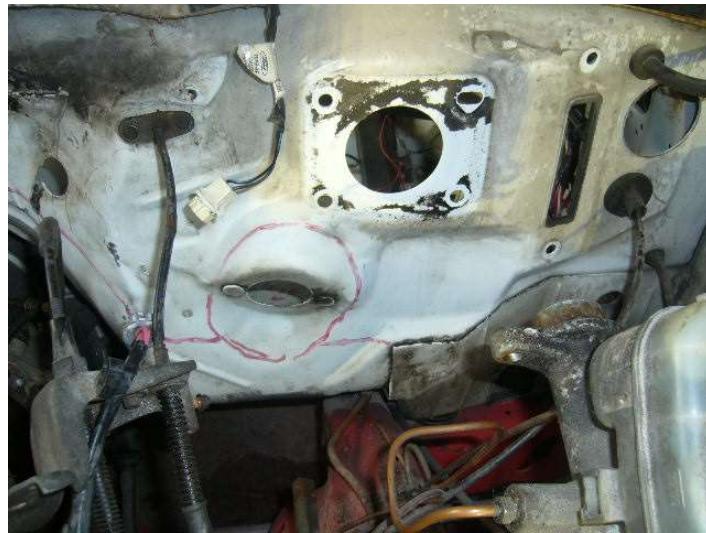
Here is the intended firewall cut - red line you can just about see.

I will cut out the steering column hole (red line) (can you cut out a hole?!!) and weld it back in later.

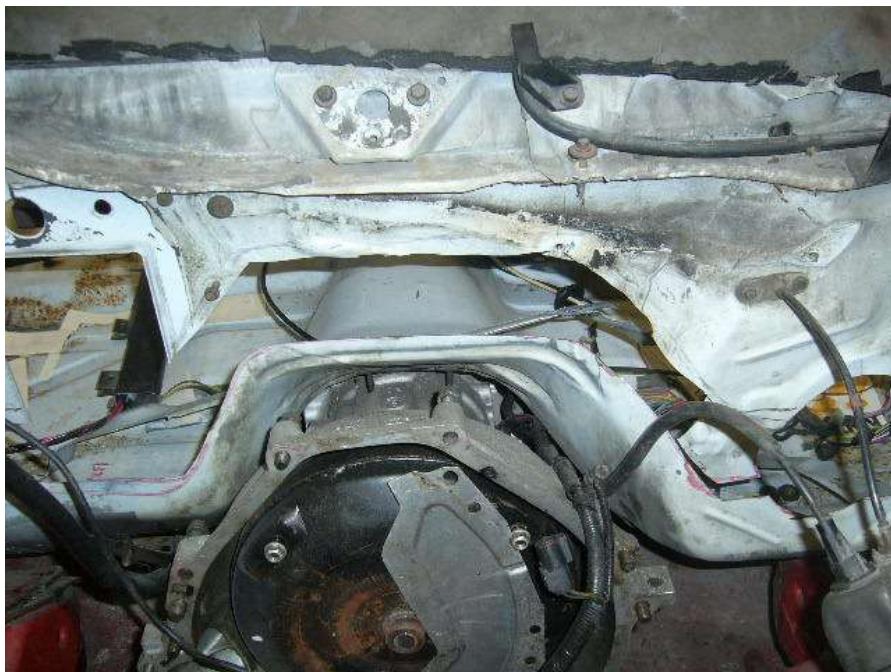
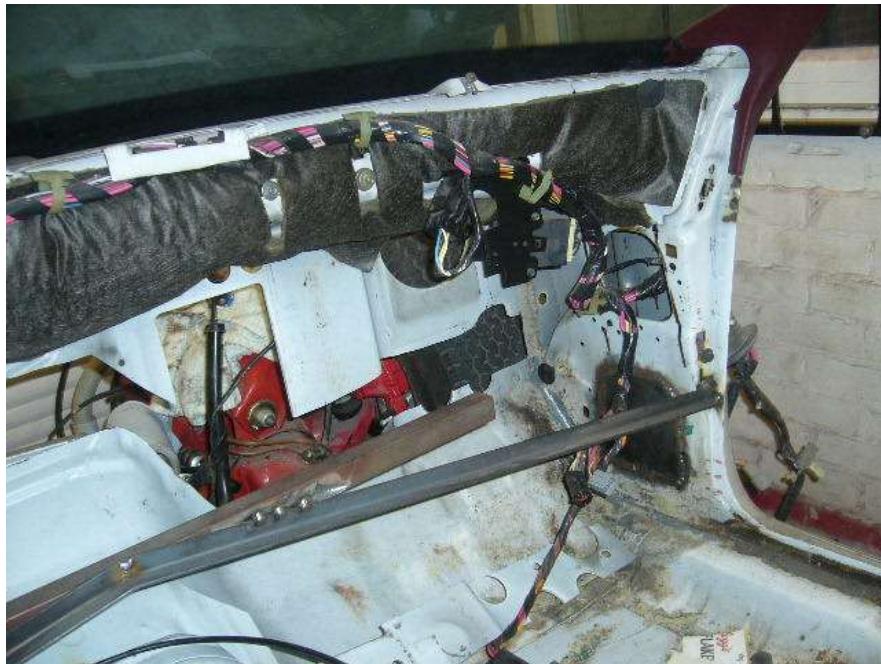
Here's a chunk of the firewall missing to enable the floor to move up 10cm.

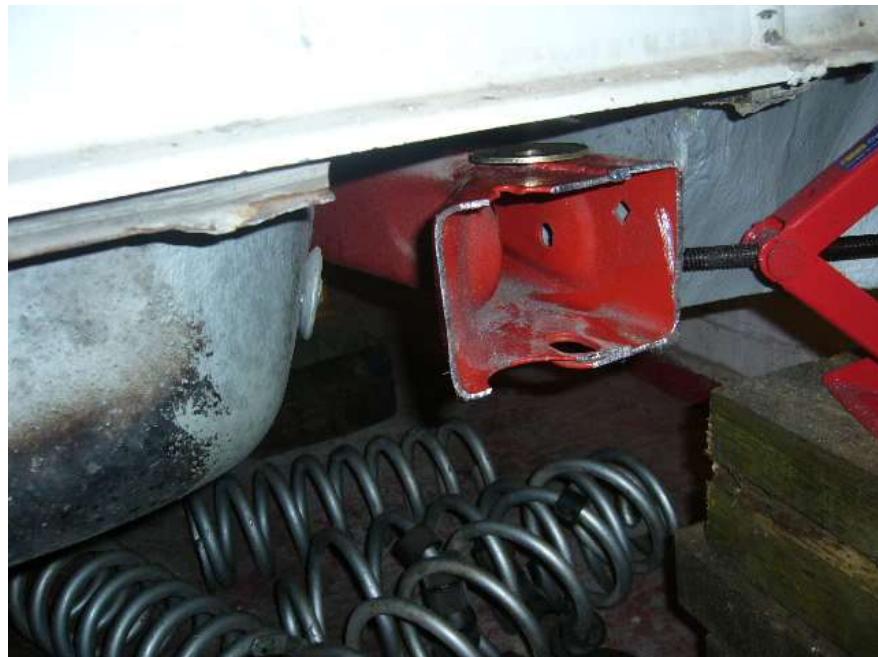
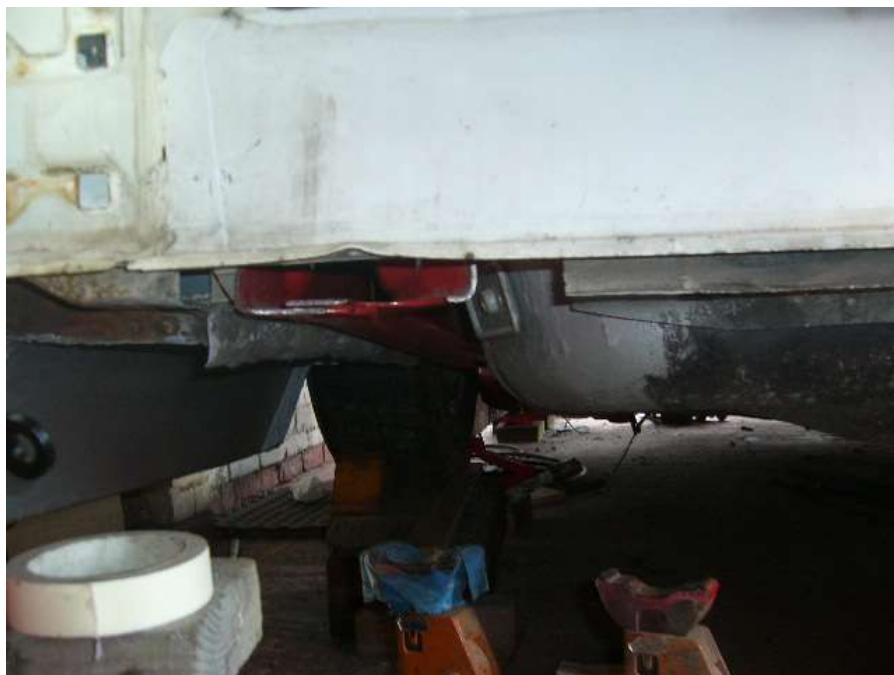
Heres a view of the rear of the frame legs before and after the body drop

This is how far the frame sat below the rocker panels before the body drop

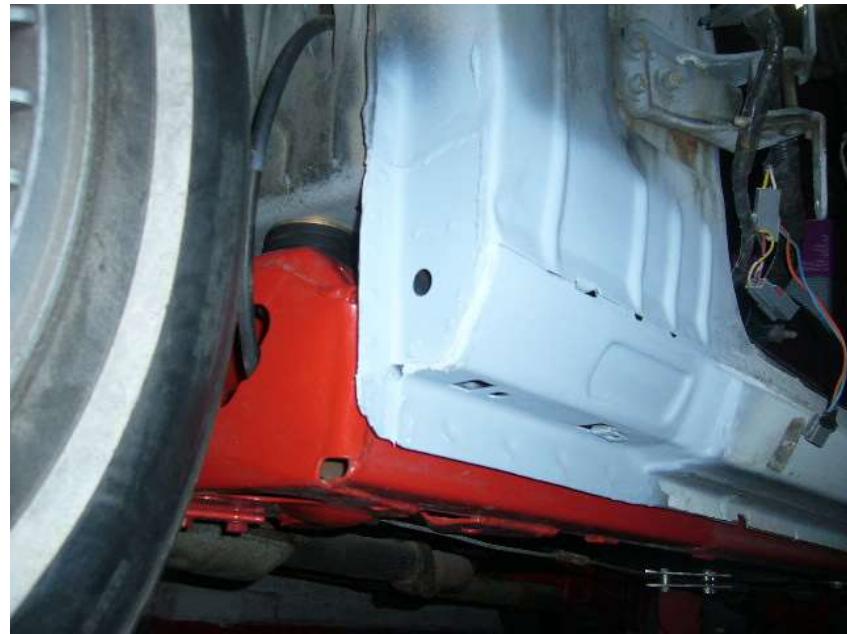
This is where the frame is now

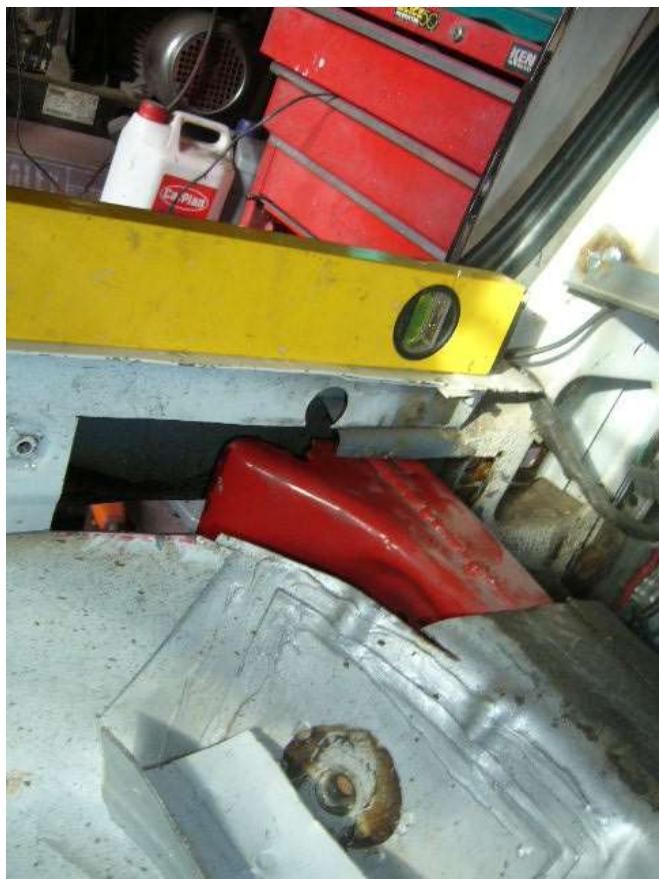
Starting at the back (because this is the hardest part!). Heres a view of the back left frame rail

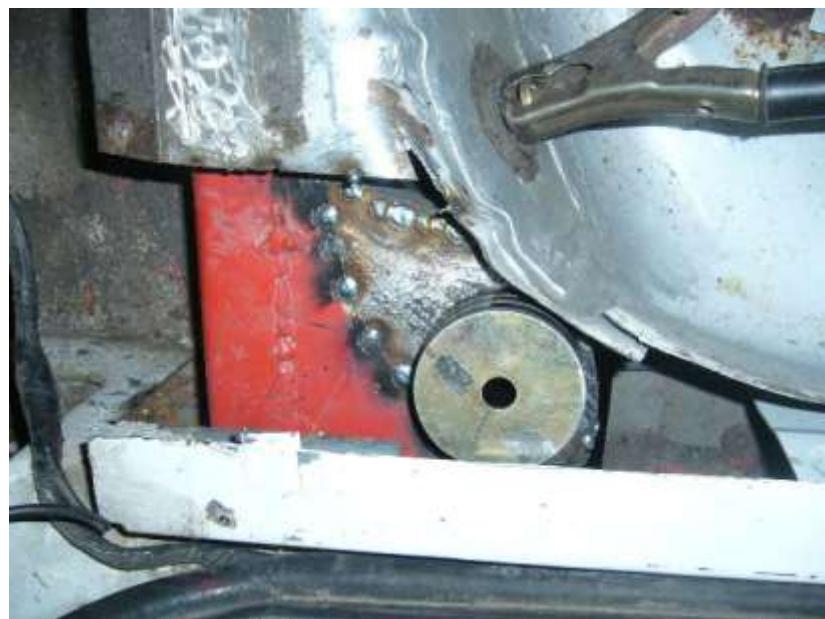
And here's a new mount tack welded in in a new place

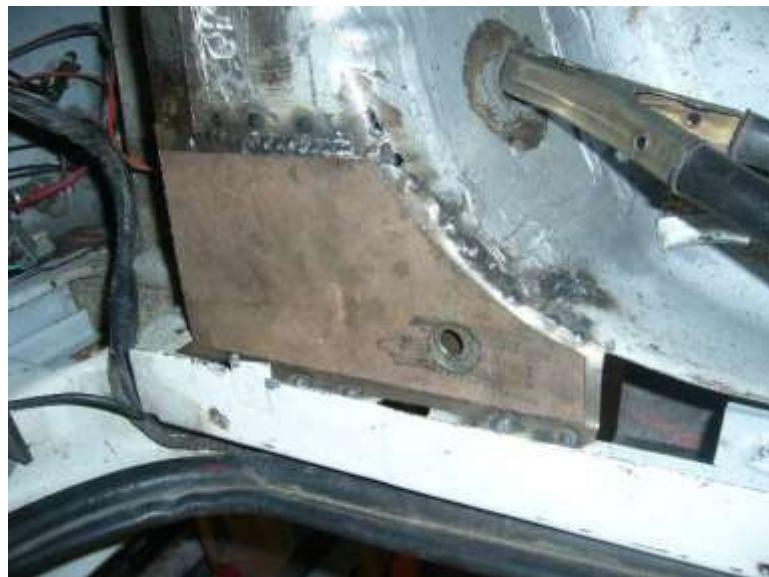
Another layer fabricated to go here
