Project Big Ford

Ford LTD Crown Victoria LX Country Squire

September 2009

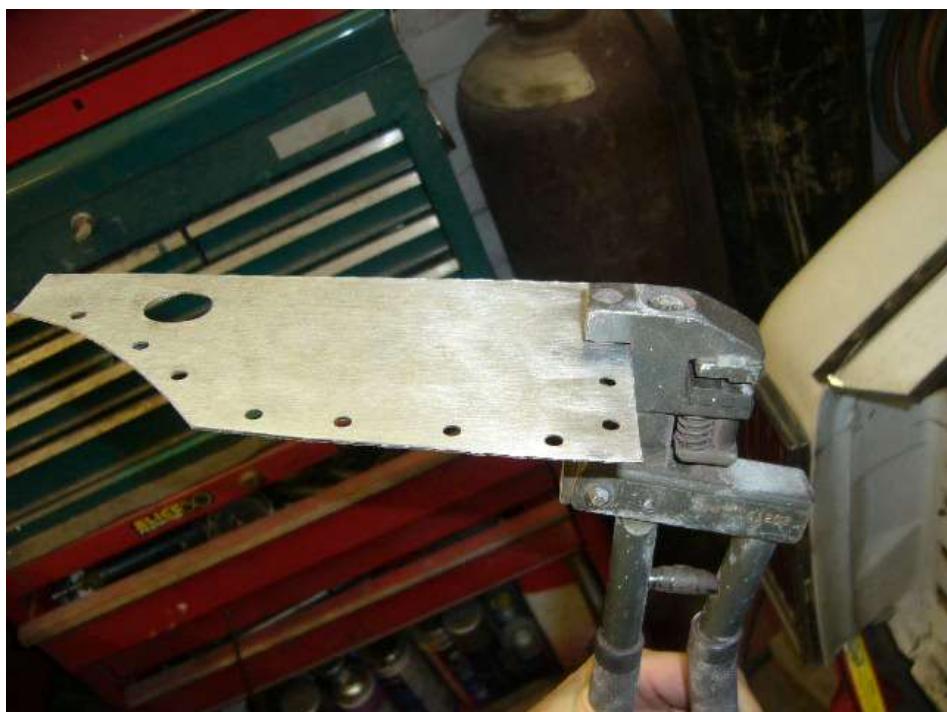
and holes punched in it to spot weld through

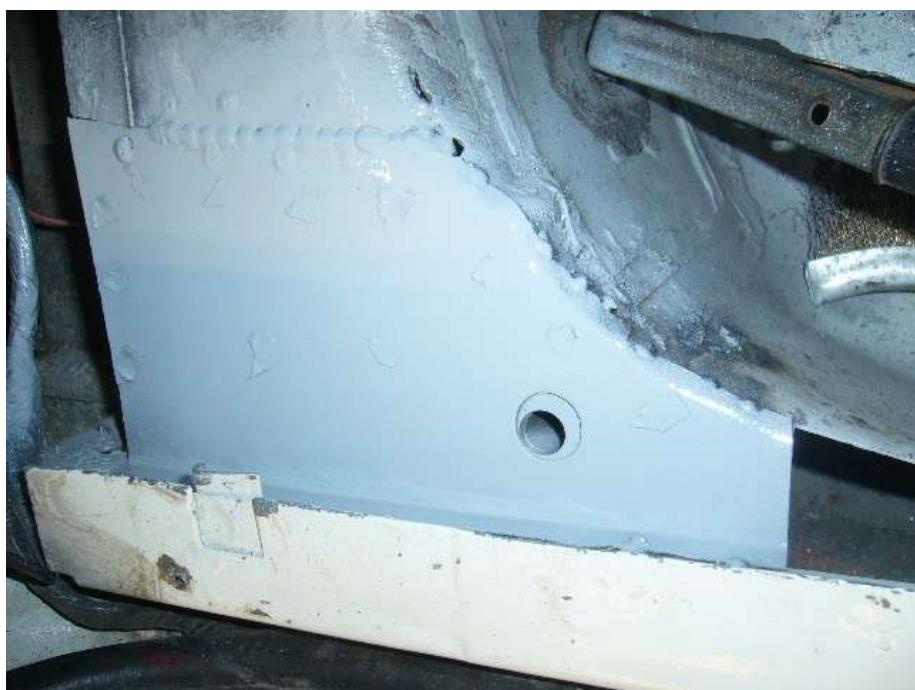
Masking tape put on where welds are going to be and etch primed on both plates and welded in

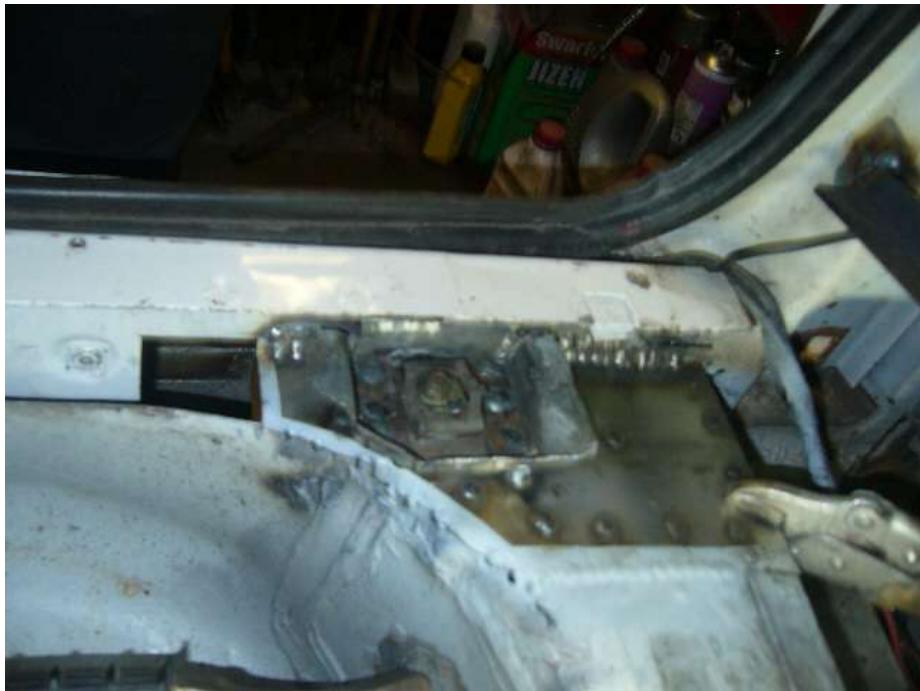
and welded in

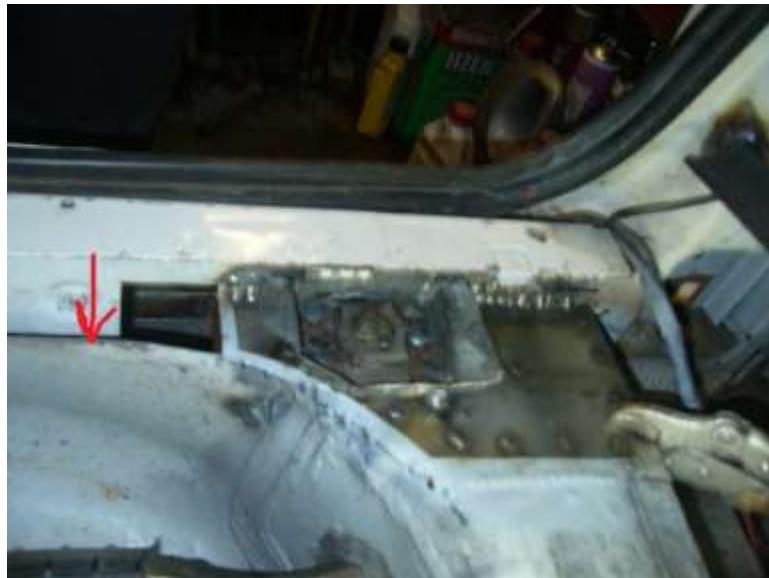
Here's where the rear floor ended up when it went further up into the body (red arrow)

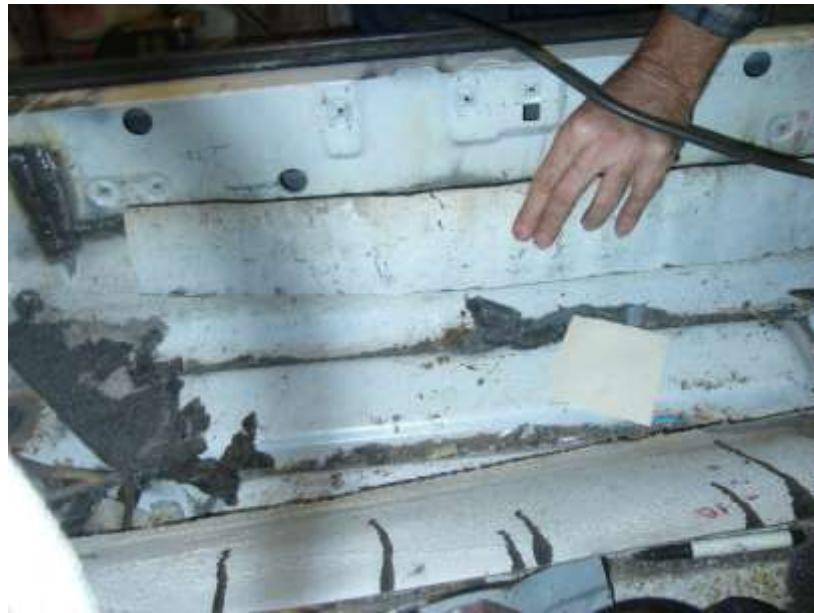
Here's the section I cut out (photographed it out of order!! Sorry.

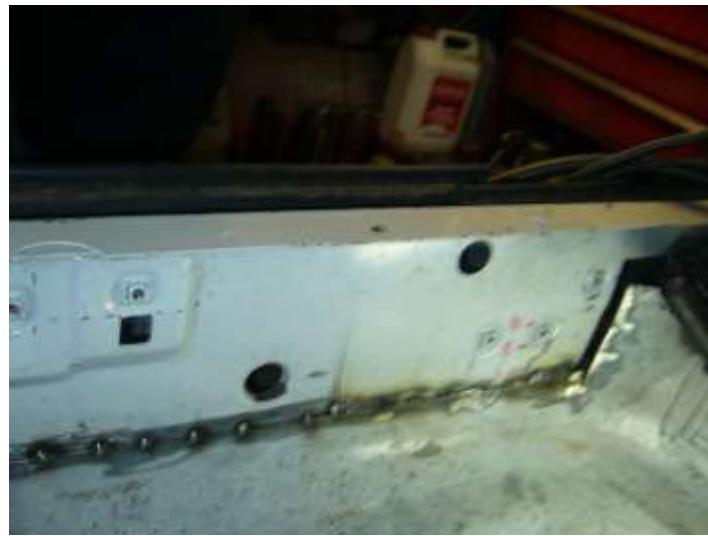
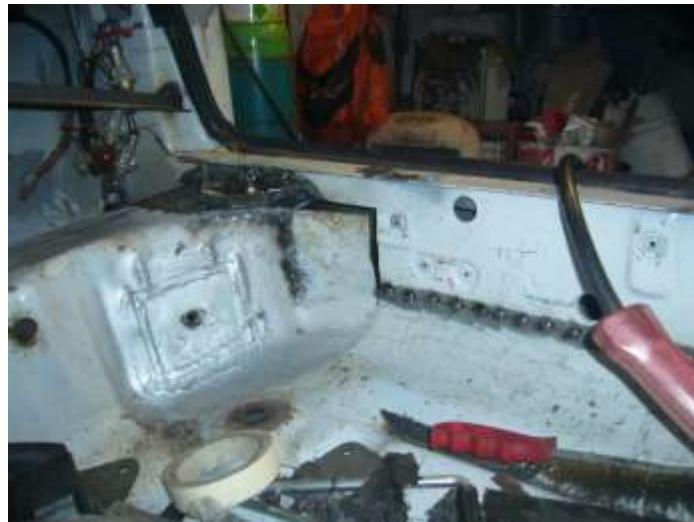
This is so I could weld it back further down

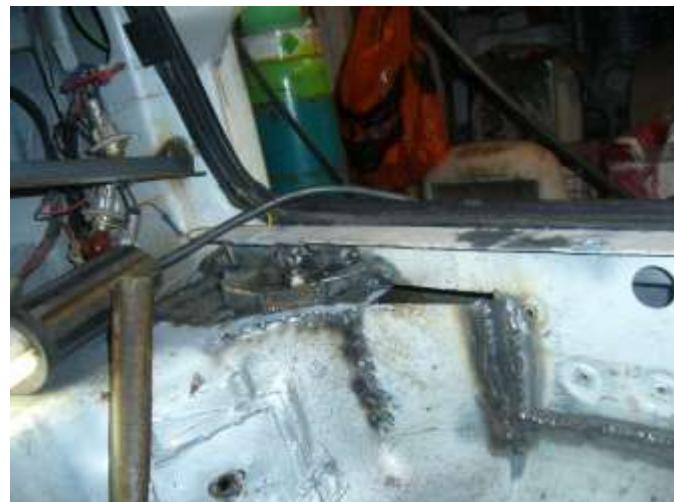
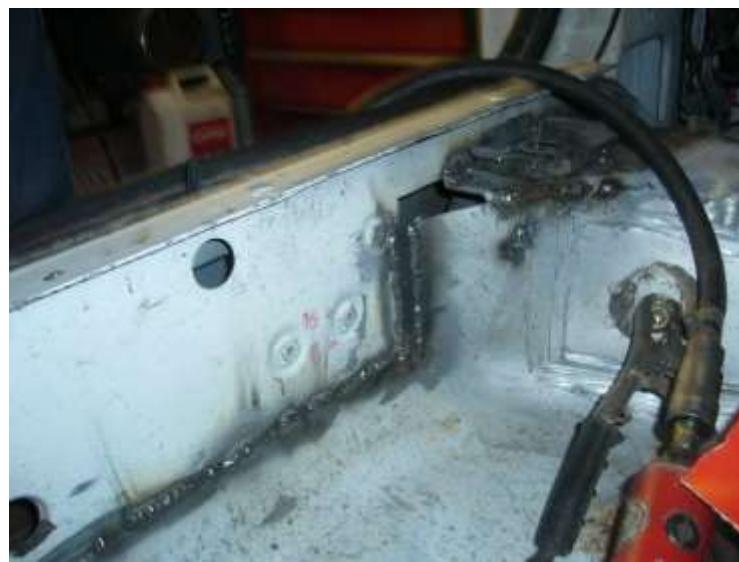
Here's a card template made of the new side panel being made to tie the rear of the car (D post) to the inner wheel arch.

Make it out of steel tomorrow.

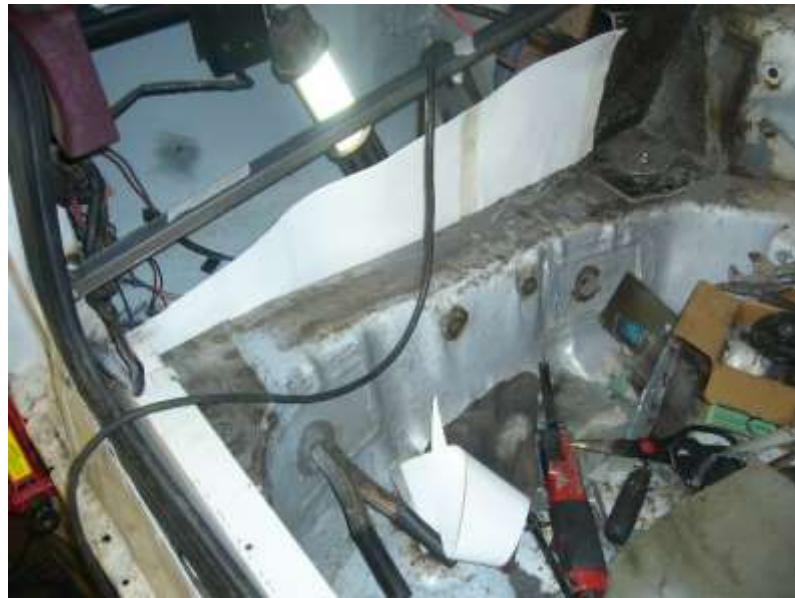
Trial fitted the side panel and a right angled strip

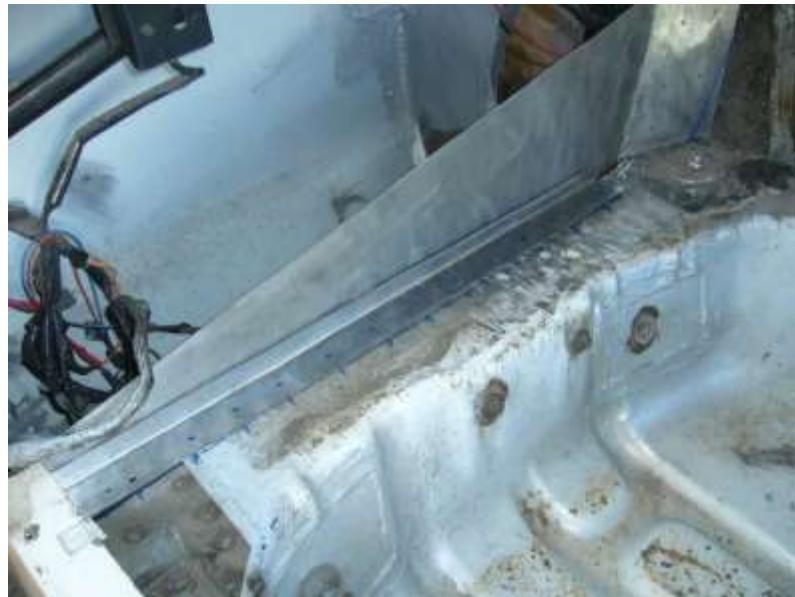
Strip spot welded in on top of rust proofing fluid that has now flowed all over because of the welding heat

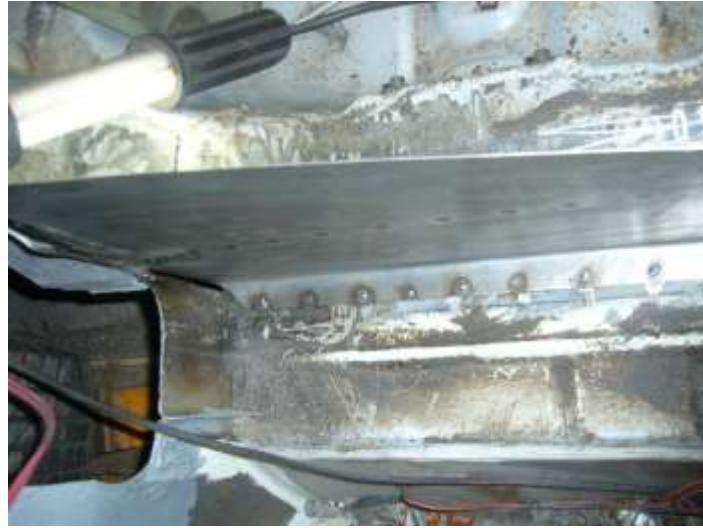
Starting to close off the side section with the boxing in of the frame captive nut

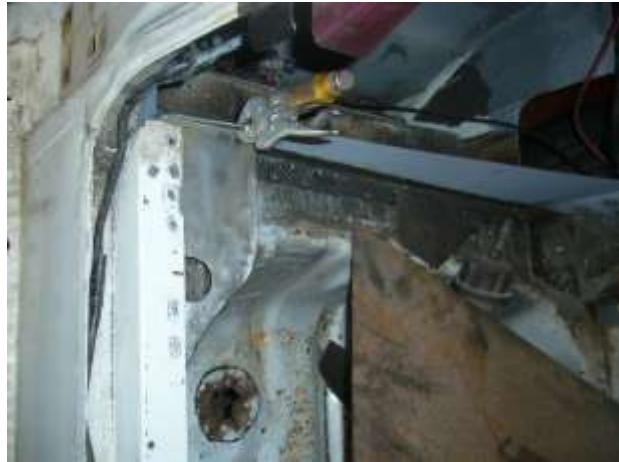
Top section made and clamped in place. This will be spot welded and plug welded in- but not before sealing it all inside with rustproofer.

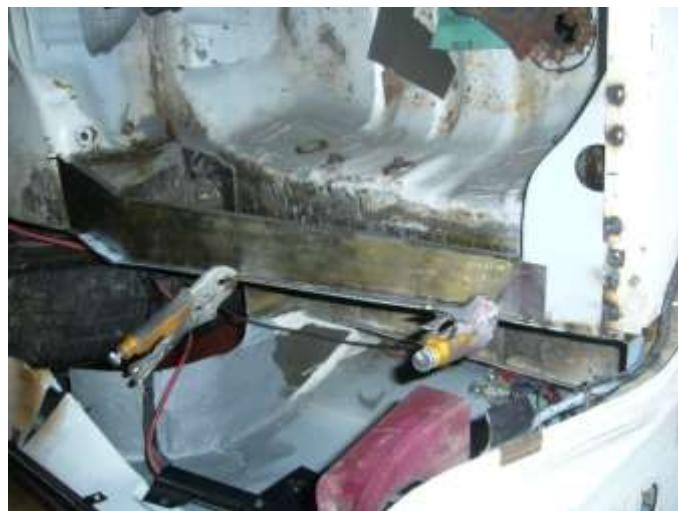
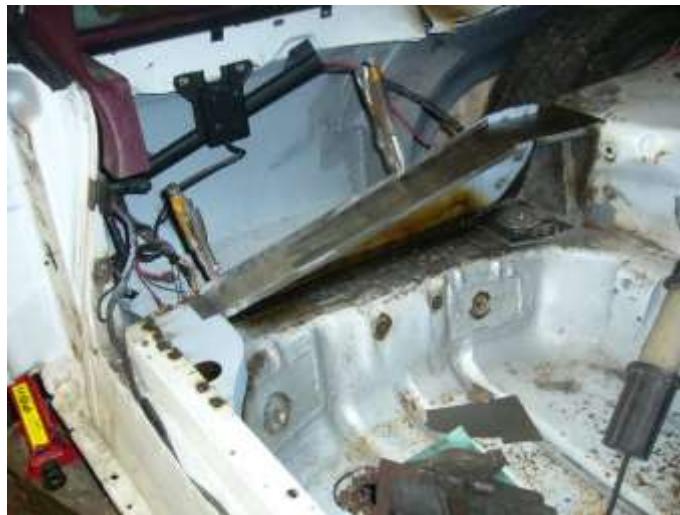
Here's the closing off side section and the top being spotwelded together

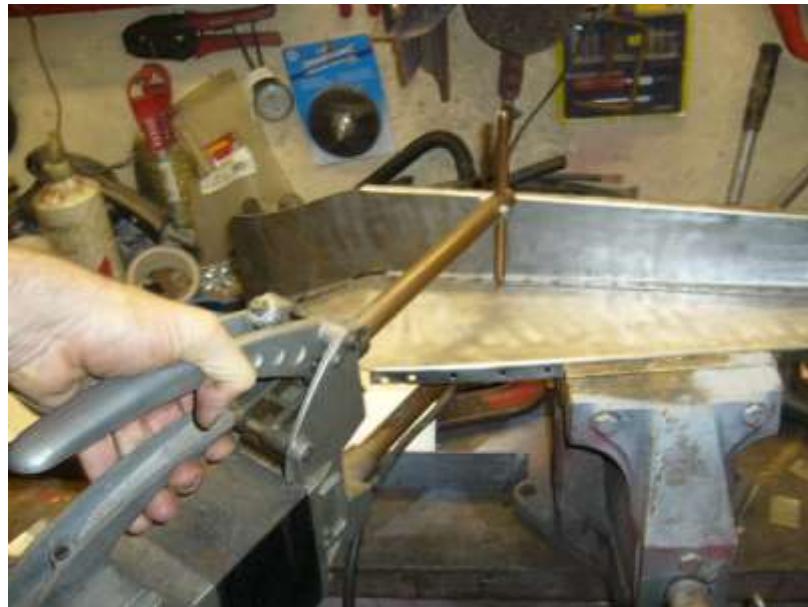
And the finished product

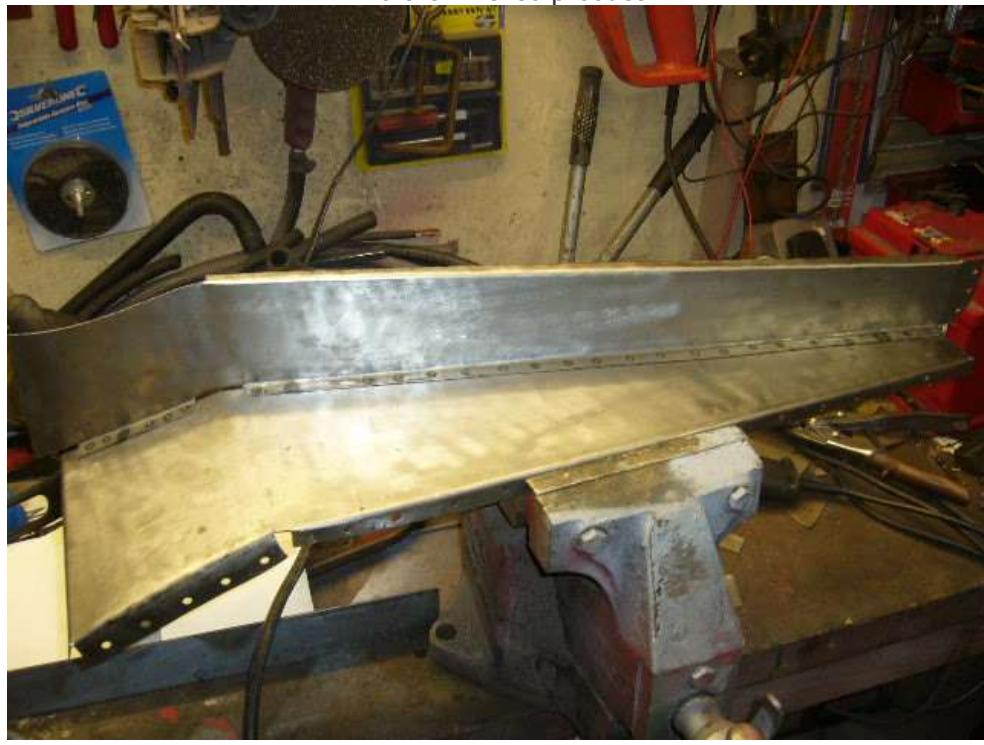
Here it is in place as a quick check for fit

Tomorrow it will be removed and seam sealed inside and etch primed, then fully rustproofed before finally welding in.

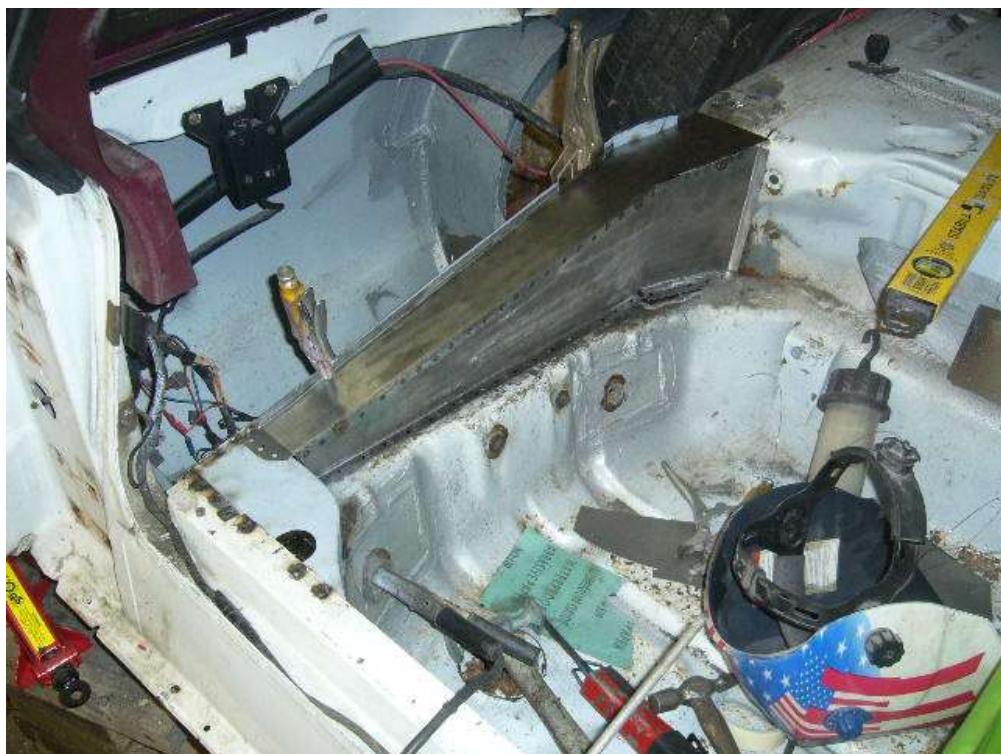
Rectangular body mount access hole cut out and edges flared to retain some rigidity.

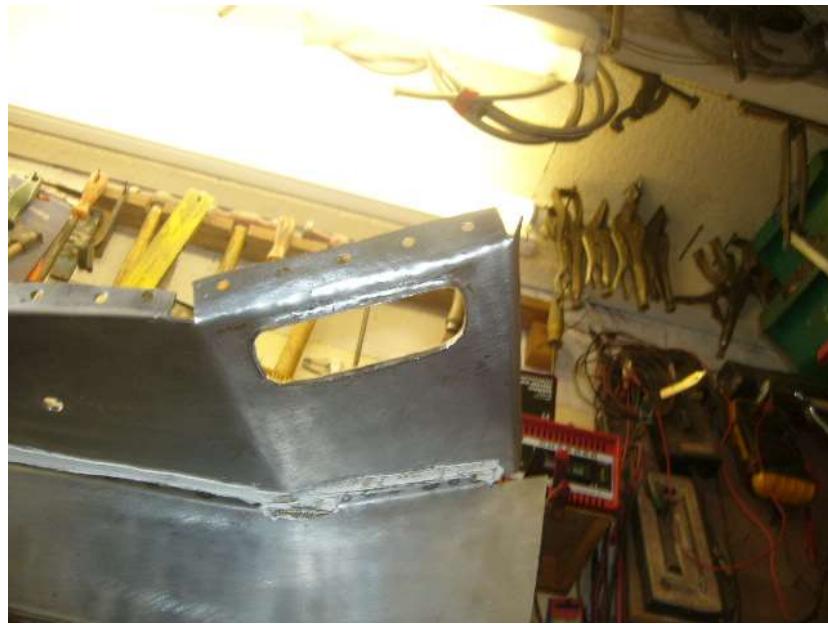
3 more access holes created by my sheet metal punch

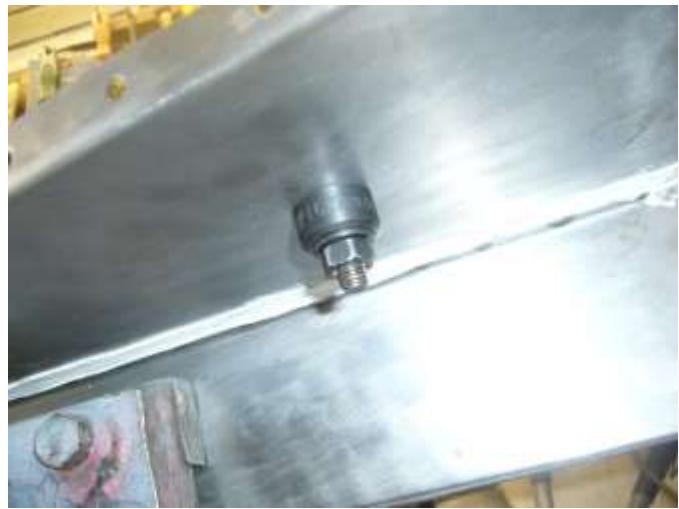
Welded joints seam sealed and inside of panels etch primed and painted white for rust protection once it is all welded in and inaccessible

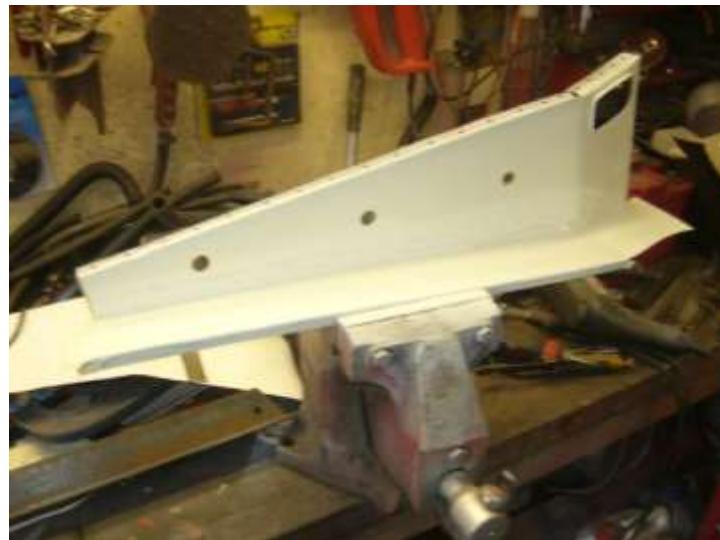
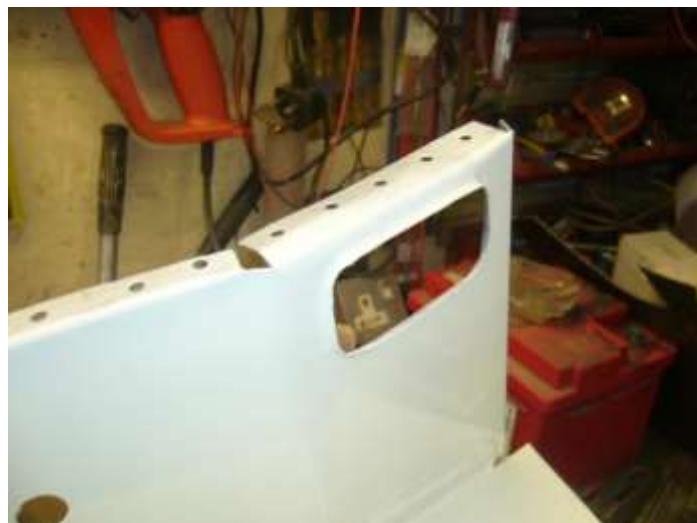
All welded in...

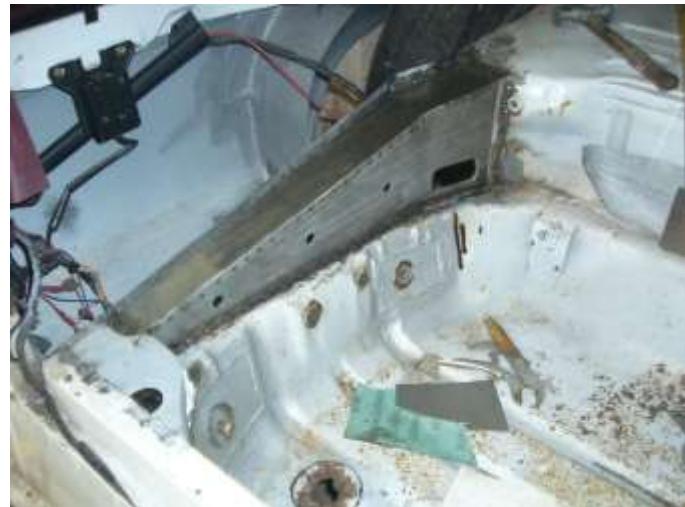
In this shot you can see the edge of the floor and where it has been cut from the rest of the body

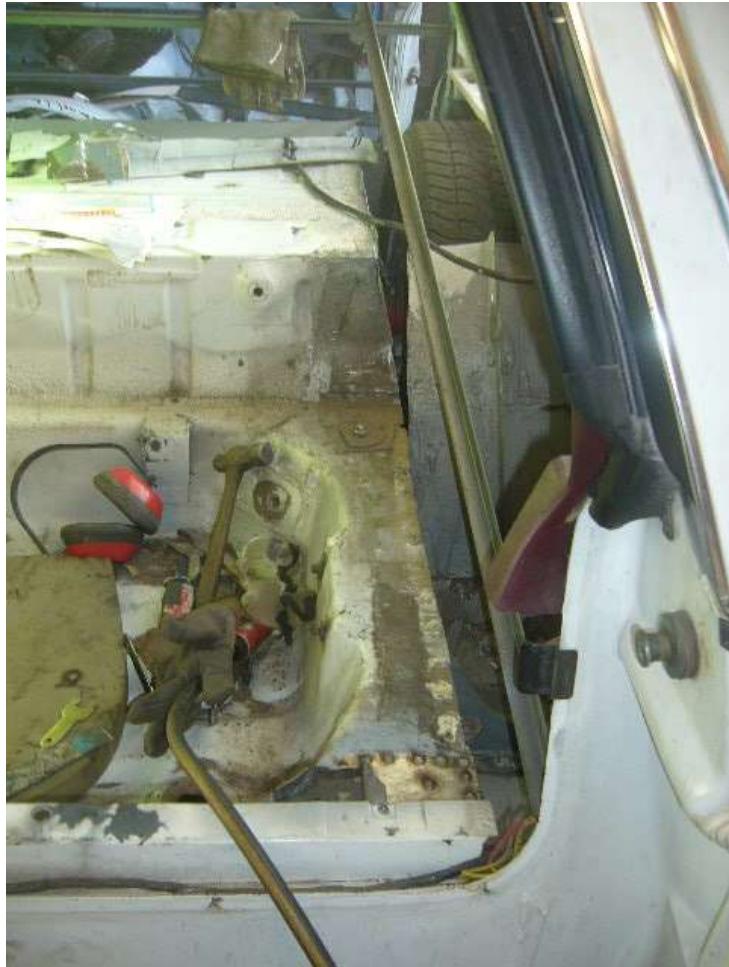
Heres a view from above that shows how much of a gap I have got to fill! Its taken from the top downwards if you are trying to figure it out

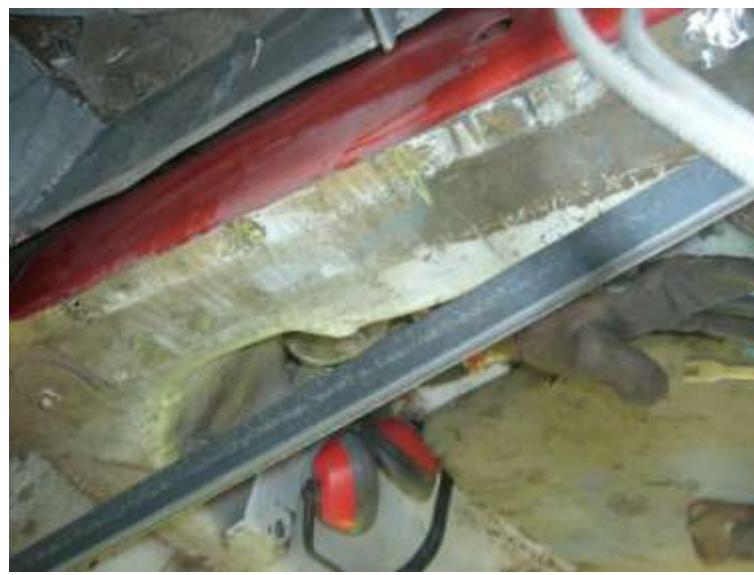
Heres the first side panel made up to fill that gap and a right angled section spotwelded on for

the floor to be welded to

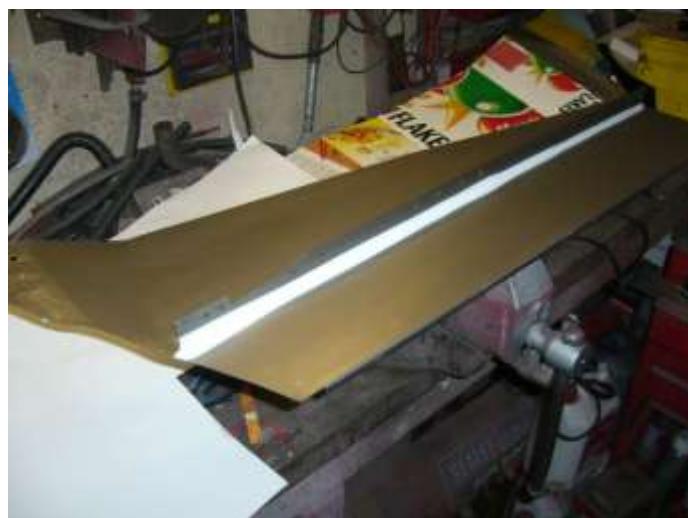
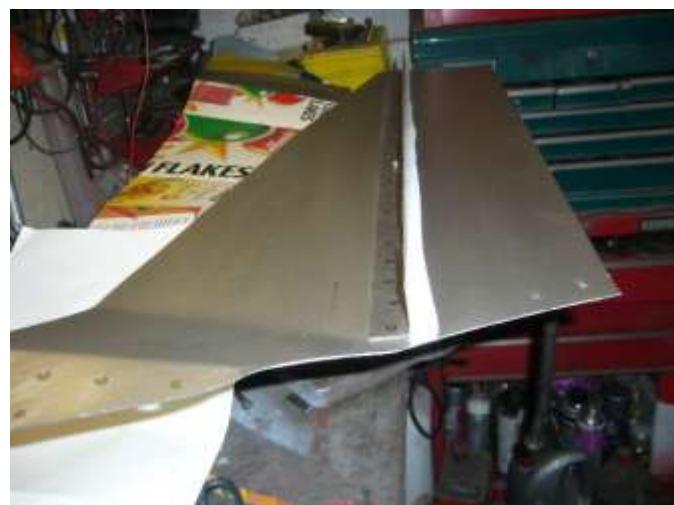
Welded in and thoroughly rustproofed before anything else

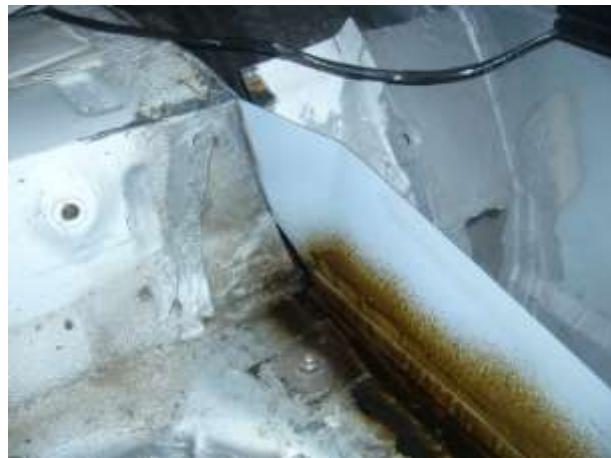
Cardboard template made up for next section

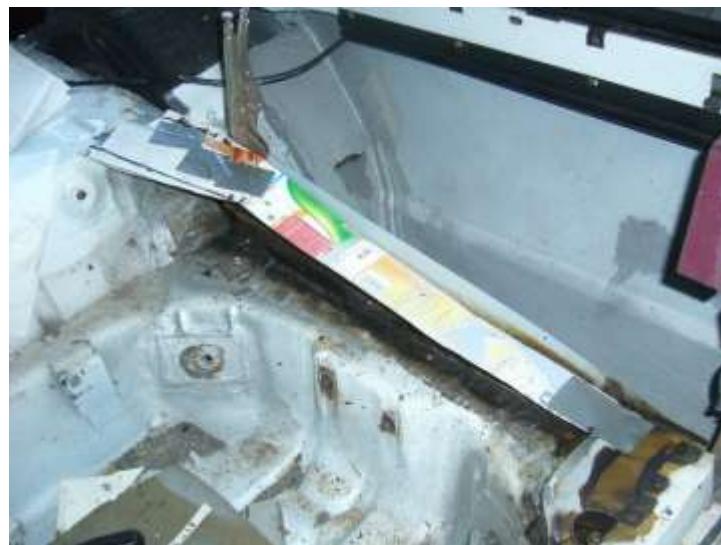
Transferred to steel and here is how I put the right angled bends in

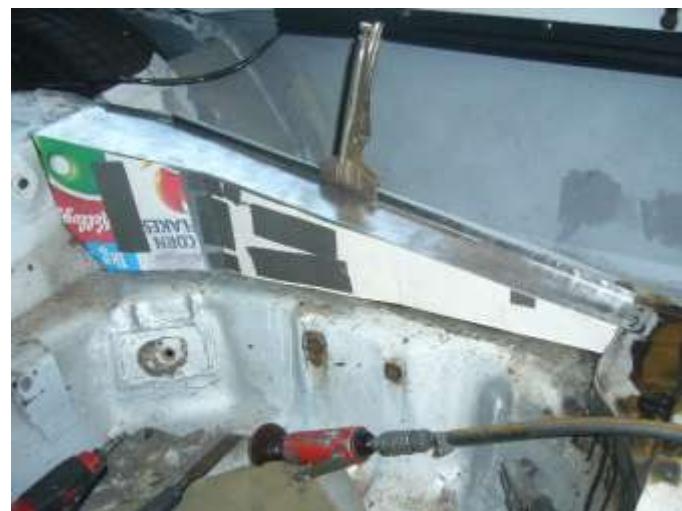
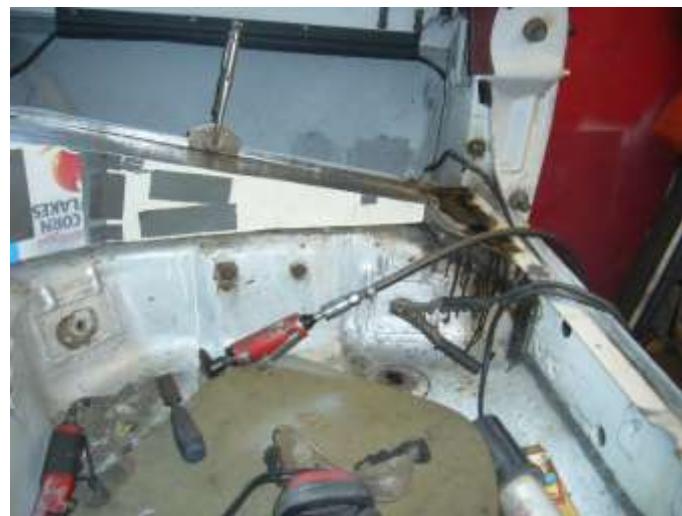
New steel cut and shaped and offered for trial fit. Not bad!

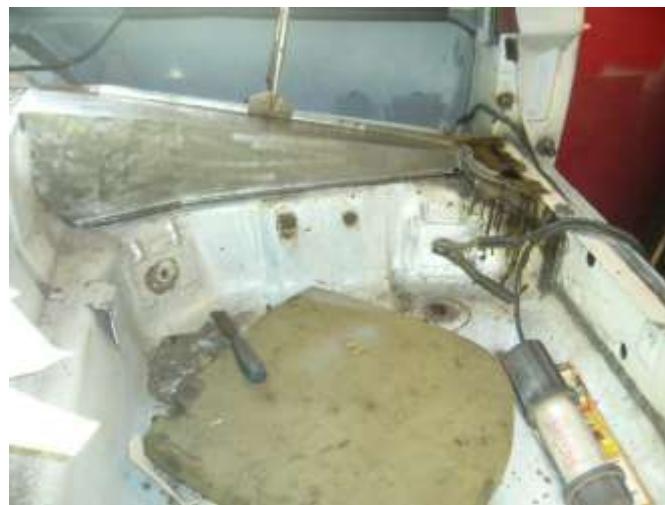
Now needs the body mount access hole and rustproofer access holes. Here is the way I get the flares on the corners...with a 3/8" extension bar and a hammer! And some mole wrenches to start the bends off.

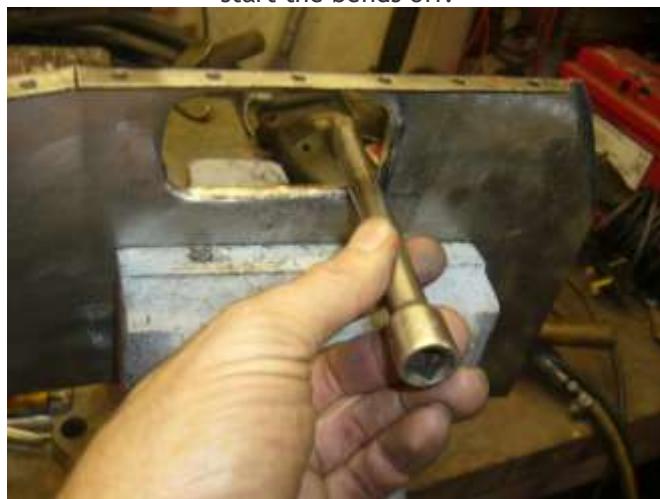
Before it gets welded in the whole interior section gets further rustproofing and the new steel gets seam sealed, etch primed and painted white (spare colour left from previous touch ups when the car used to be white!!

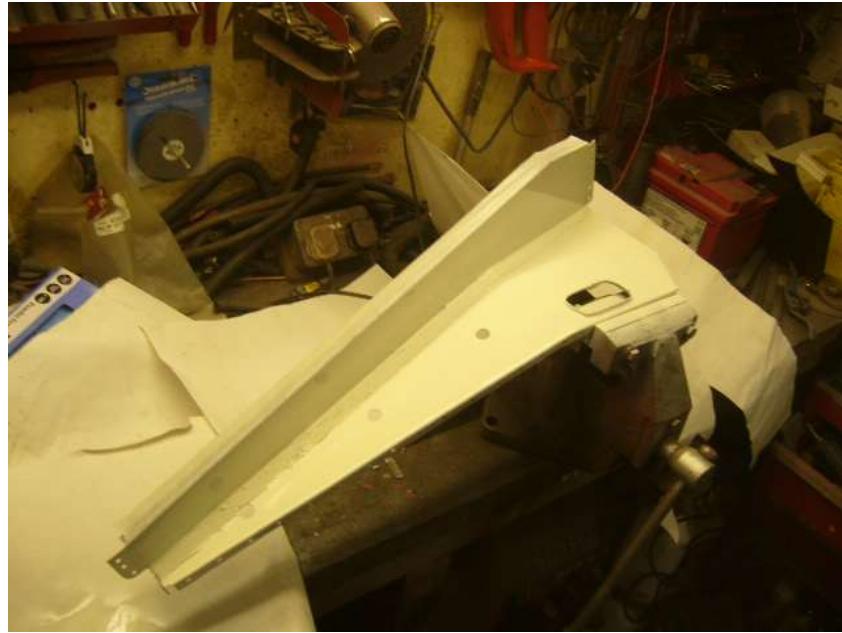
Finally finished welding it in! And loads of rustproofing injected inside.

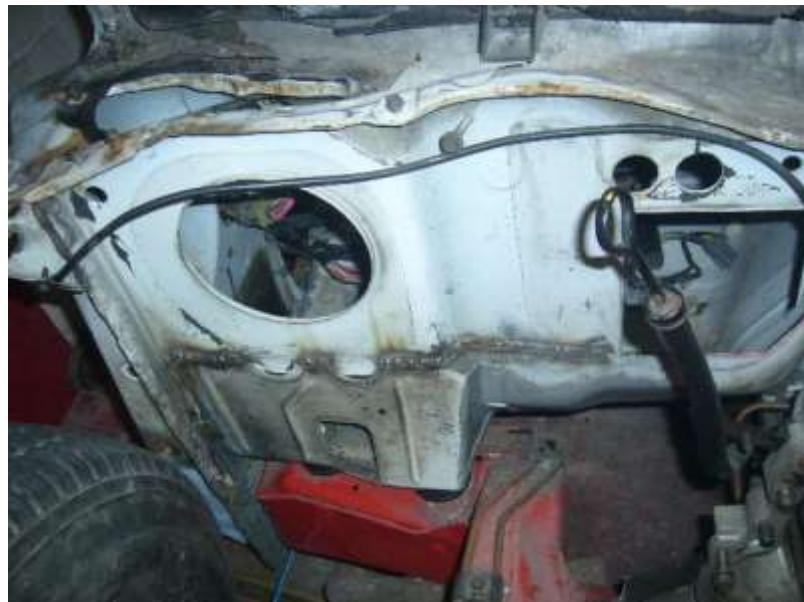
Ran a few short welds so far on the passenger side.

Have to be careful here because I am welding galvanised steel and it gives off small quantities of cyanide gas! I'm trying to grind the coating off where I can before welding.

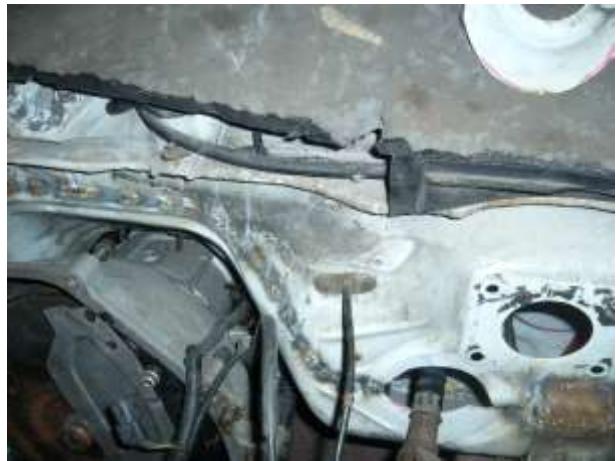
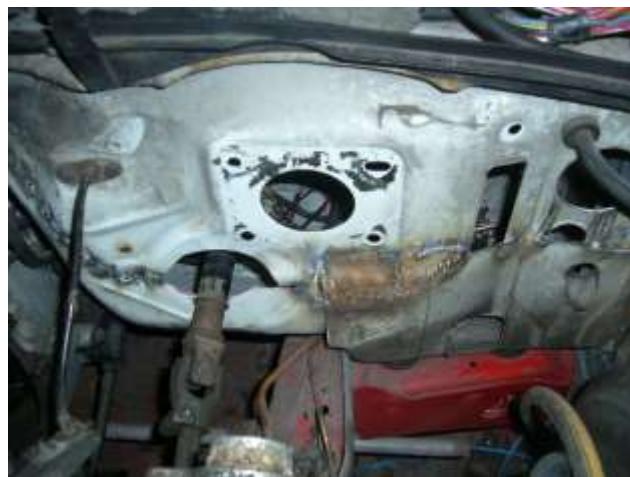
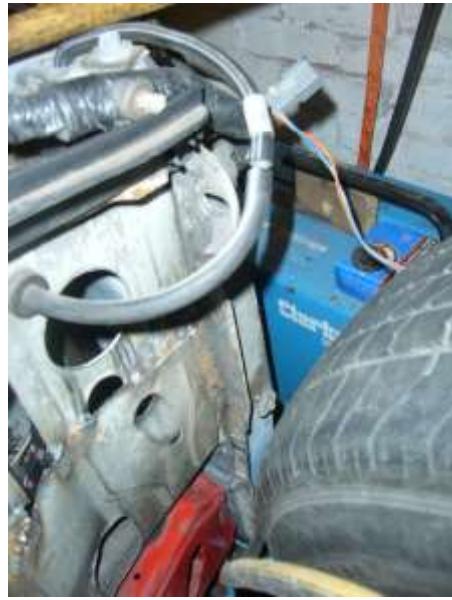
Firewall tacked together and gaps filled in at the side and just under the servo lower holes.
Excuse the rusty appearance, I've not cleaned it up yet!!

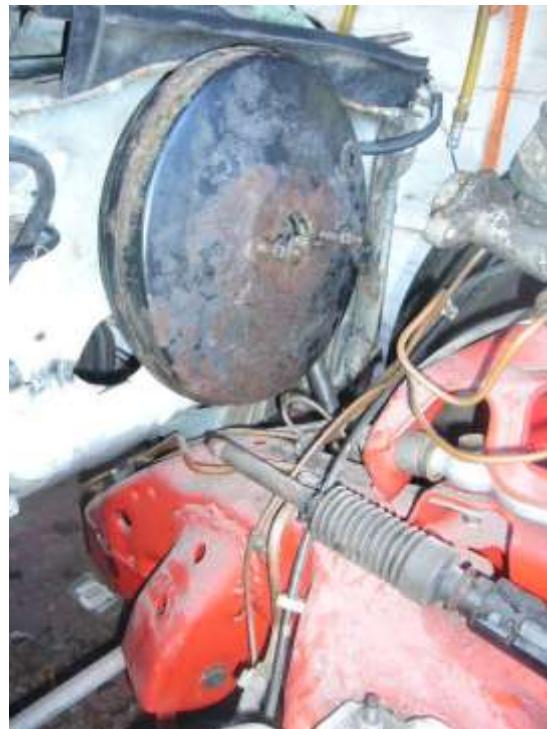
Heres a view of how far the servo has gone down. It is very close to the brake pipes, but still fits.

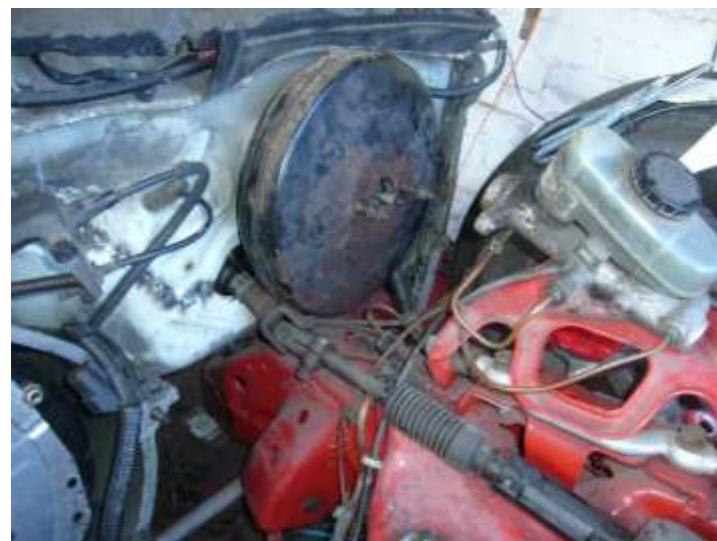
The steering column intermediate shaft goes through the firewall 10 cm further down than it used to do and I will have to make it JUST clear the servo and modify the shaft to work.

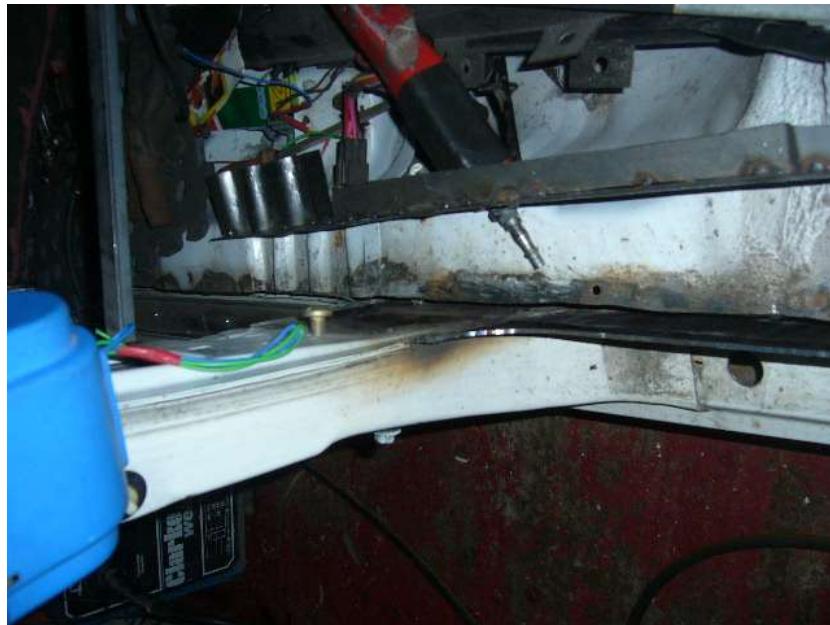
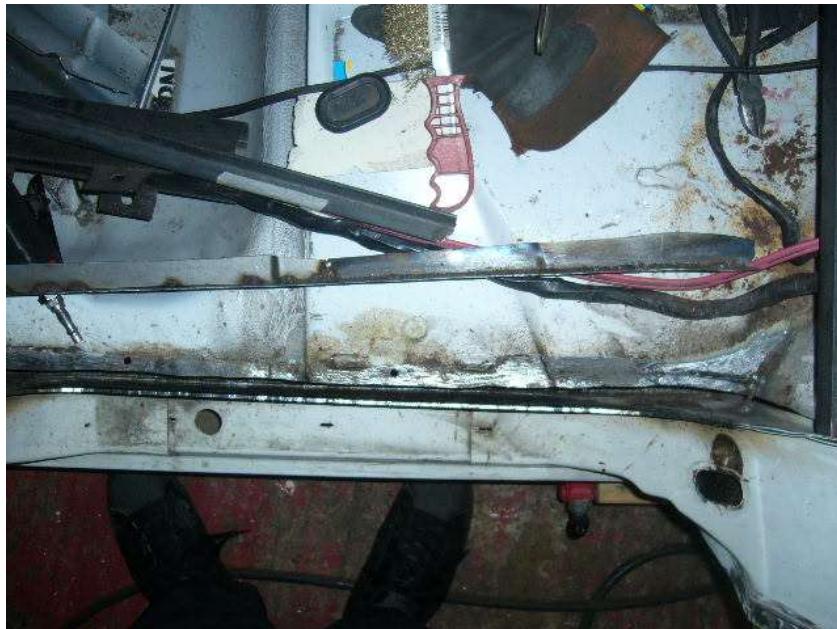
Started to close the gap between the rockers and the floorpan on the drivers side.
Hope you all can understand this but here is the gap

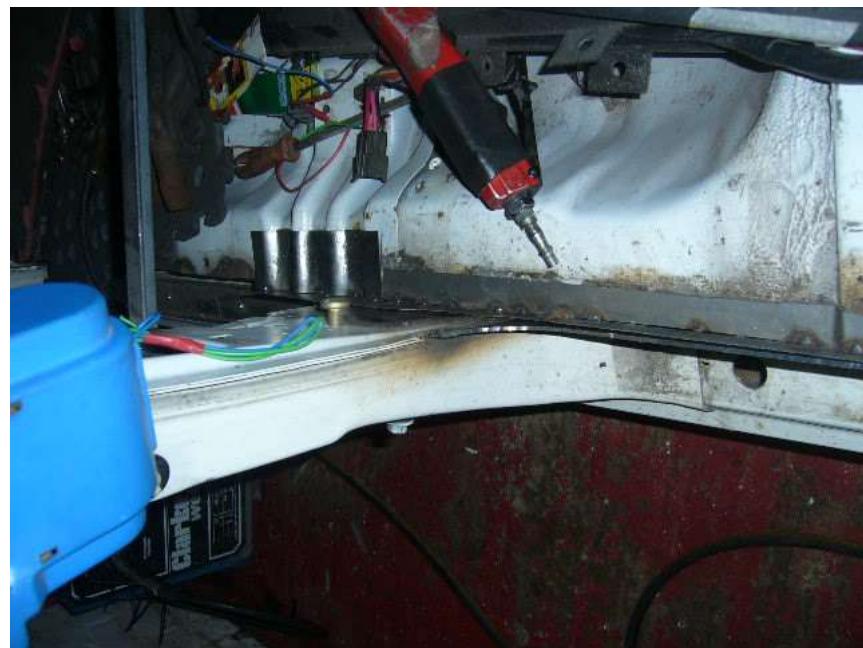
Here's a patch welded up to go in that gap

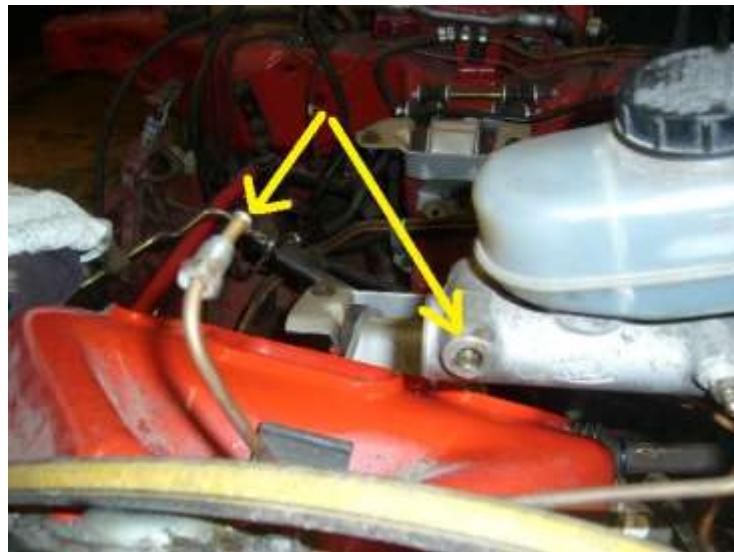
This photo shows how far the master cylinder has moved down!

Bolted the servo back in and shortened/rebent/reflared the pipes to it. But not before cleaning up the rear of the MC and associated hole in the servo with files and wet and dry.

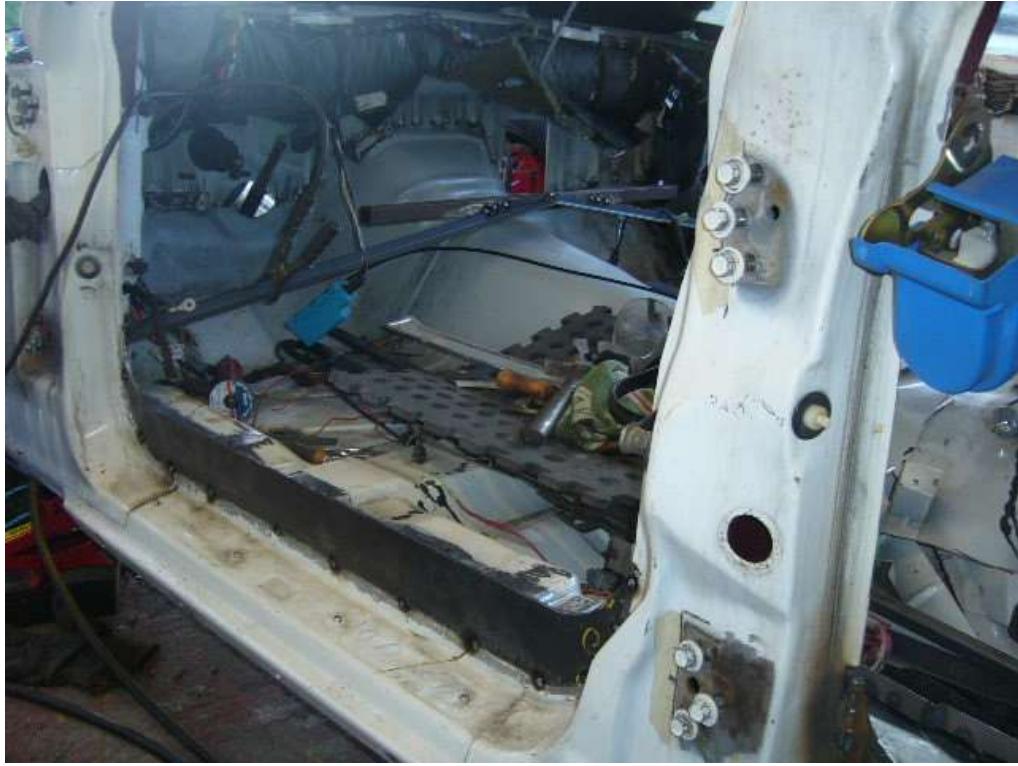
to fit here

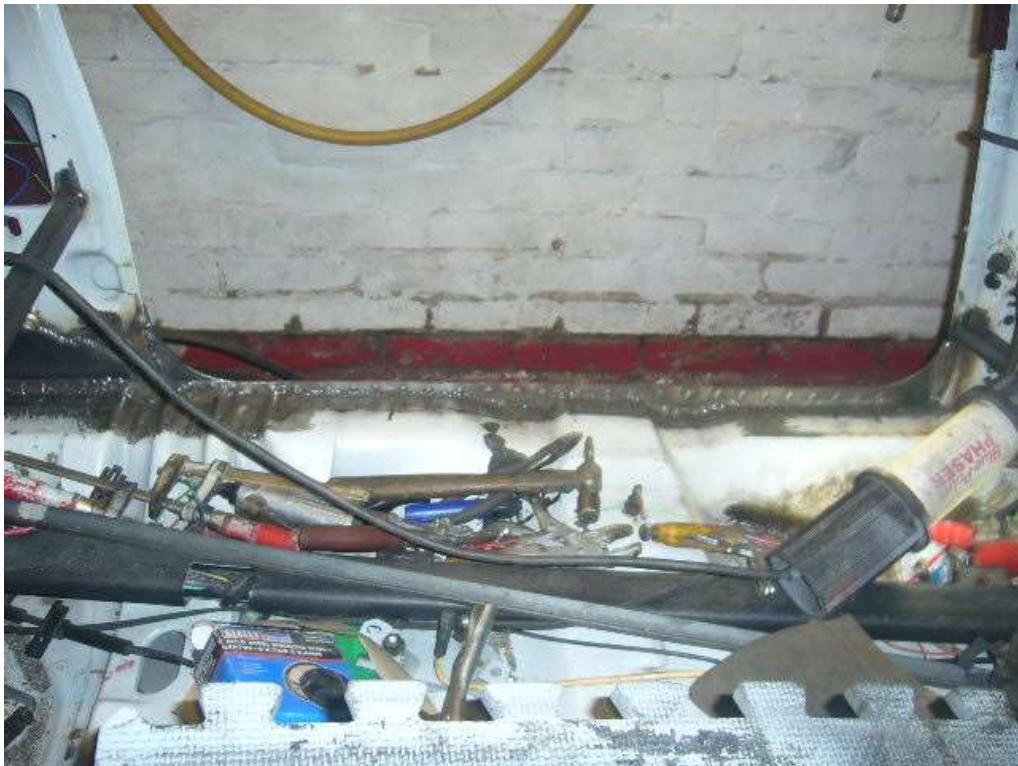
Here's a shot of the floor finally welded back to the body.

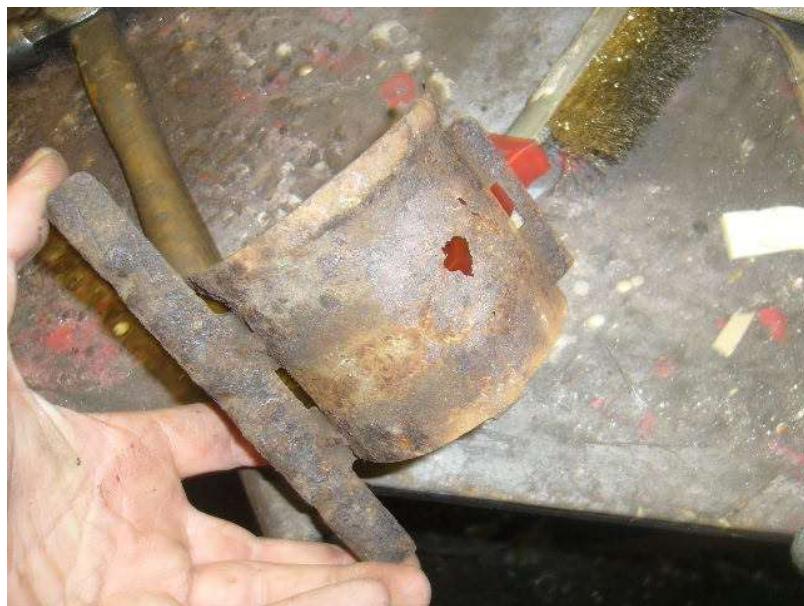
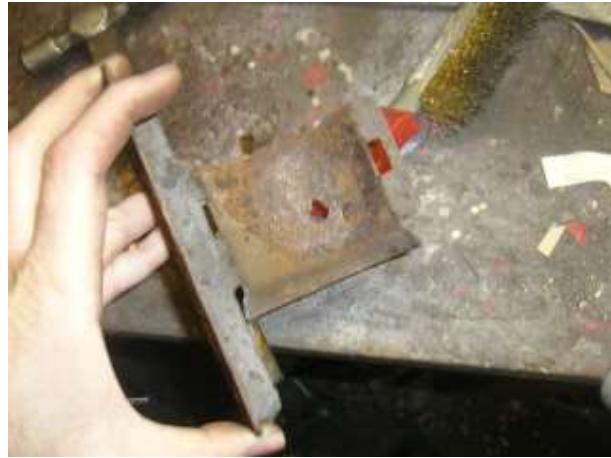
While I am welding on the passenger side I spotted the fuel filter bracket bolted to the frame.
It was the only bit I didn't have blasted and powdercoated. So off it comes and here it is

Just a little bit rusty then! So it goes into my acid tank for a few days and I will then weld it up

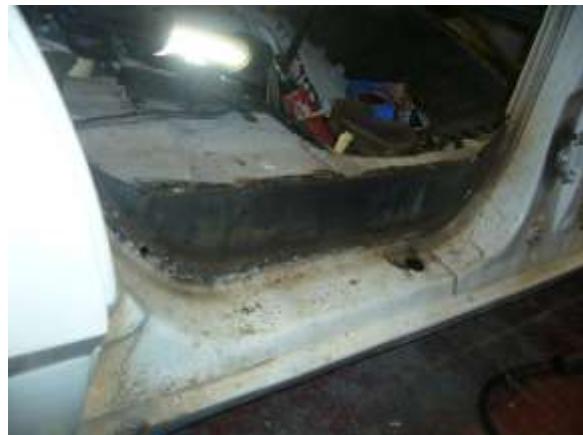
New rocker extension welded in where the rear door is

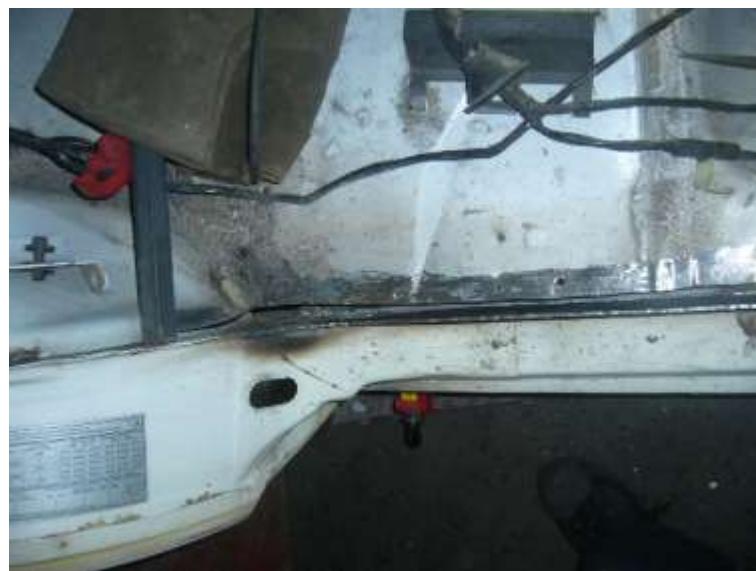
Now I will have to fill in this gap
