Project Big Ford

Ford LTD Crown Victoria LX Country Squire

September 2009

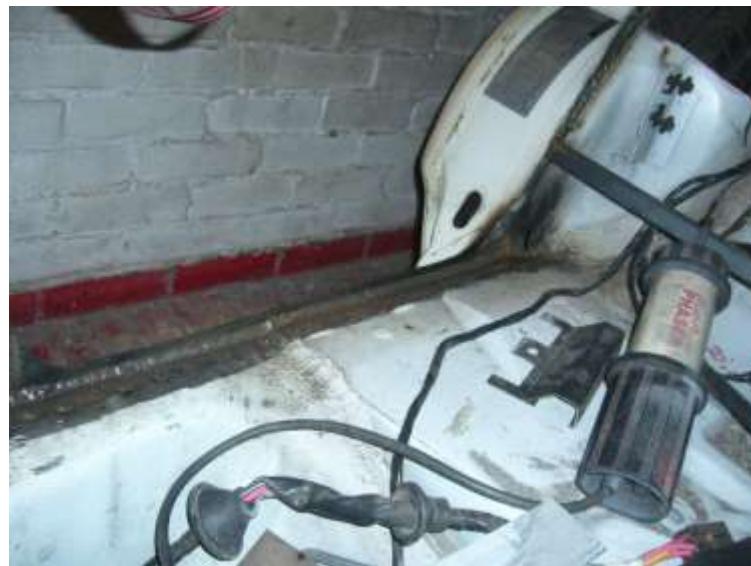
Decided to fillet weld the floor back to the rockers on the passenger side this time.

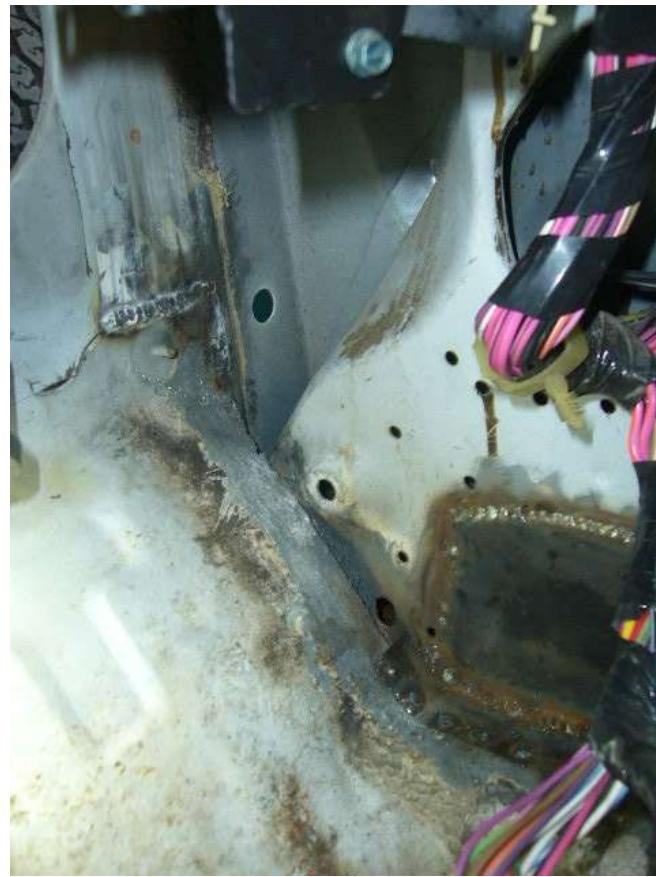
Right at the front is a bit awkward.

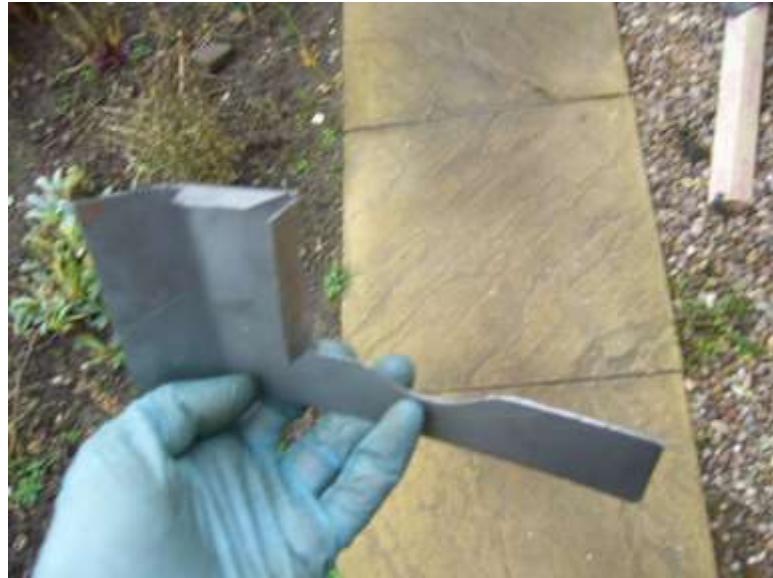
So I made this panel

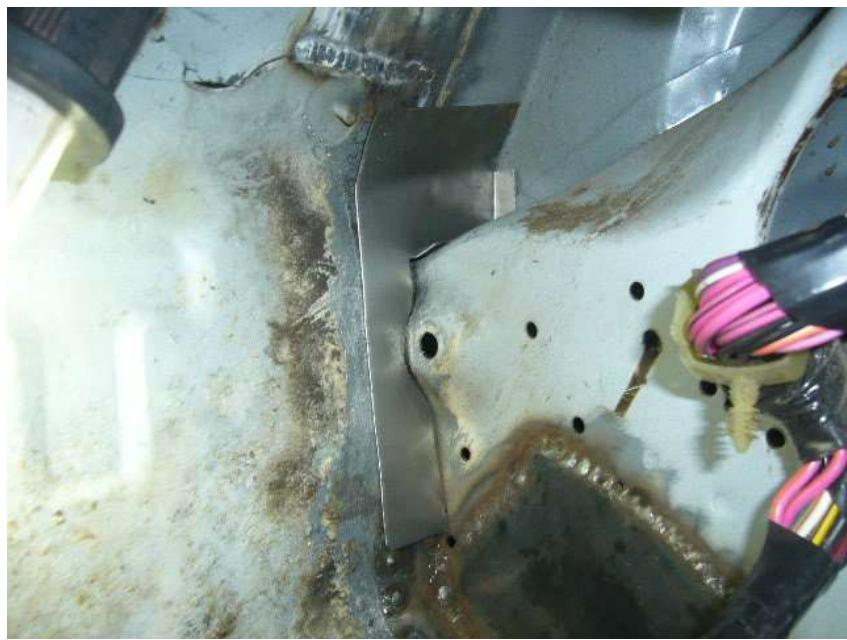
to go here.

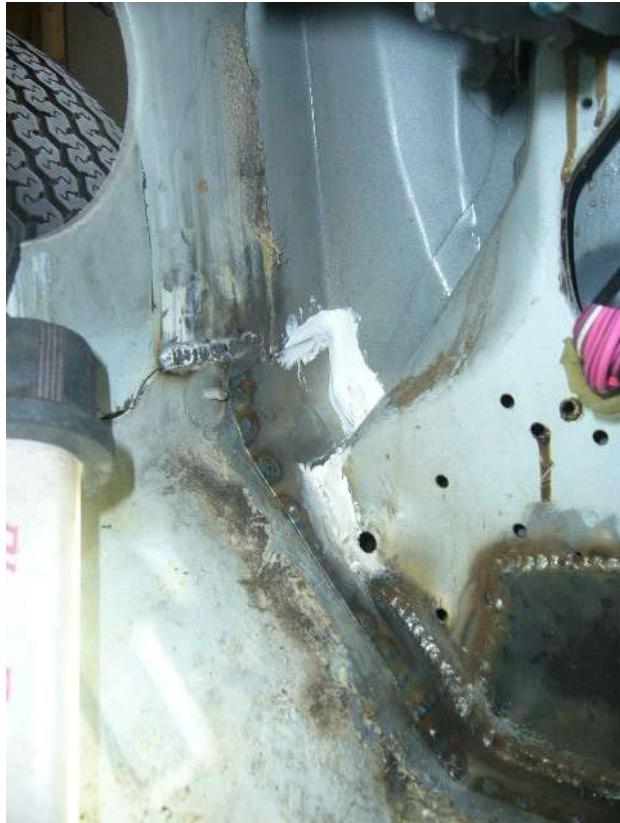
then welded up and panel adhesive where I cant get to weld

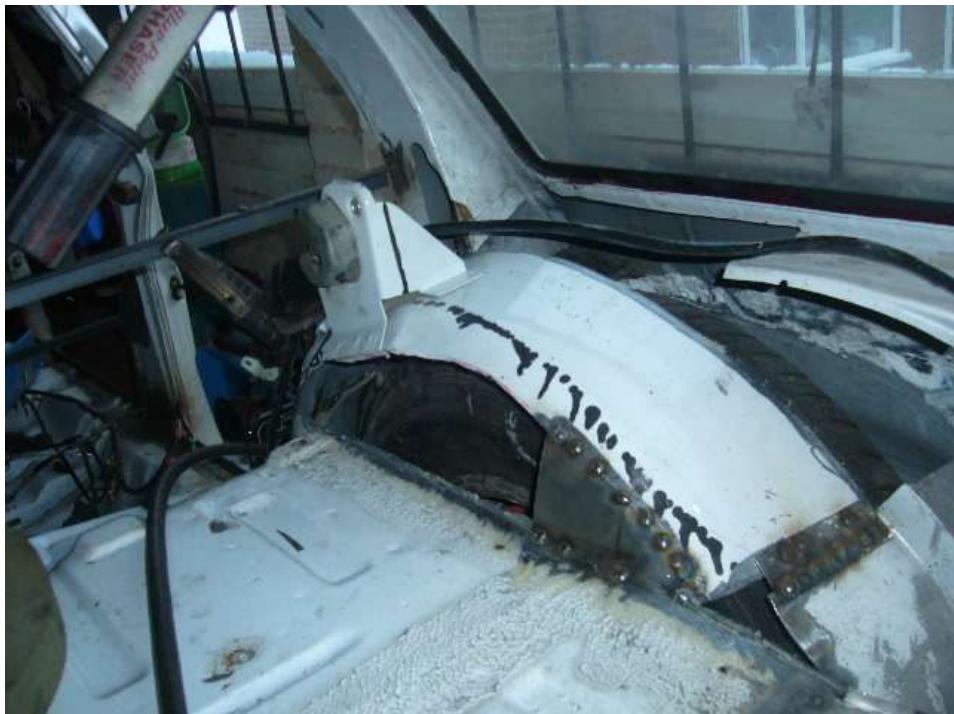
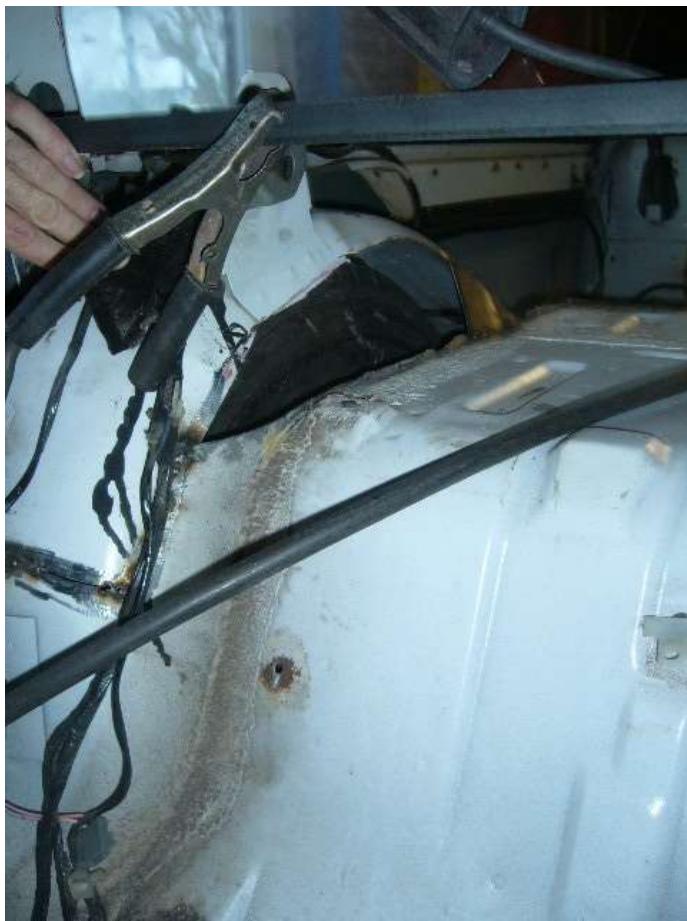
Here's the back passenger side rear wheel inner arch tacked back in 10 cm higher and slightly recurved tighter

This means that the back seat upper cushion will probably not clip into the catch, so that will need repositioning slightly.

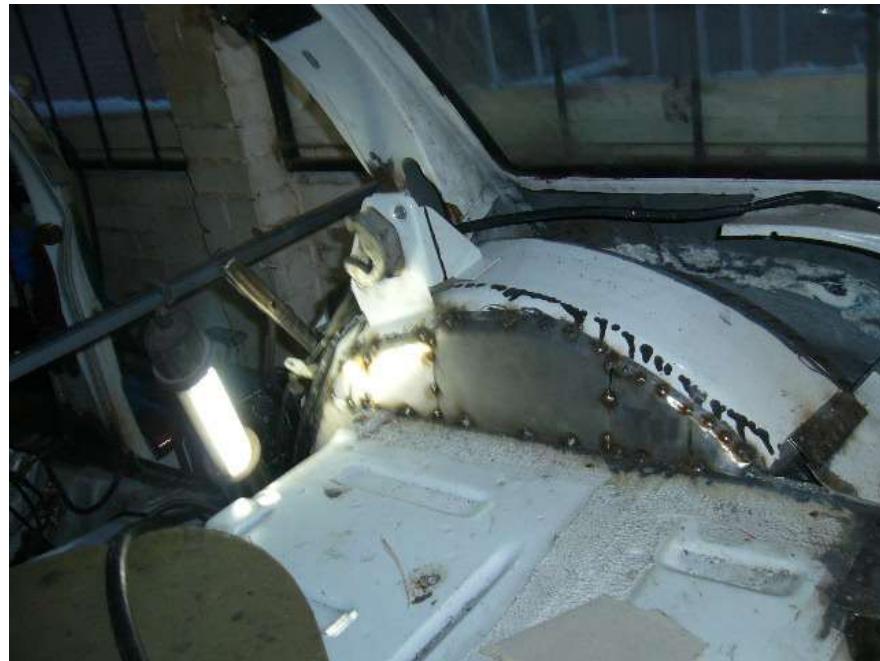
Because its double curved, I filled up the hole with a few panels, not just one

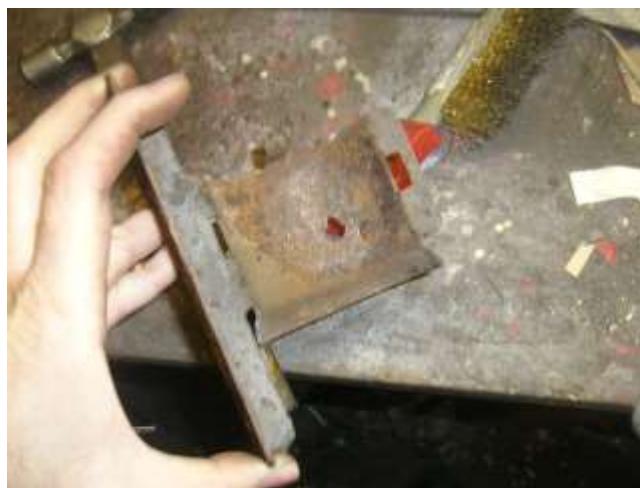
Forgot about my fuel filter bracket in my acid bath!

This is what it looked like before

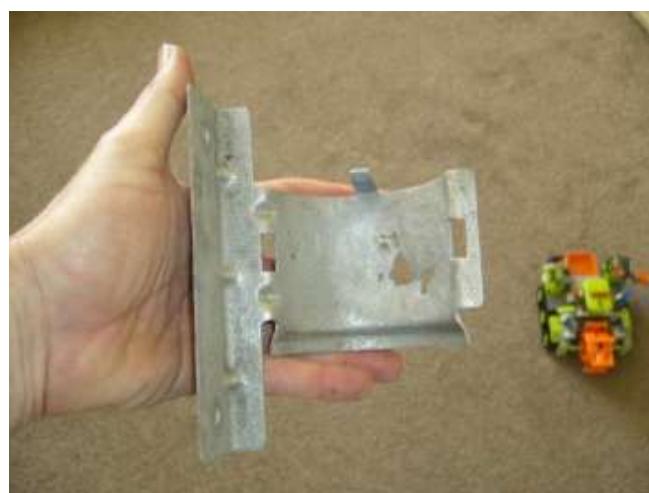
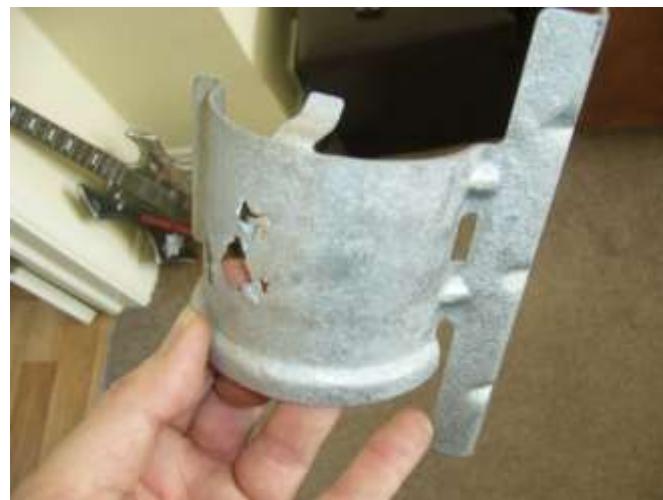
And this is how it came out

I'll weld that up the next few days, while the "welding the floor back to the bodyshell" continues into, what seems like its millionth hour.....

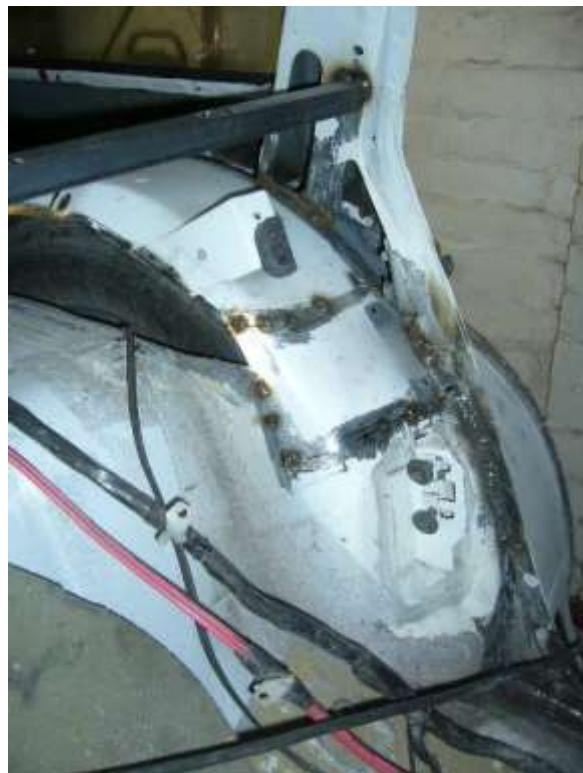
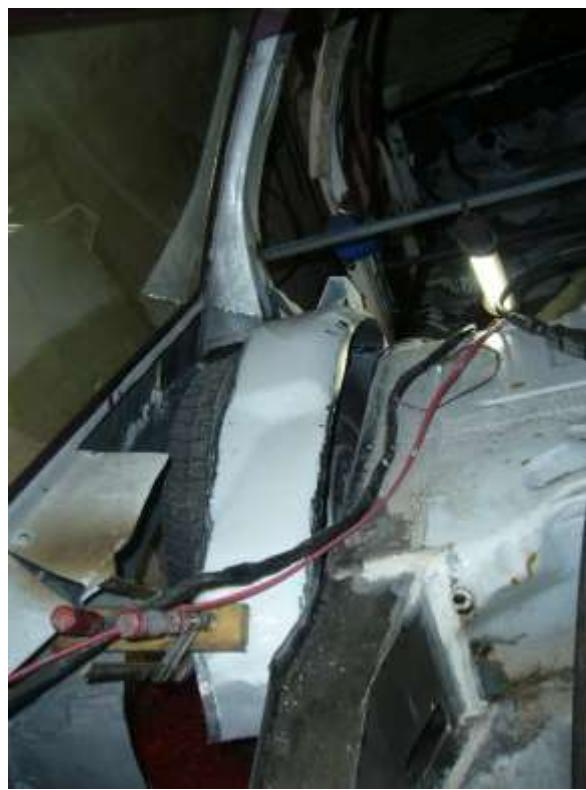
Over to rear drivers side wheelarch. Here we are tacking it all back together

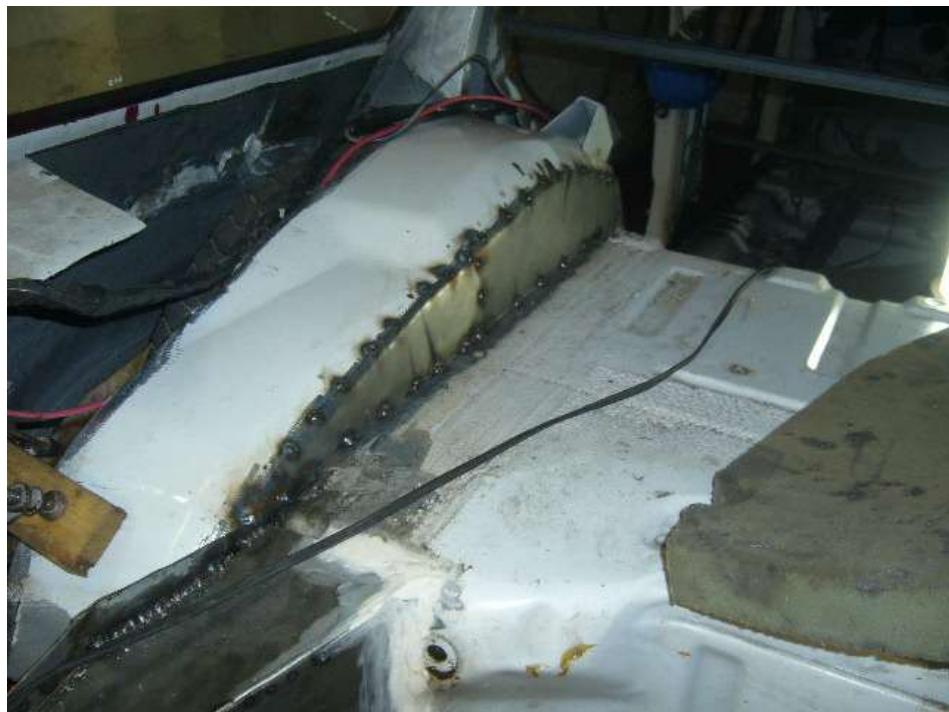
Closed off part of the inner wheelarch.

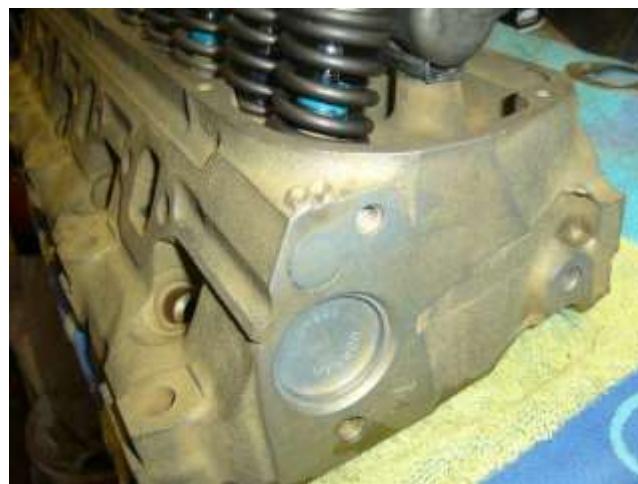
Tapered plug fitted to seal off unwanted passages

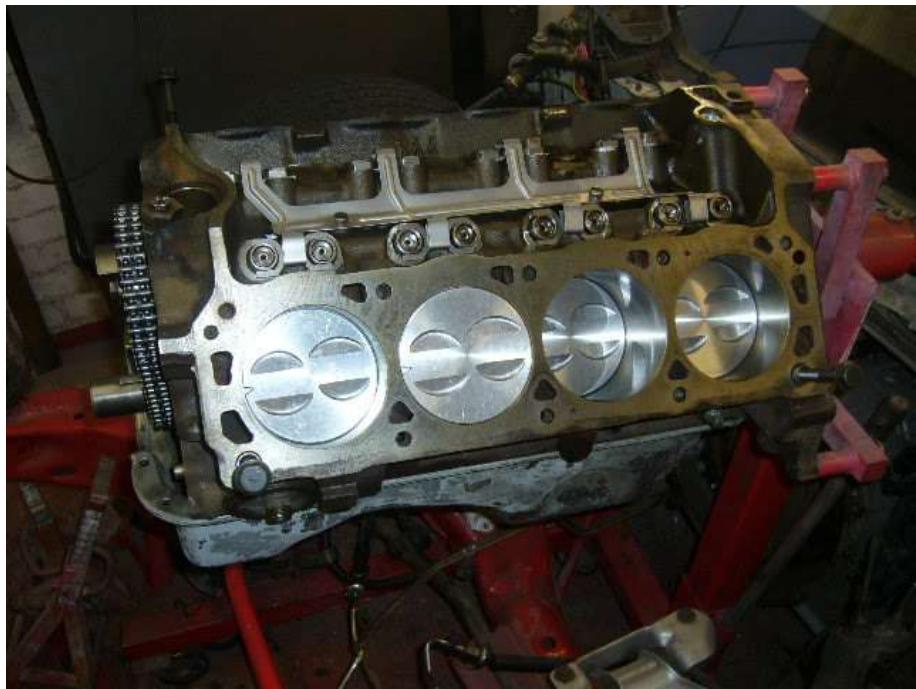
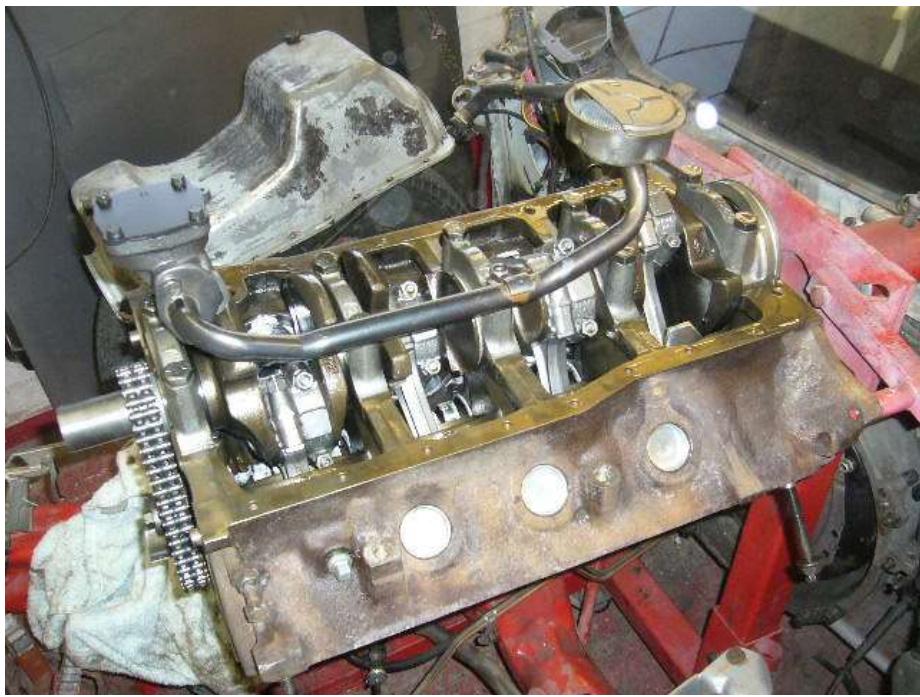
Onto the engine-bored 40 thou over

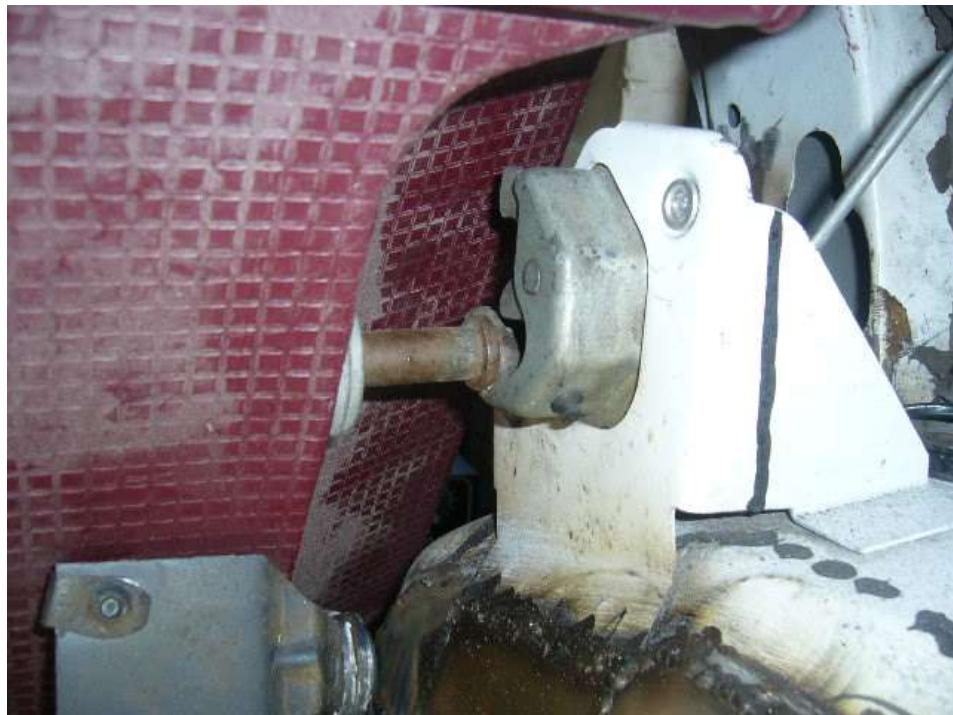
Slightly out of line on the passenger side

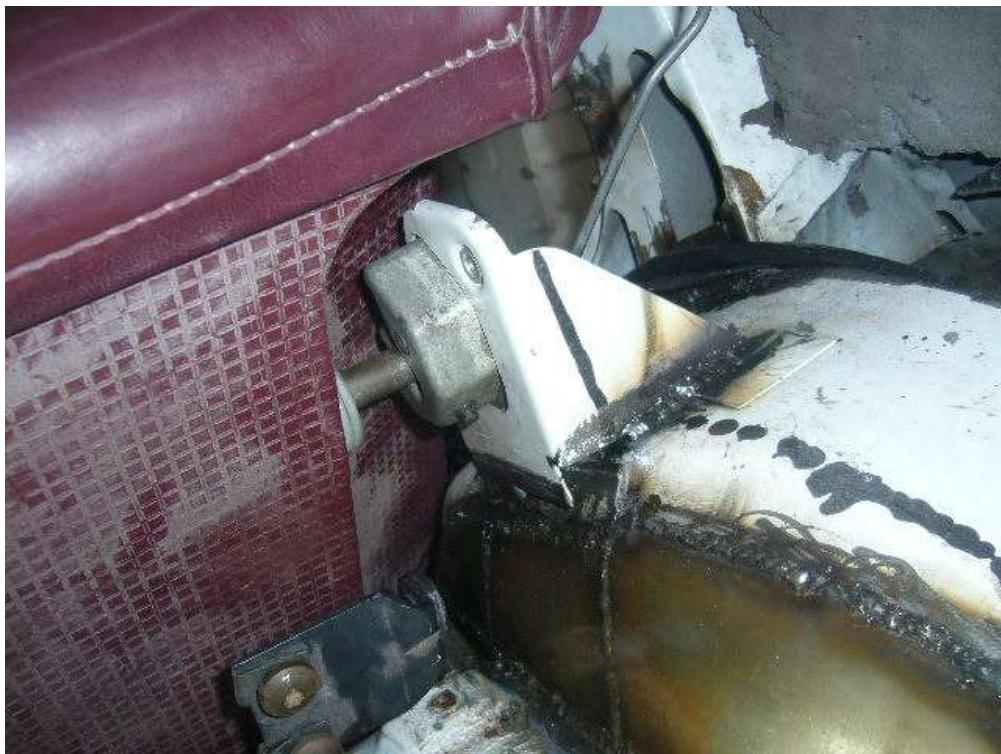
And in its new position

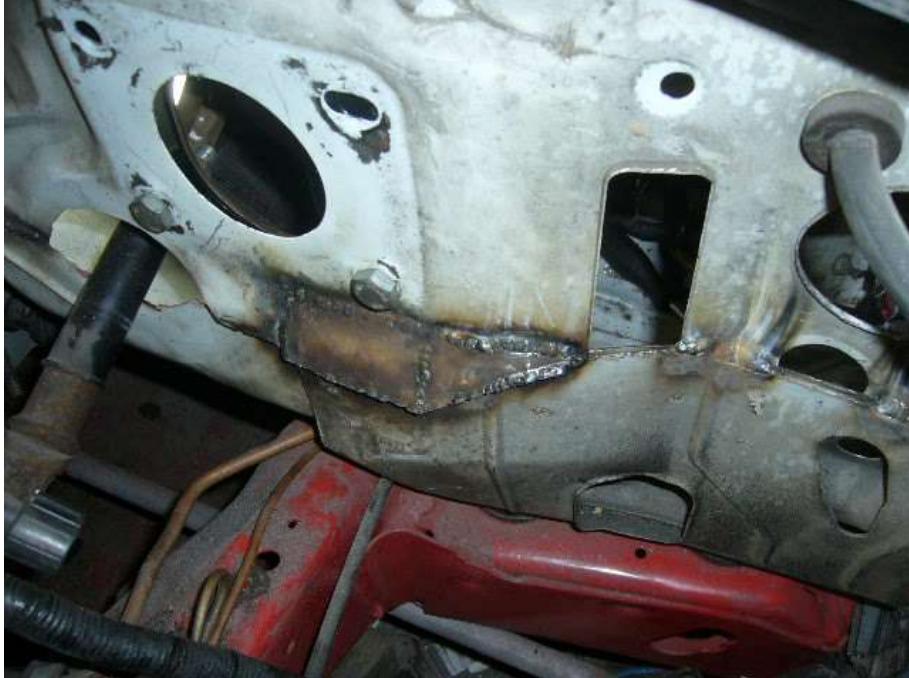
Tried to fit brake pedal box but it wouldn't fit. I welded the firewall up without bolting it up to check! Yeah, I know.....should have known better.

So, had to cut across my welds and pull the firewall out at the bottom a bit

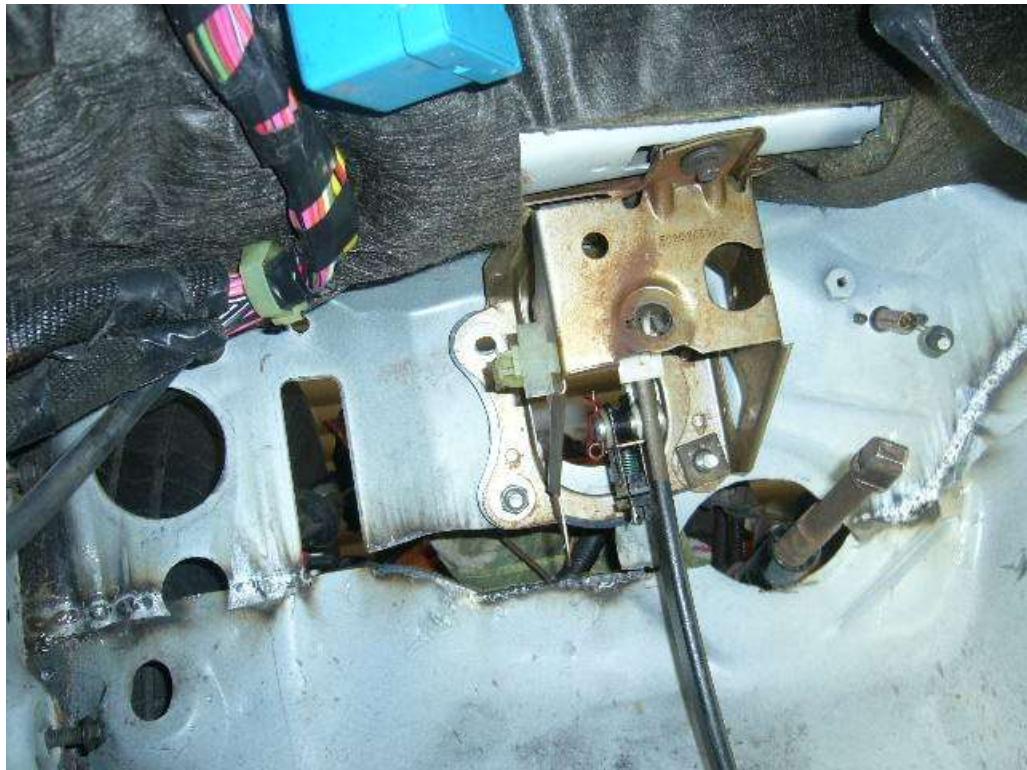
Pedal box in as first plate is welded in

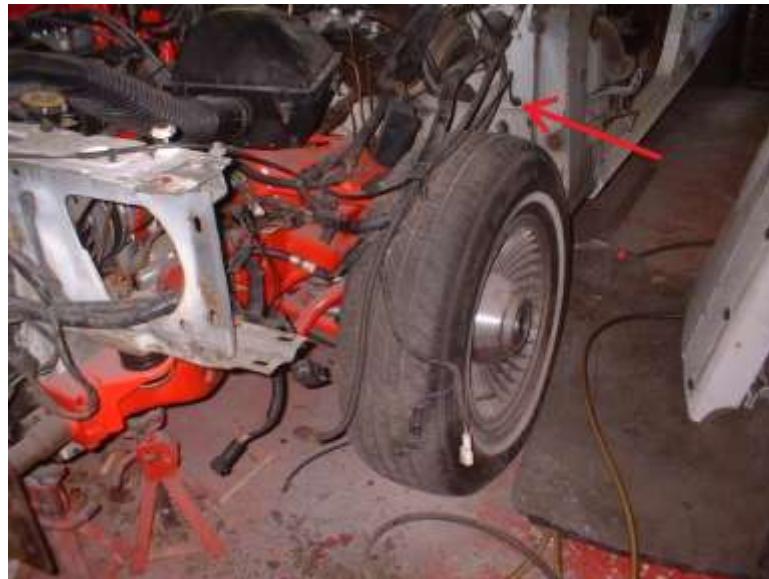
Just spotted that I have lost my hood release cable hole! Here it is/was from an old photo

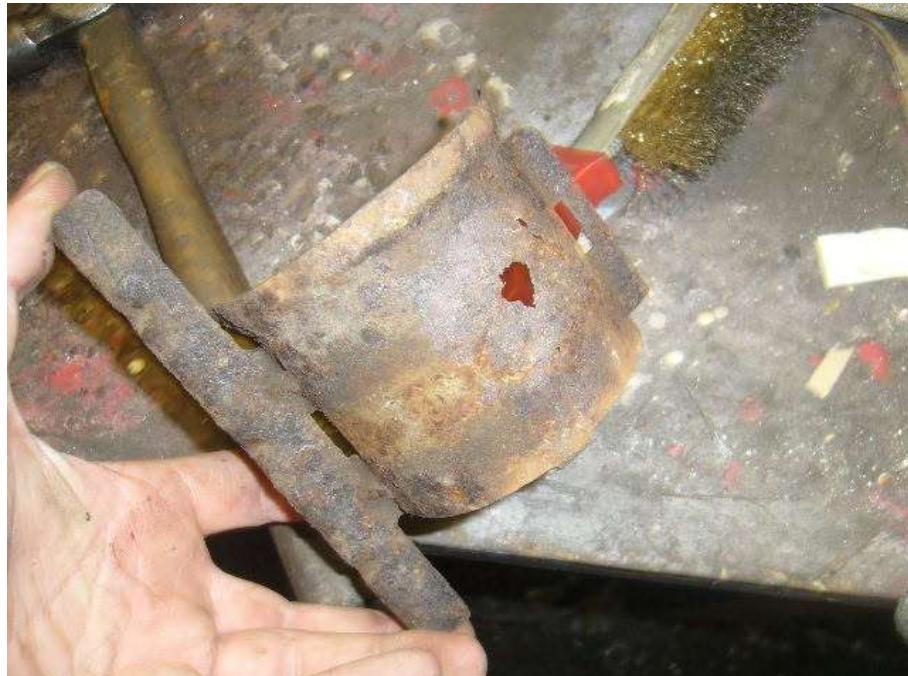
Remember this rusty thing?

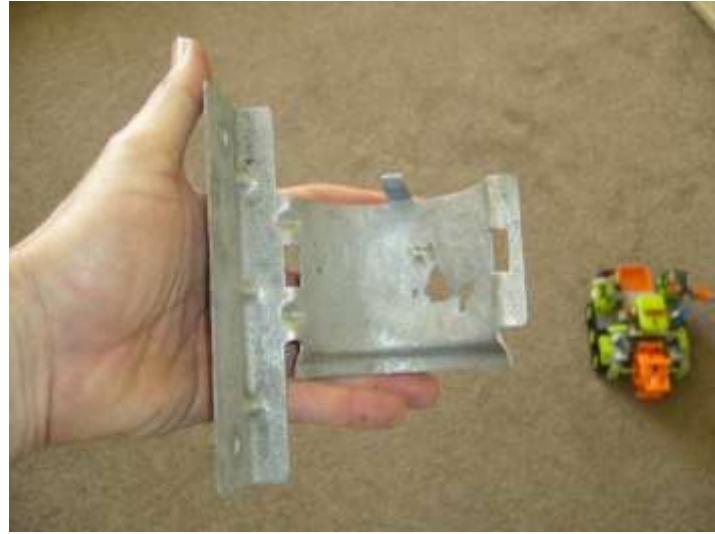
That was acid dipped to look like this?

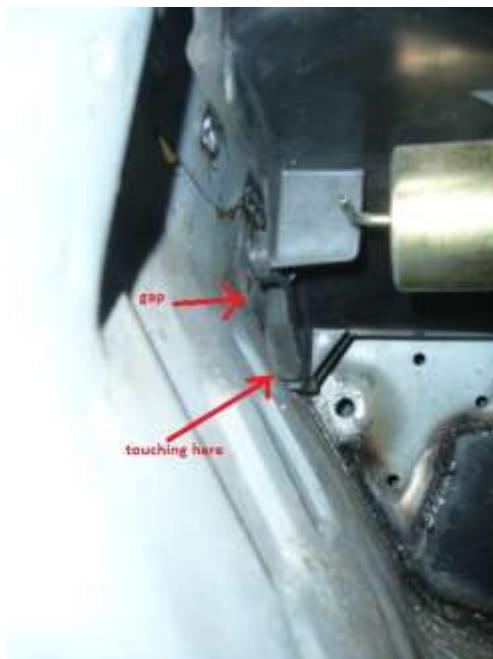
Here's a temporary fit and you can see where the bottom of it is touching the firewall before it sits flush

So I need to cut the bottom off so it has a chance of sitting flush.

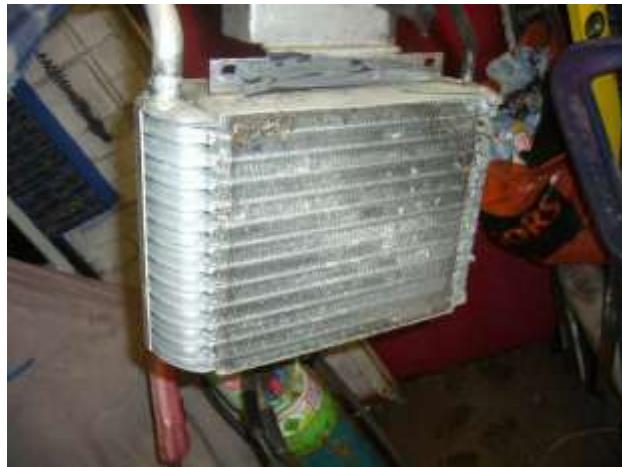
The other side of the matrix (fan side) was filthy and partially blocked with debris

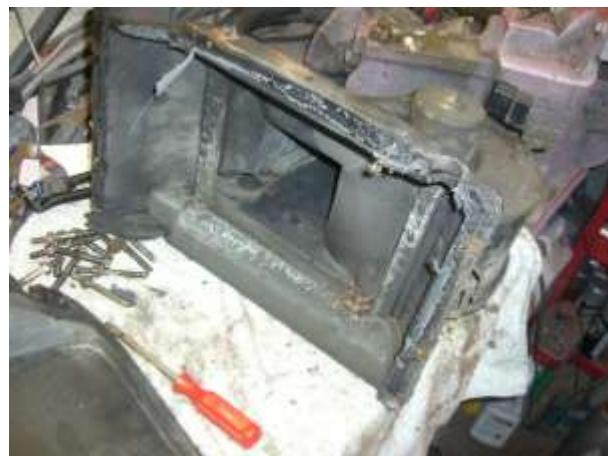
And here's some more debris in the case

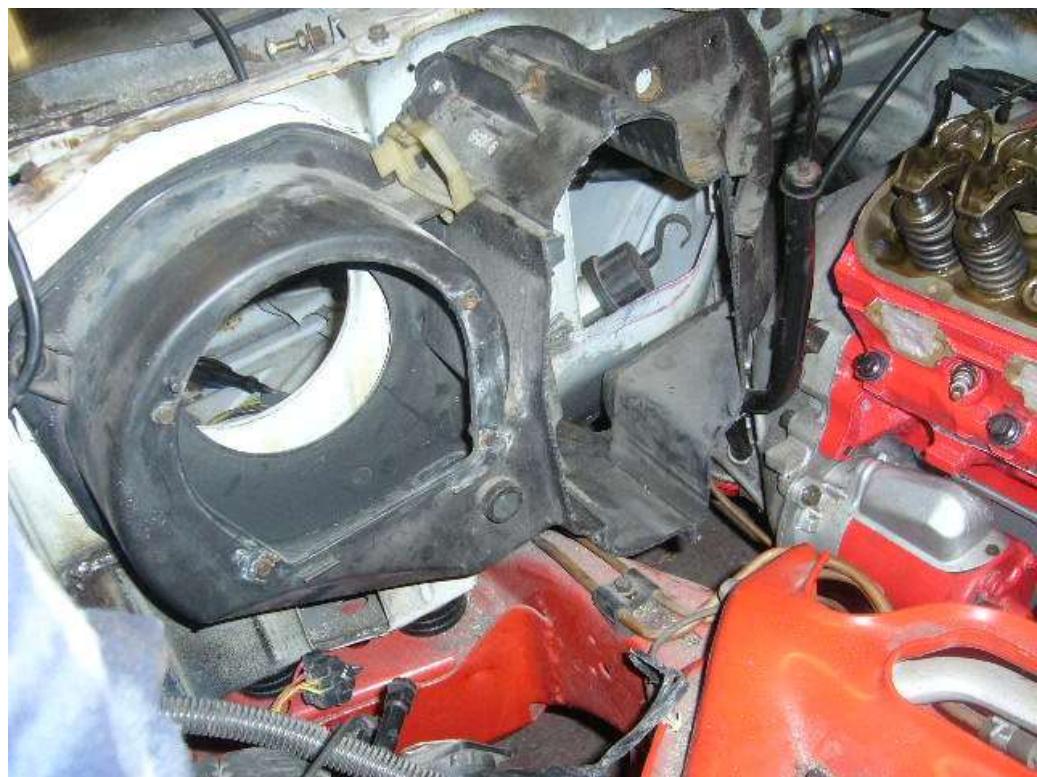
A trial fit and the base is touching the frame (just) so tomorrow I'll remove the bottom "bulge".

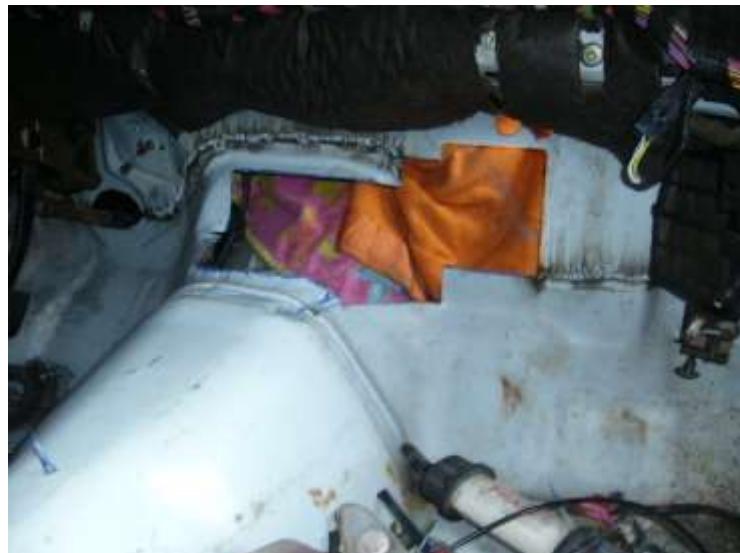
Cut out what I needed to of the firewall and transmission tunnel. More than I thought! I'll weld it up when I hoist the body off the chassis in a few weeks.

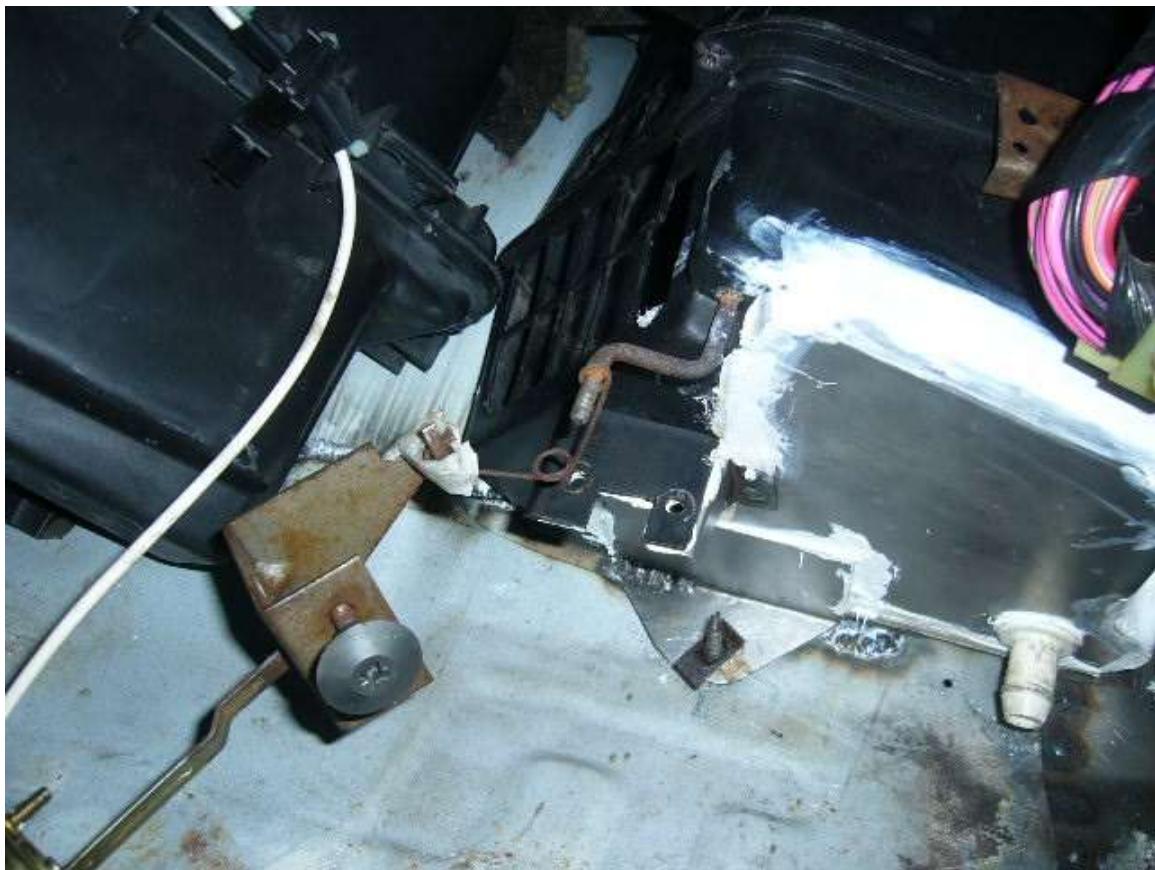
Hole drilled through firewall to help secure the corner box and the AC box together. Then bonded on a fabricated bracket.

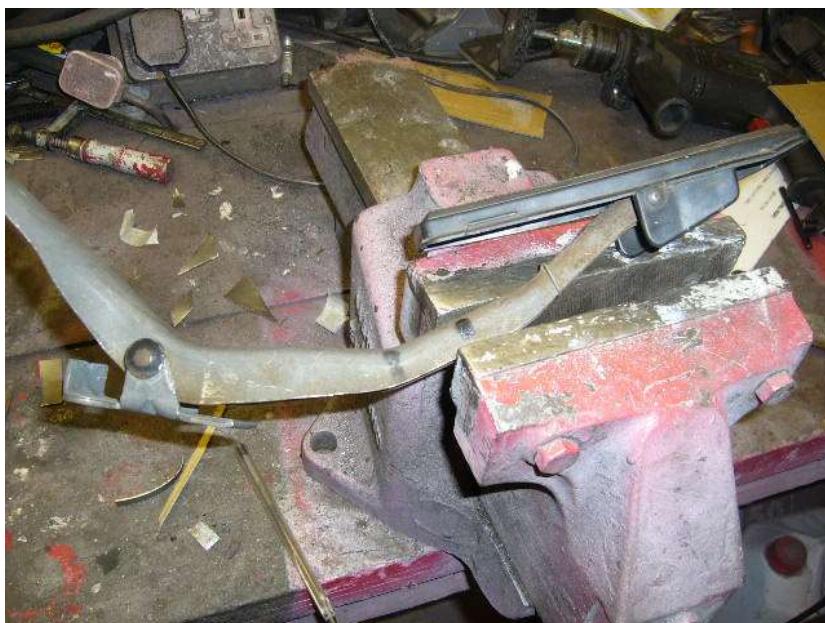
Here's the full length gas pedal

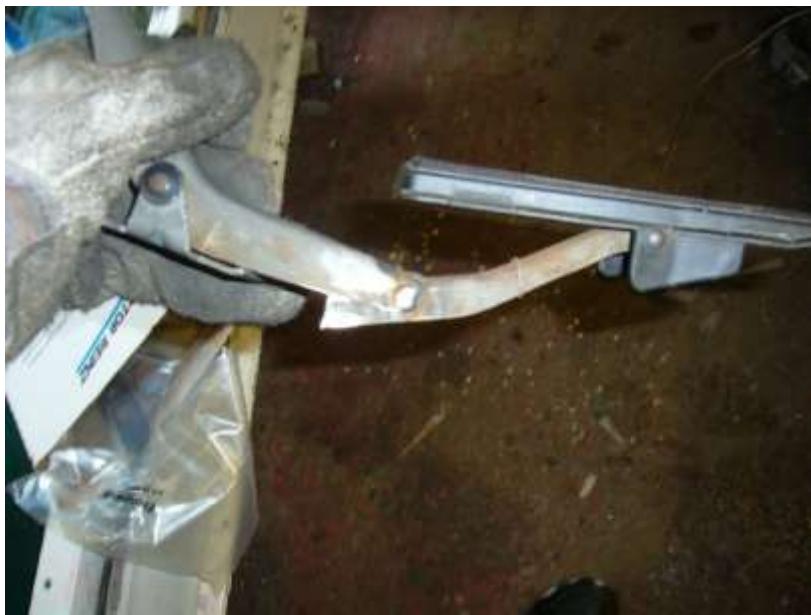
and here's the pedal shortened awaiting finishing and final welding

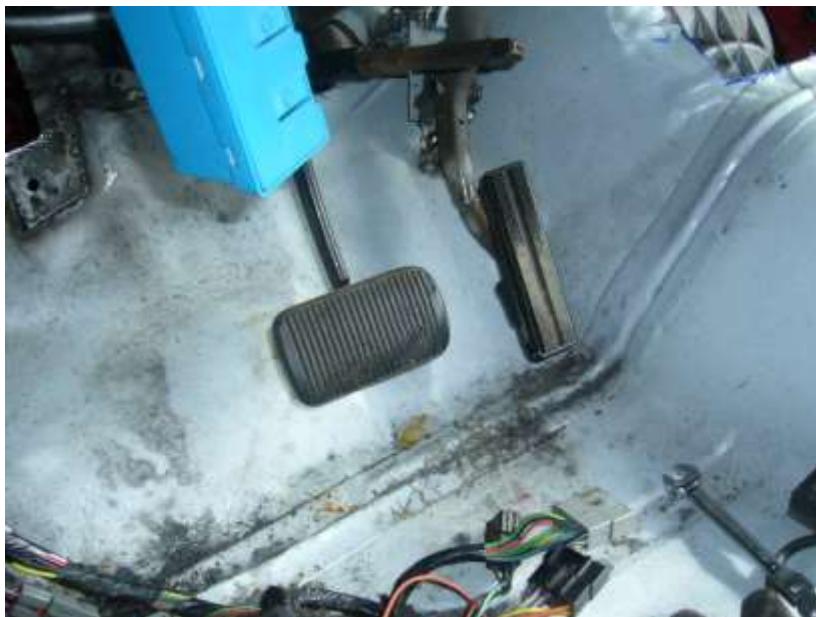
And bolted back into its new welded in mounting place

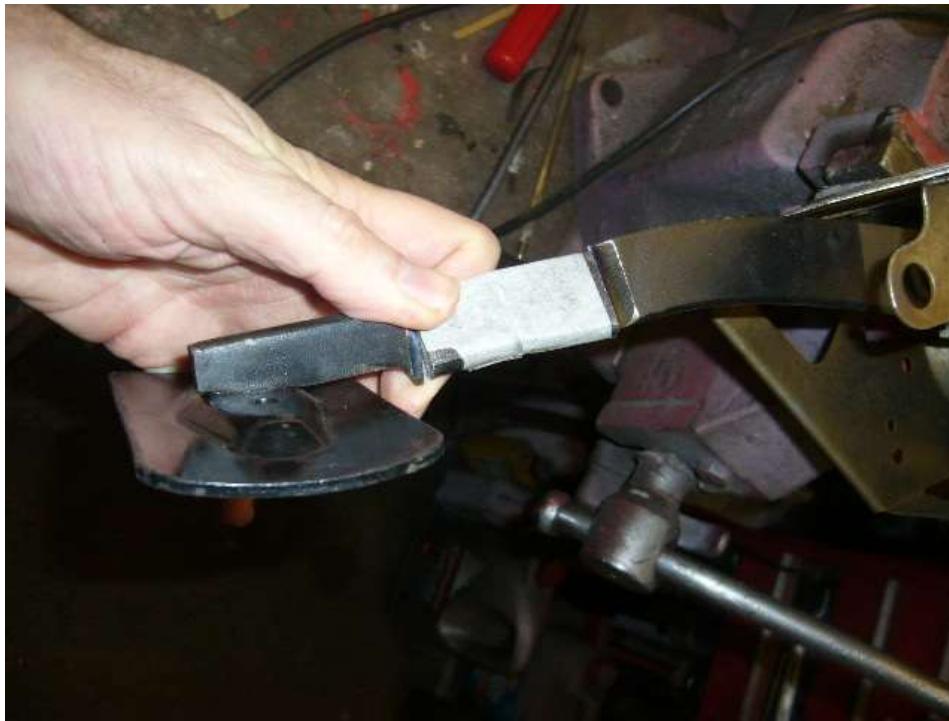
Here's a section cut-out awaiting welding back together

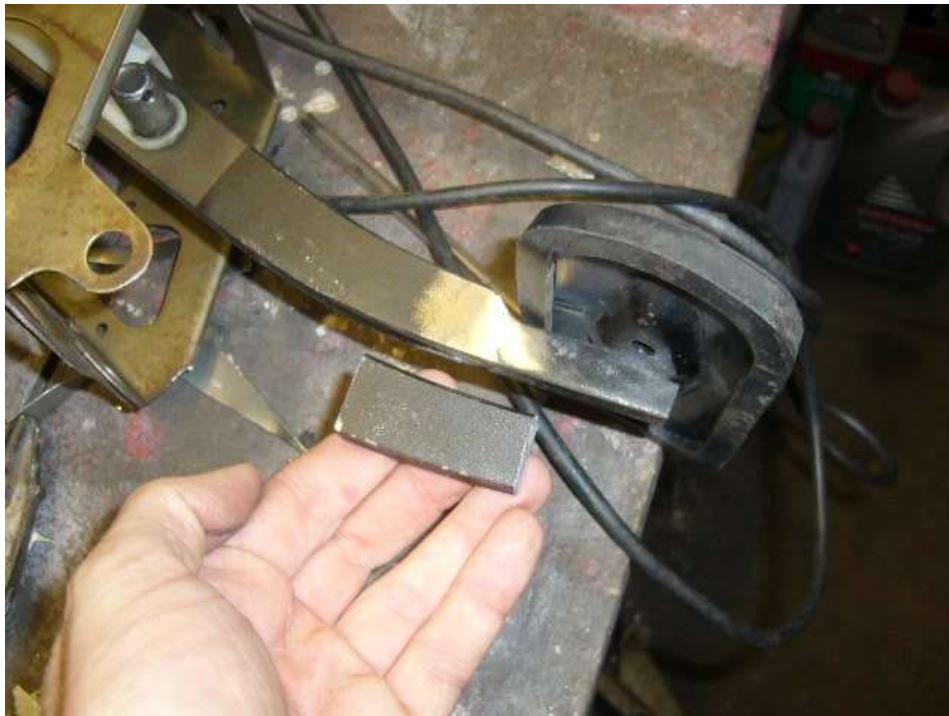
and fully welded with the missing bit looking on!

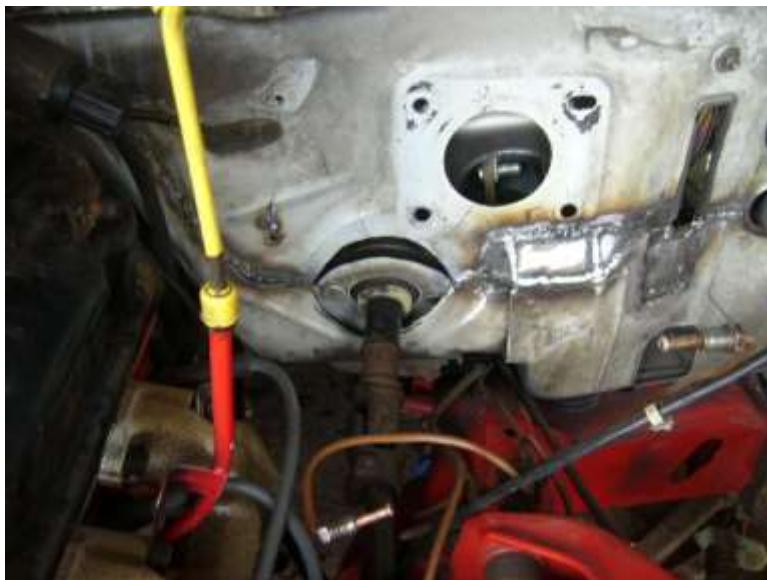
And servo removed to get access for cutting and welding.
Here's the firewall cut out a bit more and ready to tack in position. The UJ misses the bottom

of the servo by about 10mm! But it works and it steers!

Finish weld that up, strip it all out again and its hoisting up off the chassis for its final welding and painting underneath.

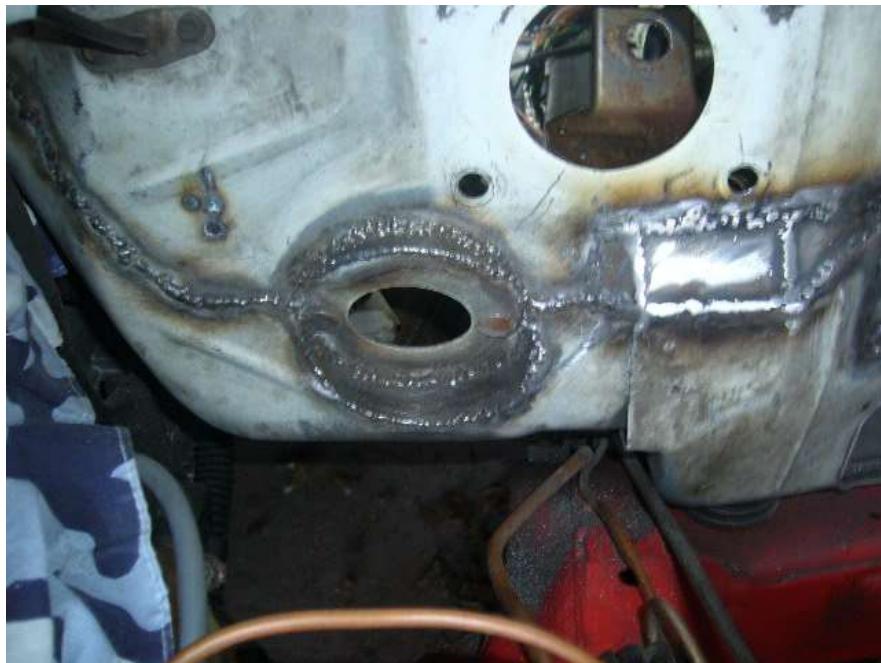
Final welded up the steering column mount through the firewall

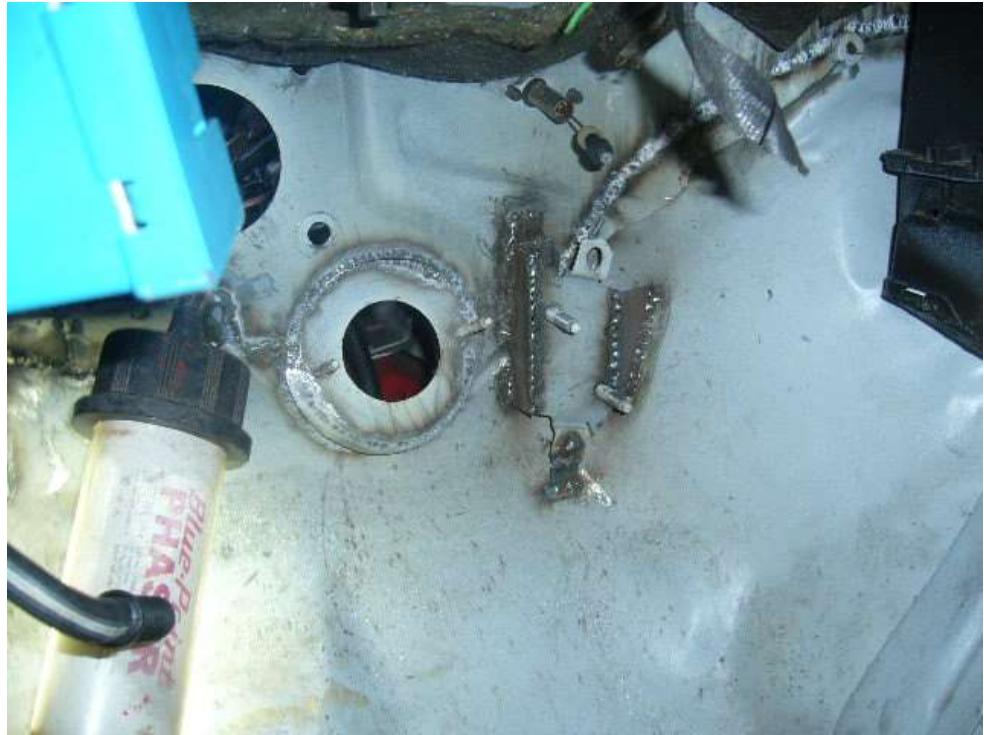
All welding completed on the firewall inside

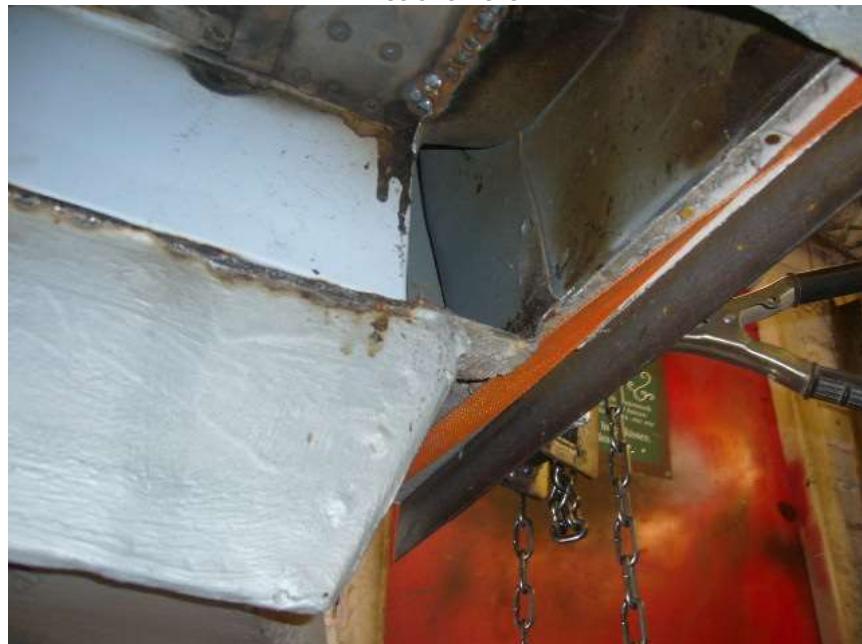
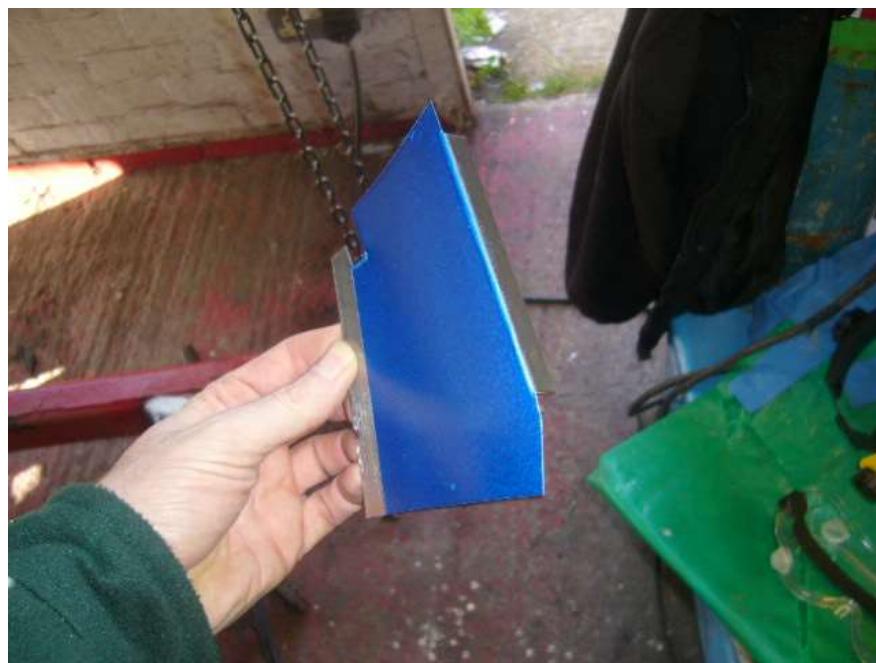
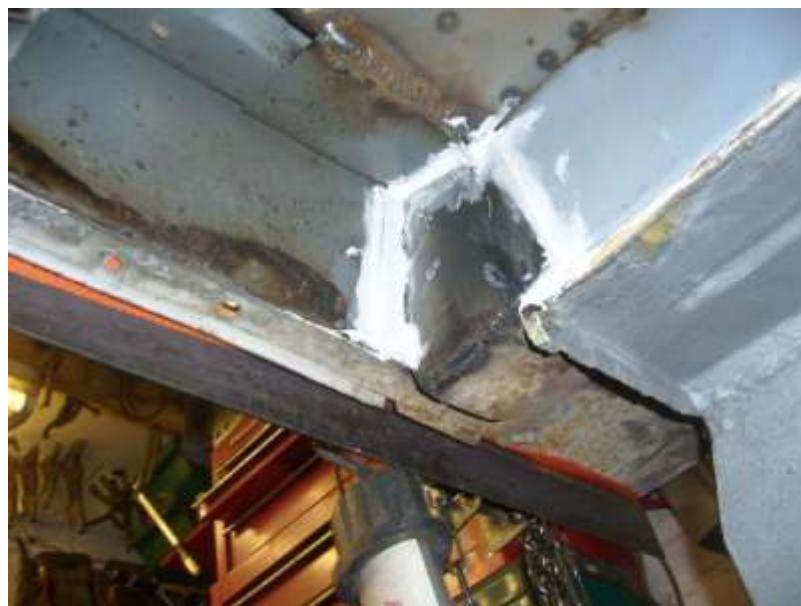
Got to start blocking holes up and reinforce areas under the floor where it has moved up 10cm.

First one here
