Project Big Ford

Ford LTD Crown Victoria LX Country Squire

September 2009

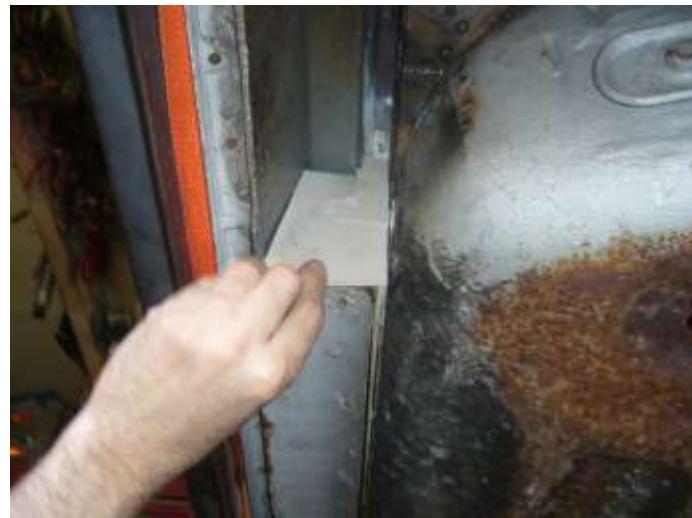
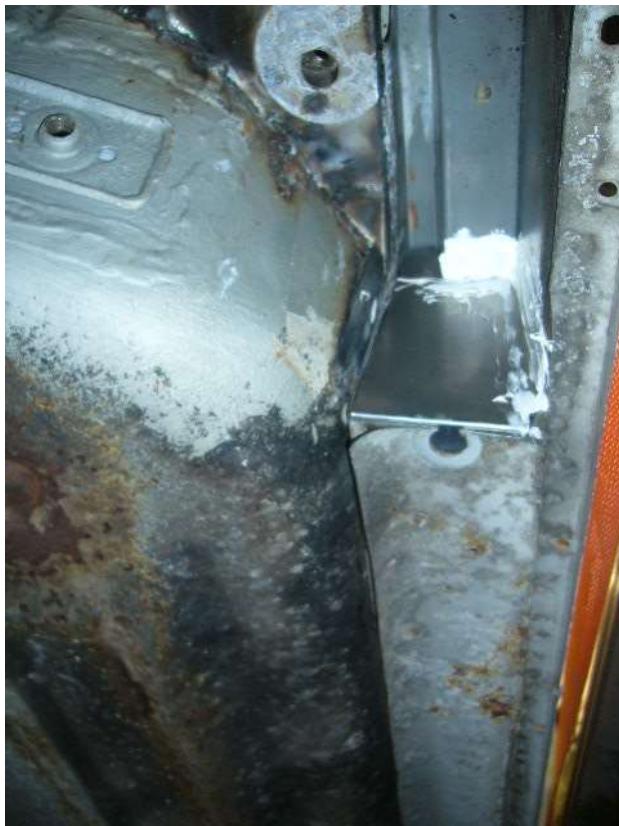
and another one

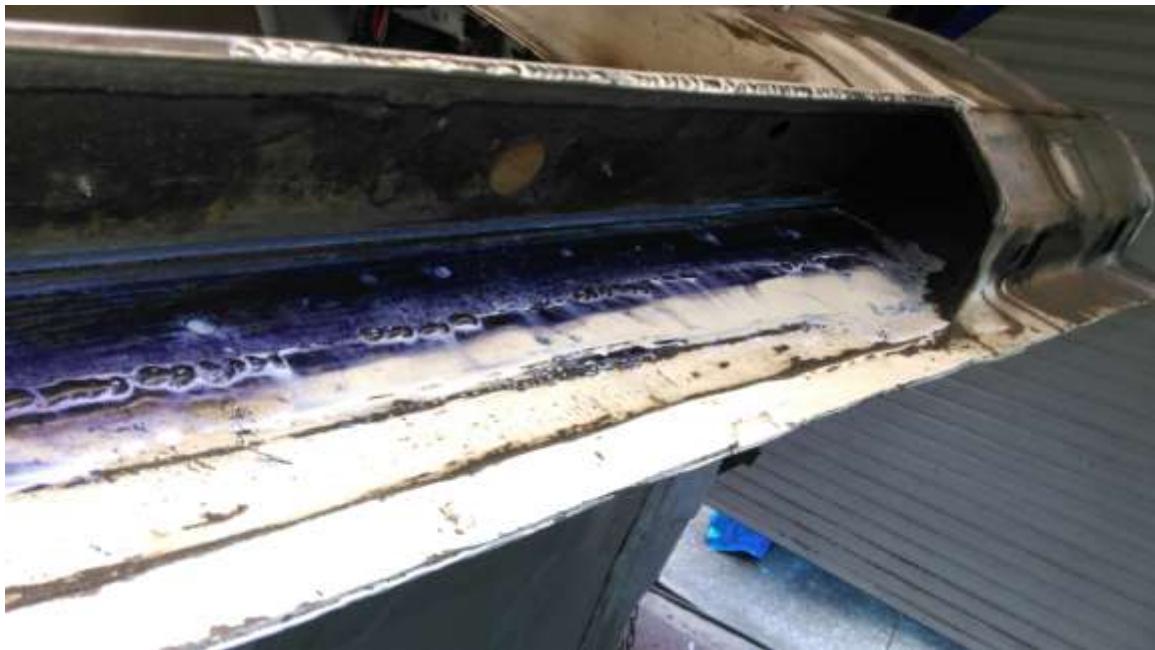
Drivers side one cut out and realised that the ones I welded up in November last year were useless due to heat distortion. So, back to square one and I will weld in the sills in 2 sections. Upper and lower.

Both inner sills derusted and painted with KURUST then etch primed and painted silver.

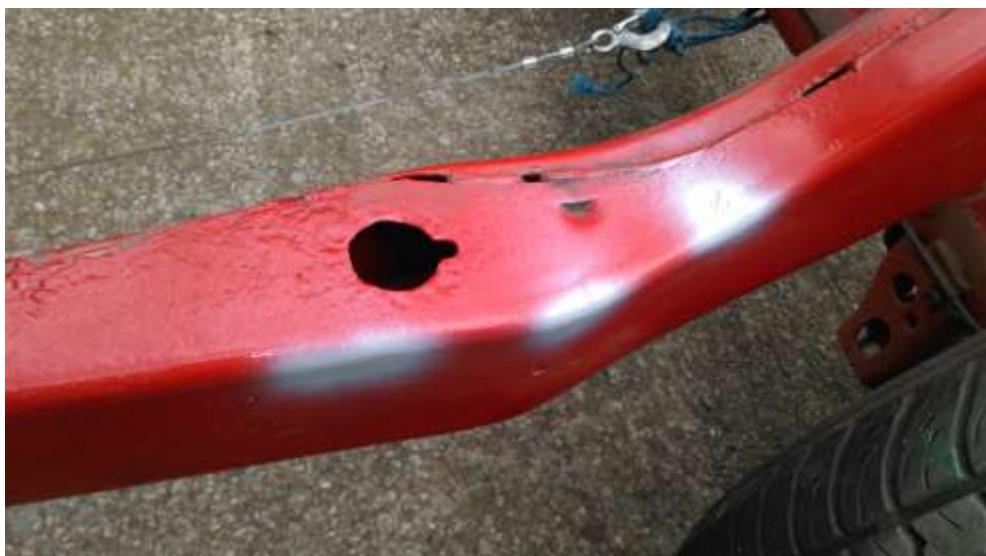
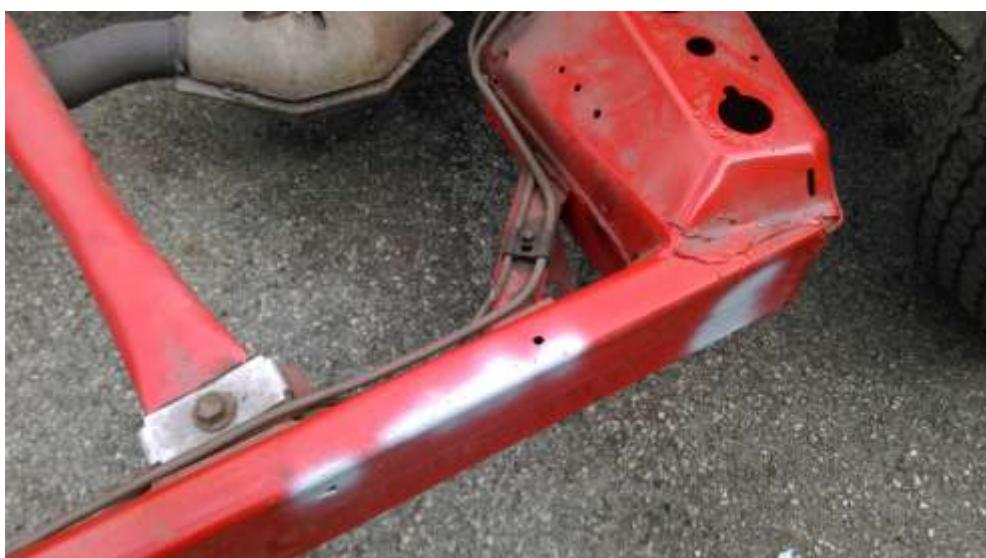
Various scratches down the frame primed and painted also.

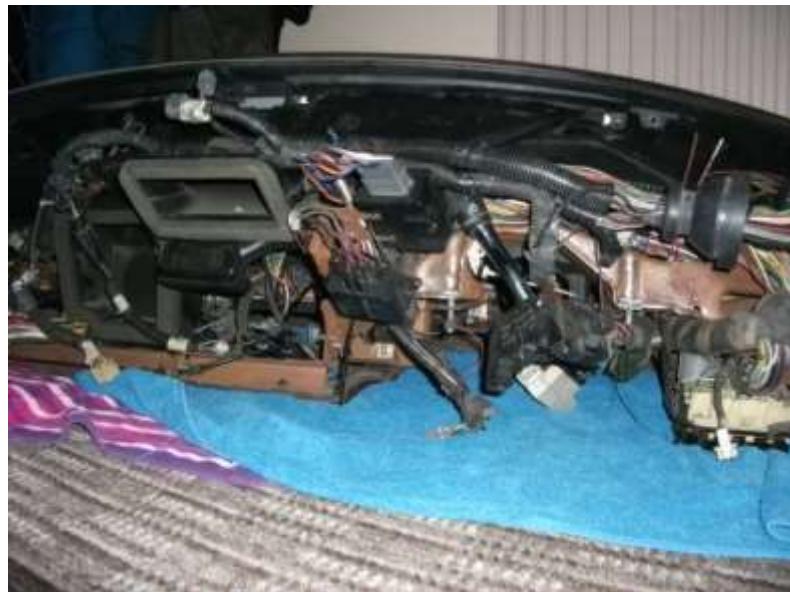
Grabbed the steering column out of the shed and put it on the bench. The 2 creamy coloured vacuum lines have disintegrated in the light through the shed window!

So, went up on ebay and bought some silicone hoses for the main vacuum line (black 9mm), the 2 deteriorated pipes (blue 3mm) and one to replace the braided one I put on top of the engine ages ago (black 4mm).

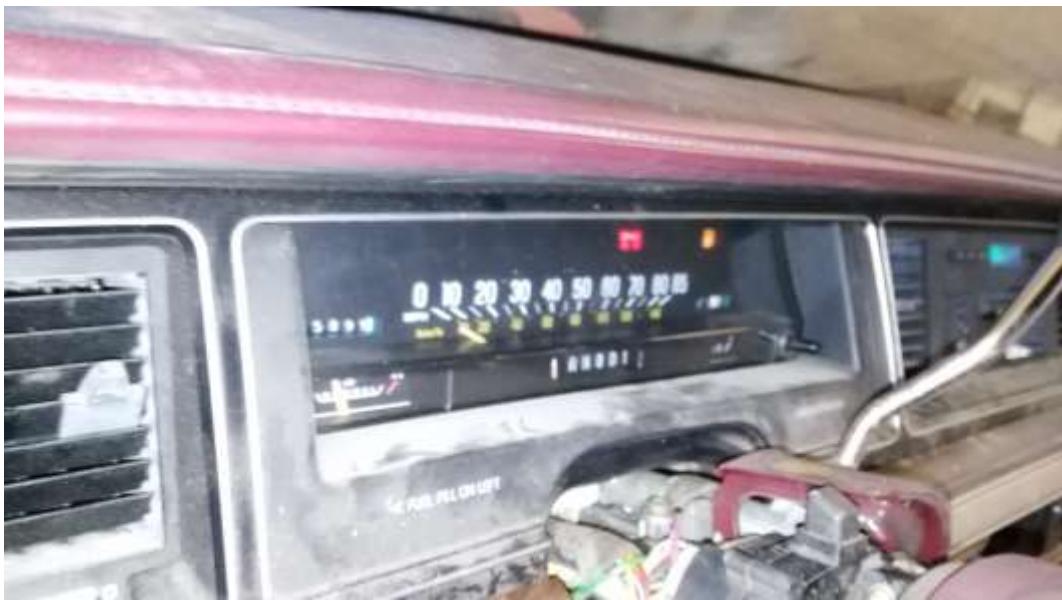
Key turned and it started!! Sounds good. Slight misfires, but no doubt injectors are sticky. Quite a time since I started it last.

Water temp gauge working ok. Fuel level reading lower than zero and low level light on. May be because the level is actually low, or sender not working.

I put a 180 ohm resistance in the sender connector at the rear and it read full. So will have to wait till I can get more fuel in to see if it works.

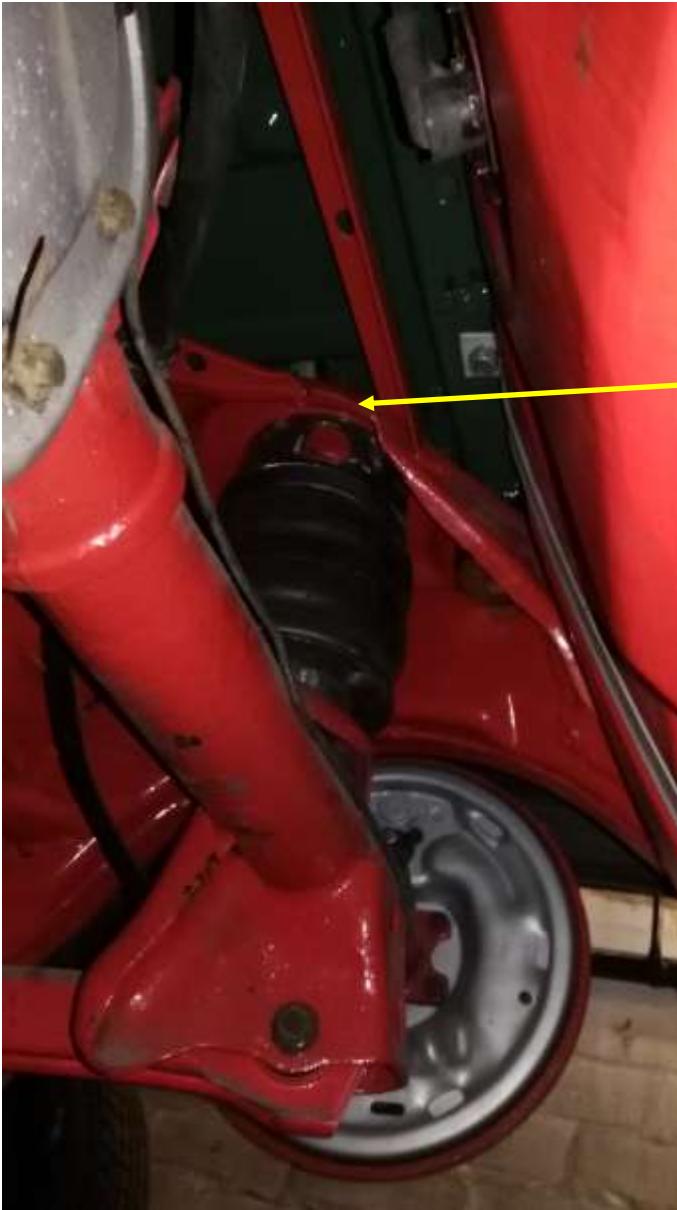
But slight problem here!!
The 3/8" line that comes
out of here are fouling on
the red chassis here.

I need to reclock the
mount so the airline
comes out of the top
mount and goes forward
slightly nearer the
shocker, then bend back
round and into the car
through the floor.

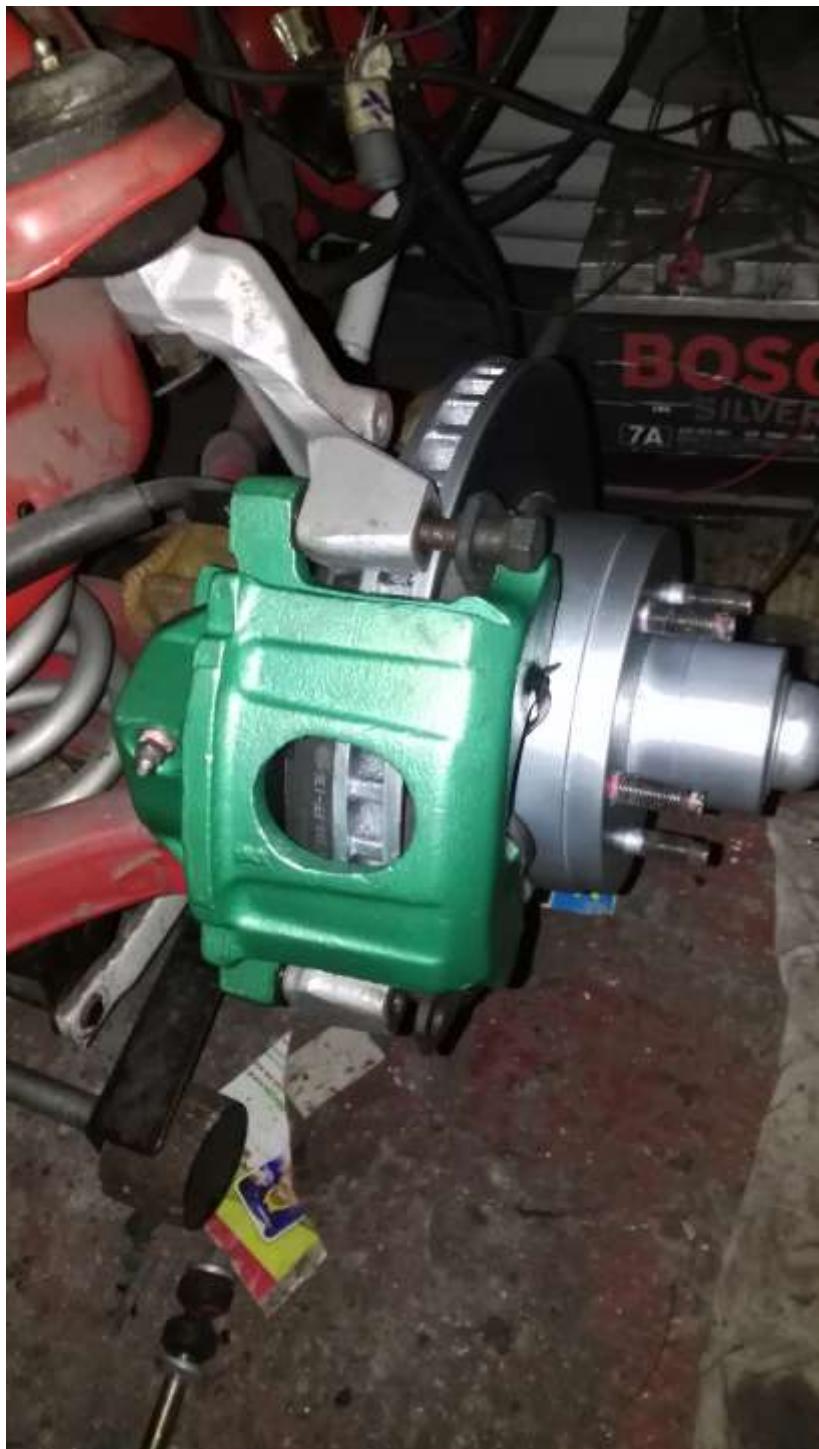
Front brakes reassembled and bled out.

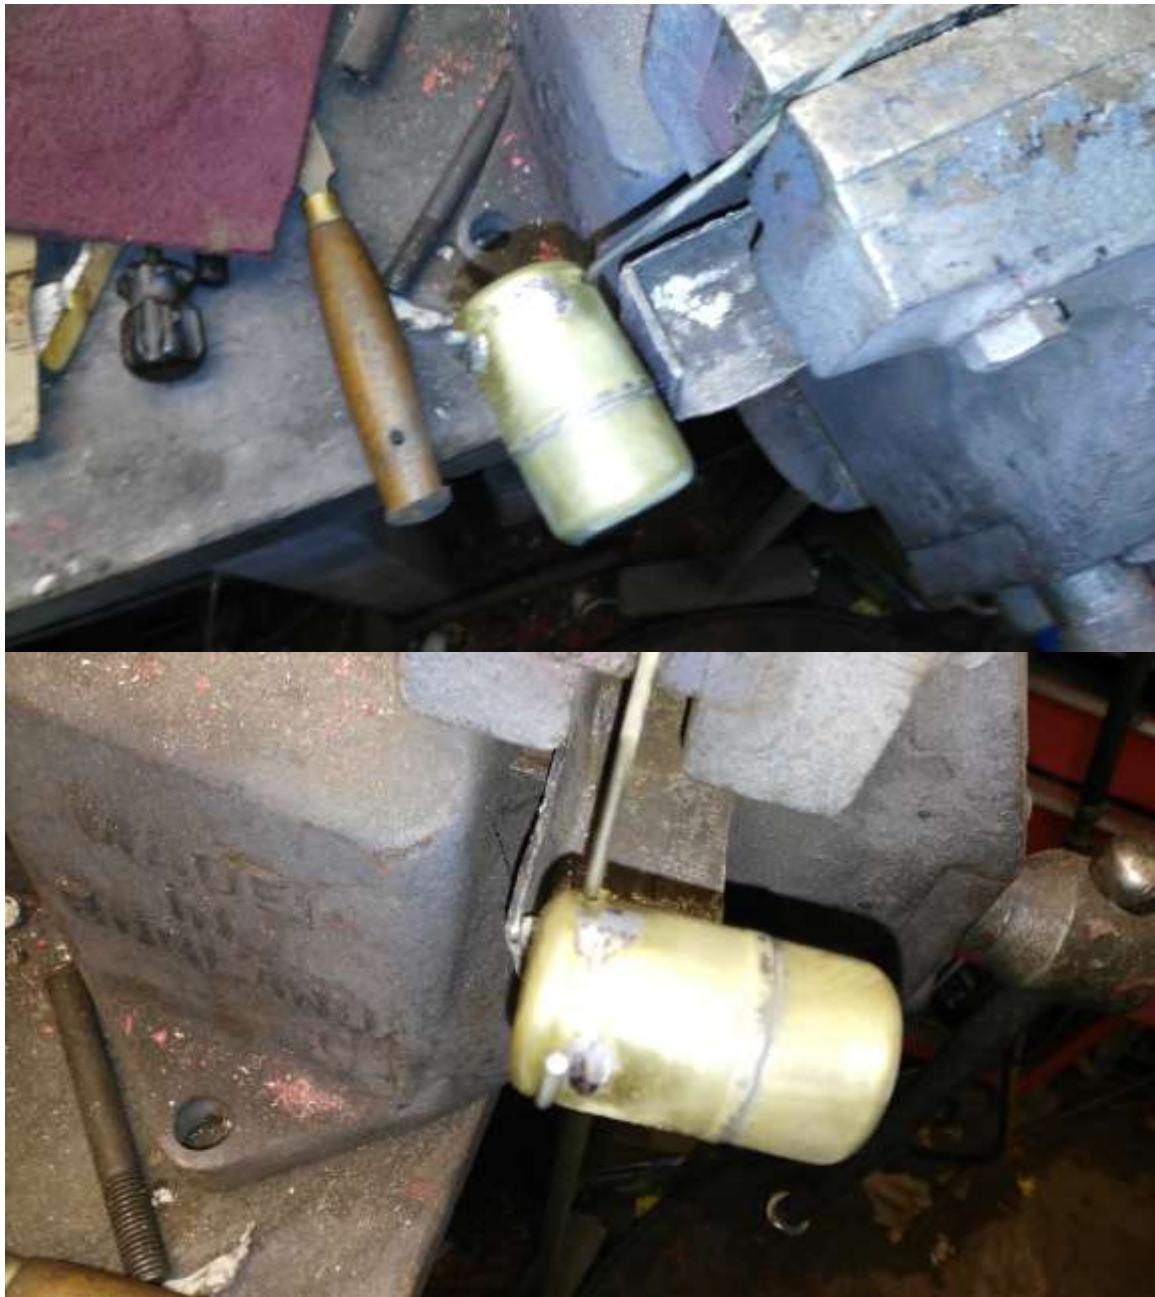
Decided to have a look at the fuel sender unit because its irritating me. Took the sender out and straightaway spotted that the float was full of fuel! So it had sank. I heated it up with a hair dryer and the fuel sprayed out like a fountain! There were 2 ver fine cracks in the brass float so I thoroughly cleaned it up and soldered them up. Refitted and all perfect!!

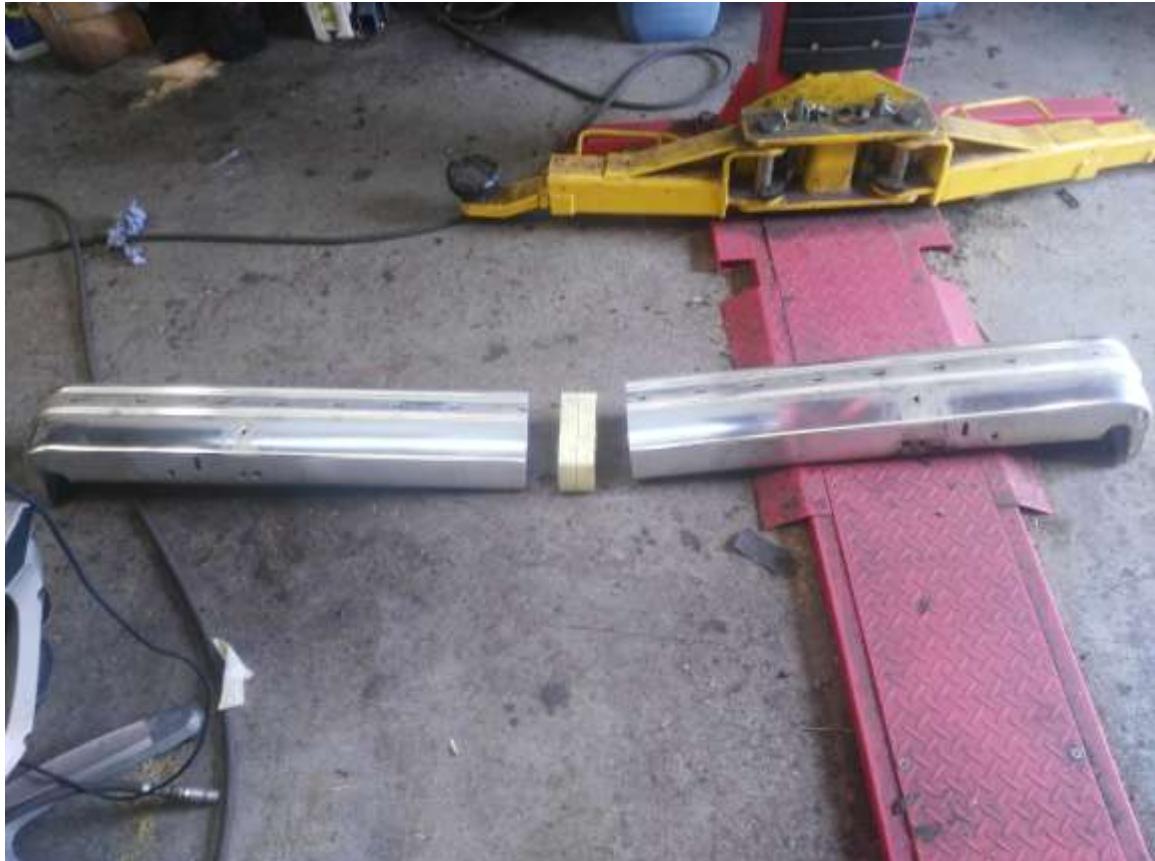
Rear bumper first. Needs fitting closer to the car and shortening.

7 cm section cut out.

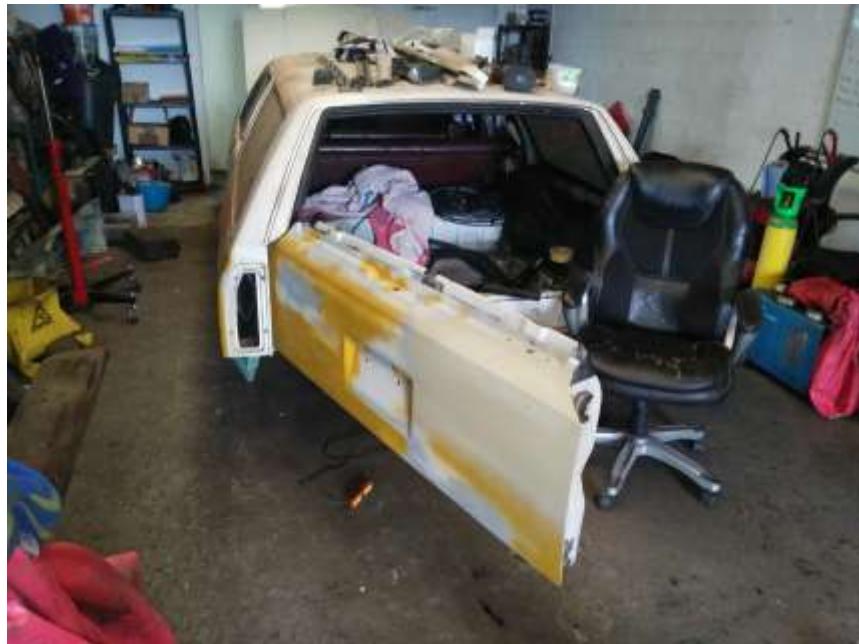
Wired up the tailgate and checked everything is working. Turns out that the rear window wont go up and down. Wiring diagrams later and discovered that I hadn't plugged in the switch on the dash!

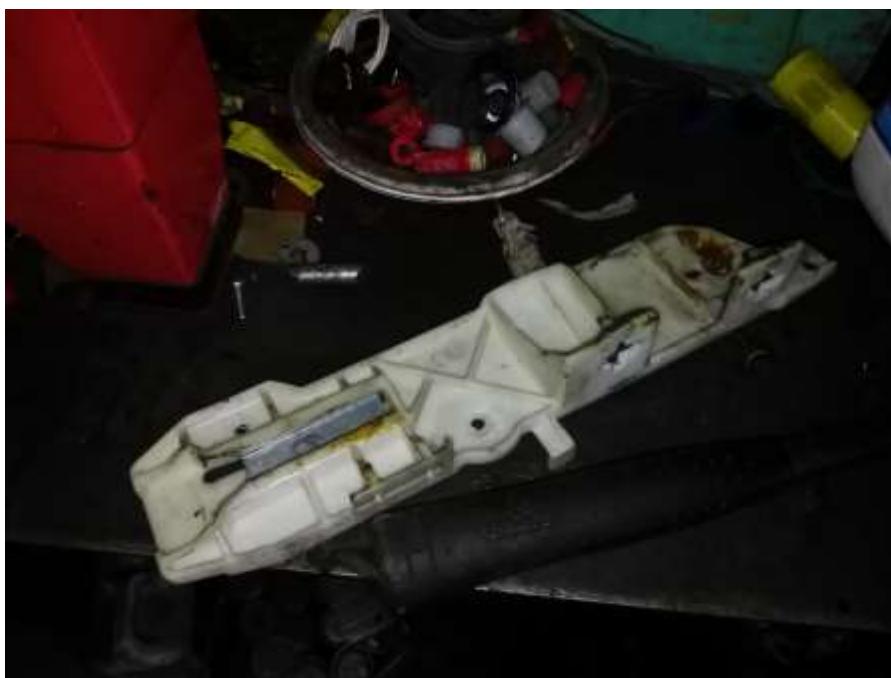
Noticed that one of the white plastic rear window brackets is cracked. Repaired it with a metal plate and tiger seal.

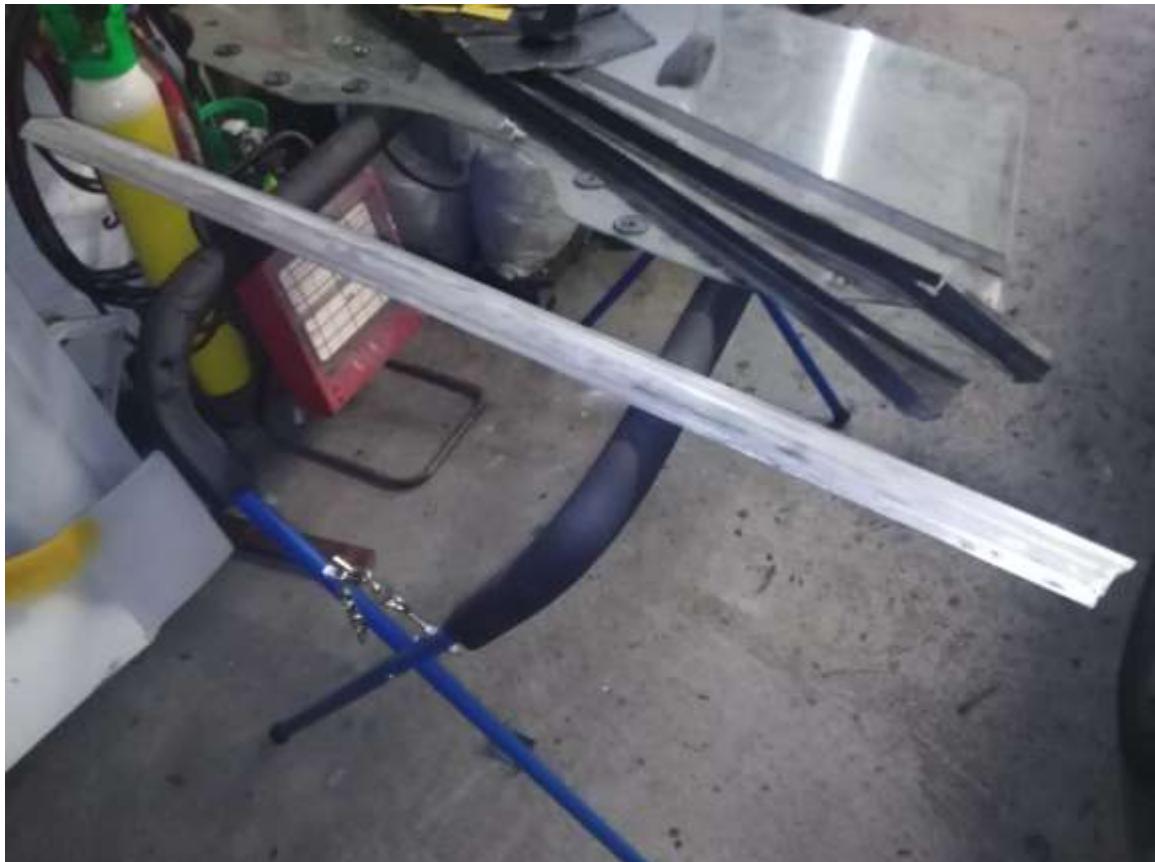
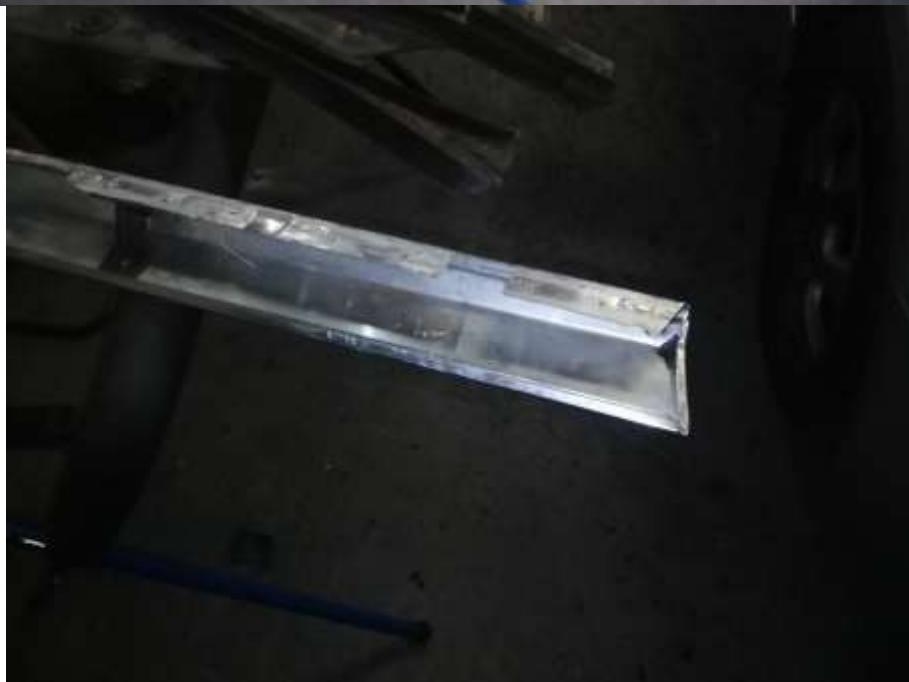
Top of tailgate trim rescued from the loft (the one from the scrap one) since it has no hi level brake light and looks waaaay cleaner.

All black paint stripped off, dents removed (may need slight filler) and all brackets removed from original one and transferred over.

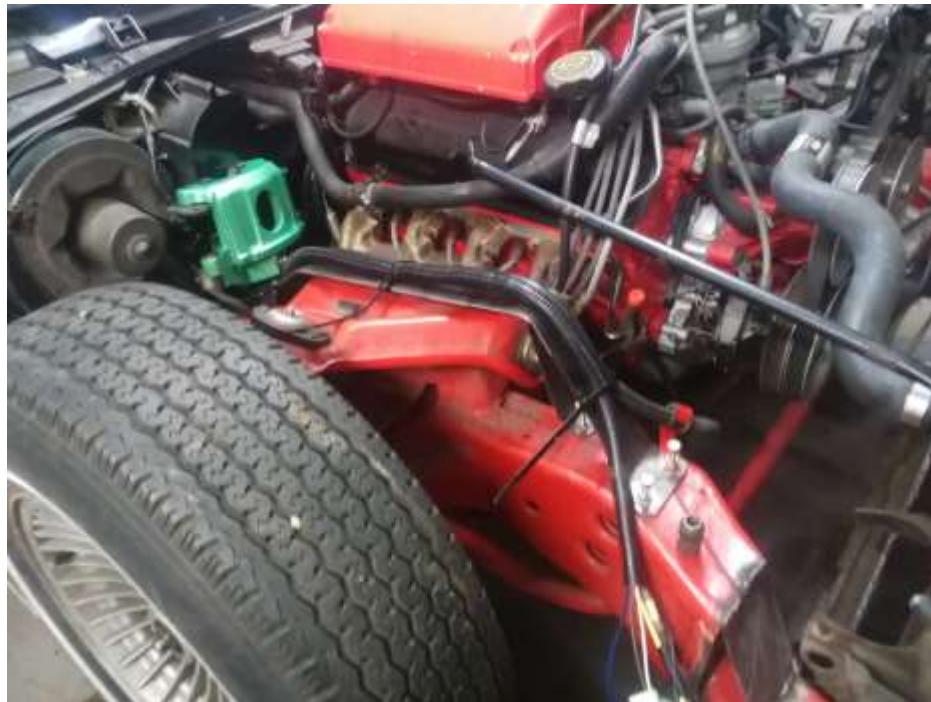
Attempted a fire up and sounded good. But the key turned like it was in treacle. Then started it a second time and the starter stuck in engagement while the engine was running. Sounded horrible, so turned the key off but starter kept turning! Disconnected battery quick. Phew.

After a bit of investigation, and after freeing the key off with WD40, I discovered the new starter solenoid had stuck on. So, threw it away, reinstalled the old one and its all systems go.

Old red battery cable clamps removed, rebent, old grommets removed, repainted and reinstalled in their new positions.

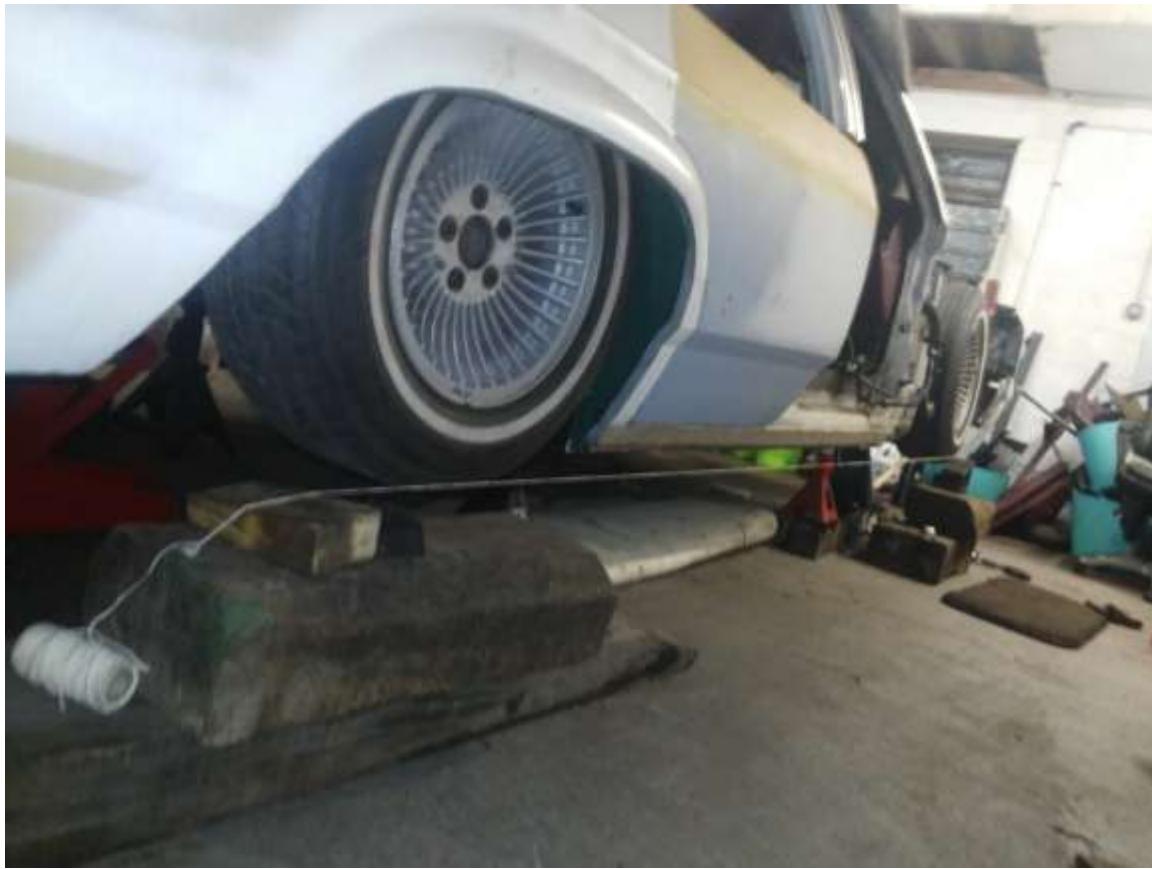
String put along the sill bottoms to determine how far the tyres stick below it. Which was about 1 to 2 cm. So very close. I need a tyre that goes to 10cm below the wheel rim at front and back. Research needed later.

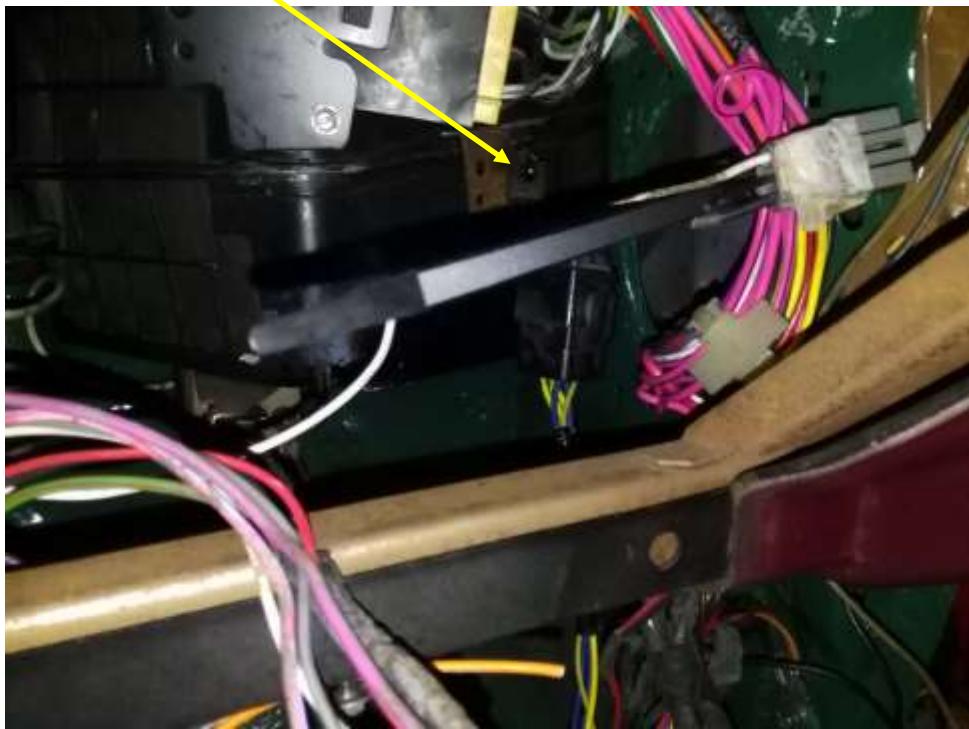
Relay located here under the passenger side of the dash. Attached to the bracket on the heater box.

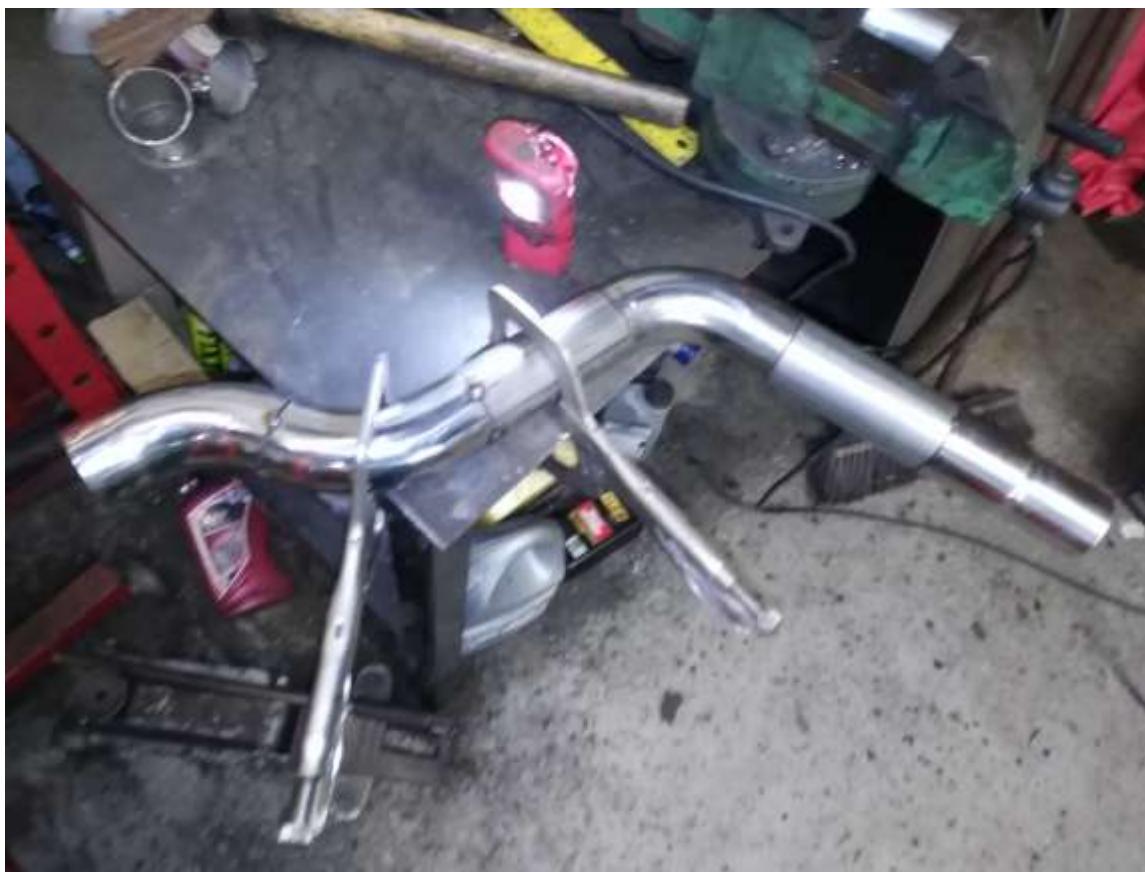
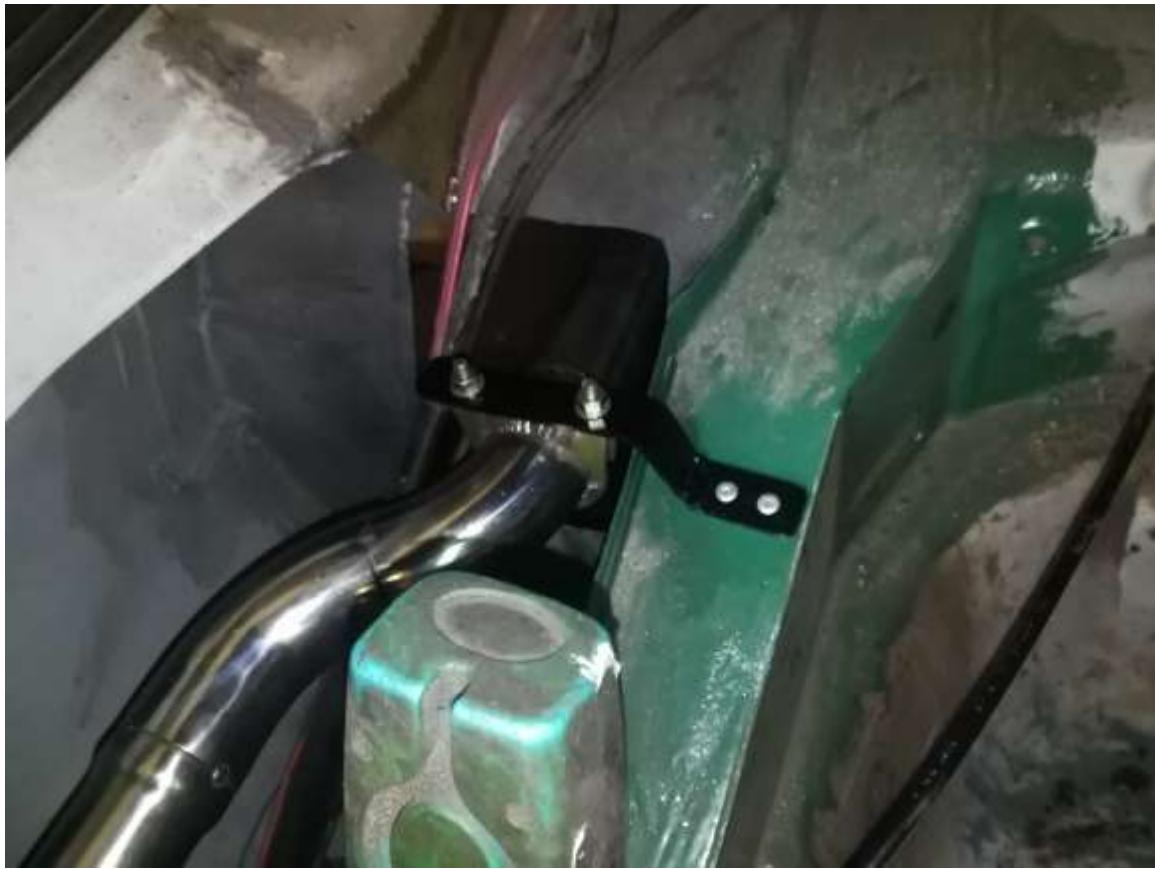
Finally arrived at this

The plan is to use the 180 degree 57mm (2 and a quarter inches) stainless pipe to come out of the tank, turn the corner, join to the 90 degree hose and join up with the fuel filler cap somewhere behind the light unit on a custom bracket.
