Implementation of Infrared Thermography in Power Utilities

Infrared thermography in Power Utilities

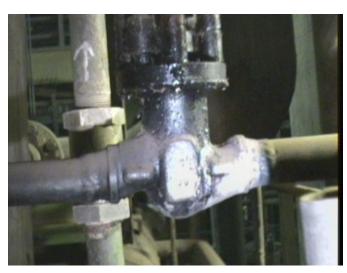
Visual image of the valve
