# Your house, understood before it's renovated.

We scanned the home in 3D and analysed structure, humidity and surfaces. This guide explains what we saw, shows you options — and collects your answers and comments so the final quotation hits exactly right.

**What's new in v2 (after your feedback of 19 August):** the kitchen water damage is now a full item — leaking stone-sink joints, the damaged cabinet below, and how we protect your quartz worktop during the works (section 08 and Q21). The roof-insulation text was clarified. Everything else is unchanged; if you already filled in pages of v1, you don't need to redo them.

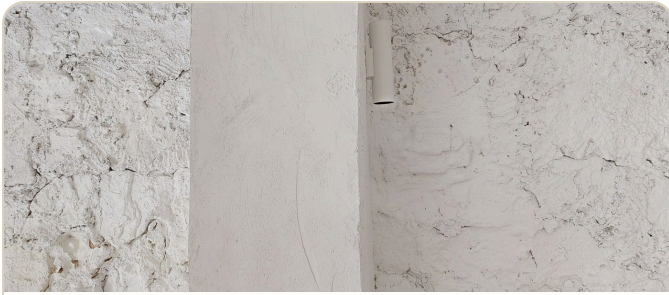
### Rising damp & crumbling joints

A watercourse is believed to run beneath the building. Moisture rises through the stone walls: the joints in the upper band crumble and stains show. The lower walls were already lined in the past — and the problem is worse today. Best proof that lining alone doesn't cure it.

The critical point are the timber beams bearing **inside** the damp wall. One has already failed. Behind cladding, that process would continue invisibly. So: first have the bearings assessed and cut the cause — then, gladly, whichever finish you choose (including a ventilated dry-lining).

1. A short diagnosis: moisture & salt readings, 2–3 small inspection openings in the existing lower cladding, and a check of every beam bearing.
2. Cut the cause: the measure follows the diagnosis — typically a horizontal damp-proof barrier at the base of the walls.
3. Restore breathably: lime joints and renders, mineral paint.
4. Then the look **you** choose: restored exposed stone or a white **ventilated** dry-lining — both fine once the cause is treated.

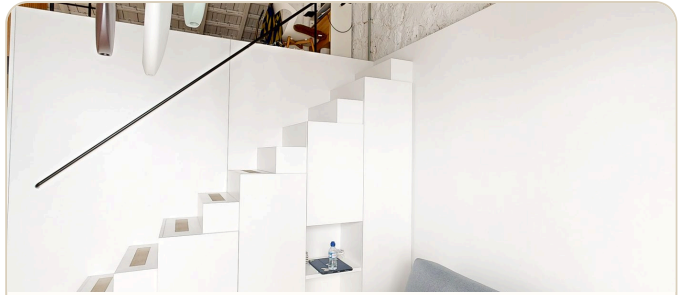
### Broken beam, sagging ceiling & non-compliant stairs

One roof beam is broken and a ceiling section sags; steel reinforcements from an earlier intervention exist. The current staircase doesn't meet building code (CTE DB-SUA).

**Q7** Happy for a structural engineer to check all beams and bearings first, and to fix the final scope after that?

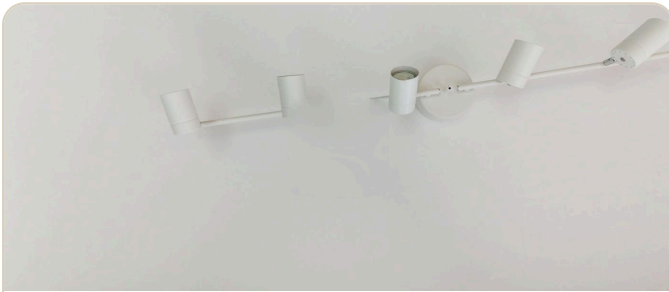
### Hairline cracks in the kitchen ceiling

Fine cracks show in the kitchen ceiling. We'll map them during the diagnosis to distinguish cosmetic cracks from structural warnings.

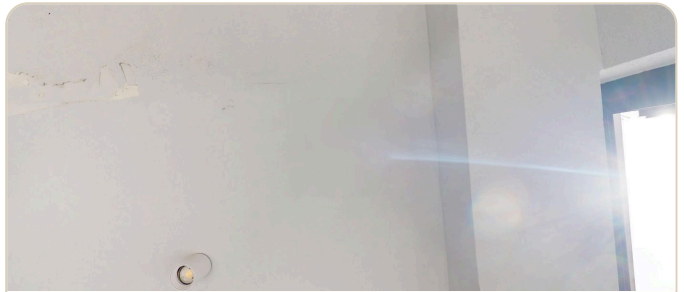
### Outdoor bathroom with damp damage

The small patio bathroom/laundry shows peeling paint, stains and mould — and the WC sits outdoors. It deserves a place in the plan.

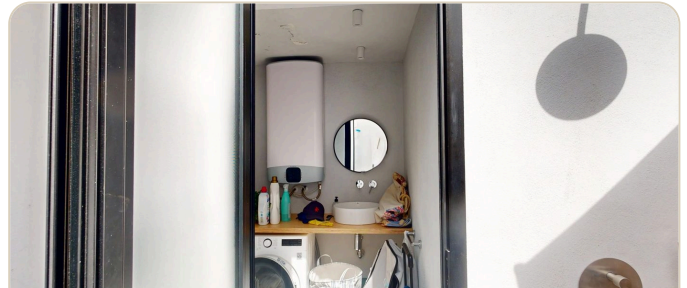
### The patio bathroom/laundry

Peeling paint, damp and an open-air WC. What would you like to do?
