# 156

## Cleaning and Lubrication of Bonnet/Hood Catch

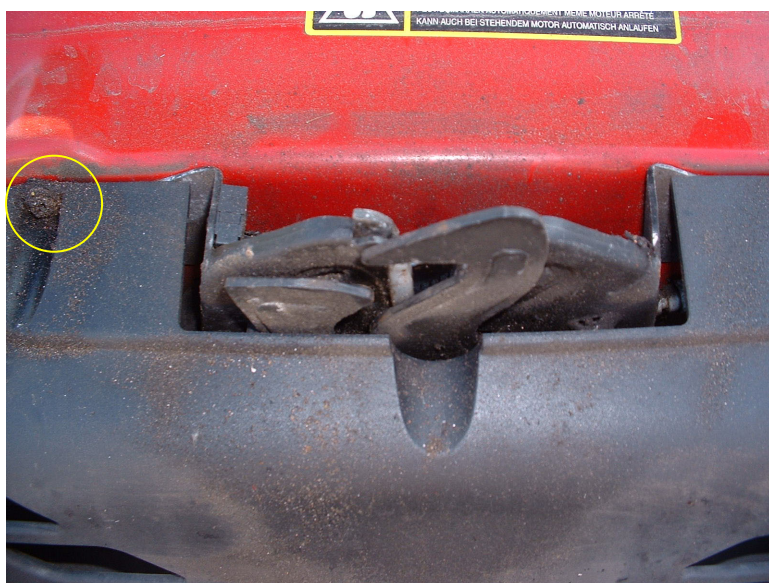
This is the catch as you probably all know, it is encrusted with dirt and grit, which has adhered to the grease. I don't therefore condone adding any more.

The plastic cover is retained by 2 pozidrive screws either side of the catch, one is circled in the photo.

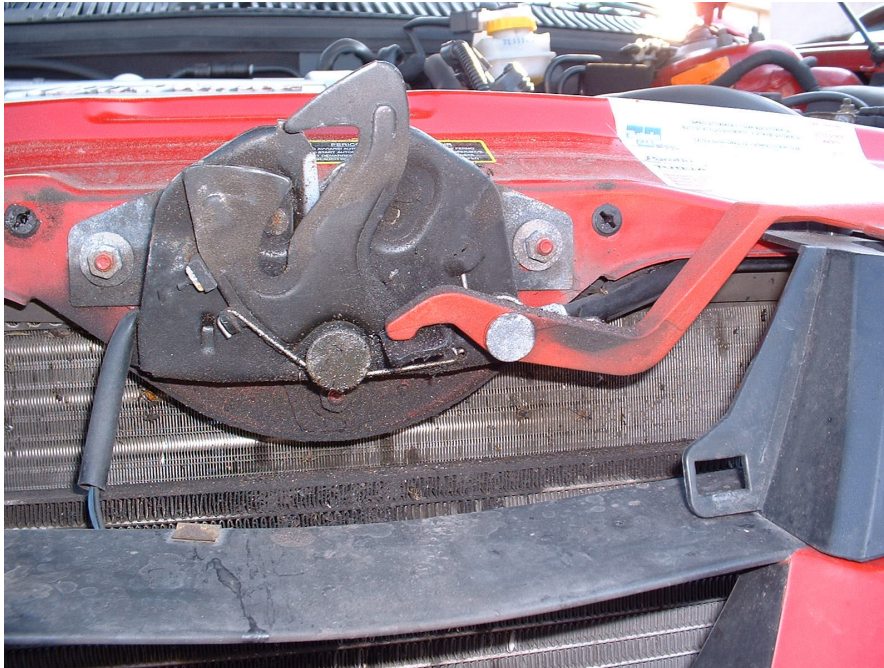
This is what the catch looks like under the cover, even with the plastic cover, you can see that it has accumulated a huge amount of dirt, this car is only a year old. The outer part of the mechanism is the secondary catch and its spring.

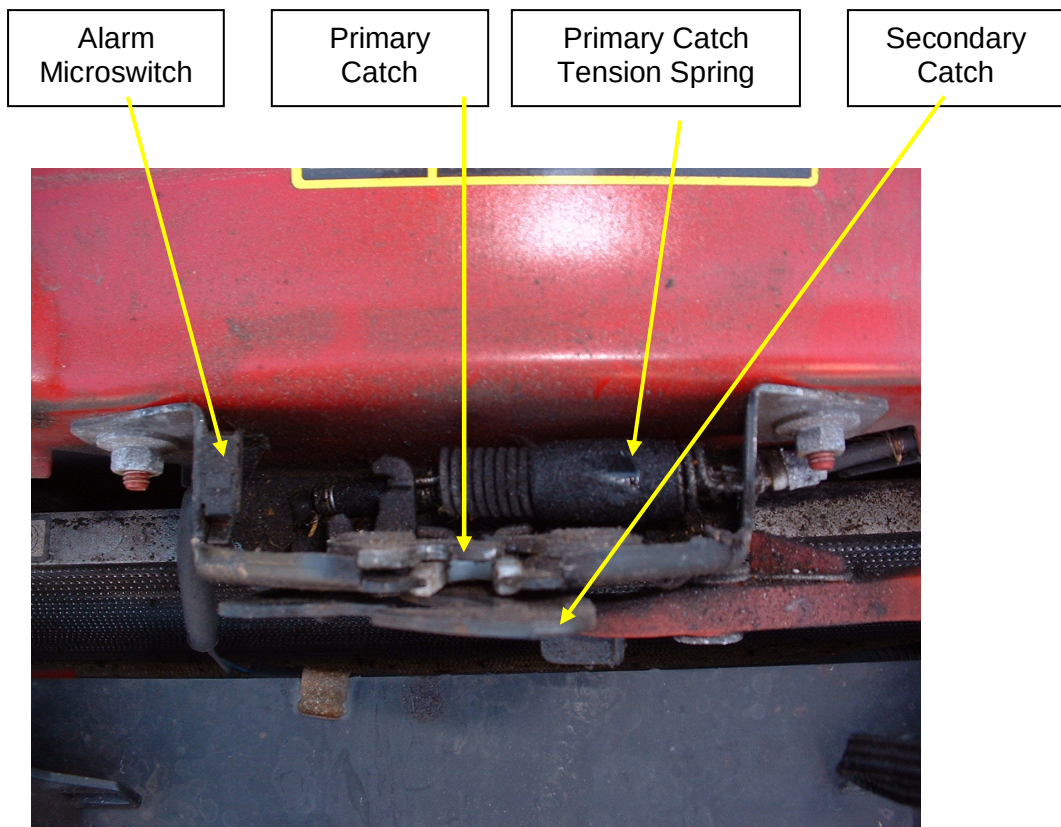
The Parts in plan Detail

The movement on my catch, although holding the bonnet steadfast, felt gritty in operation and not at all smooth, to begin, I drenched the mechanism in GT20 release and lubrication fluid, although WD 40, Duck Oil or similar products would work just as well, loosening the dirt, flushing it out and leaving lubricant behind, displacing water

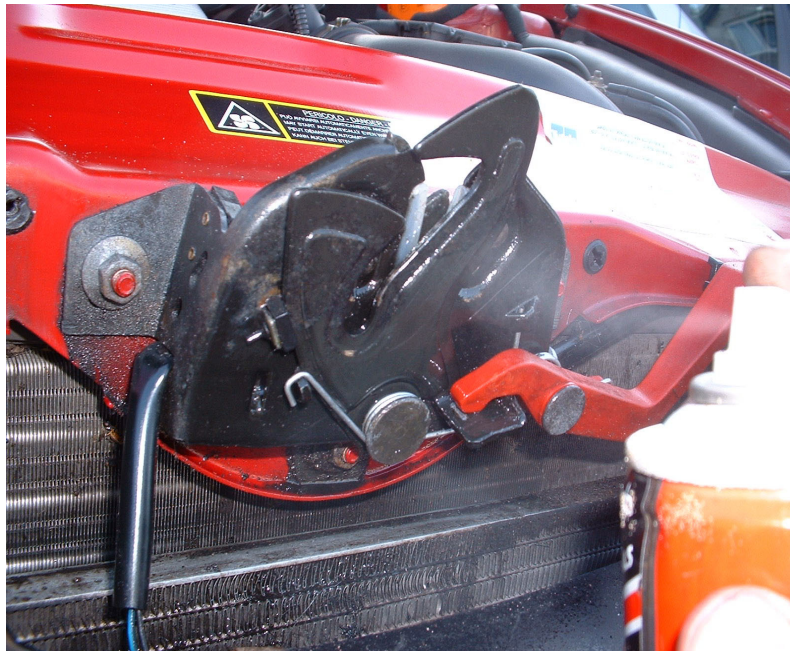
as it does so. As you can see it quickly cleaned up the secondary (outer) catch mechanism, it pays to have some rags below to catch the liquid as it falls. Keep spraying until the mechanism is completely clean, I also used cotton buds to assist in cleaning it right up. Continue this process until the mechanism moves freely and the spring returns the catch sharply to its locked position.

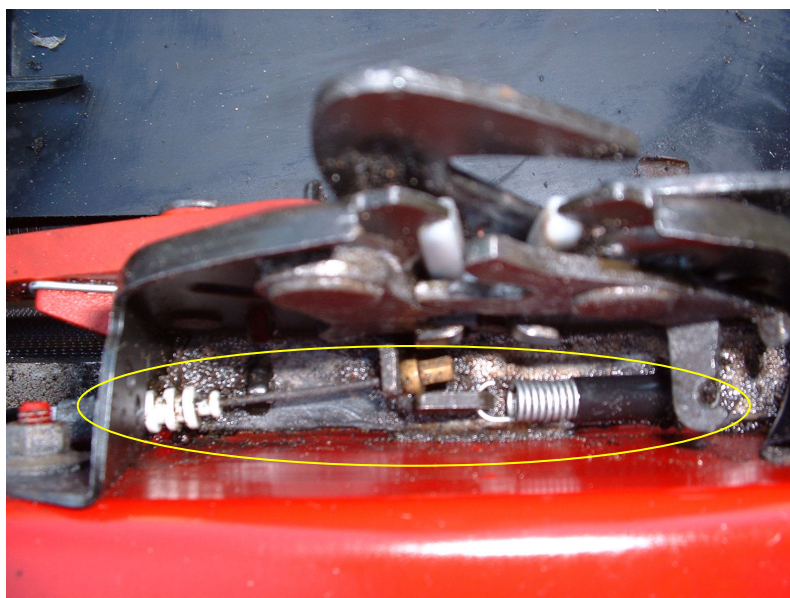
Spraying this from above though was not really satisfactory and the grit could still be felt in the main tension spring, therefore it was removed from the circled area with long nosed pliers and cleaned up off the car before replacing it carefully. Make a note of how it was attached before you remove it to ensure it goes back in the right way round as it is

asymmetrical. The smaller spring you see in the picture above tensions the release cable..

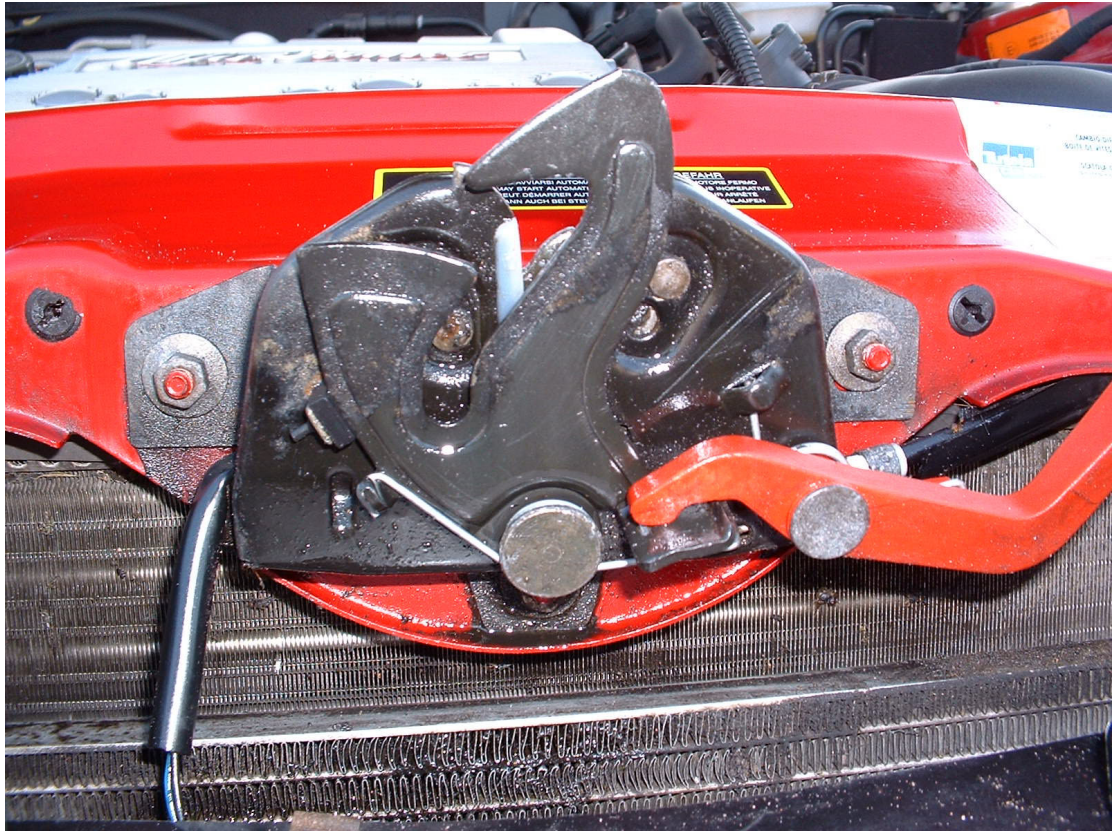
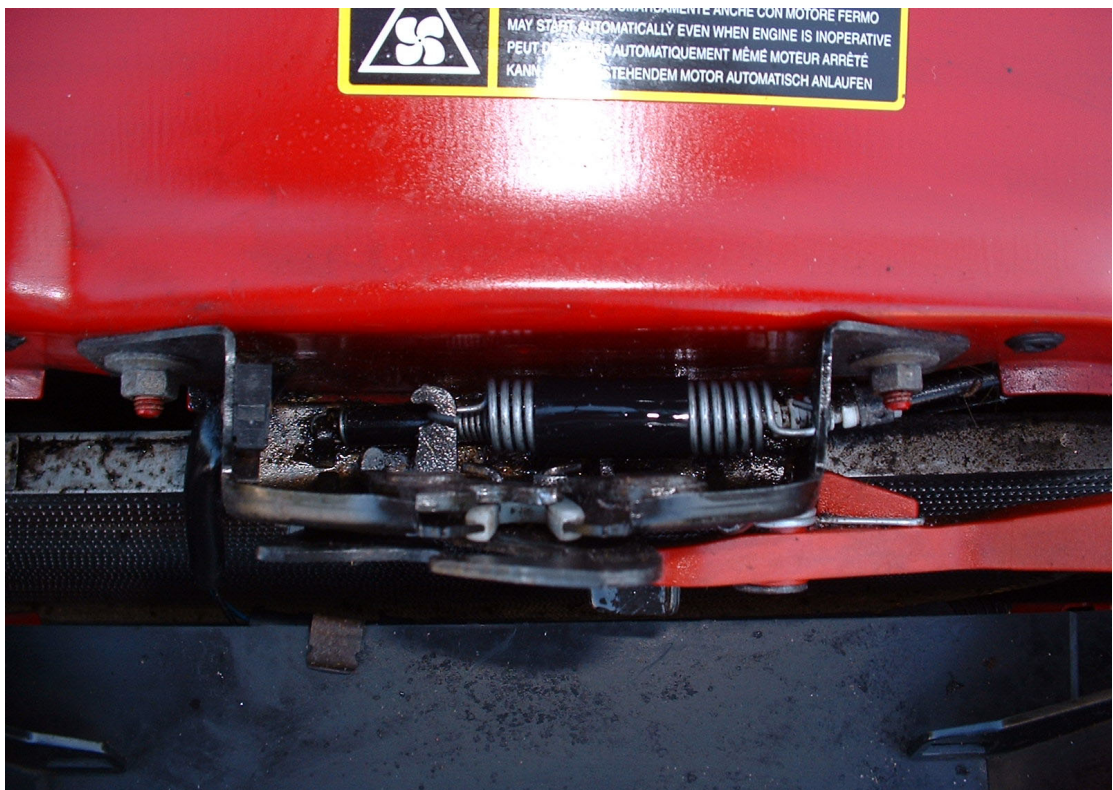
These pictures show the mechanisms fully cleaned and lubricated, the catches should move smoothly under pressure and return strongly to their latch positions. Quite an improvement on the earlier images, the dirt on the radiator and condenser are due to me not protecting them during this process – be warned!

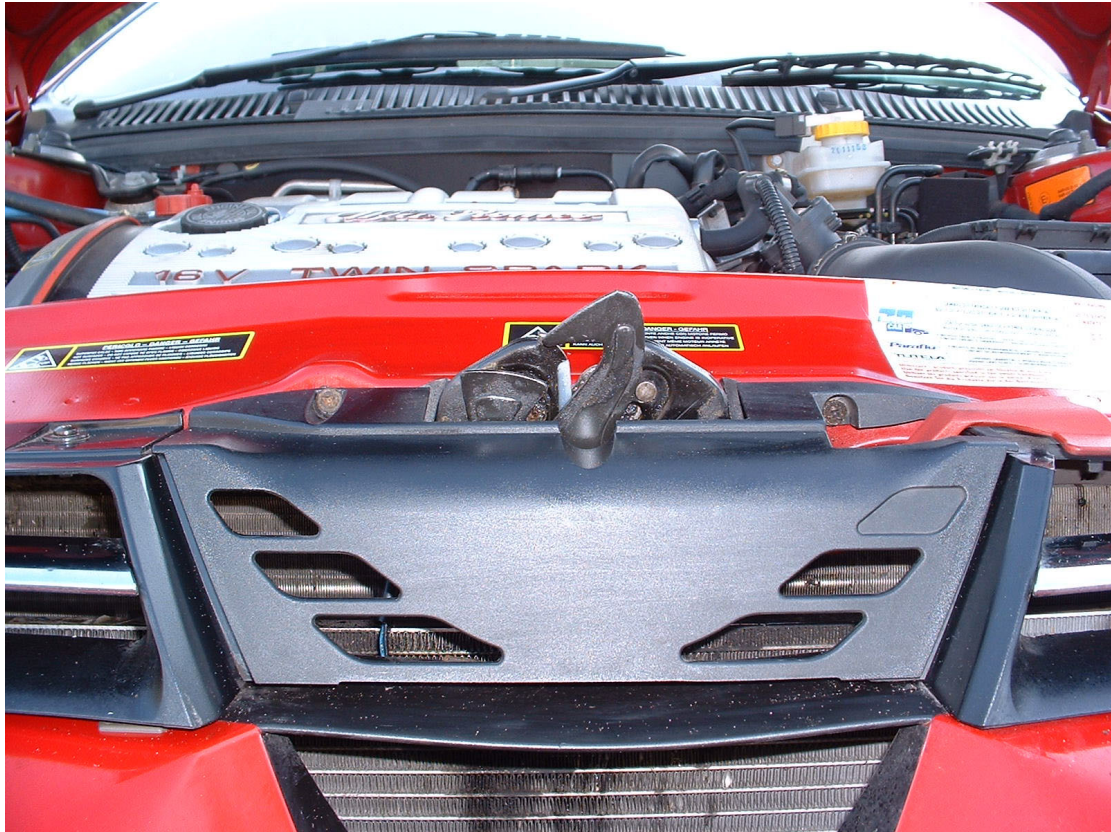
At this stage, replace the plastic cover.

Now – IMPORTANTLY close the bonnet and pull on it as hard as you can, it should stay steadfastly closed. NOW pull the bonnet catch and try and pull the bonnet past its second latch without operating the under bonnet lever, again, this should hold fast, then ensure the second catch opens, then drop it back onto the secondary latch and pull it again.

Repeat this 3 or 4 times to ensure complete security, if it slips, there is likely to be a problem with the springs, or the alignment of the mechanism or hook on the bonnet itself – GET HELP.
