# Assessment of the influence of corrosion on the structural performance of a steel truss railway bridge

Giuseppe Mugnos

Dismat s.r.l.

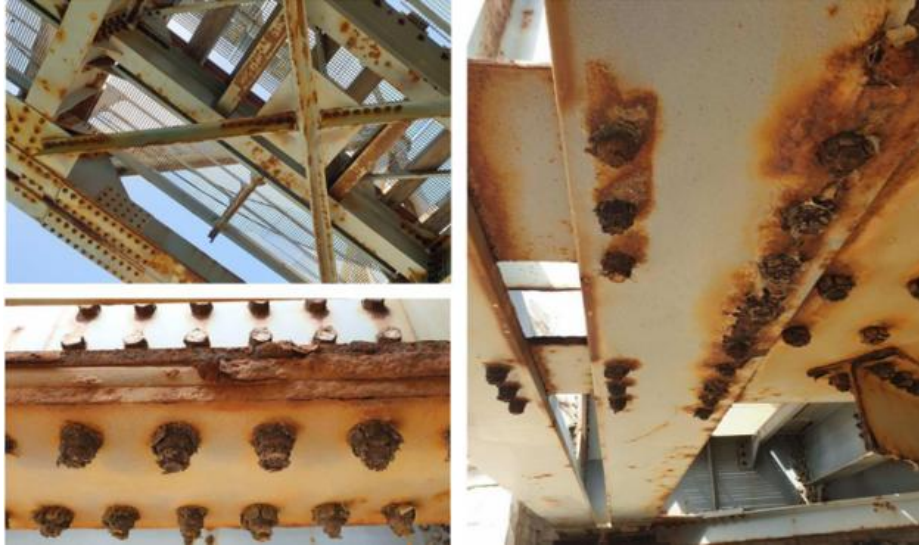
The deterioration observed prior to the work was primarily attributable to the corrosion of metal surfaces and, more notably, of the bolted connections. In some instances, oxidation had significantly affected the bolts, potentially reducing their load-bearing cross-section and consequently compromising the local efficiency of the connection. This phenomenon is particularly critical in a truss bridge, as the connections facilitate the transfer of axial forces between members and maintain the system's overall structural stiffness.

**Fig. 3.** State of corrosive degradation observed on bolted joints and metal surfaces.

The major maintenance project involved replacing the bolts, abrasive blasting the metal components, and applying a protective coating. The objective was not only to halt the surface deterioration process but also to restore connection conditions that aligned with the structure's original configuration, thereby enhancing its durability and operational performance.

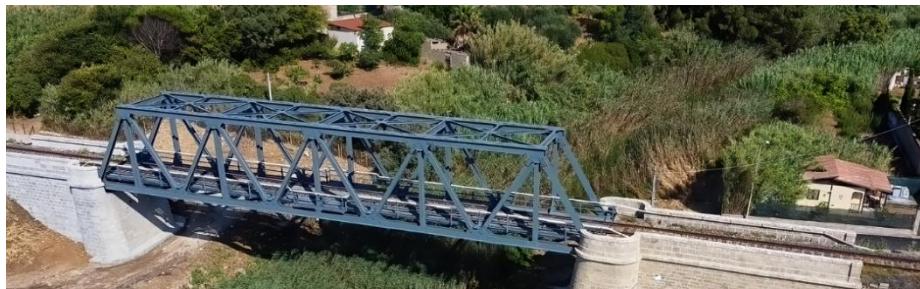
**Fig. 10.** Photo of the Forgia Bridge after completion of the work.
