# Effect of degradation on the structural behaviour of an existing cantilever reinforced concrete bridge in Southern Italy

## Abstract

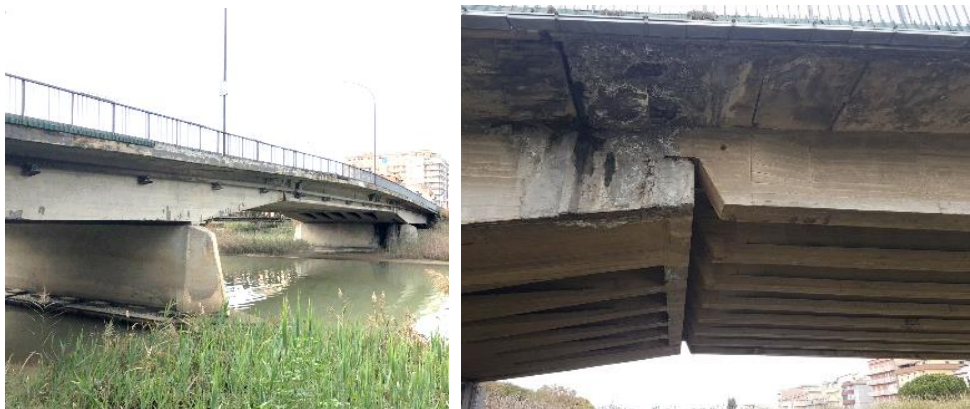
Actually, from the original drawings, it is evident that the saddle was not poorly dimensioned at the time of the project, showing no state of suffering or cracks, apart degradation (Fig. 3).

Fig. 3 Pictures of the brige. General view and Gerber saddle.

From Figure 3 it can be noted that the outermost beam presents the most deteriorated half-joint, with damage due to water drainage and corrosion of exposed reinforcements in the bottom corbel. A maintenance intervention closed the damaged zone with thixotropic mortar, but the deterioration of the saddle did not stop, and the phenomenon is still advancing with corrosion of reinforcements and drainage of water from the joint that induces damage of internal beams, too.
