# Risk of failure for the salso river railroad steel bridge

Giuseppe Campione<sup>a,\*</sup>, Elio Lo Giudice<sup>b</sup>, Francesco Cannella<sup>a</sup>

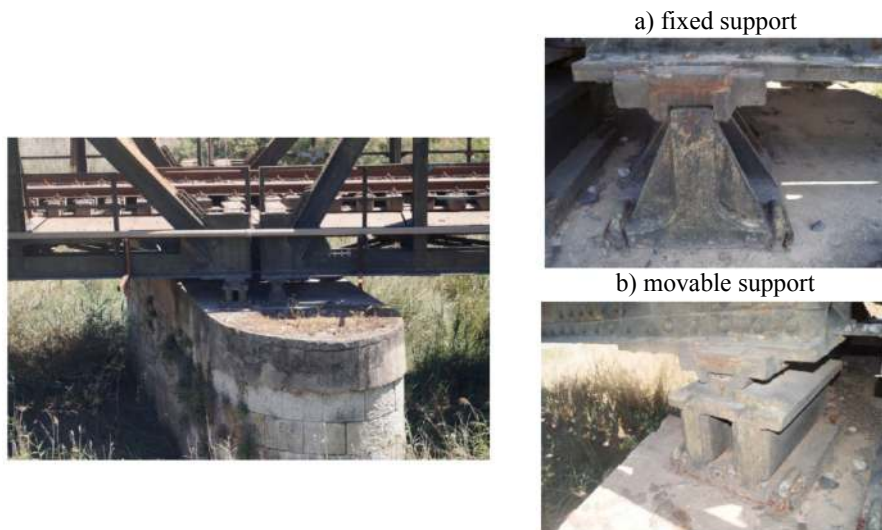
Fig. 9. Damages induced by corrosion on steel devices of the bridge.

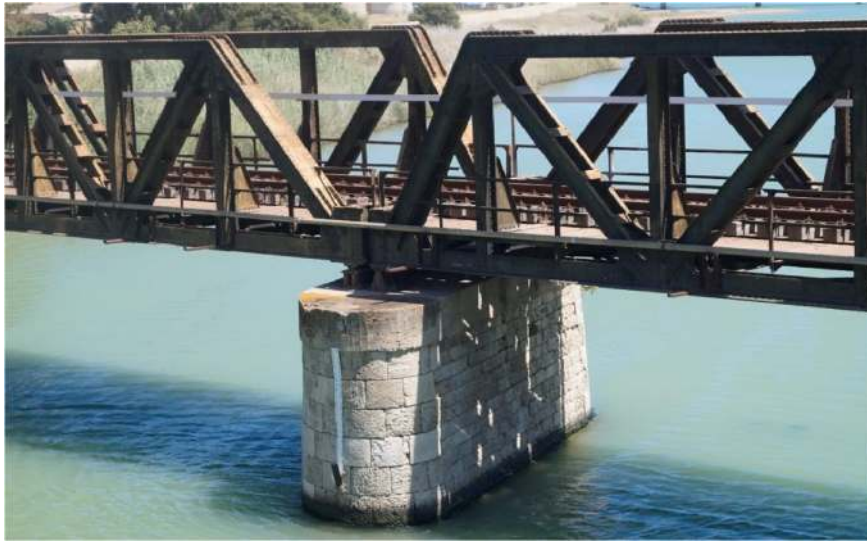
Fig. 10. Masonry central pier.

The substructures constituted by two shoulders and two piles are realized in masonry with squared stone blocks having at the top a partition in reinforced concrete on which the support devices rest (see Fig. 10). The shoulders have a height of 340 cm; one of the stacks of 396 cm and the other 530 cm, and their axis is inclined by  $19^\circ$  with respect to the direction normal to the bridge axis (they follow the direction of the river's flow). It has to be stressed that the substructures are those of the original bridge (with multiple trellises); they were maintained for installation of the new deck. About the reinforced concrete curb, it is therefore assumed that it was made when the steel bridge was replaced. Fig. 11.

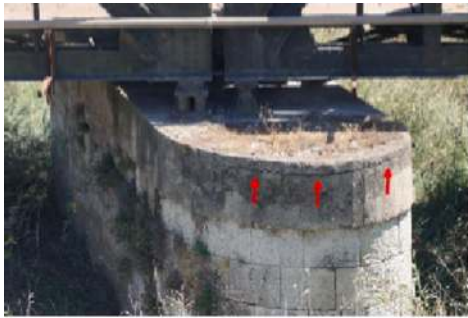
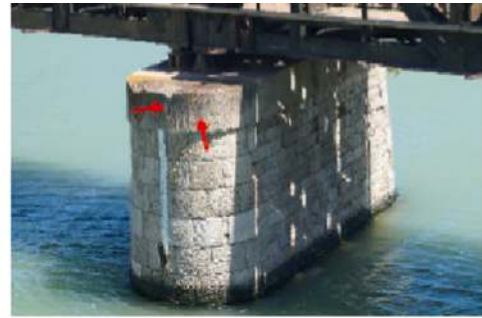
Signs of deterioration are also visible on the piles, where there are lesions, loss of concrete cover, and disintegration of the mortar joints.

Fig. 11. Damages due to: a) concrete cover spalling; b) disintegration of mortar joints.

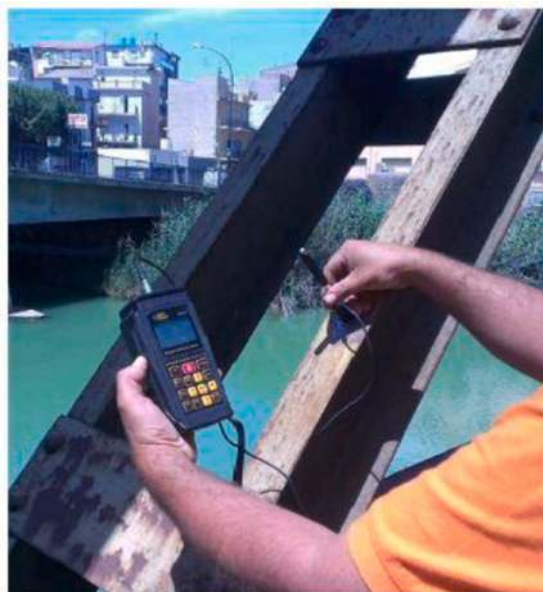
The microhardness tests with the Leeb method, was based on the dynamic (rebound) method according to the following methodology: a stop body with a metal tip hard is projected by a spring against the surface of the object to be analyzed; the impact causes slight deformation of the surface, which leads to a loss of kinetic energy. This loss is calculated by measuring the speed of impact ( $v_i$ ) and rebound ( $v_r$ ) at a precise distance from the surface. These are measured through a permanent magnet in the impact body, which generates an induced voltage in the firing pin probe. The voltage identified is proportional to the speed of the impact body. Signal processing provides hardness. Fig. 12 showed the execution of tests. Table 1 gives the Leeb Hardness values, which in accordance with ASTM A956 was related to Vickers hardness and yielding stress. Hardness values were related as suggested in ASTM A956 to range of yielding stress in between 350 and 400 MPa.

Fig. 12. Hardness test of steel profiles with Leeb method.

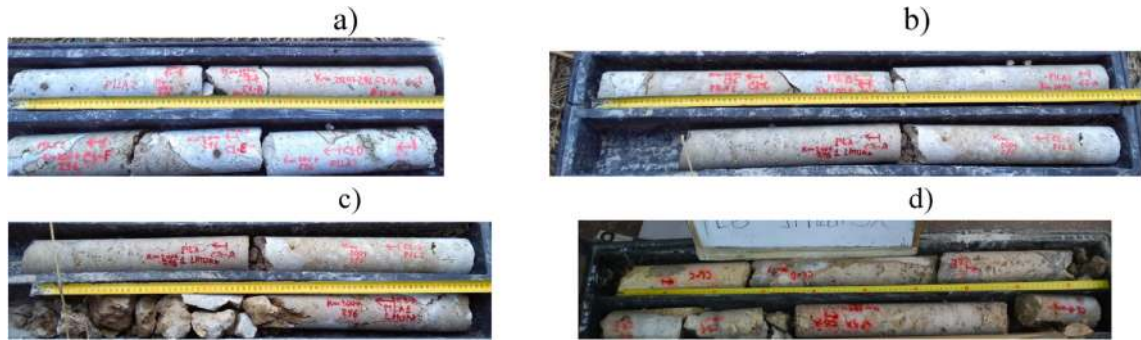
Carrots 1, 2, 3, 4, 5, shown in [Fig. 14](#) a), b), c), d), are extracted neatly and placed in the appropriate boxes, from which it is possible to identify the succession of the layers crossed and therefore the relative depth.

Fig. 14. Core extracted from piers and batimens.

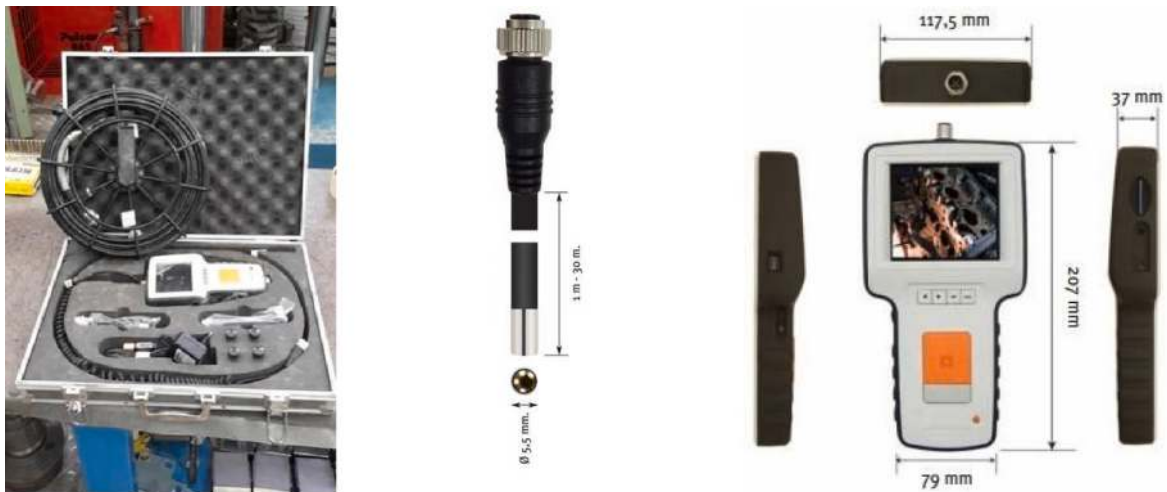
[Fig. 15](#) shows the images of the endoscopic investigations performed with an MIGS v03 handheld model endoscope. The endoscopic images were taken inside each coring for a depth of about 160 cm. The entire wall facing is uniform, and there are no obvious discontinuities in the wall type. However, as can be seen in the images, there are slight cavities inside the masonry. Furthermore, the part that constitutes the curtain and that of the filling are clearly distinguished.

Fig. 15. Endoscopy for investigation on masonry.

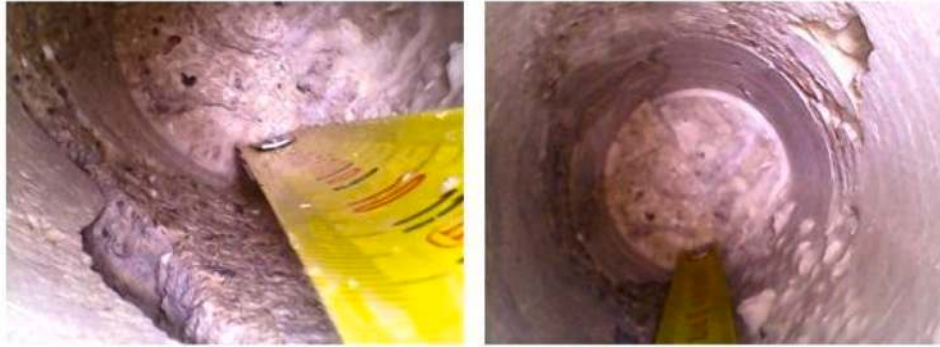
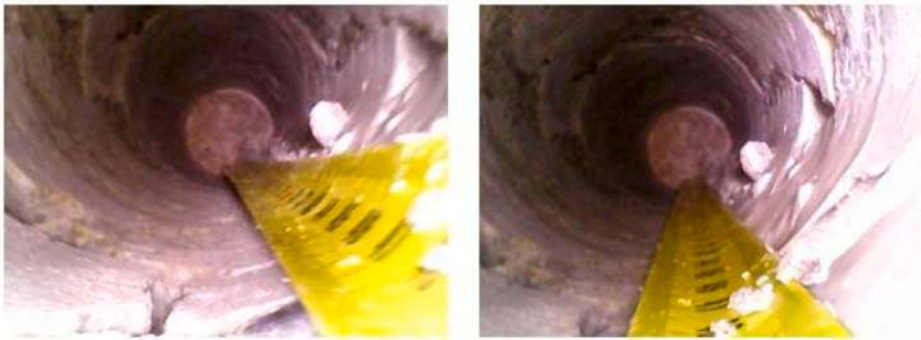
Fig. 16. Endoscopic tests on hole determined on per by extraction of core 1 and 2.

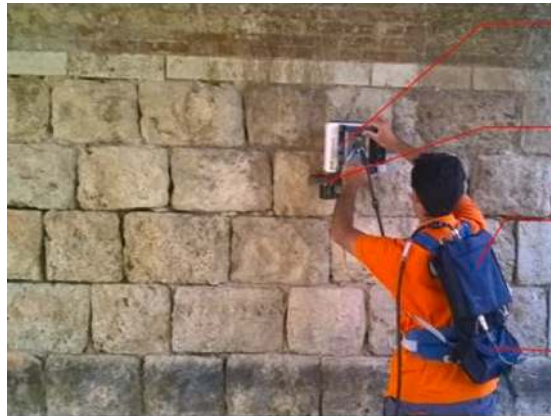
From the georadar survey carried out, no anomalies were found inside the masonry. In some radargrams shown in Fig. 18, perturbations were found, probably attributable to large-sized stone material. Below is one of the radargrams of the survey on which the perturbations are highlighted in the red boxes.

Fig. 17. Georadar test on pier 1 and 2.
