# **CII-SR Kaizen Circle Competition 2018**

**(EVEREST INDUSTRIES LIMITED)**

**Kaizen Theme:** To Reduce power consumption by eliminating vacuum pump & 60hp motor.

**Implemented Area:** Sheeting Machine -1 Shop floor, Podanur Works, Coimbatore

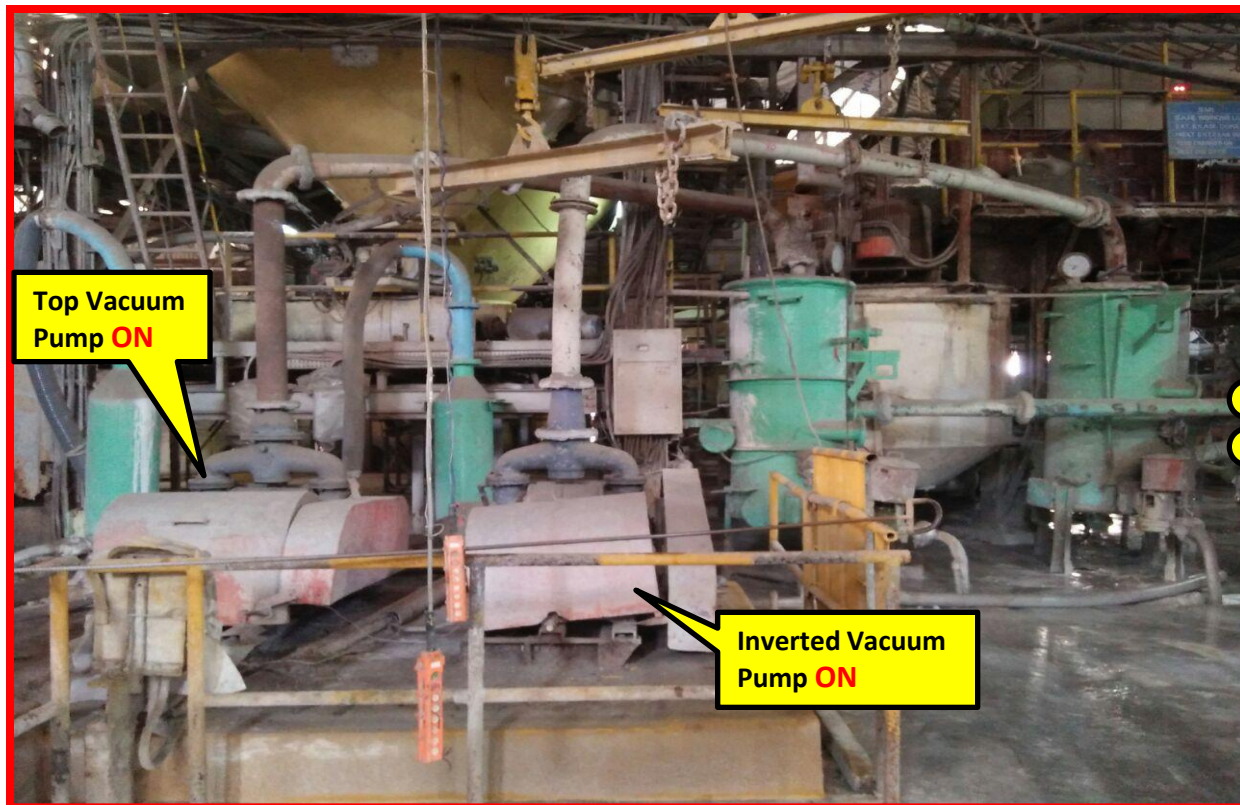
- In this, it shows flow of Vacuum through the pipe lines & vacuum chambers towards Top & Inverted vacuum pumps when both the vacuum pumps are in **ON** Condition.

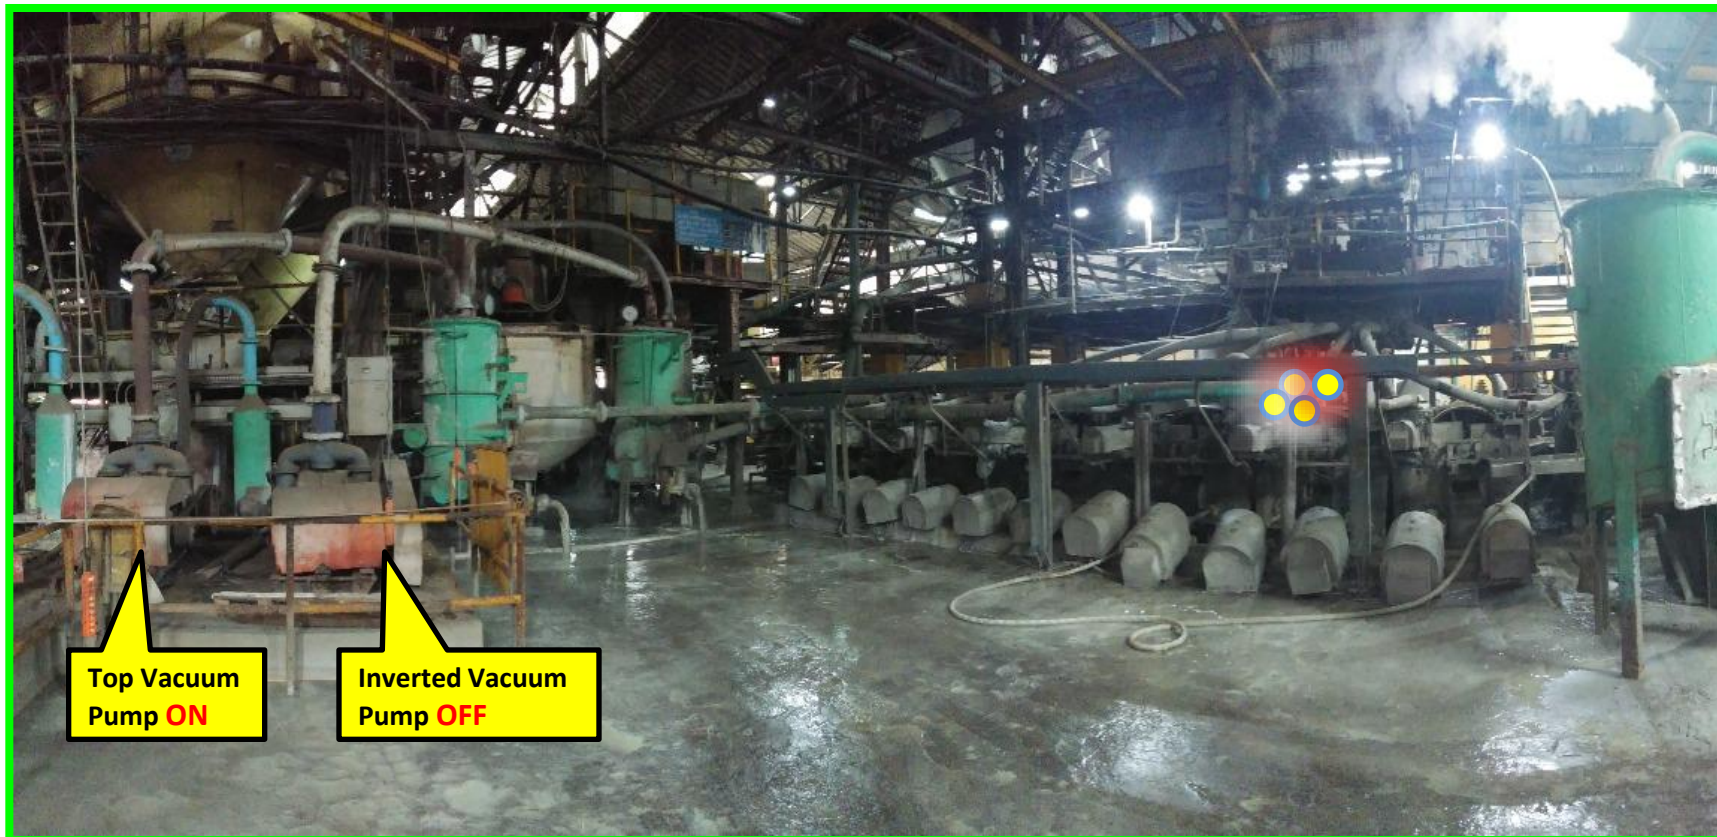
- In this, you can see Top vacuum pump is **ON** bottom vacuum pump is **OFF**.
- Vacuum flows towards Top Vacuum Pump through Top & Inverted vacuum trays pipe lines & vacuum chambers. But vacuum does not flows towards Inverted vacuum pump.
- Vacuum from inverted vacuum trays flows towards Top vacuum pump through pipe lines, then to Inverted vacuum chamber and then to Top vacuum chamber.

| SN | Counter Measure Activity |
|---|---|
| 03 | Provided common vacuum line b/w top trays vacuum chamber & Bottom vacuum chamber to utilize one vacuum pump instead of two vacuum pumps. |
