# **CII SR -14th Edition Kaizen Compétition 2019**

**EVEREST INDUSTRIES LIMITED**  
**(Podanur Works – Coimbatore)**

**Kaizen Theme:** To improve productivity by reducing Machine cycle time.

**Implemented Area:** Sheeting Machine-1 Shop Floor, Podanur Works, Coimbatore

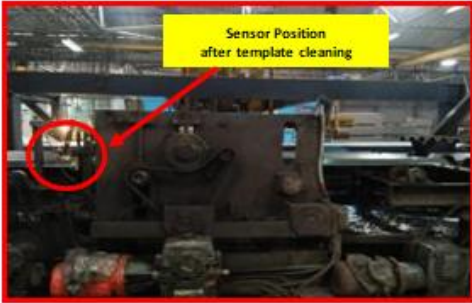
| Kaizen Sheet | | | | | | | Company | MM/YY | S.No | | | | | | | | | | | | |
|---|---|---|---|---|---|---|---|---|---|---|---|---|---|---|---|--|--|--|--|--|--|
| <b>Problem/Present Status:</b><br>Cycle time of the Template supply system to Piling machine is 16 seconds. Because of this we can't able to reduce the machine speed below 16 sec. | | | | <b>Before Improvement:</b><br> | | | <b>Implemented by:</b><br>M. Vijay Kumar, Srinivasagam, M. Gnanaprakash, N. Anil kumar, N. Karthikeyan, Narayanasamy | | | | | | | | | | | | | | |
