# **CII SR -14th Edition Kaizen Compétition 2019**

**EVEREST INDUSTRIES LIMITED**  
**(Podanur Works – Coimbatore)**

**Kaizen Theme:** To reduce Breakdowns of Hog Beater Gear Box.

**Implemented Area:** Sheeting Machine-1 Shop Floor, Podanur Works, Coimbatore

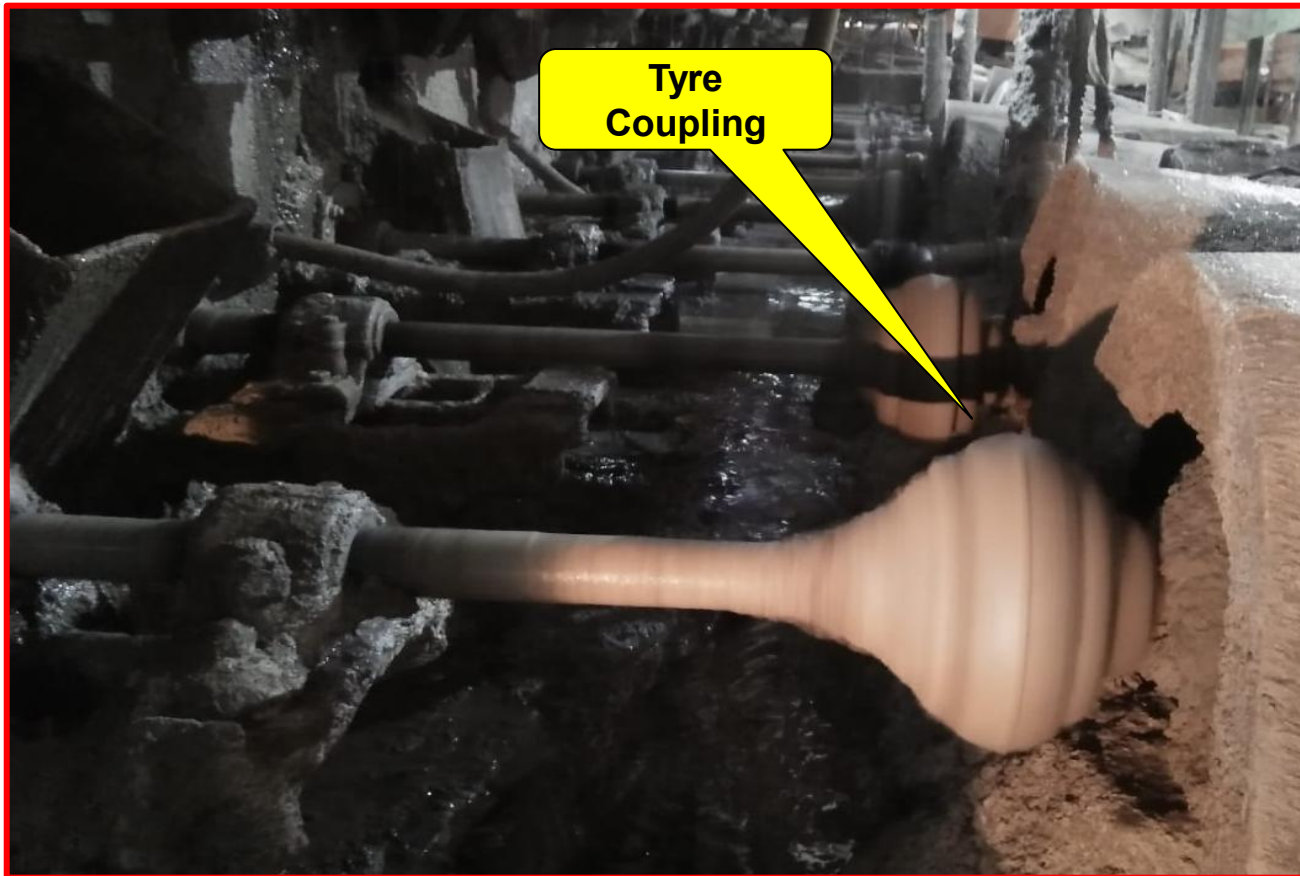
By using Tyre coupling, vibrations from Hog Beater shaft is transferring directly to Gear Box. Due to this there is frequent failure of Gear Box.

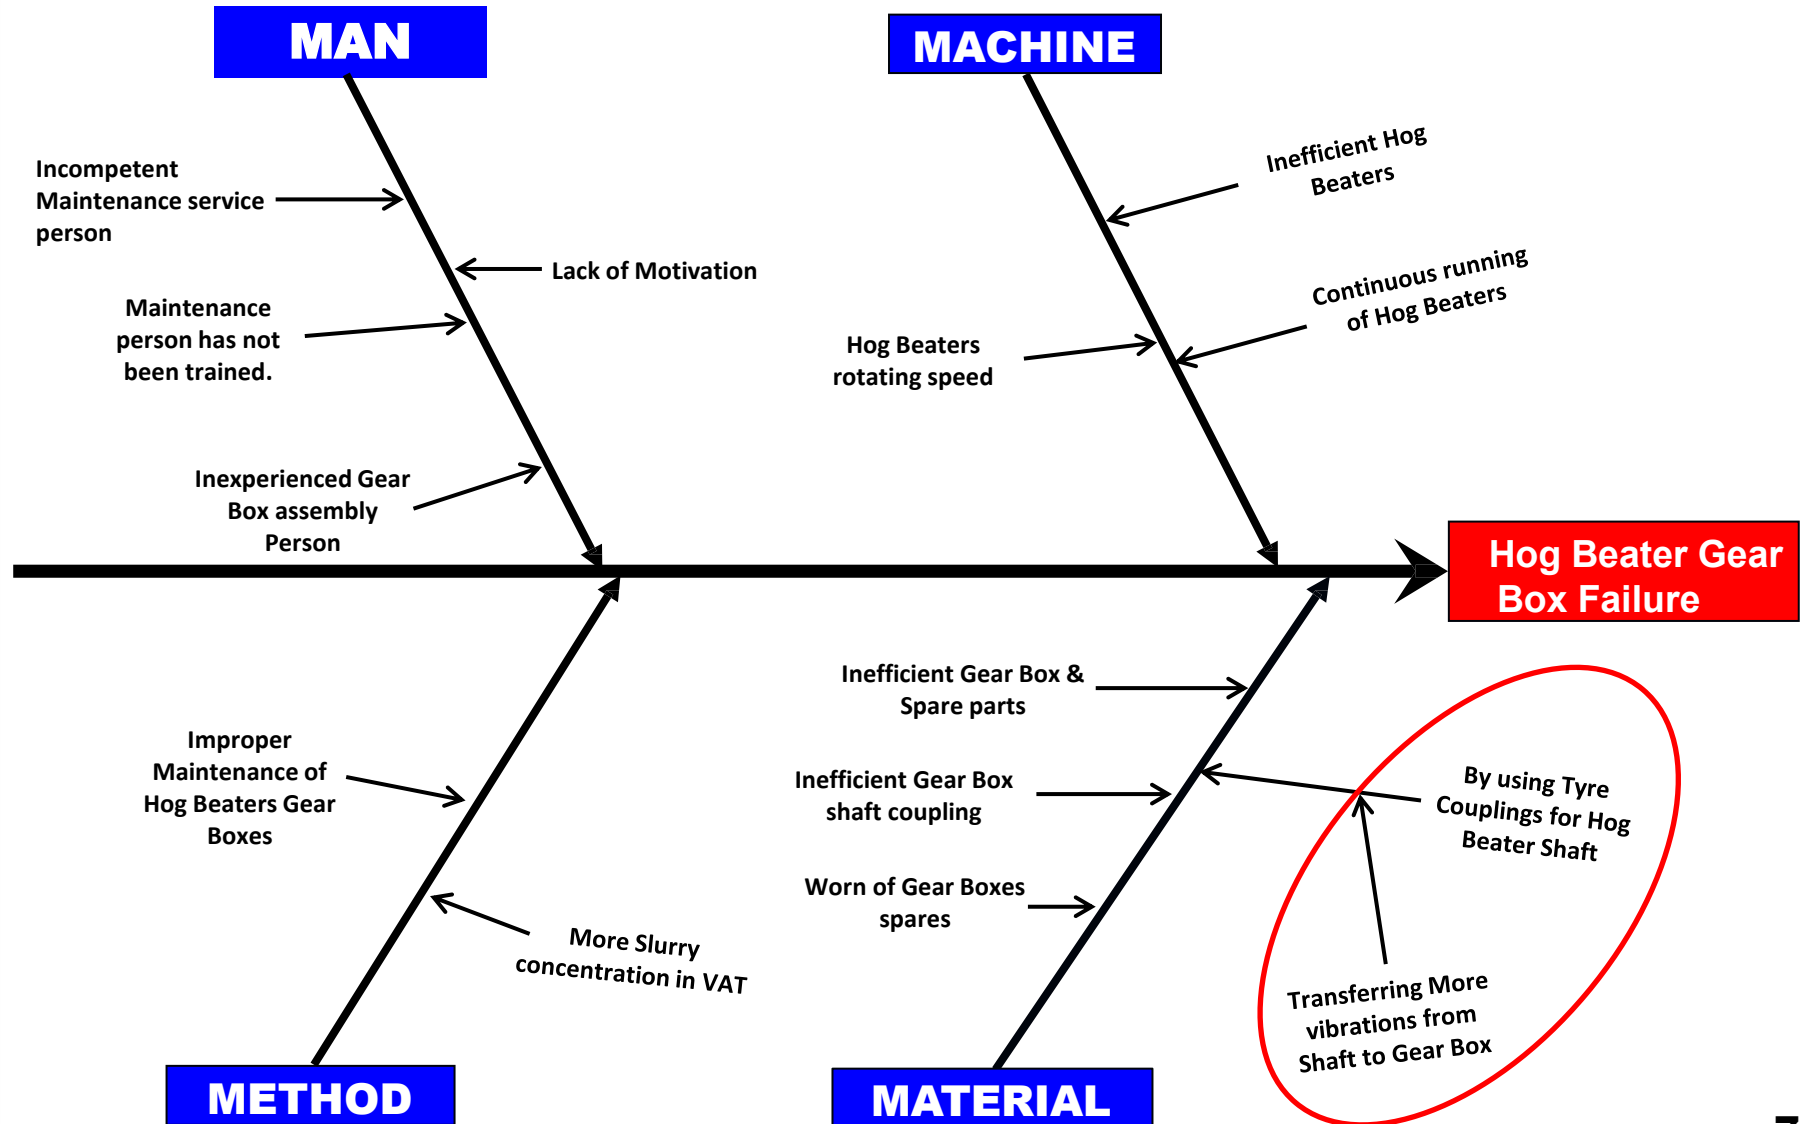
# Cause & Effect Analysis

**Problem:** Frequent Hog Beater Gear Box failure.

**Why 1 :** Gear Box is experiencing vibrations.

**Why 2 :** Hog beater shaft is transferring vibrations to Gear Box.

**Why 3 :** Hog beater has Tyre coupling and it is not absorbing vibrations and oscillations of shaft.

**Root Cause:** Tyre coupling is not absorbing vibrations and oscillations of the shaft.

**Idea Generation:** To change all the Tyre couplings of Hog Beaters to Universal Joint Coupling.

**Action:** Replaced all the Tyre coupling of Hog Beater with Universal Joint coupling.

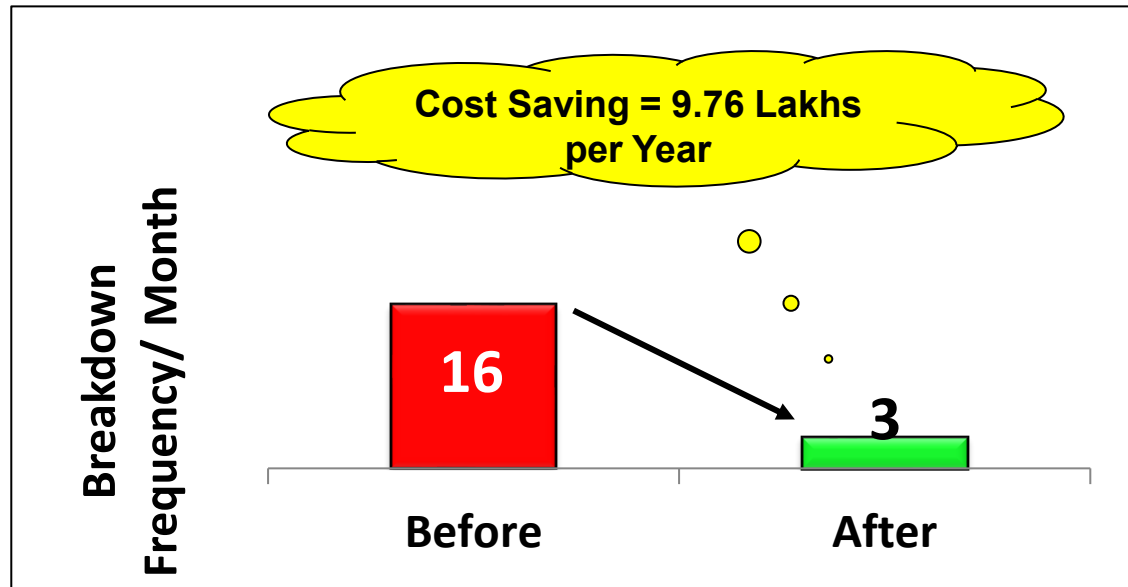
- Cost of 1 Gear Box servicing = 10,091 Rs/Gear Box
- Maintenance Cost of Hog Beater Gear Boxes = 83,956 Rs/Month
- Maintenance Cost of Hog Beater Gear Boxes = 10.07 Lakh/Annum

- Out Hog Beater Gear Box failure has reduced by 81% from 16 Times per Month to 3 Times per month.
- Cost Saving of 9.76 Lakh/Annum.
