Fence Test

Florida, US

Testing Overview

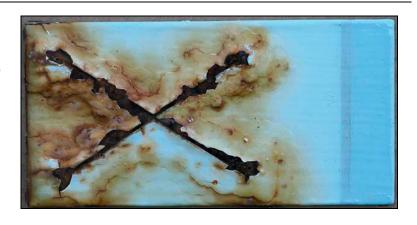
Two-coat epoxy/polyurethane system

Primer: two-component epoxy Finish coat: two-component acrylic aliphatic polyurethane

Discoloration = very heavy Loss of gloss = 72.99% Rust creep = extreme Bleed-through rust = extreme Pinhole rust = medium Adhesion loss = extreme

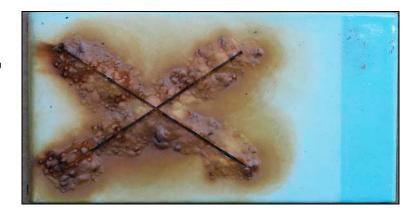
Two-coat epoxy/polyurethane system

Primer: two-component, high solids epoxy
Finish coat: two-component, high solids polyurethane

Discoloration = very heavy Loss of gloss = 98.66% Rust creep = very heavy Bleed-through rust = extreme Pinhole rust = very slight Adhesion loss = very heavy

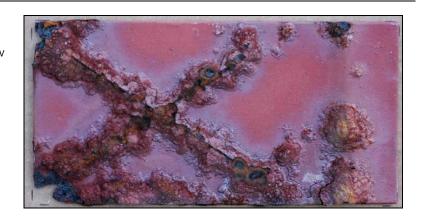
Two-coat alkyd system

Primer: non-pigmented, inhibitor-, surfactant- and siccative-enriched alkyd Finish coat: non-pigmented, inhibitor-, surfactant- and siccative-enriched alkyd

Discoloration = extreme Loss of gloss = 97.32% Rust creep = extreme Bleed-through rust = extreme Pinhole rust = extreme Adhesion loss = extreme
