Client: ABC  
Pipeline Name: XYZ  
Pipeline Section: AN9

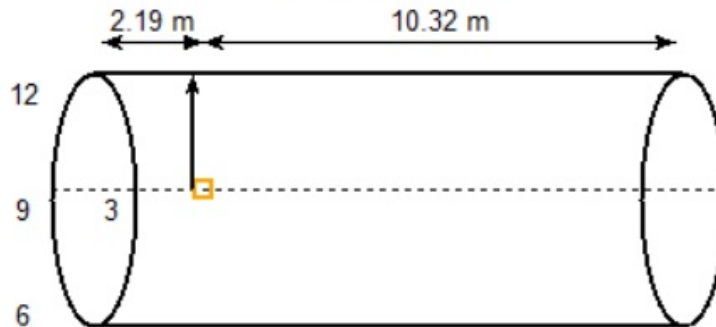
## Feature Location on Pipe:

| Feature: | Corrosion | Absolute Distance (m): | 622.123 |
| Feature type: | Metal Loss | Length (mm): | 49 |
| Anomaly dimension class: | AXIAL GROOVING | Width (mm): | 22 |
| Surface Location: | Internal | Max. Depth(%): | 19 |
| Remaining wall thickness (mm): | 10.3 | Orientation(hr:min): | 09:14 |
| ERF: | 0.308 | Latitude: | 16.46085615 |
| Safe pressure (kg/cm²): | 405.88 | Longitude: | 82.18708905 |
