# Client Description:

Client: ABC  
Pipeline Name: XYZ  
Pipeline Section: AN9

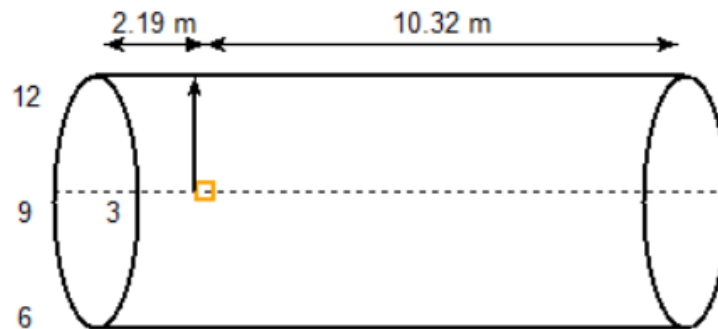
## Feature Location on Pipe:

| Feature: | Corrosion | Absolute Distance (m): | 622.123 |
| Feature type: | Metal Loss | Length (mm): | 49 |
| Anomaly dimension class: | AXIAL GROOVING | Width (mm): | 22 |
| Surface Location: | Internal | Max. Depth(%): | 19 |
| Remaining wall thickness (mm): | 10.3 | Orientation(hr:min): | 09:14 |
| ERF: | 0.308 | Latitude: | 16.46085615 |
| Safe pressure (kg/cm <sup>2</sup> ): | 405.88 | Longitude: | 82.18708905 |
