PROBLEM ANALYSIS LABORATORY

PRACTICAL REPORT

GURU NANAK DEV ENGINEERING COLLEGE, LUDHIANA
(An autonomous college under UGC Act, 1956)

Defect Mapping and Condition Survey of GNDEC Campus Buildings

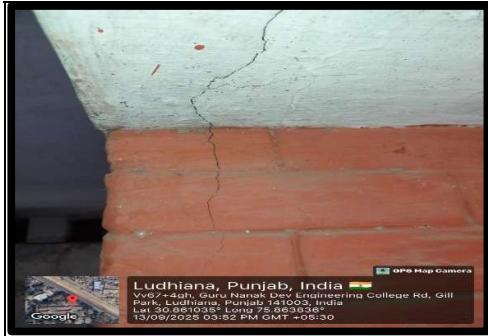
Fig 1 : Crack in Slab to wall

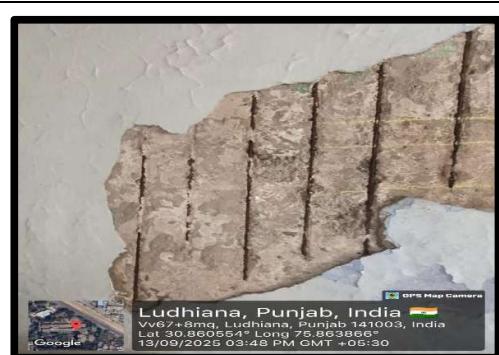
Fig 2 : Corrosion in slab

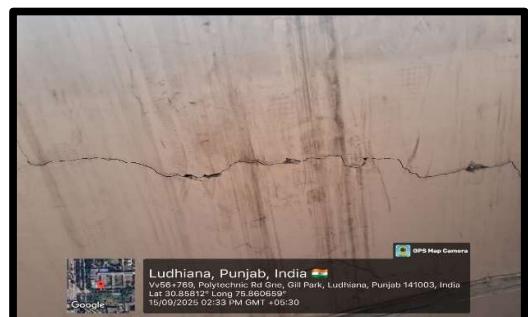
Location : Near outside of Model lab

Fig 4 : Crack in the wall

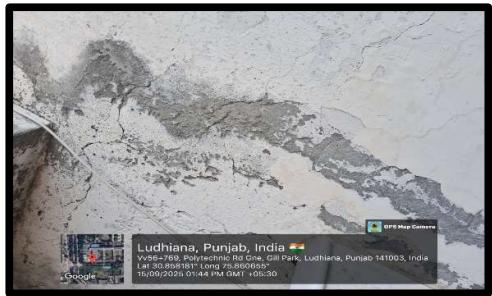
Location : Near outside right to model lab

Fig 4 : Crack and Dampness in wall

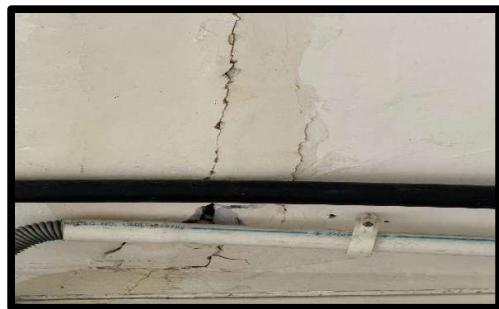
Location : Near ECE department HoD

Fig 5 : Crack on the wall

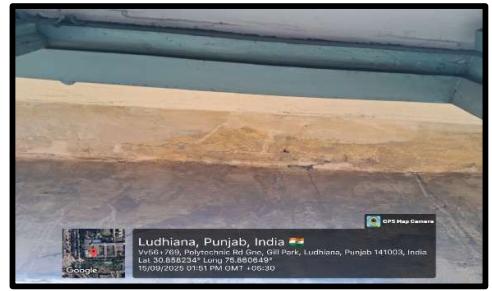
Location : Near F-104

Fig 6 : Crack near the upside of window

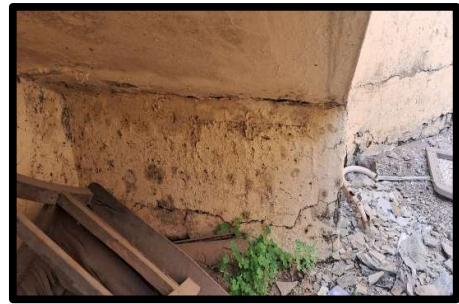
Location : Near ECE Department

Fig 7 : Crack near behind the staircase

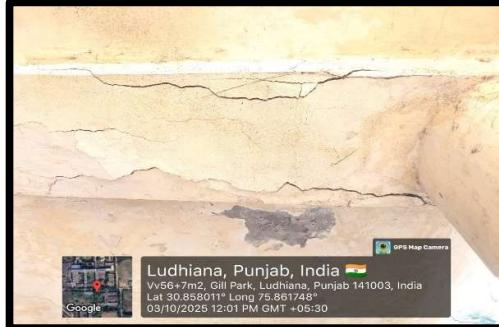
Location : Near Diploma Building

Fig 8 : Crack in the middle of Beam

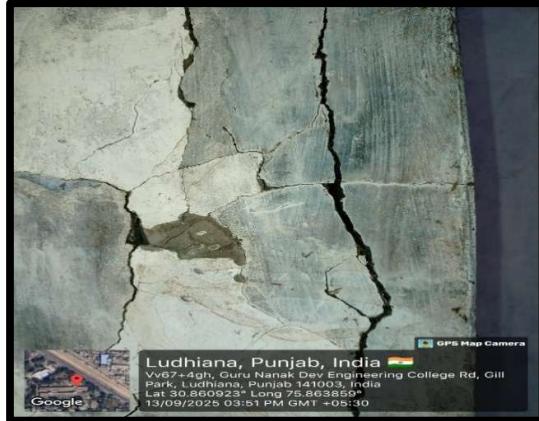
Location : Hostel No1

Fig 1.1: Shrinkage Crack in Beam

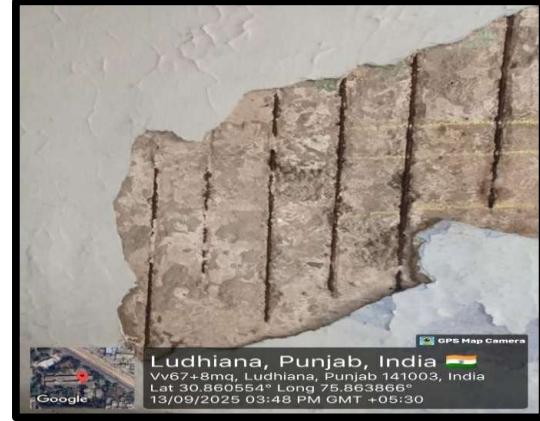
Location : Hostel No1near washroom

Fig 1.2 : Crack due to Corrosion

- In corrosion-induced cracks, restore alkalinity or use cathodic protection systems to stop steel deterioration (per IS repair guidelines).

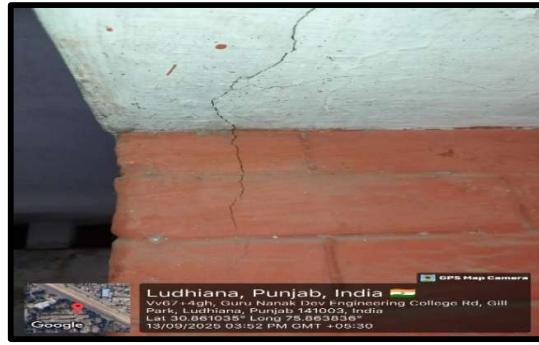
Location : Hostel No 1

Fig 1.3: Crack due to Shear

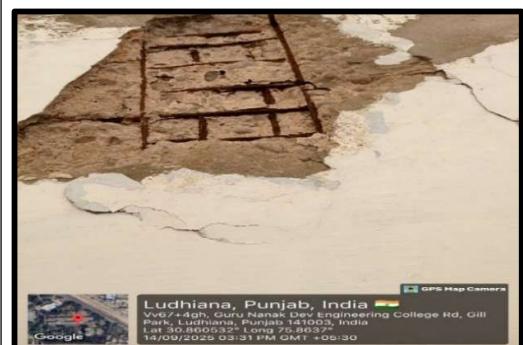
Location : Hostel No 1

Fig 1.4 : Crack overloading on slab

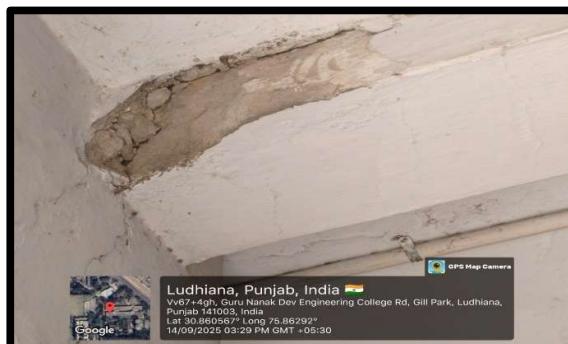
Location : Hostel No 1

Fig 1.5: Crack due to overloading in Beam

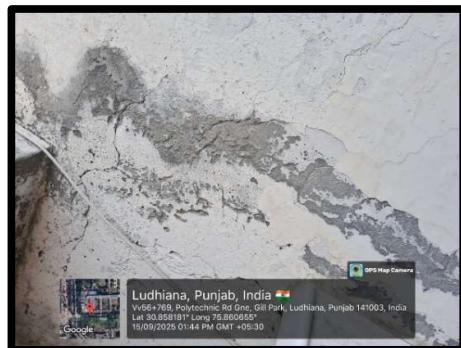
Location: In model lab

Fig 1.7:Crack in wall

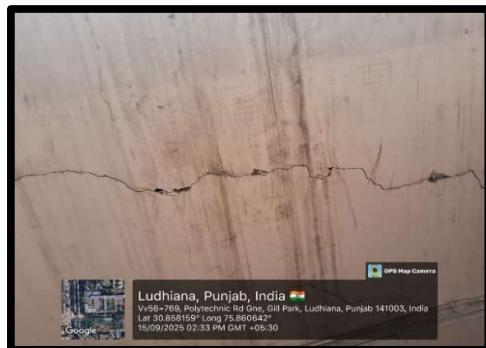
Location: Near Boys washroom

Fig 1.8 :Shear crack in wall

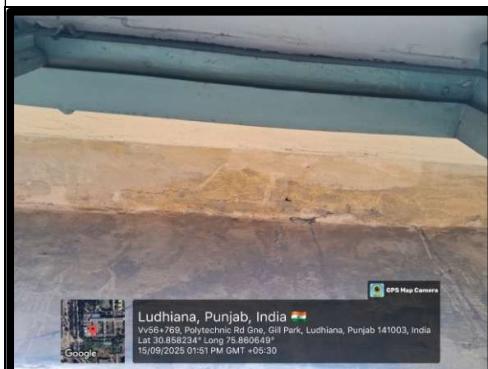
Location: Near Model lab

Fig 1.9:Structural crack in wall

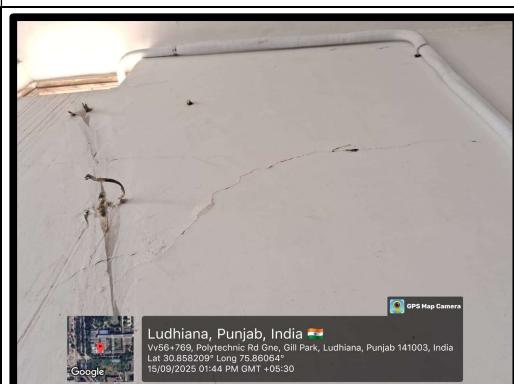
Location: Near room S201

Fig1.10 : Plastic Shrinkage Crack

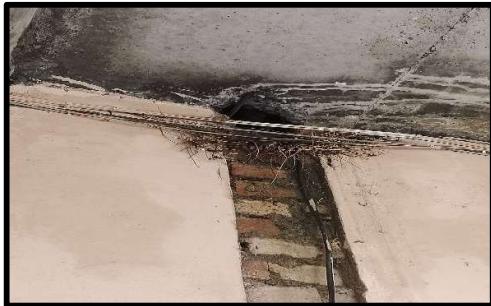
Location : Hostel No 2

Fig 2.1 : Corrosion in Slab

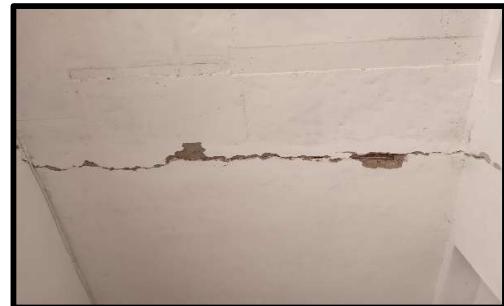
Location : Hostel No 1

Fig 2.2 : Corrosion in middle of slab

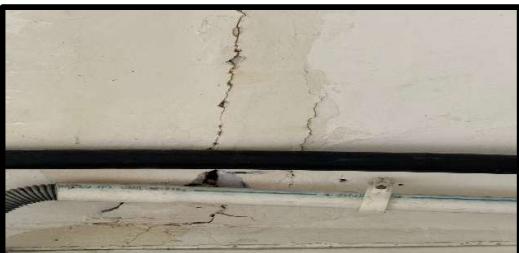
Fig 2.3 : Corrosion Near the end of Slab
Location: mechanical department

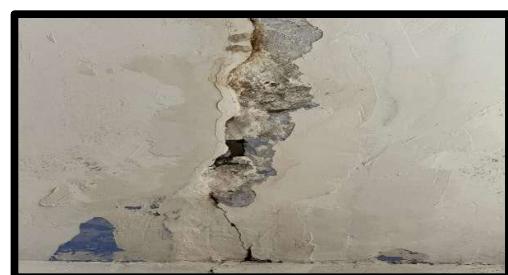
Location : Back side of ECE department

Fig 2.4 : Corrosion at starting of Slab

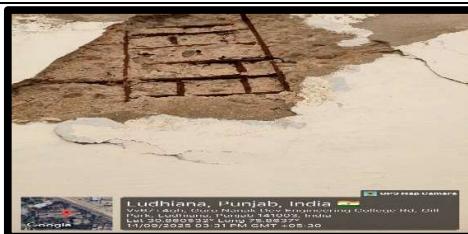
Location : Hostel No 1

Fig 2.5: Corrosion in the Slab

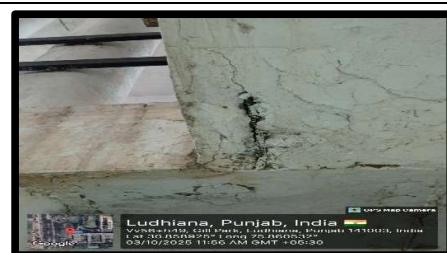
Location : Near Diploma app department

Fig 2.6: Corrosion at bottom of Column

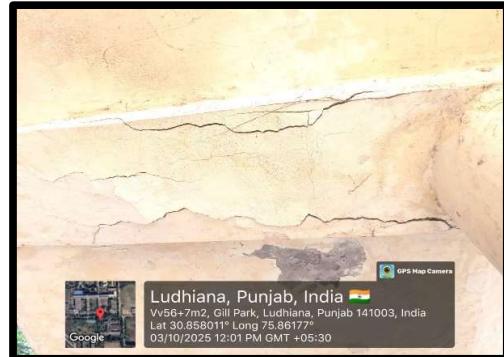
Location: Backside of TCC office

Fig 3.1: RCC beam (Mid spam)

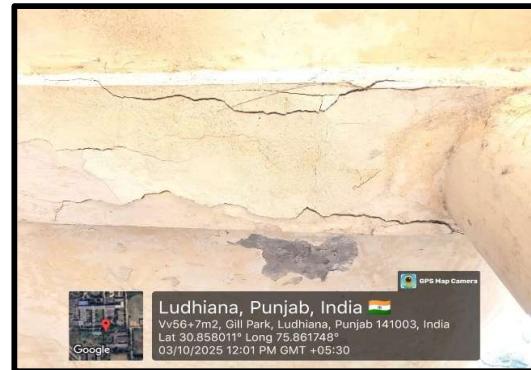
Location: Near ECE Department

Fig 3.2 : Slab Pannel

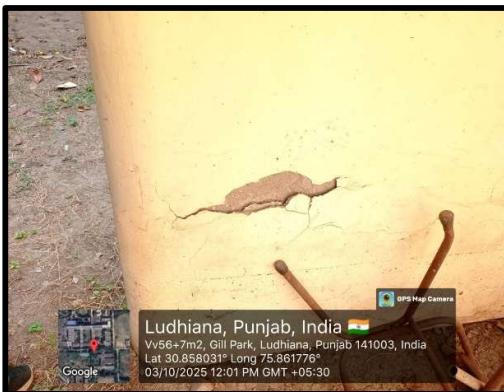
Location : Near ECE Department

Fig 3.3: Deflection Crack at bottom of Column

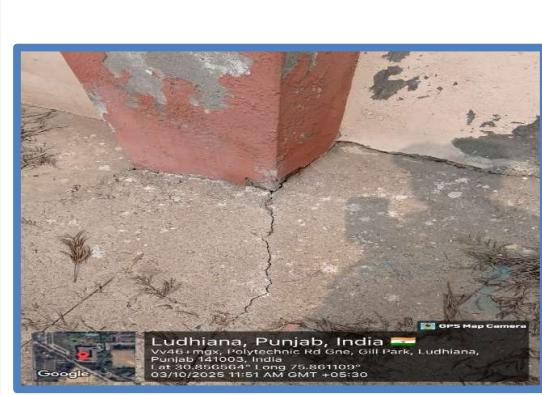
Location : Near Diploma building

Fig4.1 : Crack on the near ground

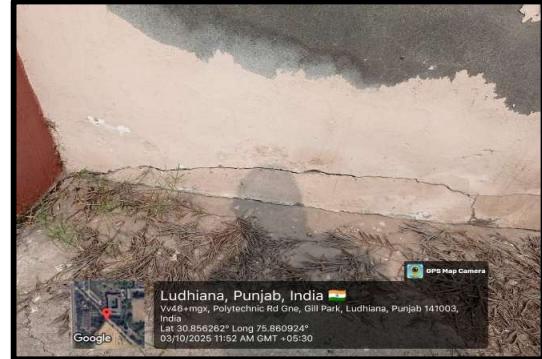
Location : Near diploma building

Fig4.2 : Crack on the near bottom of wall

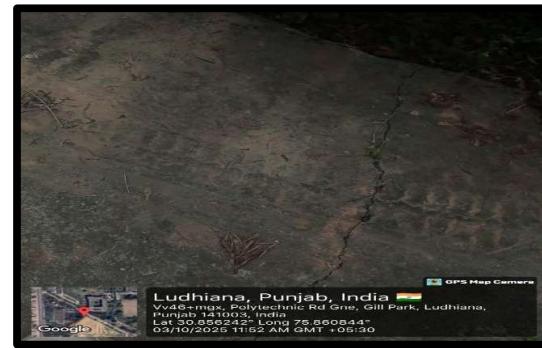
Location : Near outside of TCC seminar hall

Fig 4.3 : Settlement crack on the ground

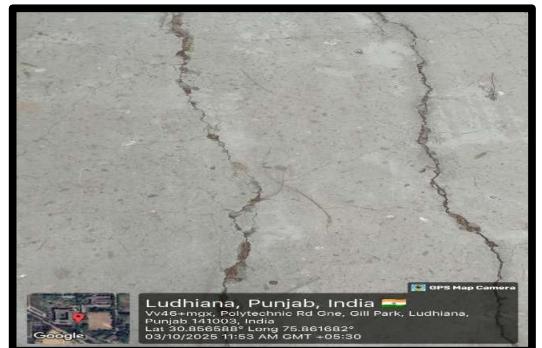
Location : Near the diploma building

Fig 4.4 : Settlement Crack on the ground

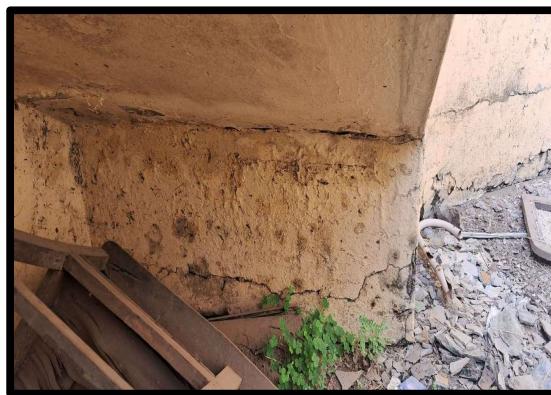
Location : Near the back side of App science of staircase

Fig 4.5 : Crack Near the bottom of staircase due to settlement

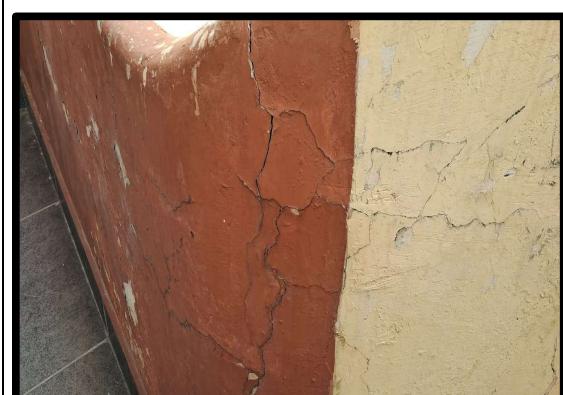
Location : Near TCC office gate

Fig 4.6 : Settlement crack near the bottom of wall
