Field Visit Report Weheragala Anicut canal – Arabedda Canal Development/ Rehabilitation (Phase II – CSIAP) Southern Province

FIELD VISIT REPORT

ARABEDDA CANAL (DOWNSTREAM WORKS) REHABILITATION (PHASE II - CSIAP)

Date of Visit: 02/07/2025

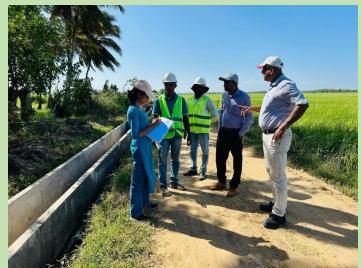
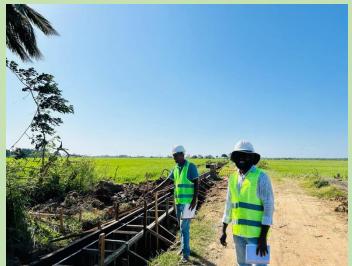
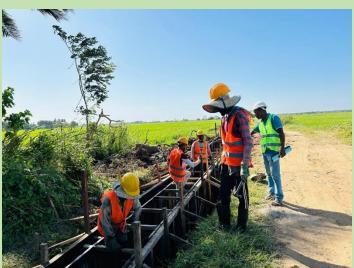
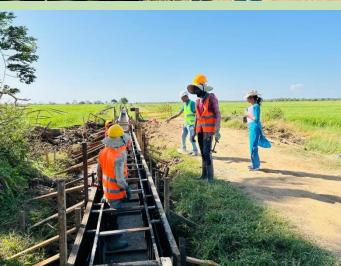
Officers from the implementing agency, along with workers, the contractor's site supervisors, the DPDO technical team, and the safeguard team, were present at the site.

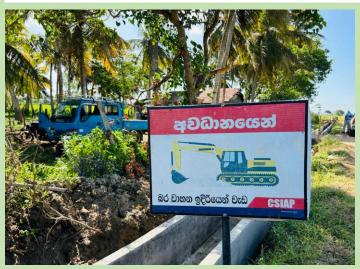
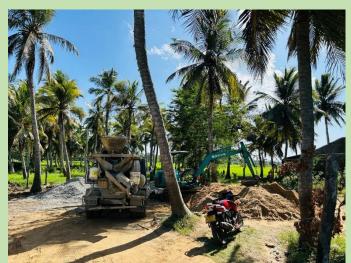
A site office, safety signboards, and machinery were also observed.

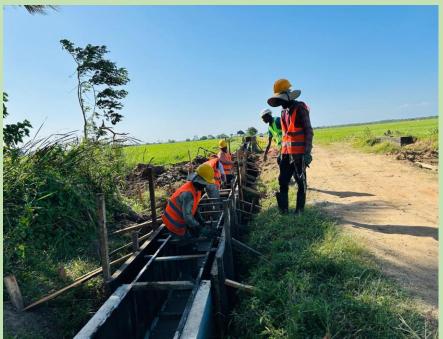
It was observed that workers were wearing personal protective equipment (PPE) while carrying out the work.

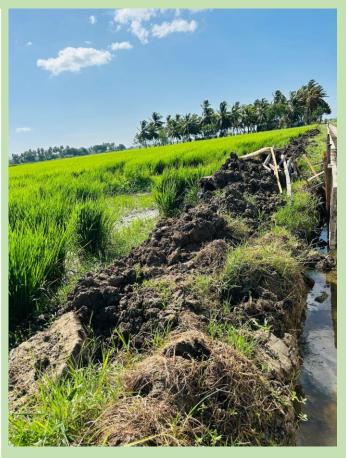
- Farmers have cultivated their paddy fields during the Yala season 2025, and the harvest is expected in 3–4 weeks from the date of the field visit. A total of over 192 farmers are cultivating approximately 300 acres of paddy land, jointly across the Arabedda and Kokkara canals, during both the Yala and Maha seasons. Currently, water is released to the paddy fields three days per week. Therefore, work can only be carried out four days per week.
- No tree removal was observed at the worksite. Furthermore, safety signboards were visible, and workers were wearing personal protective equipment (PPE) while carrying out their tasks.
- Dredged material should be properly removed and disposed of after the rehabilitation work is completed.

- 1. It is recommended that the contractor mobilize at least two separate teams to carry out canal lining and road rehabilitation simultaneously during non-rainy periods. This will help expedite progress, minimize delays due to adverse weather, and ensure timely completion of works before the onset of the rainy season.
- 2. Continue to ensure that no tree removal or other environmentally sensitive activities occur within or near the rehabilitation area.
- 3. The contractor must display the subproject name board prominently at the site to promote public awareness and ensure transparency and accountability.
- 4. Dredged material should be properly removed and disposed of in an environmentally safe manner after the completion of rehabilitation work.
- 5. It is encouraged to hire local laborers for the work as much as possible.
