iMX8M_HMI_Platform BATCH-1 ASSEMBLY ISSUE REPORT (20 BOARDS)

PCB ASSEMBLED DATE – 19/11/2018 ASSEMBLY LOCATION: PODRAIN, Bangalore

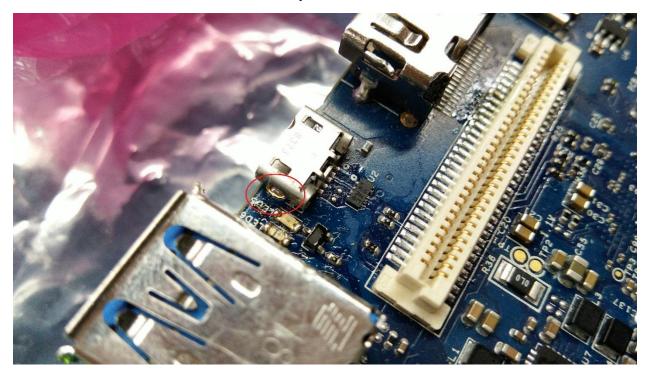
Issue-1 - Mechanical Pin of Panel connectors are not soldered in multiple boards. We had to do manual touch up in house

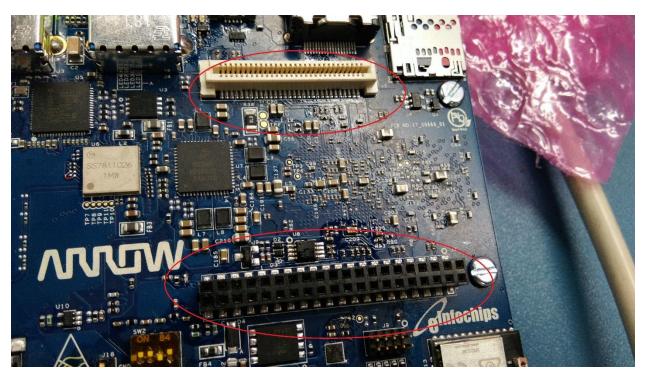
Issue-2 – In multiple boards we have faced issue of dry solder on connectors J6 and J7.

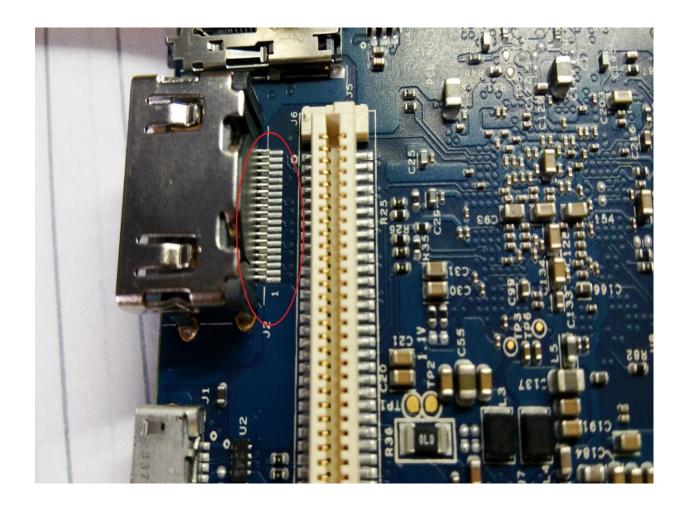
Issue-7 -In one board HDMI connector (J2) was mounted bit offset.
