Mining Compliance Report: Odisha_0

Site: odisha_0 | Generated: 2025-10-15 23:07

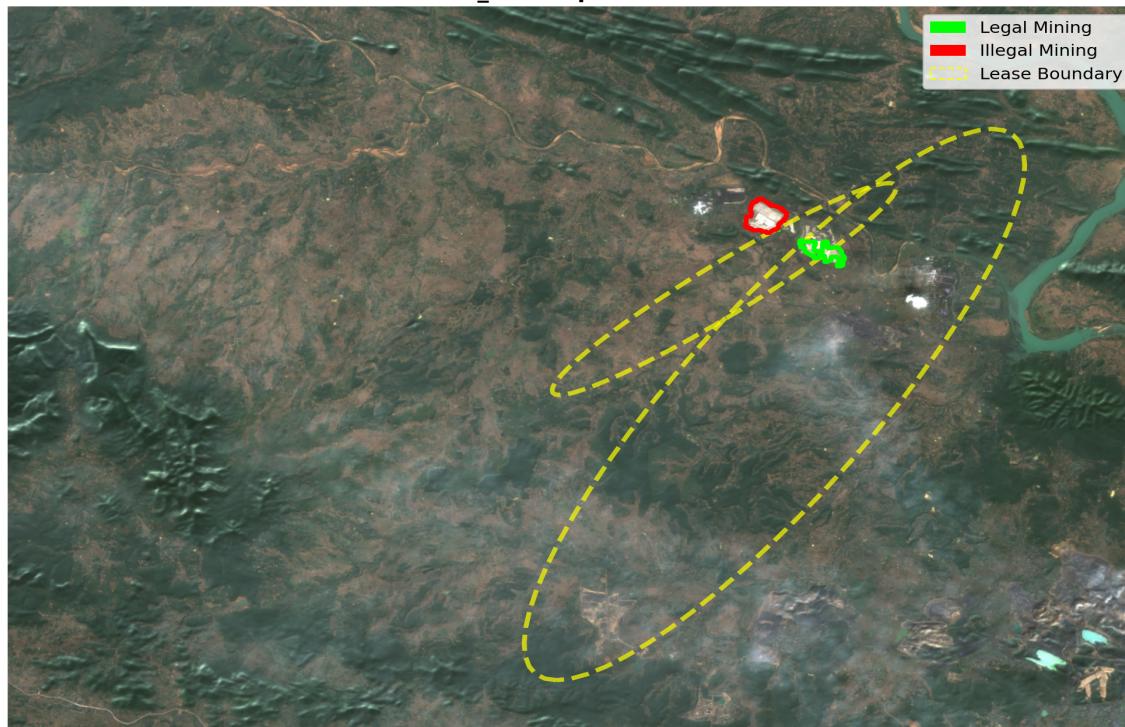
odisha_0: Compliance Check

Block	Area_m2	MeanDepth_m	Volume_m3	OutsideLease
Block-1	117400.0	4.18	314327.3	No
Block-2	214400.0	5.51	739868.8	Yes
TOTAL	331800.0	-	1054196.1	214400.0 m ² VIOLATION
