membrane integrity monitoring at the UF/RO Heemskerk plant

**Joop C. Kruithof, Peer C. Kamp, Gilbert Galjaard
N.V. PWN Water Supply Company North Holland**

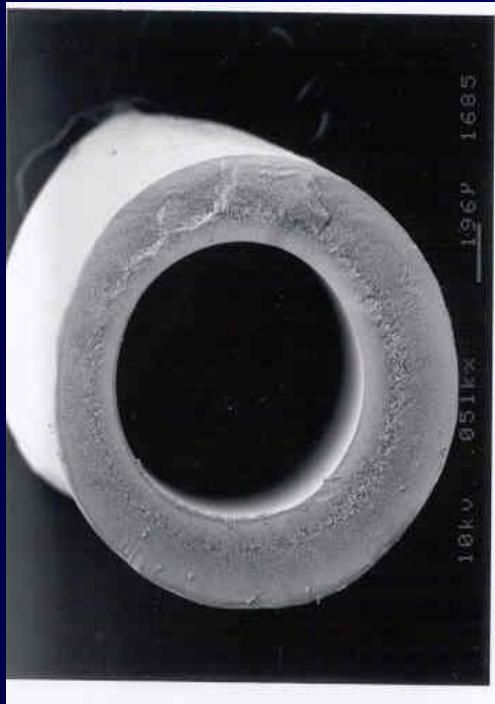
results from autopsies

- defects - product related cause eccentricity

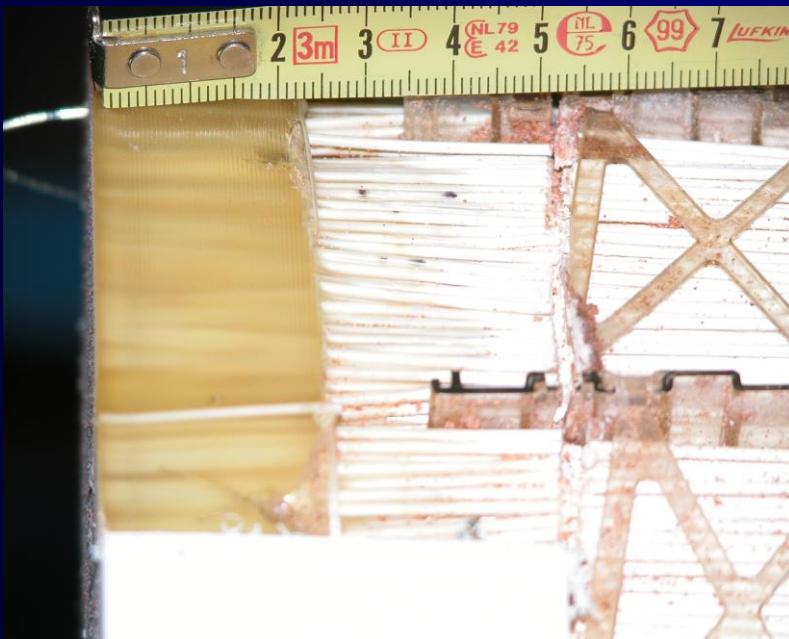
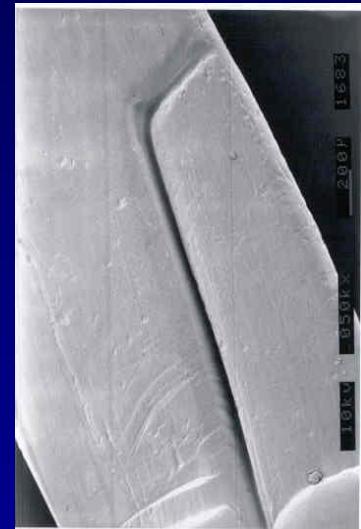
- defects – product related cause damaged fibre

Defects near to outer side
of element
due to low epoxy height

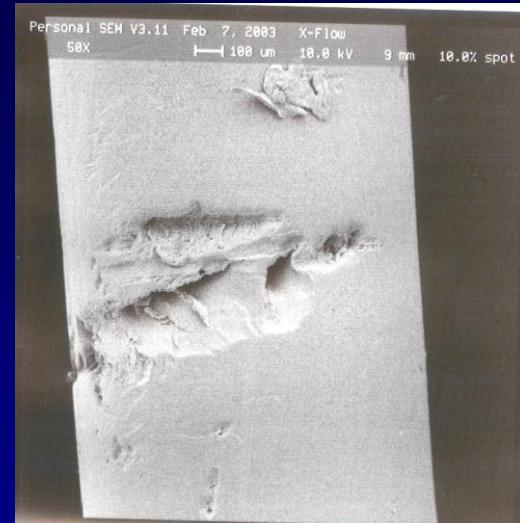
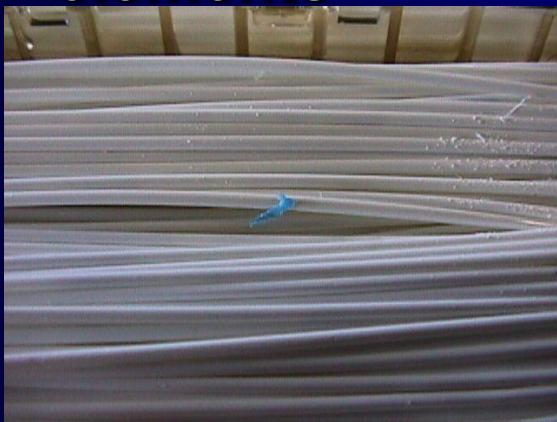
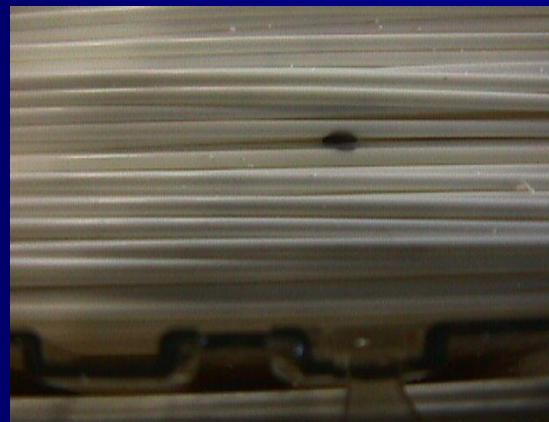
- defects – external cause
- foreign materials found in elements
