HISTORICAL LAND USE SURVEY (HLUS) REPORT

CONTRACT CR206

**Historical Land Use
Survey for the Advanced
Engineering Study for
Cross Island Line Phase 2
(CRL Phase 2) – CR2001**

Preliminary Report (CR16)
(CR2001/DOC/DES/0043/-)

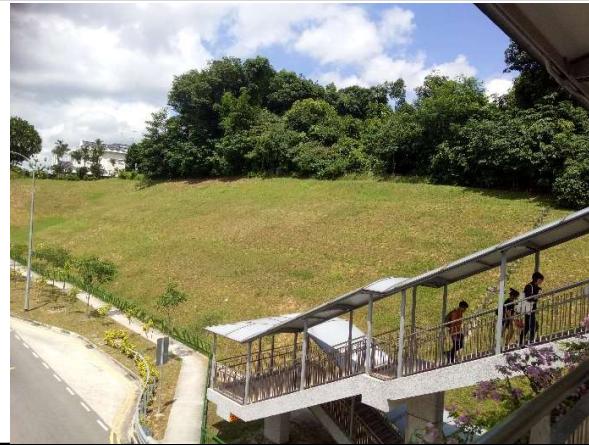
Photo 7:
Forested Area to the East of Clementi Road (ID: 1)

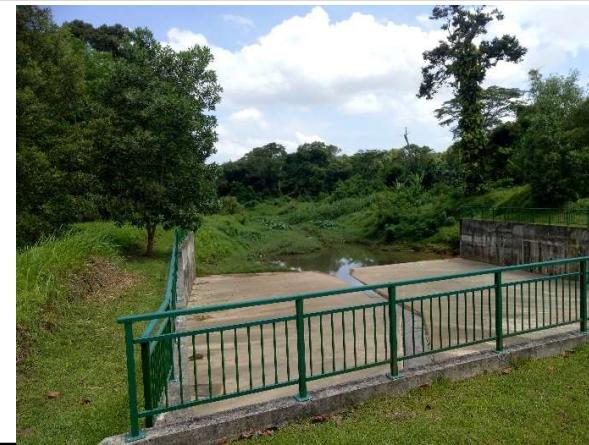
Photo 8:
Canal from Ngee Ann Polytechnic through
Forested Area (ID: 2)

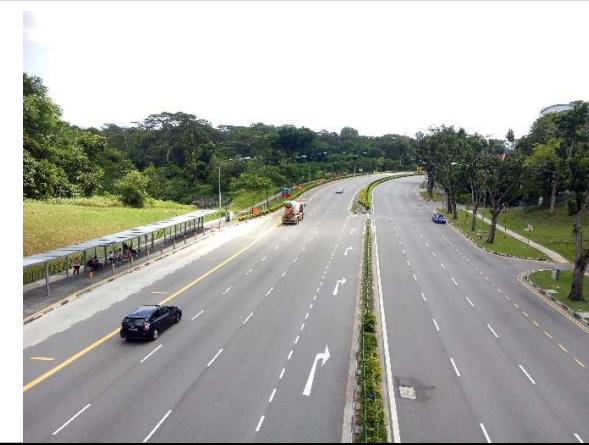
There is only one major road currently found within the Study Area – Clementi Road (Receptor ID: 3). Clementi Road is a major arterial road which predominantly carries traffic from one region to another and experiences heavy traffic throughout the periods of the day especially during peak hours. In addition, ERM observed from the site walkover that a proportion of traffic on this major road comprised heavy vehicles. Given the heavy traffic, there is a possibility that at some point in time, fuel leaks and spills from vehicles would have occurred. An online search also yielded a recent record of prior spills or leaks on the road in 2017 (*Lam, 2017*).

Photo 9:
Clementi Road (ID: 3)

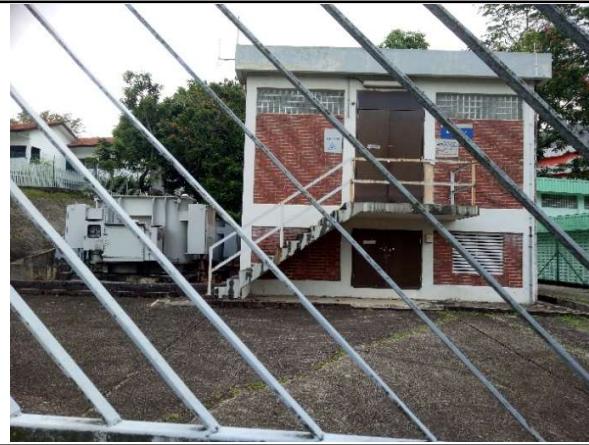
Photo 10:
Ngee Ann Polytechnic Substation (ID: 4)

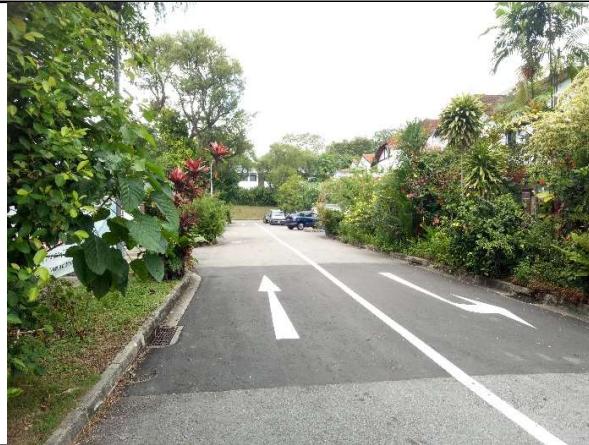
Photo 11:
Rosedale Terrace Houses (479-501 Clementi
Road) (ID: 5)

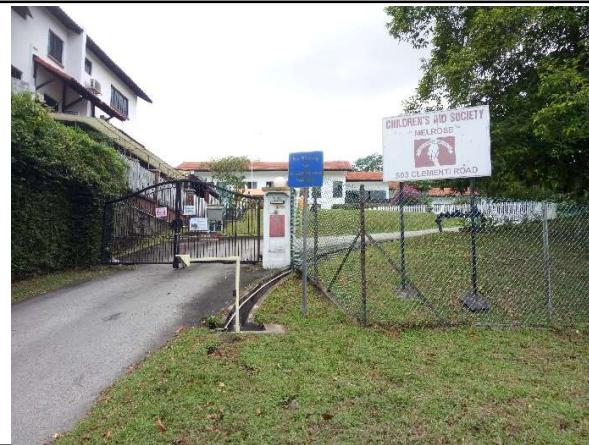
Photo 12:
Children's Aid Society (Melrose) (ID: 6)

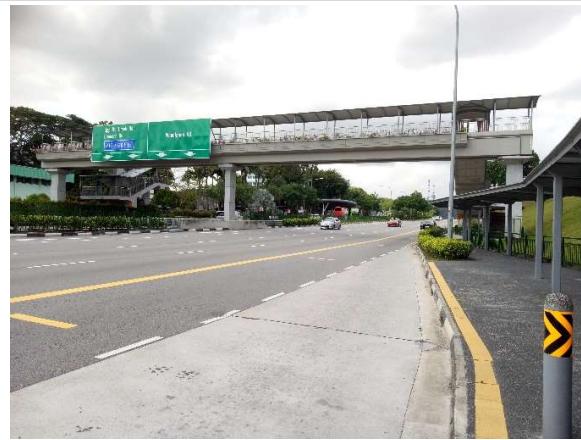
Photo 13:
Overhead Bridge across Clementi Road (ID: 7)

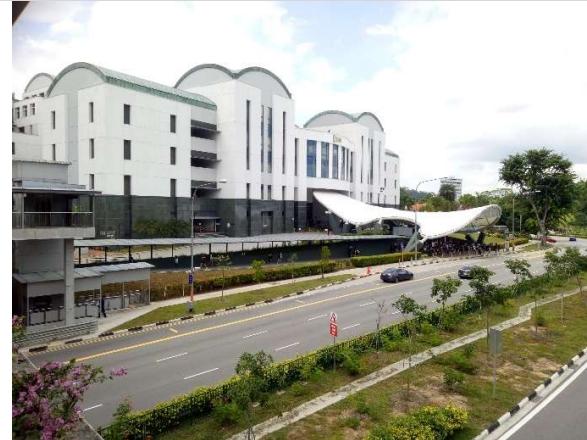
Photo 14:
Singapore Institute of Management HQ (ID: 8)

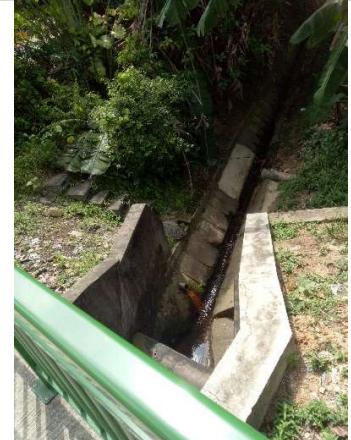
Photo 15:
Drain between SUSS and Private Property (ID: 9)

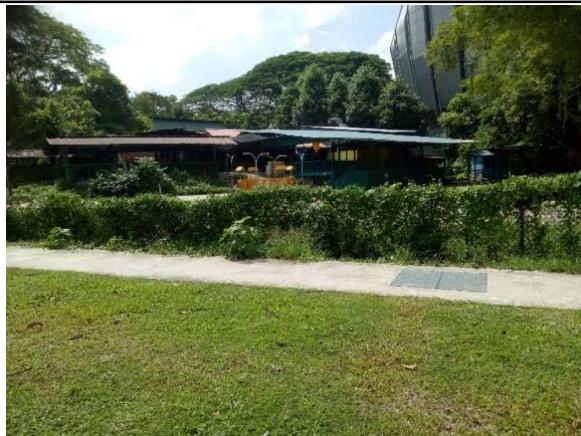
- An Unused Site comprising a zinc-roof establishment located along Clementi Road, adjacent to Singapore University of Social Sciences (ID: 10); and
- Old Railway Line, part of the abandoned railway tracks emerging from under Clementi Road leading into the forest (ID: 14).

Photo 16:
Unused Site (ID: 10)

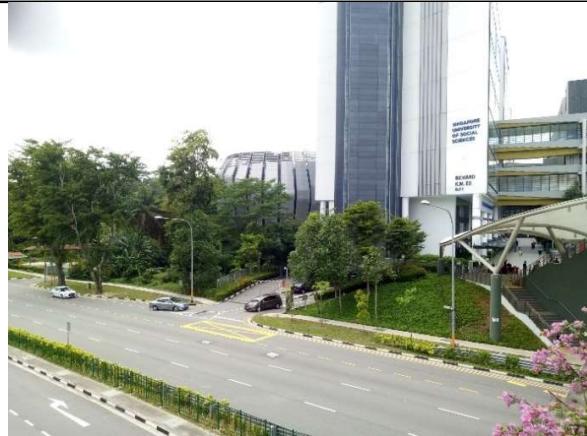
Photo 17:
Singapore University of Social Sciences (SUSS) (ID: 11)

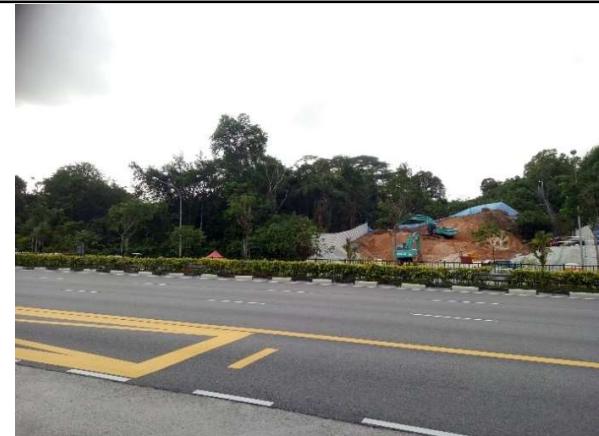
- **Construction Works:** Ongoing construction works were observed during the site walkover along the southern boundary of Maju Camp, which is likely the extension of Brookvale Walk Road to Clementi Road (ID: 13).

Photo 18:
Construction Site next to Maju Camp (ID: 13)

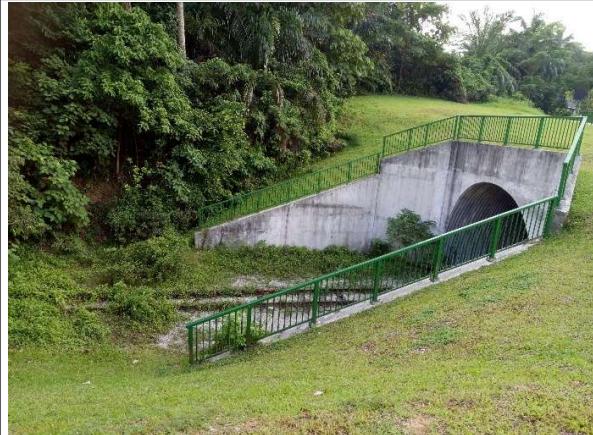
Based on site walkover and desktop review of historical land use, the Jurong Railway (ID: 14) was identified to be within the Study Area. Jurong Railway was developed in the late 1960s, comprising a 19.63 km track running from Bukit Timah Railway Station next to King Albert Park, through Pasir Panjang and ending at Shipyard Road. The majority of the railway track has been removed but some sections of the railway tracks are still intact, albeit rusting.

Photo 19:
Old Railway Line (ID: 14)

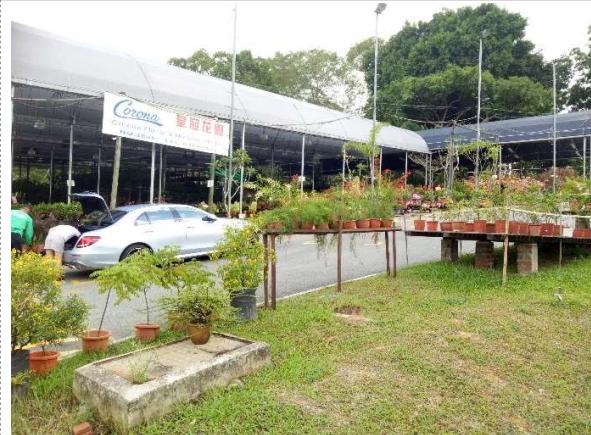
Photo 20:
Corona Florist & Nursery Pte Ltd (ID: 15)

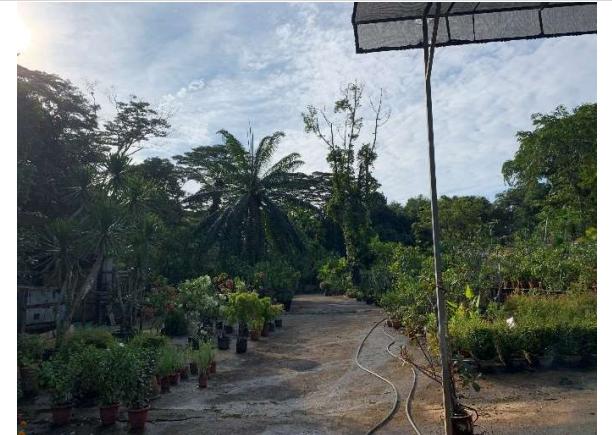
Photo 21:
Corona Florist & Nursery Pte Ltd (ID: 15)

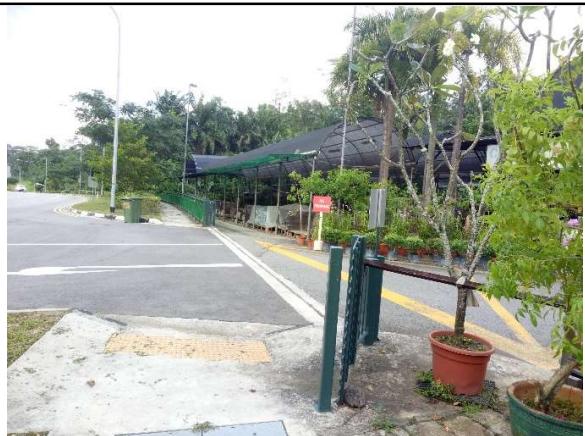
Photo 22:
Corona Florist & Nursery Pte Ltd (ID: 15)

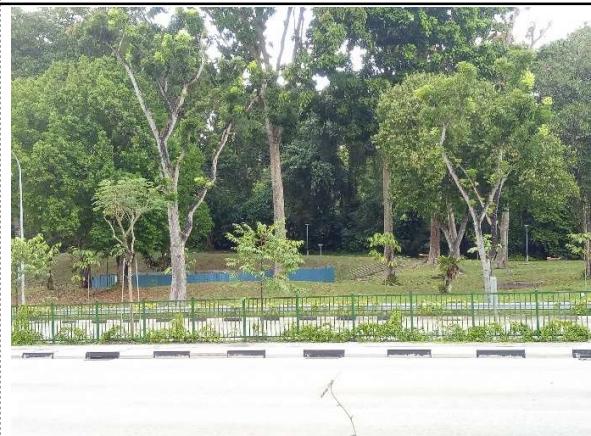
Photo 23:
Clementi Neighbourhood Park (ID: 16)

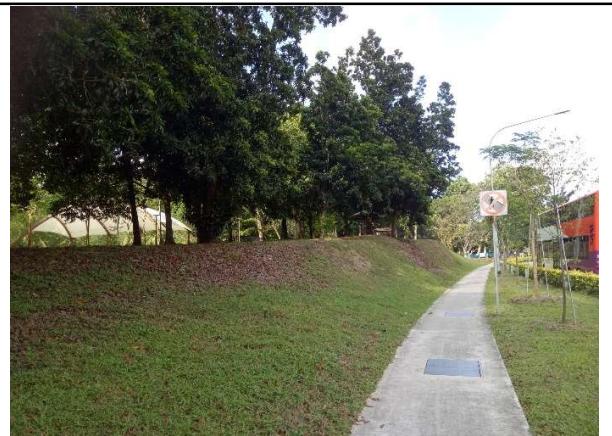
Photo 24:
Clementi Neighbourhood Park (ID: 16)
