SHELL PAKISTAN LIMITED

TENDER PACKAGE

CONVERSION OF MCH-02 FROM HSD TO MOGAS AT MACHIKE INSTALLATION (TANK REPAIR WORKS)

Doc. No.	3059-GEN-TR-001B	Tender Package
Revision	2	-
Date	04-05-2021	Issue Date

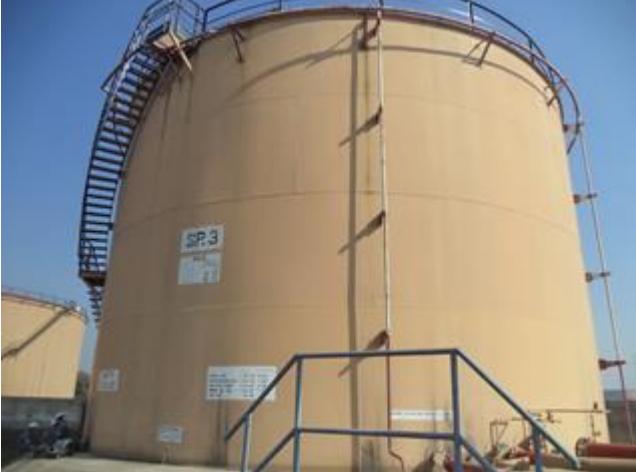
General View of Tank MCH-03

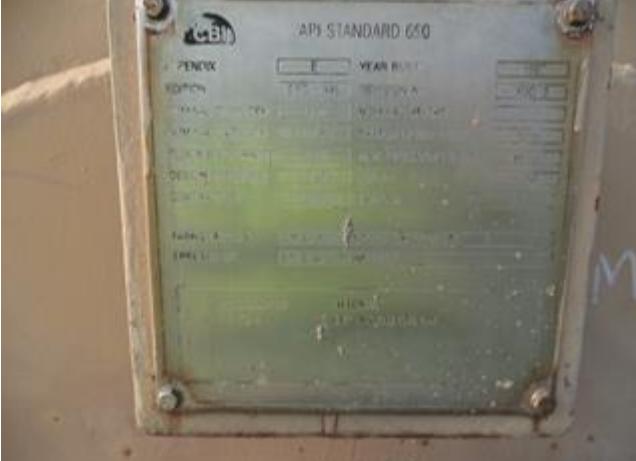
General View of Name plate

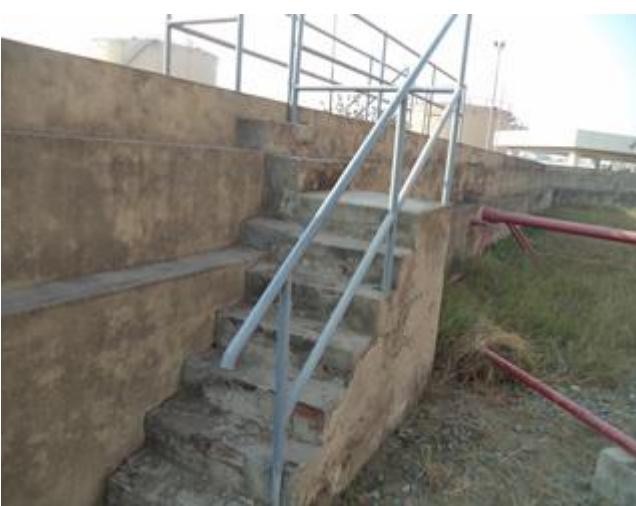
1.3.2. Foundation

Access Way Finding: There are three access ways at west, east and north side, cracks observed on west side accessway Recommendation: It is therefore recommended that cement plaster shall be restored by masonry work in order to avoid further deterioration. Repair Priority: <i>Online Or Offline</i> Finding: One side handrail found missing. Recommendation: Need to installed the handrailing on missing location. Repair Priority: Offline
---	--

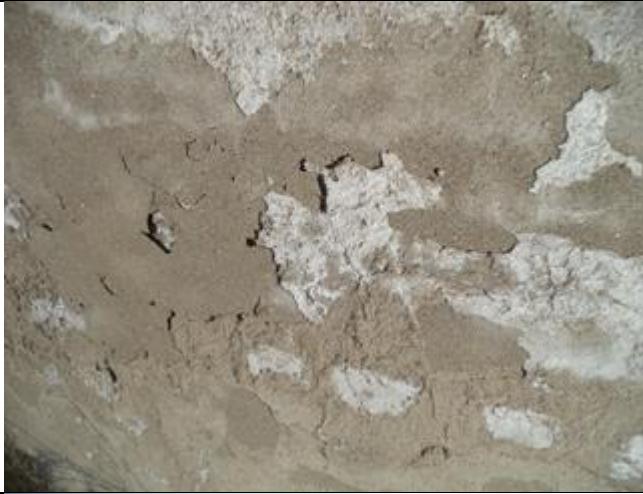
**Dyke wall****Finding:**

Same as above

Repair Priority: *Online Or Offline*

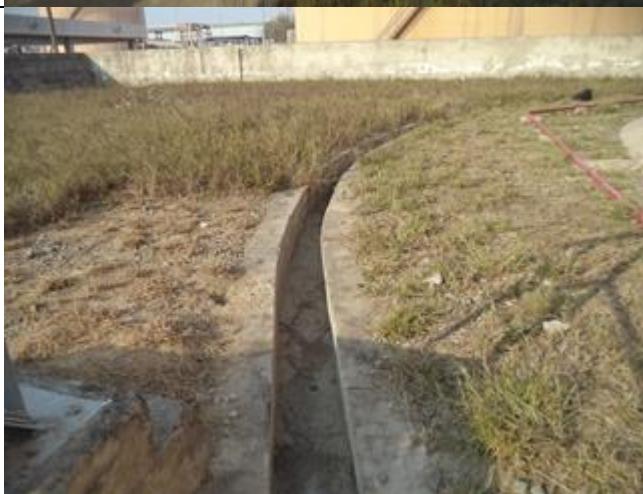
**Drainage System****Finding:**

Visually found in satisfactory condition.

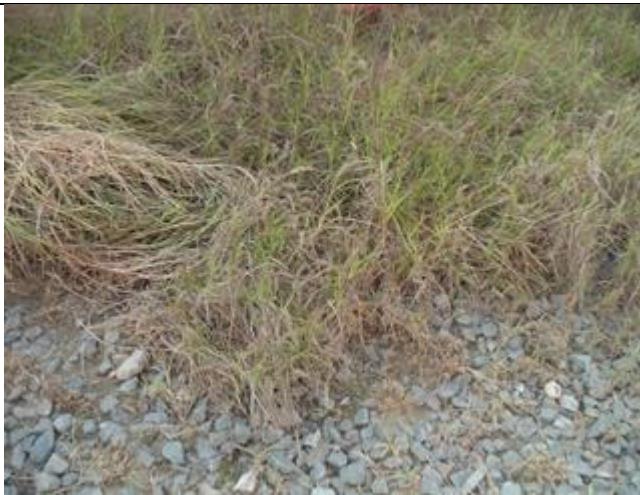
**Tank Area****Finding:**

Vegetation growth observed around the tank foundation.

Repair Priority: *Online Or Offline*

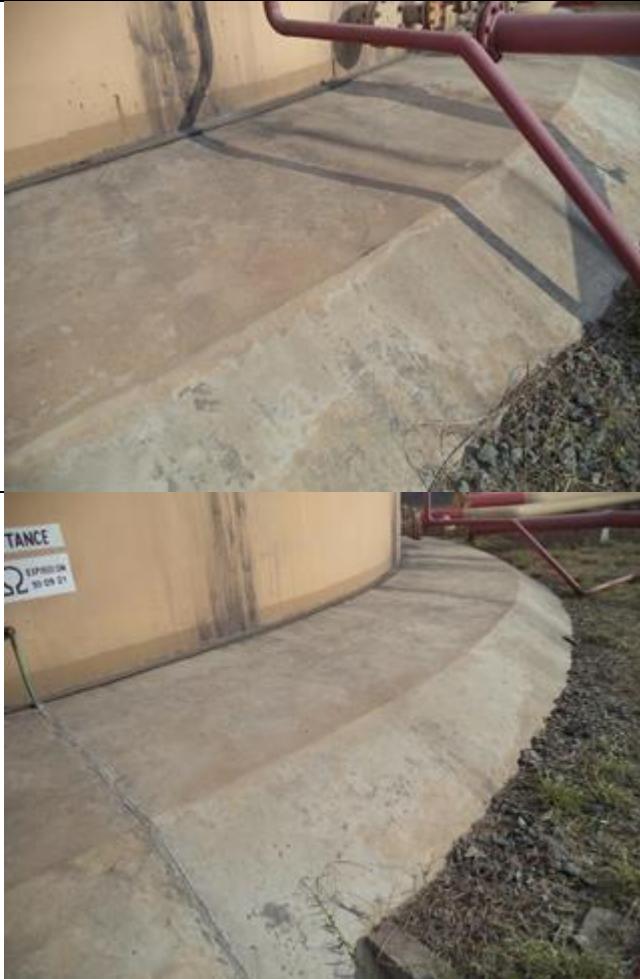
**Cement Tank Pad****Finding:**

Visually found in satisfactory condition without spalling and cracks

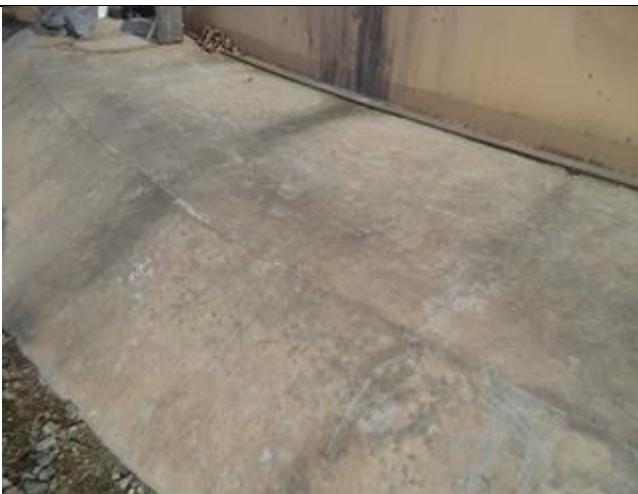
**Cement Tank Pad****Finding:**

Same as above

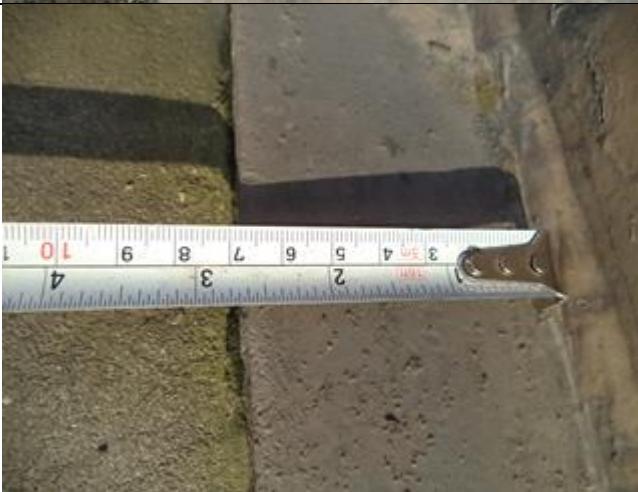
**Bottom Projection Plate****Finding:**

Projection plate found beyond the out side toe of shell to bottom weld is not less than 3/8", which is compliance the code API 653 requirement.

Nil, just for info.

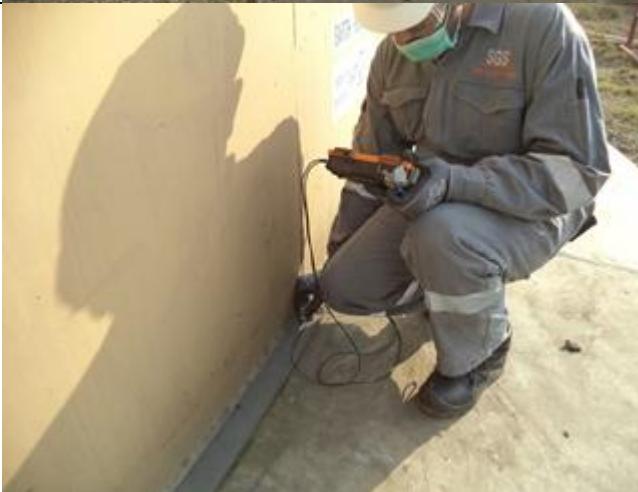
**Projection Plate****Finding:**

UTG carried out on bottom projection plate, No significant metal loss noted during testing.

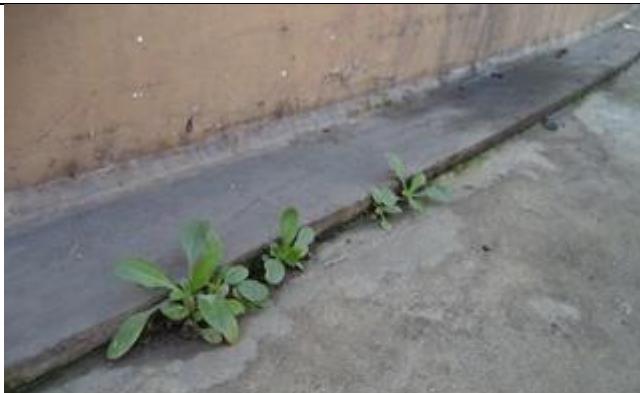
**Bottom Projection Plate and Foundation****Finding:**

Vegetation growth observed b/w the projection and foundation at satirway side.

Need to clean the existing vegetation and take measures to avoid future growth

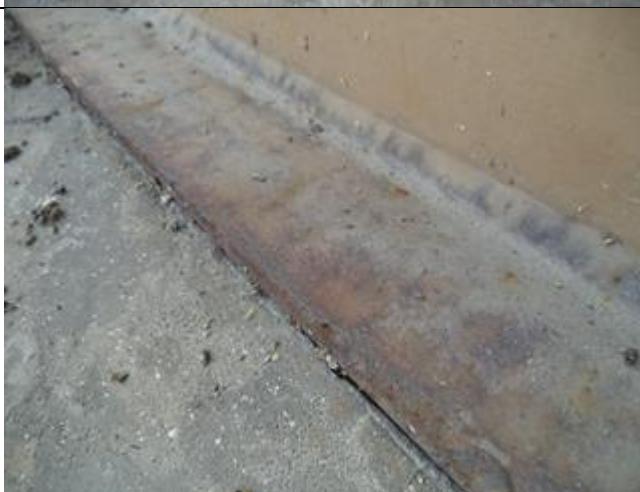
**Bottom Projection Plate****Finding:**

Atmospheric corrosion observed on projection plate due to painf failure.

To made good surface preparation and recoat as per paint manufacturer' specification.

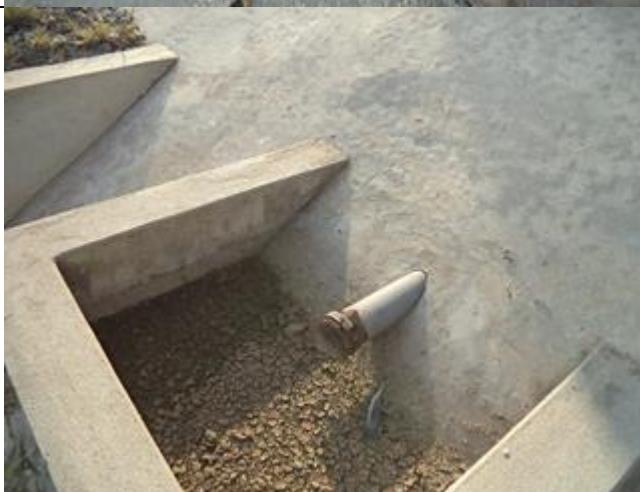
**Tell-Tale Pipe - Leak Detection****Finding:**

Visually found satisfactory condition.

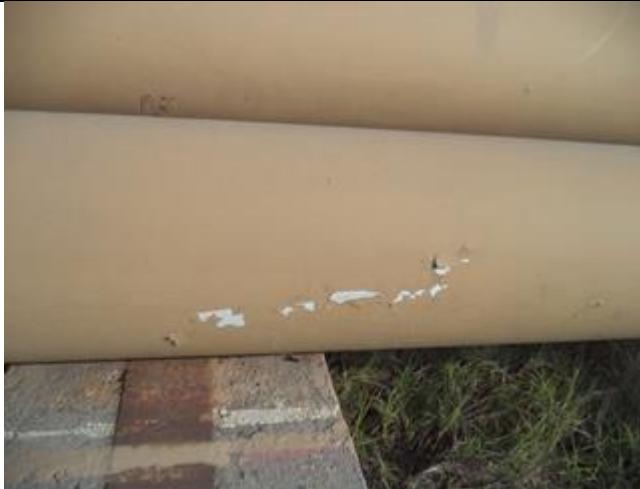
**Piping****Finding:**

Paint failure observed at different locations

To make good surface preparation and recoat as per paint manufacturer's specification.

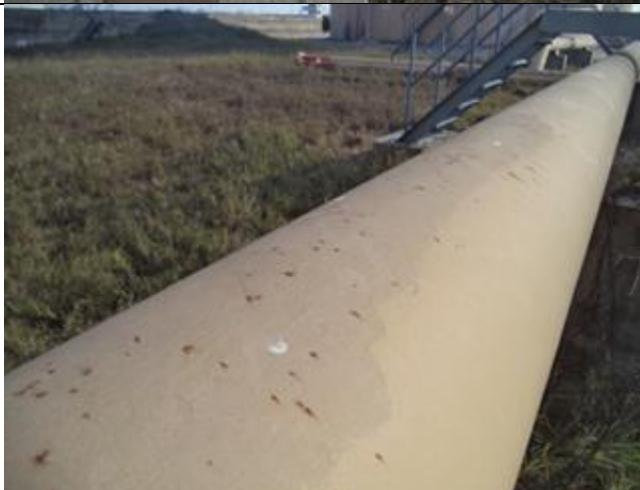
**Piping****Finding:**

Same as above

Same as above

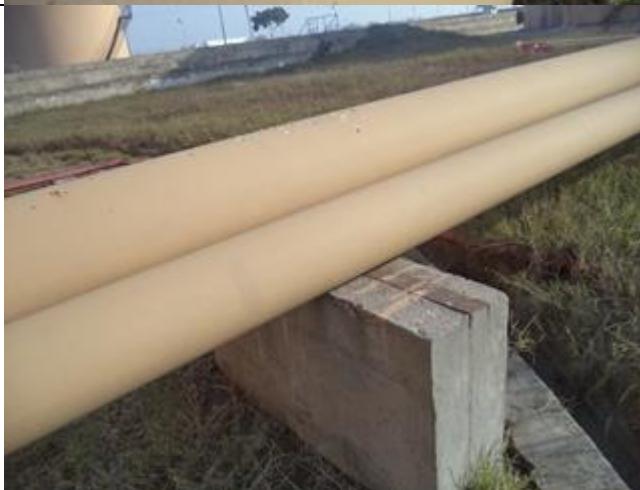
**Piping****Finding:**

Support of piping found satisfactory without cracks

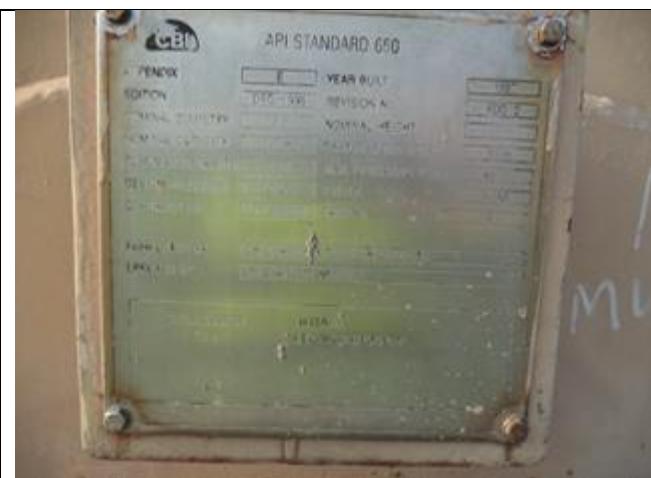
Name Plate

Name plate found on the tank shell as per API code

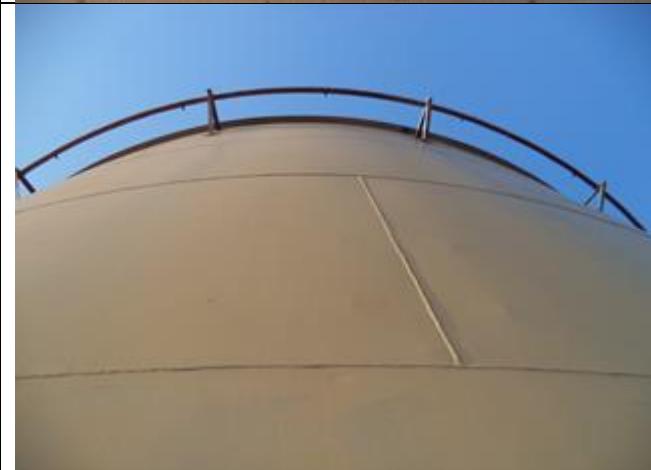
Shell Plate

Visually shell course plates found in satisfactory condition without paind failure and surface pitting.

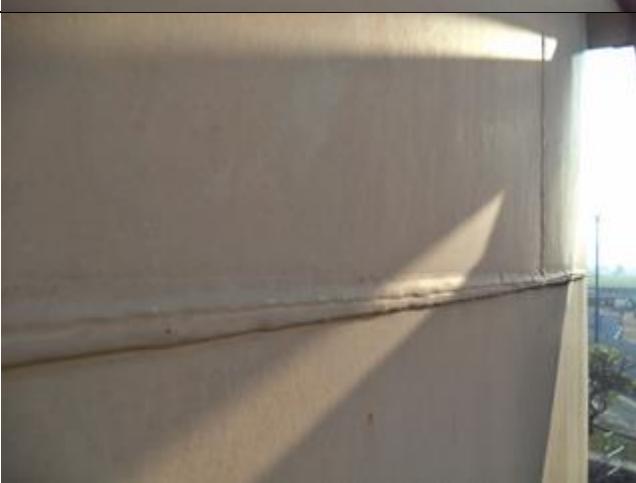
<p>Shell Plates</p> <p>Finding: Same as above</p> <p>Recommendation: Same as above</p> <p>Repair Priority: N/A</p>

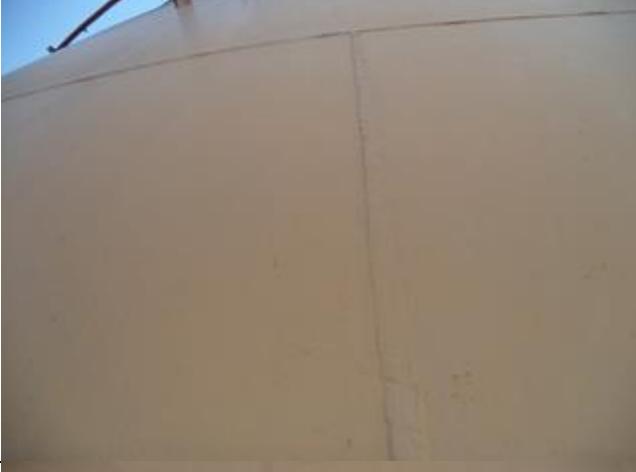
<p>Vertical joints</p> <p>Finding: Visually found in satisfactory condition.</p> <p>Recommendation: Nil, just for info.</p> <p>Repair Priority: N/A</p>

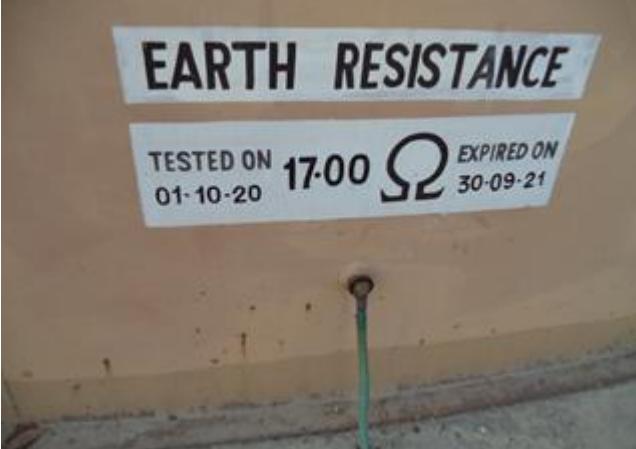
<p>Tank Earthing</p> <p>Finding: The Earthing bosses have been observed on two locations on tank shell with values of electrical resistance up to date written on them, which is well within acceptable limit of 25 ohms</p> <p>Recommendation: To monitor.</p> <p>Repair Priority: To Monitor</p>

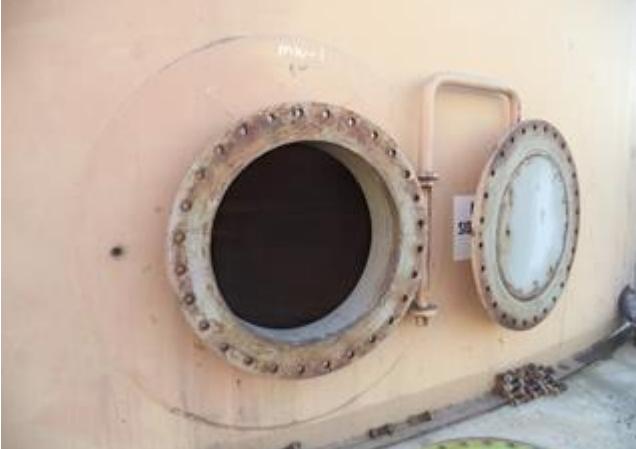
<p>Manway</p> <p>Finding: Visually found in satisfactory condition.</p> <p>Recommendation: Nil, just for info.</p> <p>Repair Priority: N/A</p>

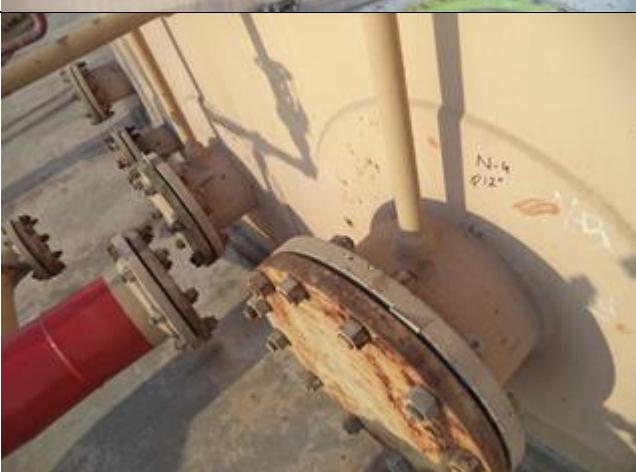
<p>Shell Nozzle</p> <p>Finding: Atmospheric corrosion observed due to minor paint failure.</p> <p>Recommendation: To make good surface preparation and recoat as per paint manufacturer's specification.</p> <p>Repair Priority: Offline</p>

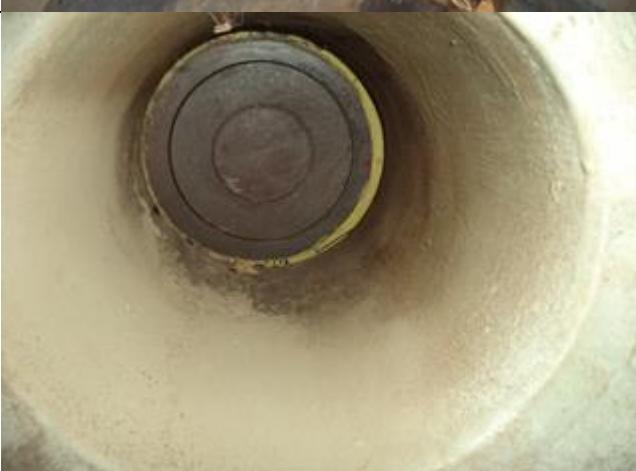
<p>Shell Nozzle</p> <p>Finding: Internally shell nozzles were found satisfactory without pitting.</p> <p>Recommendation: Nil, just for info.</p> <p>Repair Priority: N/A</p>

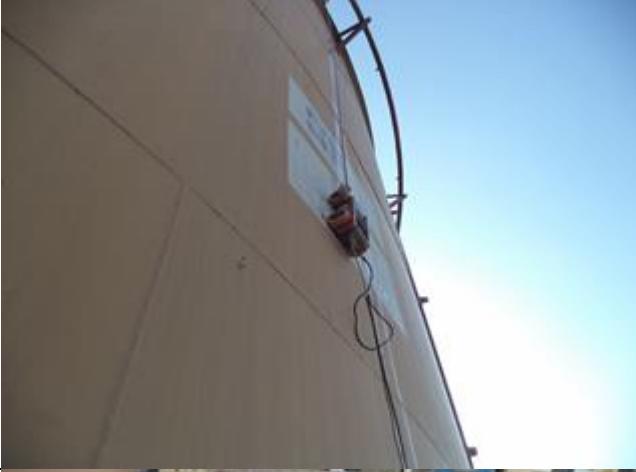
Shell course Finding: UT crawler carried out on shell course plates to record the thickness. No significant metal loss noted during testing. Recommendation: Nil, just for info. Repair Priority: N/A

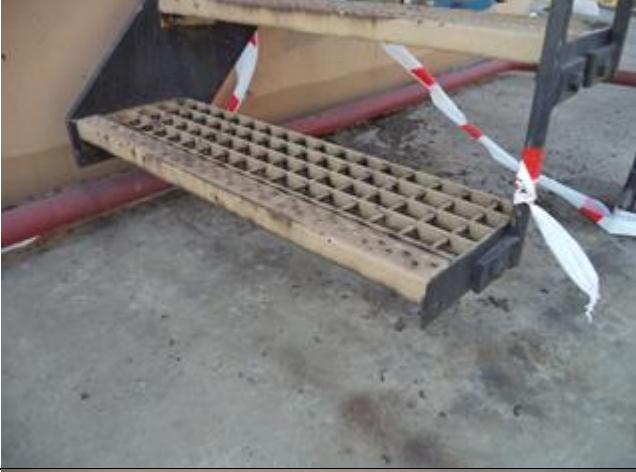
Stairway Finding: Stairway is not properly supported with foundation due to which shell plates bear more stresses Recommendation: It should be properly supported with foundation Repair Priority: Offline

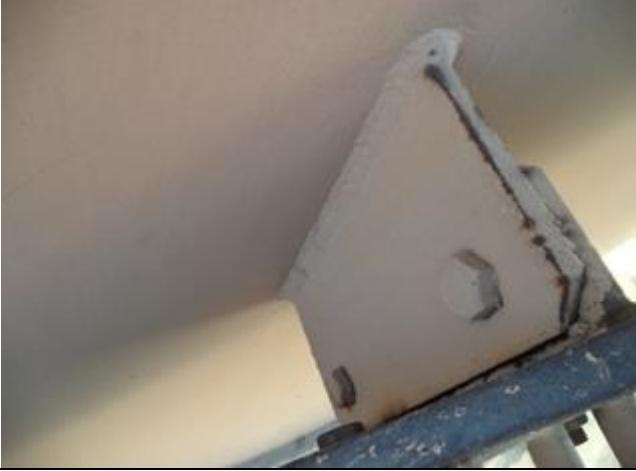
Stairway Finding: Support of stairway directly welded with shell plates. Recommendation: Nil, just for info. Repair Priority: N/A

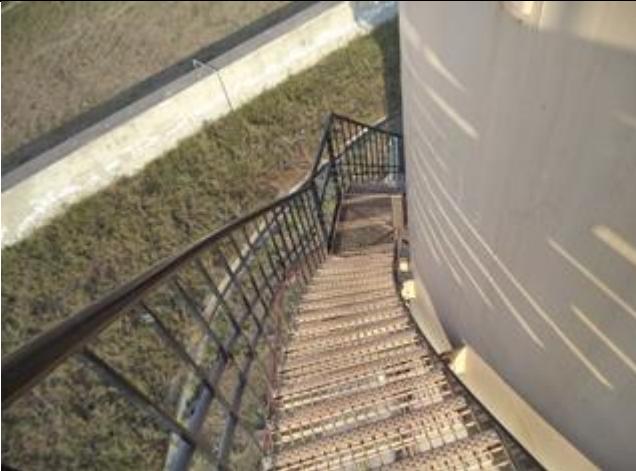
<p>Stairway</p> <p>Finding: Visually found in satisfactory condition without pitting and paint failure.</p> <p>Recommendation: Nil, just for info.</p> <p>Repair Priority: N/A</p>

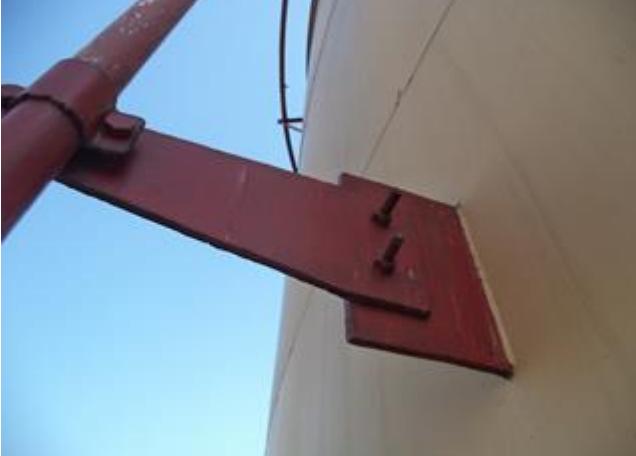
<p>Hydrant Line</p> <p>Finding: Support of hydrant line directly welded with shell plates</p> <p>Recommendation: Nil, just for info.</p> <p>Repair Priority: N/A</p>

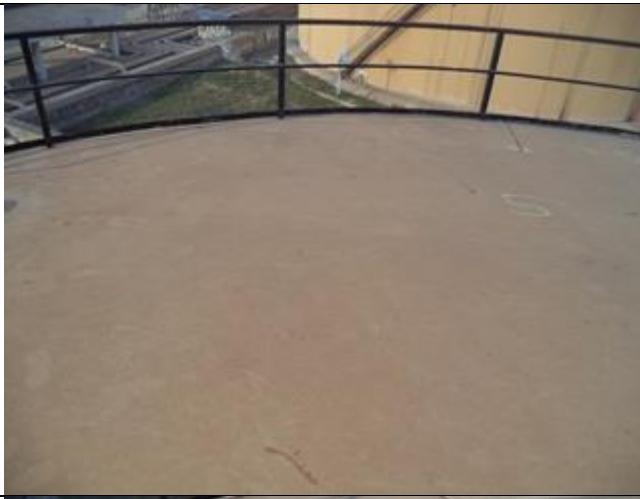
**Roof Plates****Finding:**

Visually found in satisfactory condition without paint failure and surface pitting.

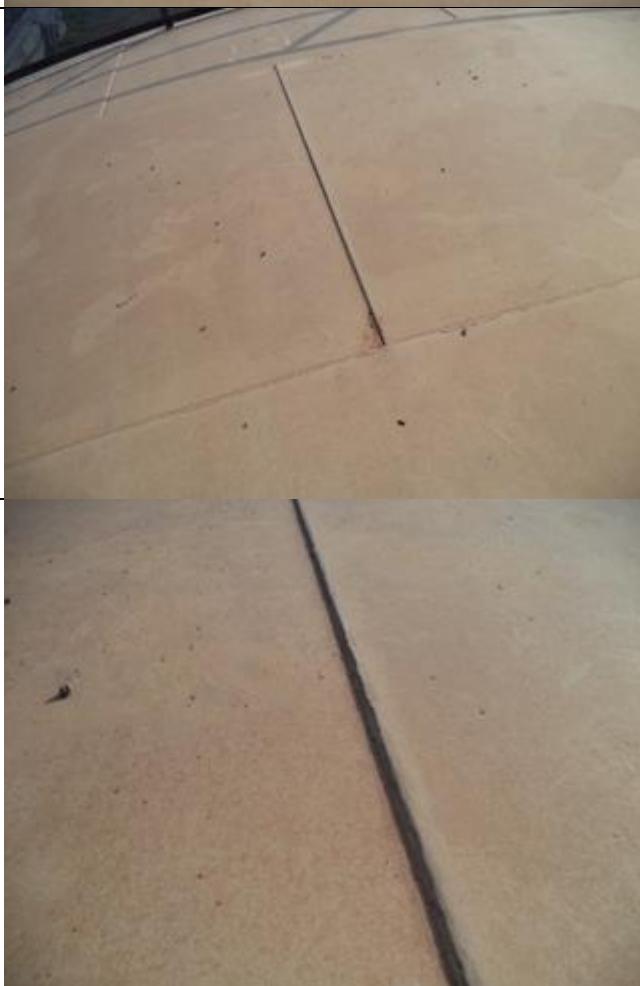
**Roof Plates****Finding:**

All roof lapped welded seams (short and long) was found satisfactory, no visual defect was observed.

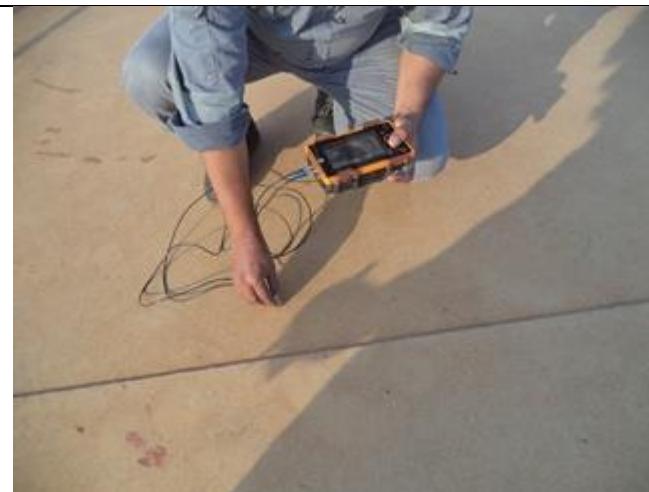
**Roof Plates UTG****Finding:**

UTG carried out on roof plates to record the thickness , No significant metal loss noted during testing.

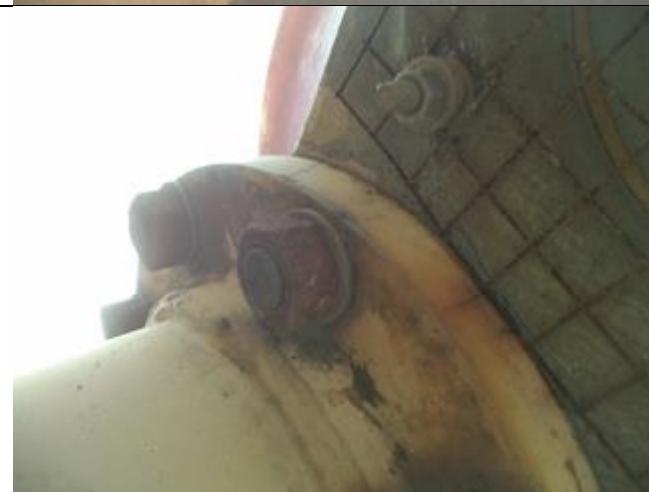
**Goose Neck****Finding:**

Atmospheric corrosion observed on nut bolts of goose neck.

Repair Priority: Offline

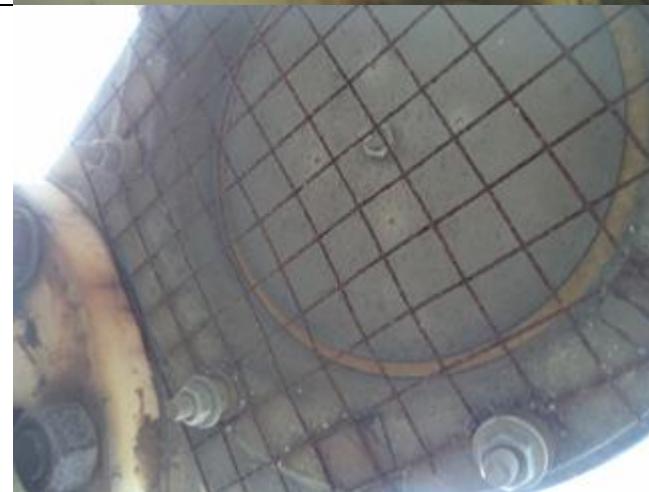
**Mesh screen.****Finding:**

Corrosion observed on mesh screen.

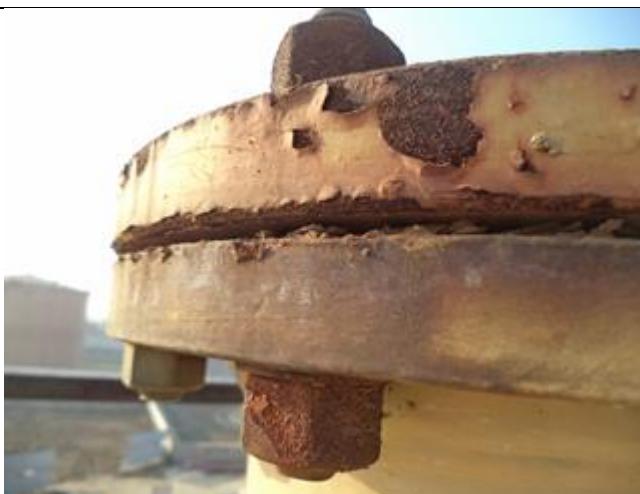
**Blind Nozzle****Finding:**

Paint failure and atmospheric corrosion observed.

Repair Priority: *Offline*

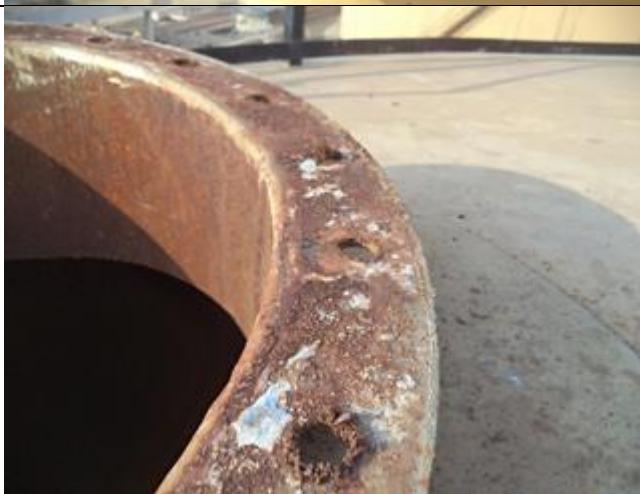
**Manway****Finding:**

Visually found in rusted condition.

Repair Priority: *Offline*

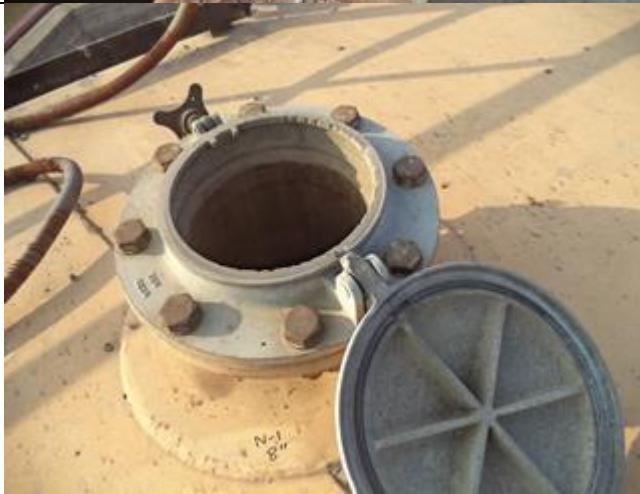
**Sampling/ Gauging Hatch****Finding:**

Visually found in satisfactory condition.

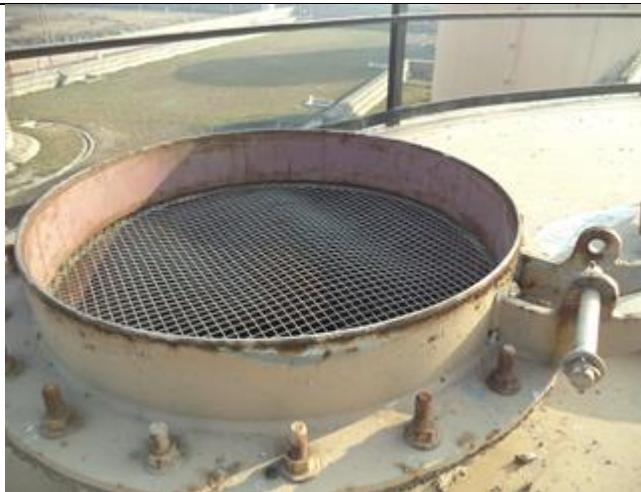
**ESV****Finding:**

ESV 24 " dia instelled with minor paint failure

To made good surface preparation and recoat as per paint manufacturer' specification.

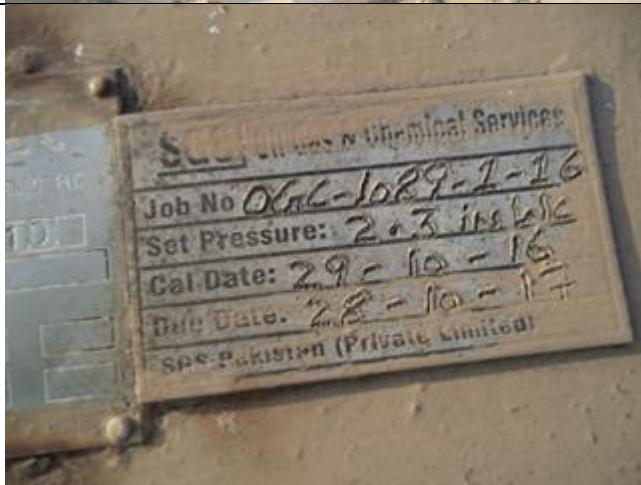
**ESV****Finding:**

Calibration tage found with expired date.

Need to calibrate the ESV.

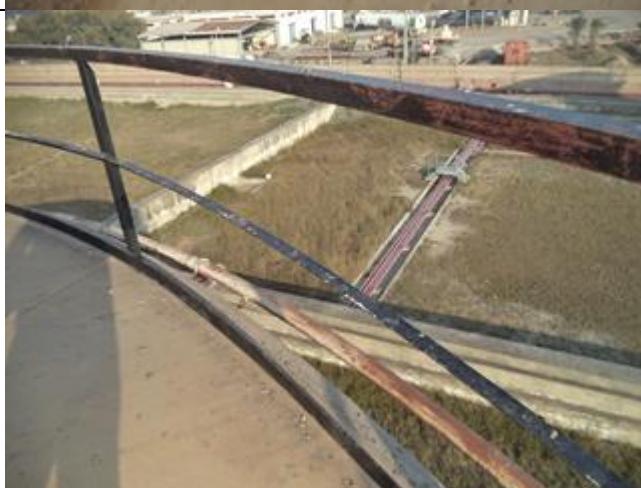
**Handrail****Finding:**

Paint failure and atmospheric corrosion observed.

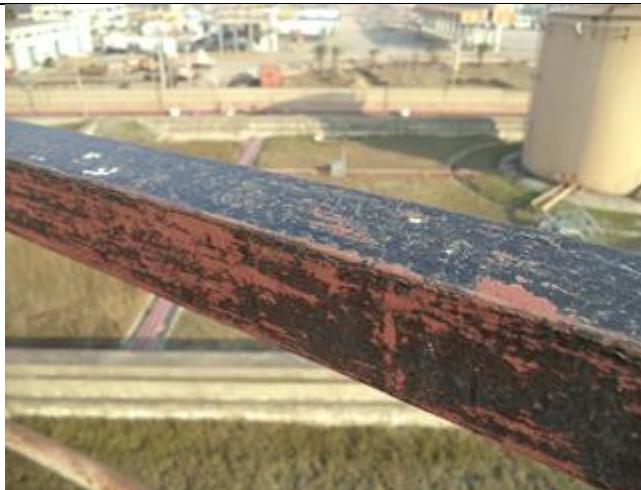
**Handrail****Finding:**

Same as above

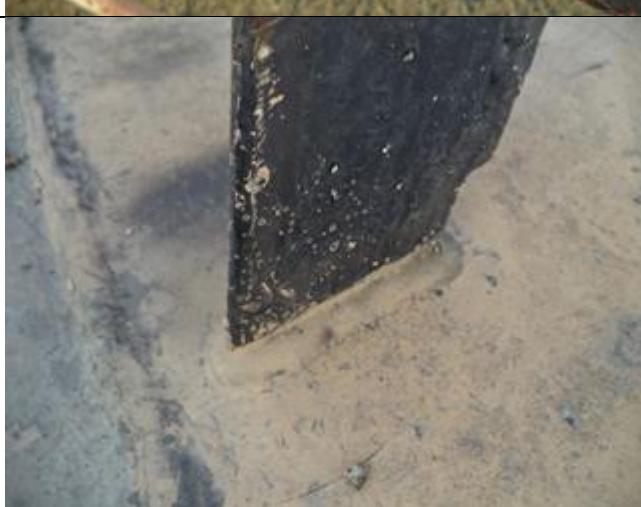
**Handrail****Finding:**

Support of handrail welded on roof plates

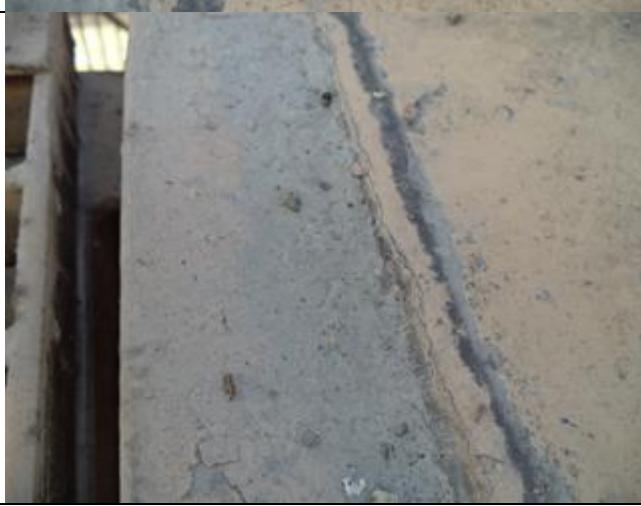
**Frangible joint (Joint between roof plate and shell top angle)****Finding:**

During visual inspection of Frangible joint found seal weld with satisfactory condition, without any significant discontinuities

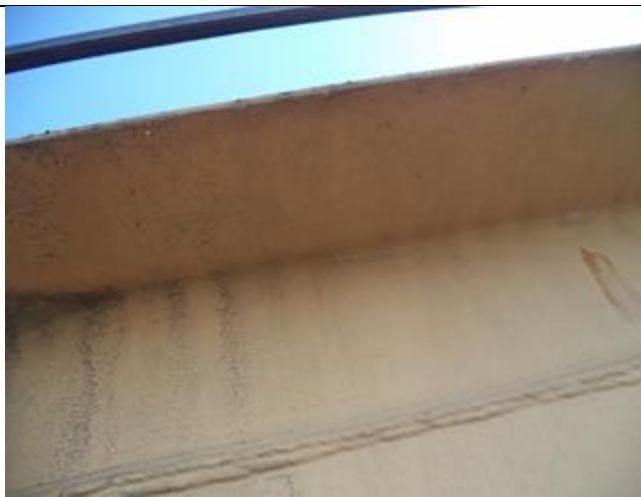
**Curb angle plate****Finding:**

Visually found in satisfactory condition without paint failure and surface pitting.

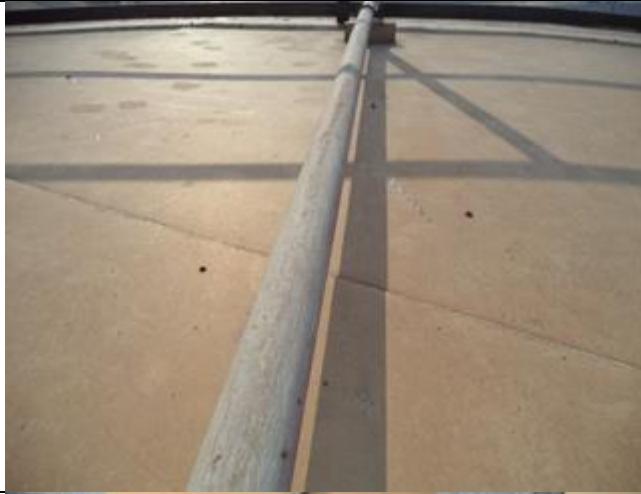
**Hydrant Line****Finding:**

Paint deterioration & flakes scrutinized on hydrant line

Repair Priority: Offline

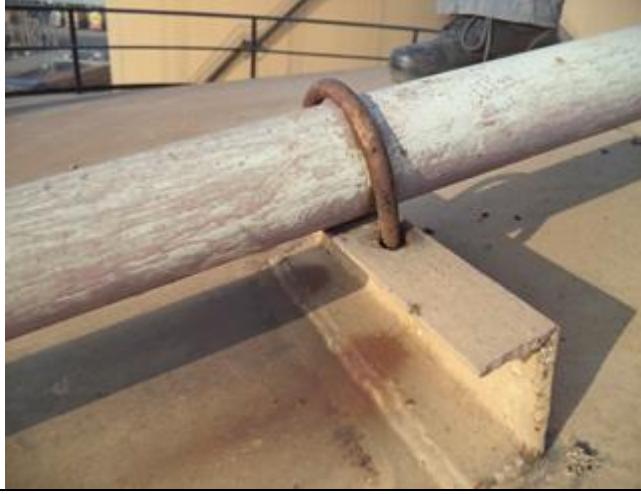
**Hydrant Line****Finding:**

Support of hydrant line found in satisfactory condition without corrosion.

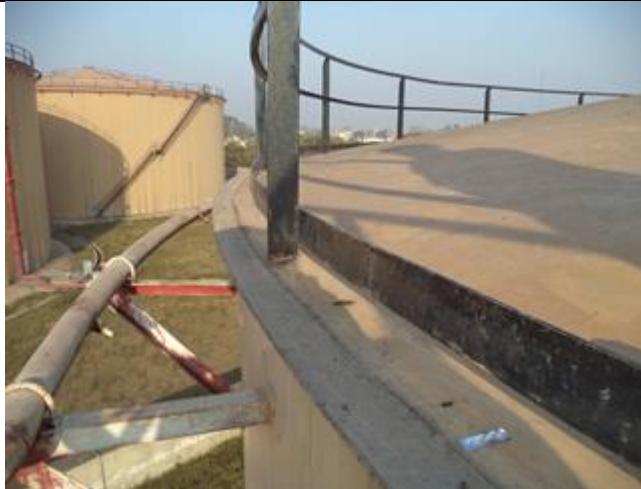
**Hydrant Line****Finding:**

Installed hydrant line on top shell course, paint failure observed.

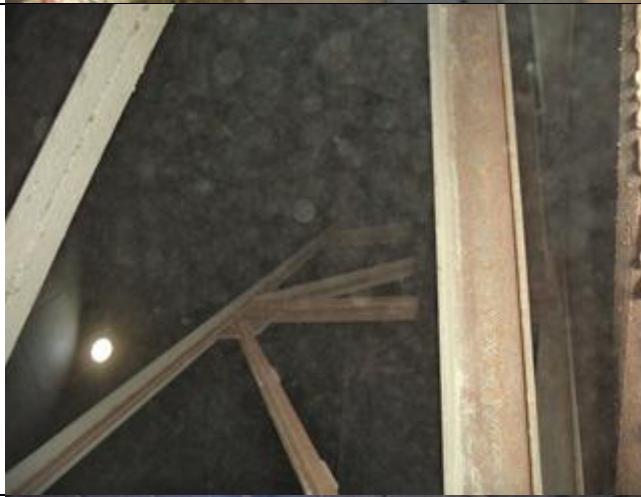
**Roof structure****Finding:**

Visually found in satisfactory condition.

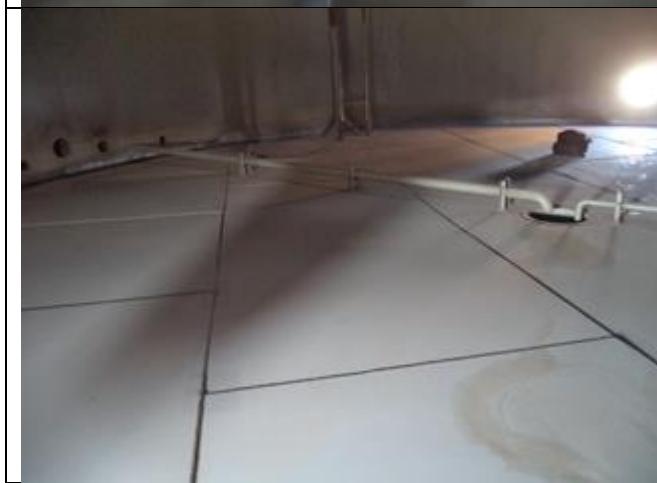
**Bottom Plate****Finding:**

Painted surface noted

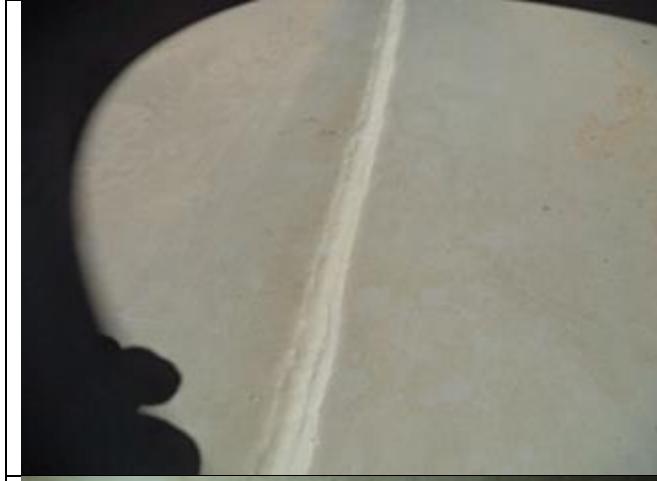
**Bottom Plate weldment****Finding:**

Visually bottom lap joints found satisfactory condition.

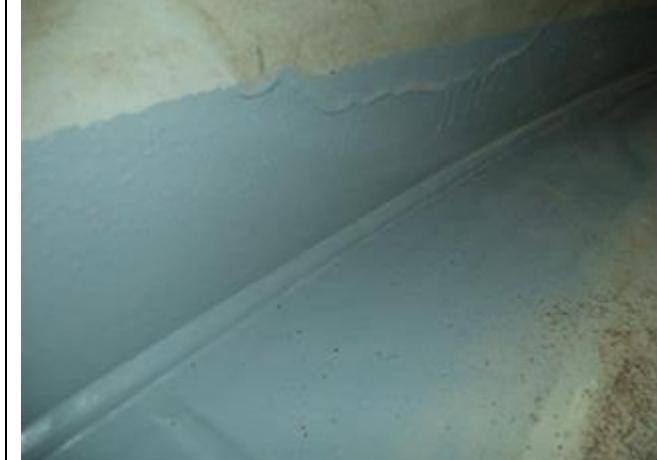
**Shell to Bottom Joint****Finding:**

Shell to bottom joint inspected visually and with NDT method of MPI, where found no surface defects.

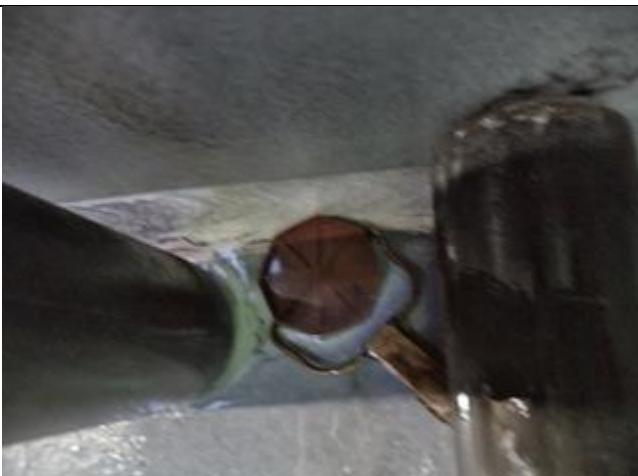
**Shell to Bottom Joint****Finding:**

Same as above

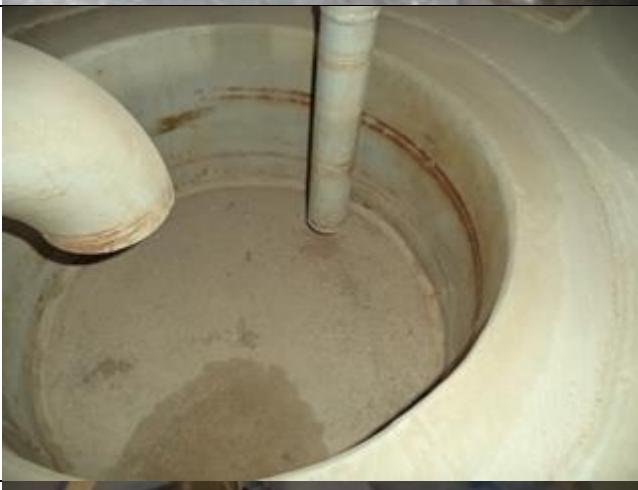
**Sump****Finding:**

Tank bottom sump pit visually inspected and found satisfactory.

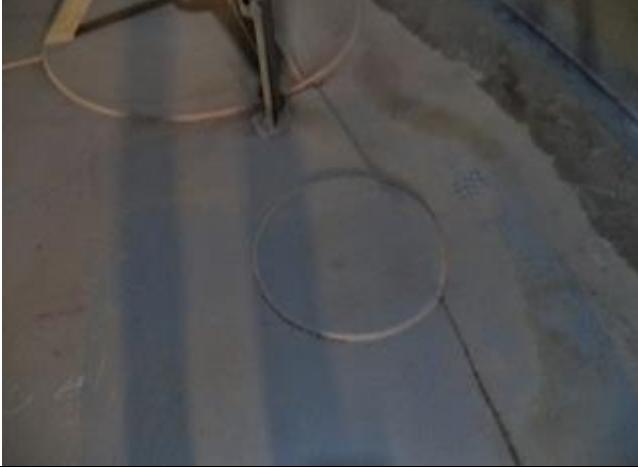
**Dipping Plate/ Datum Plate****Finding:**

Visually found in satisfactory condition.

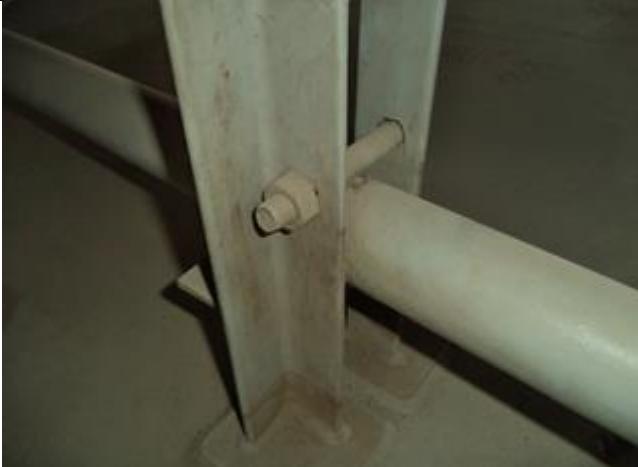
**Piping****Finding:**

Support of pipeline found satisfactory condition.

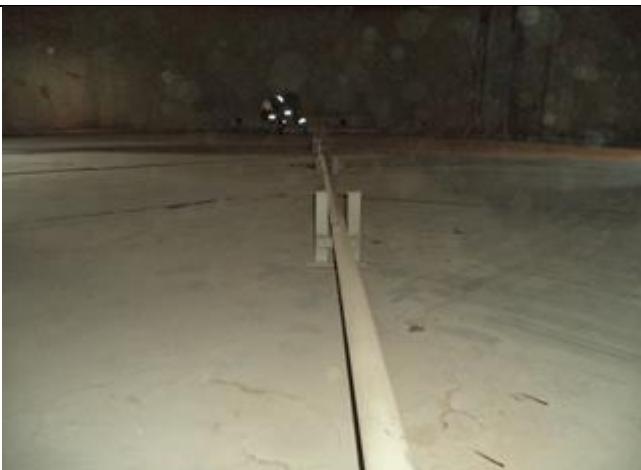
**Pipeline****Finding:**

visually found in satisfactory condition without paint failure and pitting.

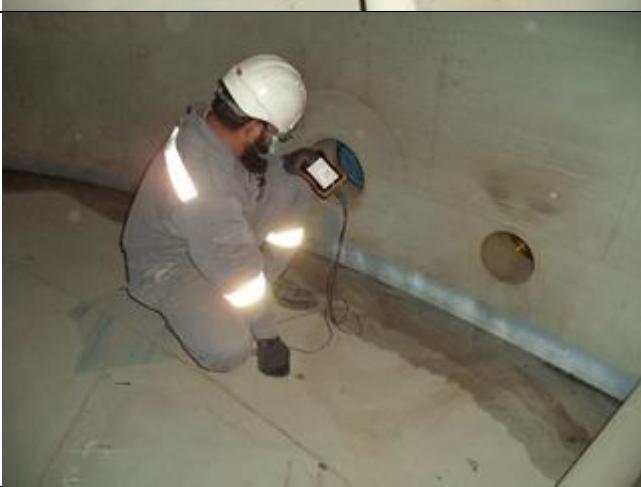
**Bottom Plate****Finding:**

UTG Carried out on bottom plates to record the thickness, No significant metal loss noted during testing.

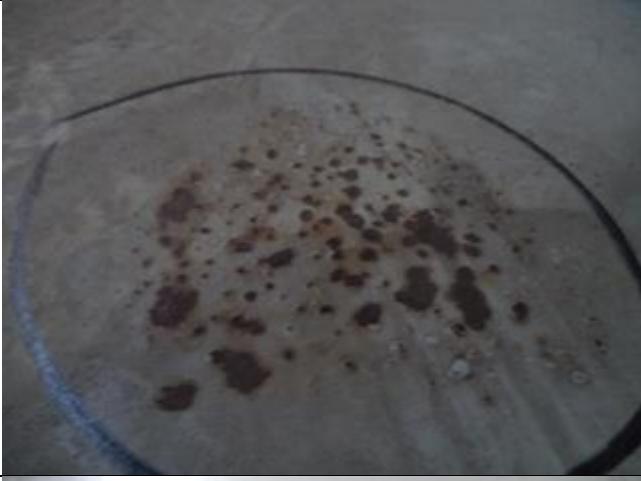
**Annular Plate****Finding:**

Paint blisters and flakes observed on Annular plate number 02

To made good surface preparation and recoat as per paint manufacturer' specification.

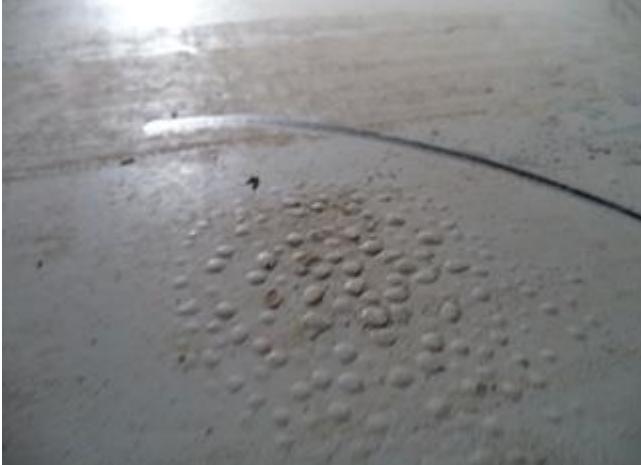
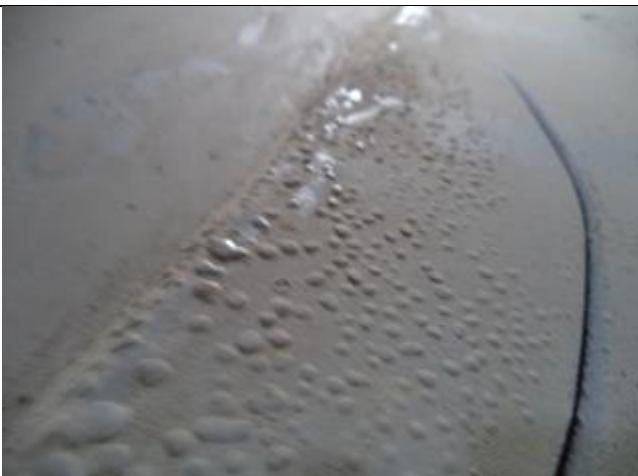
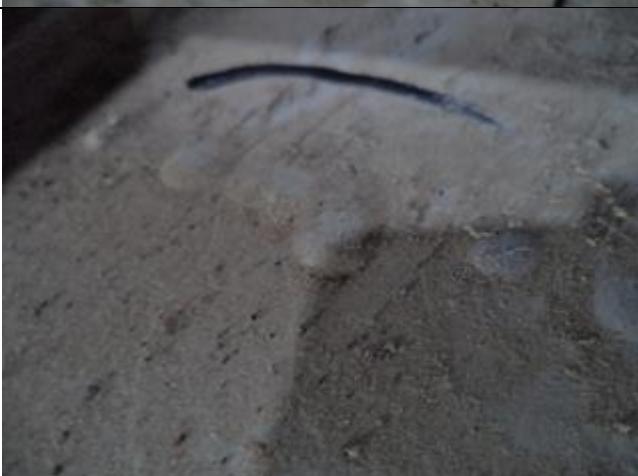
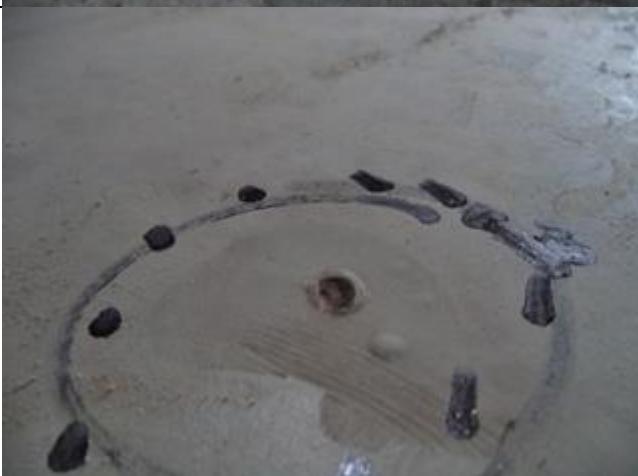
**Bottom plate coating****Finding:**

Paint blisters and flakes observed on bottom plates at different locations which permanently marked.

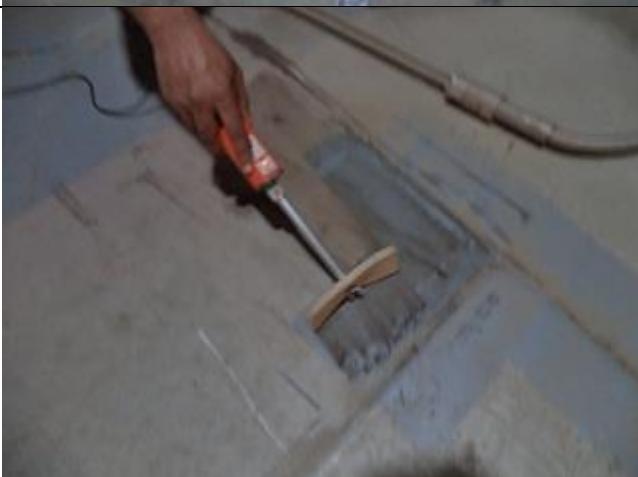
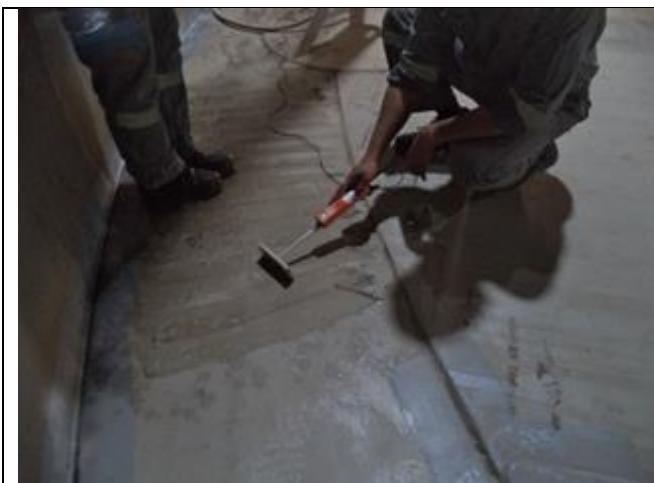
**Holiday test****Finding:**

Low voltage pin hole detector carried out on bottom plate and bottom weld seams, Paint blistering and flake observed on different locations

To made good surface preparation and recoat as per paint manufacturer' specification.
