SHELL PAKISTAN LIMITED

TENDER PACKAGE

CONVERSION OF MCH-02 FROM HSD TO MOGAS AT MACHIKE INSTALLATION (TANK REPAIR WORKS)

Doc. No.	3059-GEN-TR-001B	Tender Package
Revision	2	-
Date	04-05-2021	Issue Date

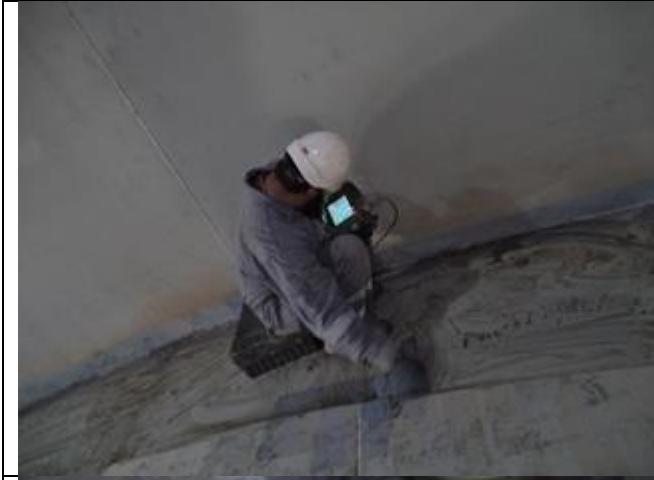
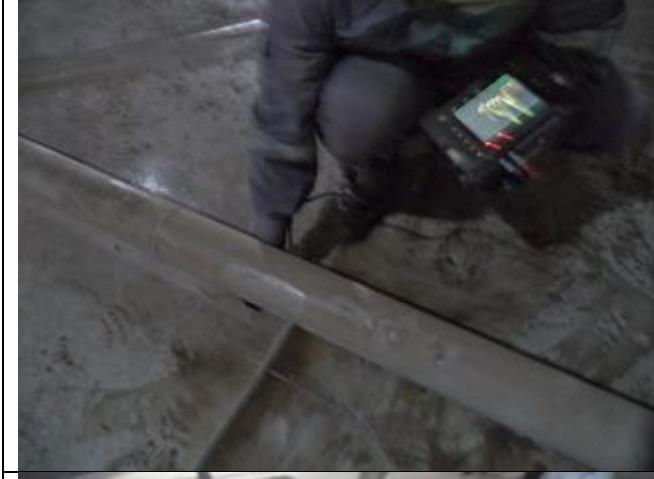
**Bottom plates****Finding:**

UT A scanning carried out on annular plates and unscane area of MFL, No significant metal loss noted during testing

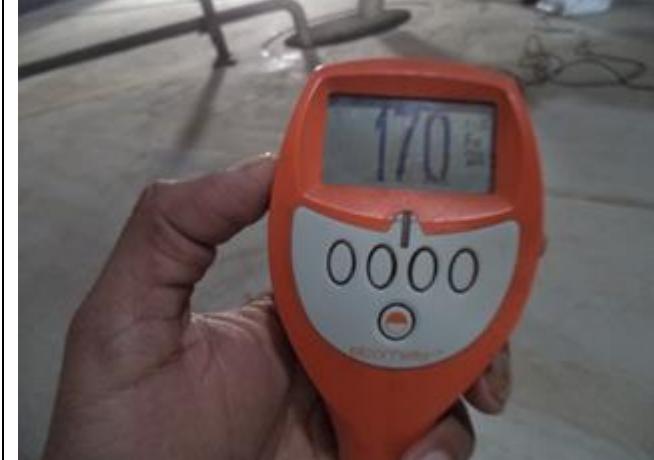
**DFT****Finding:**

DFT carried out on bottom plates Thickness of coating observed in the range of 150 to 200 microns

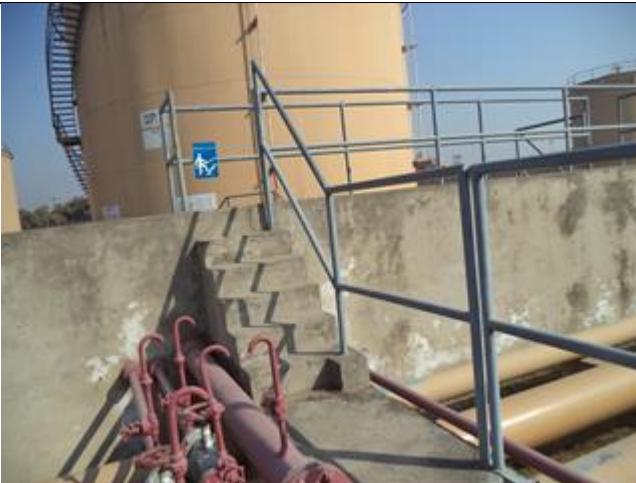
Access Way Finding: One side handrailing missing Recommendation: Need to installed the handrailing on missing side Repair Priority: Offline
---	--

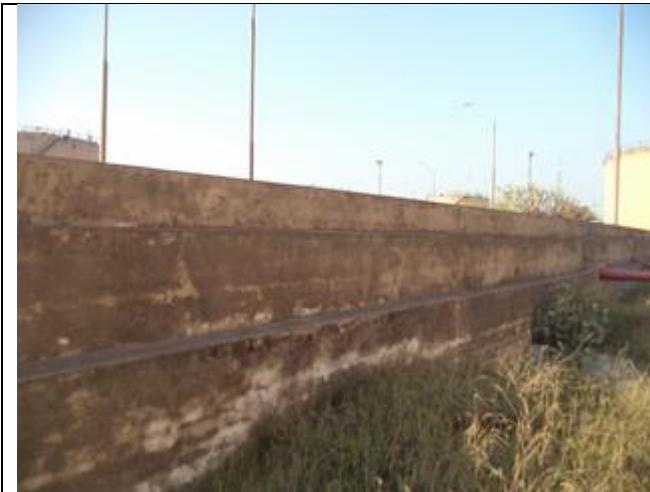
**Dyke wall****Finding:**

Reinforced Concrete ring wall observed around the tank, found minor cracks and cement plaster failure at different location

It is therefore recommended that cement plaster shall be restored by masonry work in order to avoid further deterioration.

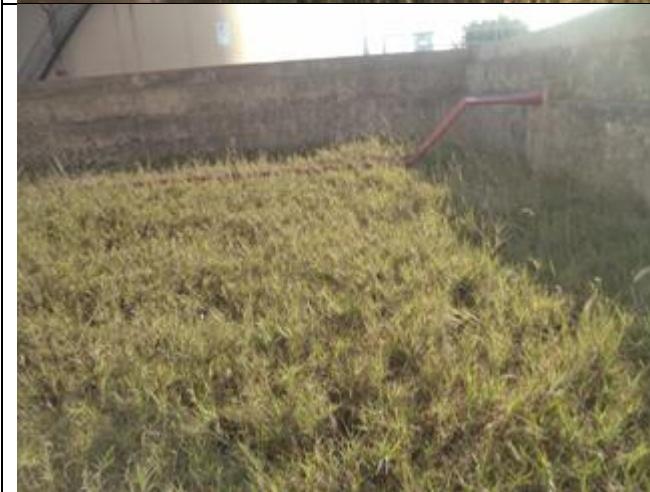
**Tank Area****Finding:**

Vegetation growth observed around the tank foundation.

Need to clean the existing vegetation and take measures to avoid future growth

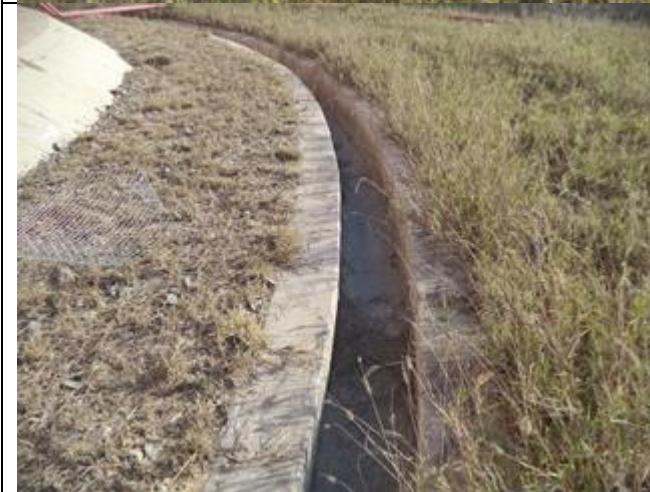
**Drainage System****Finding:**

Drain channel observed around the tank, Visually found in satisfactory condition

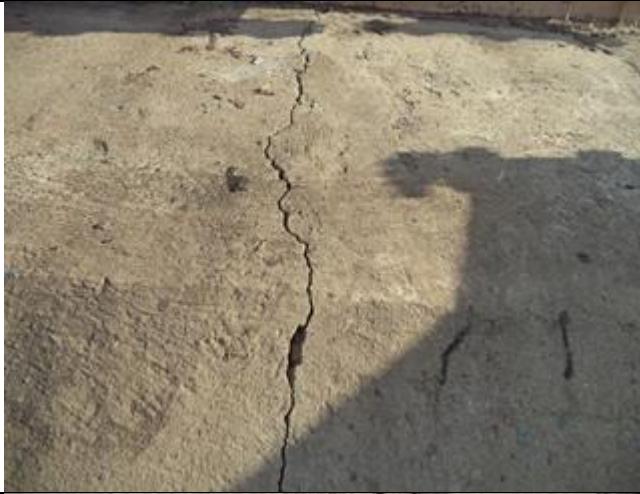
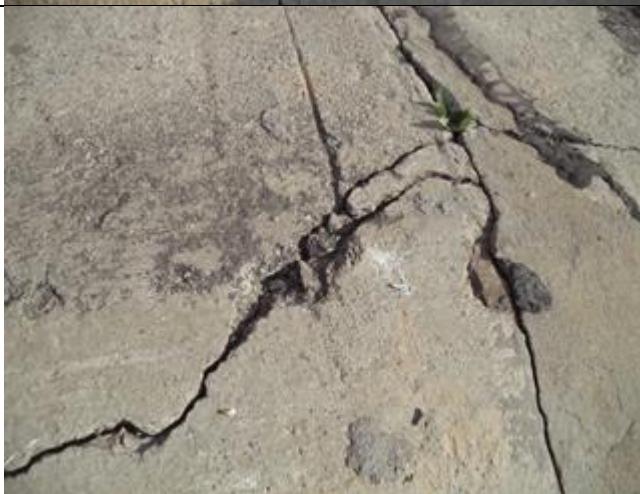
**Cement Tank Pad****Finding:**

5. Cement Tank Pad	Spalling, broken Asphalt observed on tank foundation pad	<ul style="list-style-type: none"> Need to repair the foundation pad with non shrikage grout 	Online Or Offline

Spalling, broken Asphalt observed on tank foundation pad

Need to repair the foundation pad with non shrinkage grout

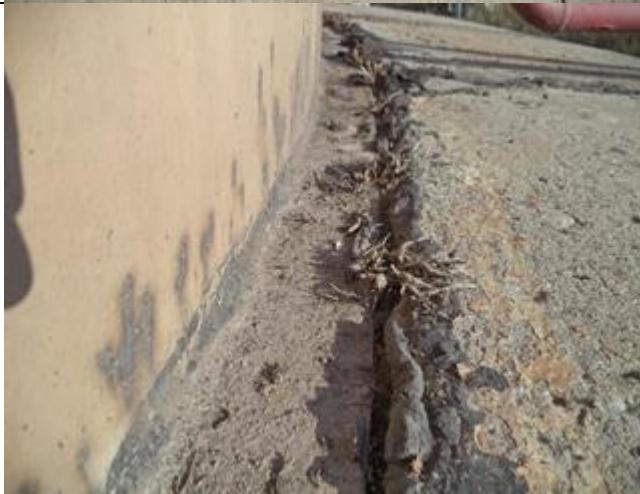
**Tank Foundation****Finding:**

6. Tank Foundation	Tank foundation level is higher than bottom projection plate, causing runoff rainwater from the shell, remain stagnant on projection plate. Water can damage the paint and cause corrosion of projection plate	<ul style="list-style-type: none"> To trim tank foundation to allow proper water drainage. 	Offline

Tank foundation level is higher than bottom projection plate, causing runoff rainwater from the shell, remain stagnant on projection plate. Water can damage the paint and cause corrosion of projection plate

To trim tank foundation to allow proper water drainage.

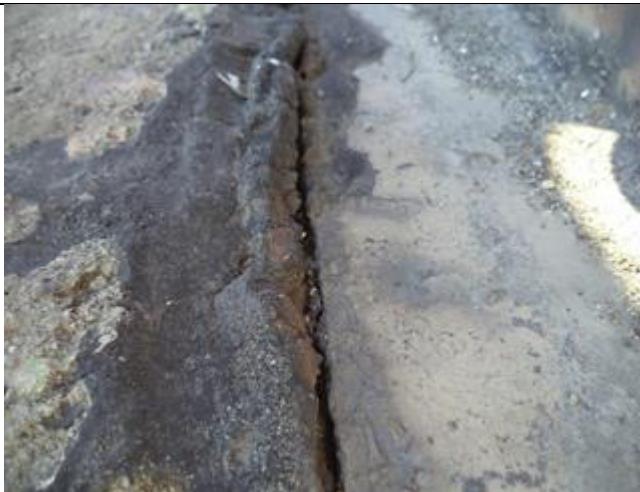
**Bottom Projection Plate and Foundation****Finding:**

7. Bottom Projection Plate and Foundation	Gap noted between bottom Projection Plate and tank foundation, which may allow water to seep in under the tank.	<ul style="list-style-type: none"> It should be filled with water proof sealant to avoid the moisture ingress beneath the bottom 	Offline
	Vegetation growth observed in b/w the projection plate and foundation.	<ul style="list-style-type: none"> Need to clean the existing vegetation and take measures to avoid future growth 	Online Or Offline

Gap noted between bottom Projection Plate and tank foundation, which may allow water to seep in under the tank.

It should be filled with water proof sealant to avoid the moisture ingress beneath the bottom

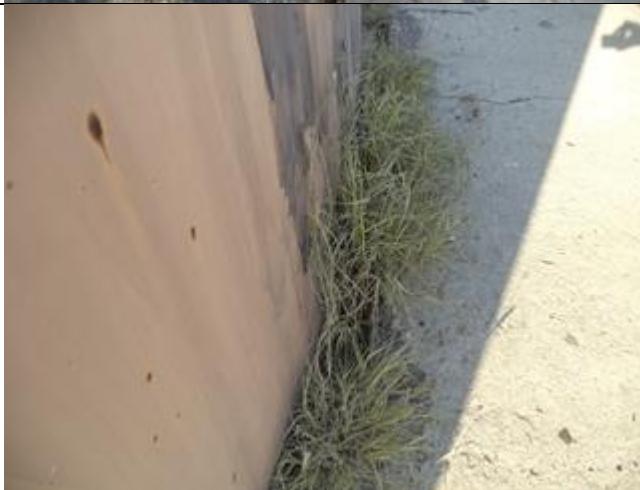
**Bottom Projection Plate and Foundation****Finding:**

Vegetation growth observed in b/w the projection plate and foundation.

Need to clean the existing vegetation and take measures to avoid future growth

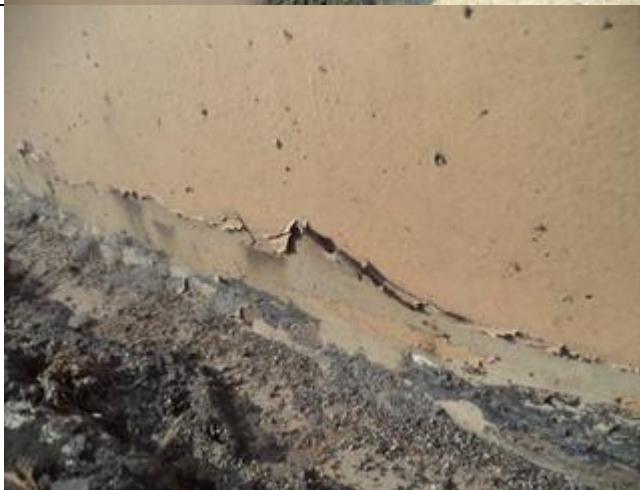
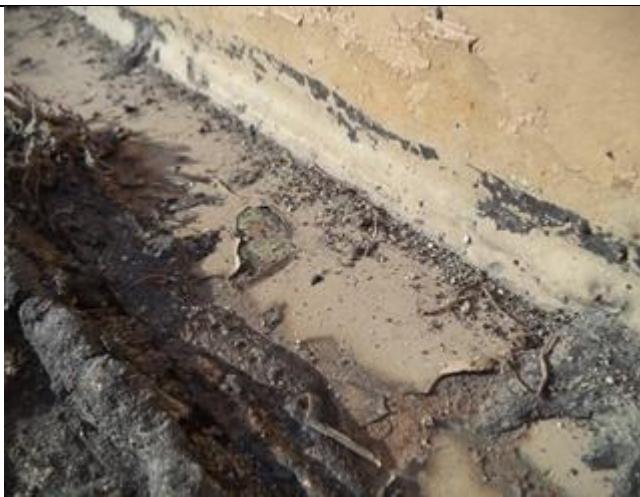
**Bottom Projection Plate****Finding:**

8. Bottom Projection Plate	Paint failure observed on projection plates	<ul style="list-style-type: none"> To made good surface preparation and recoat as per paint manufacturer' specification. 	Offline

Paint failure observed on projection plates

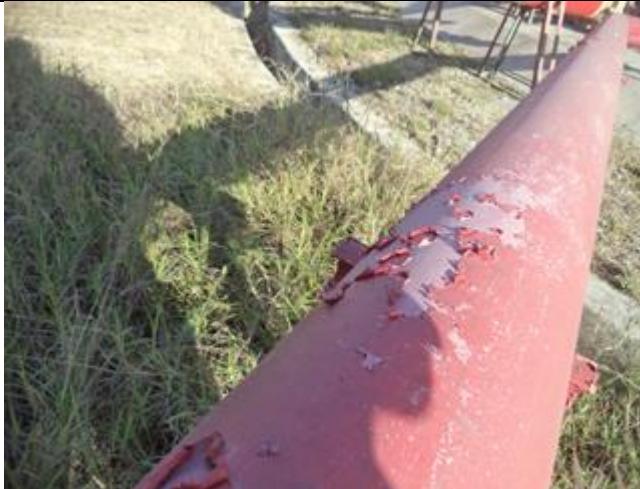
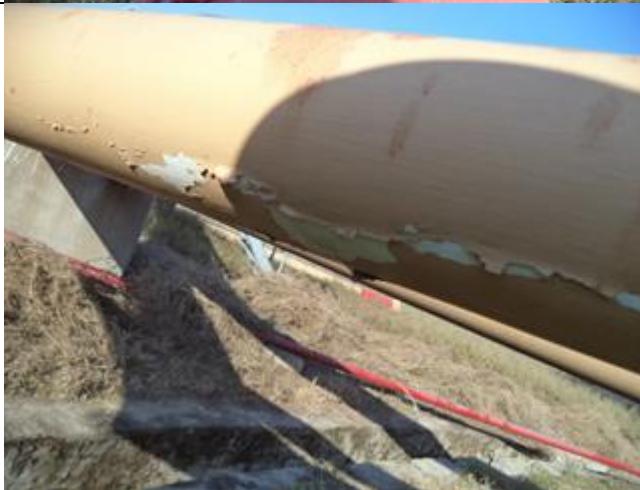
**Piping****Finding:**

9. Piping	Paint failure observed on piping at different locations	<ul style="list-style-type: none"> To made good surface preparation and recoat as per paint manufacturer' specification. 	Offline

Paint failure observed on piping at different locations

To made good surface preparation and recoat as per paint manufacturer' specification.

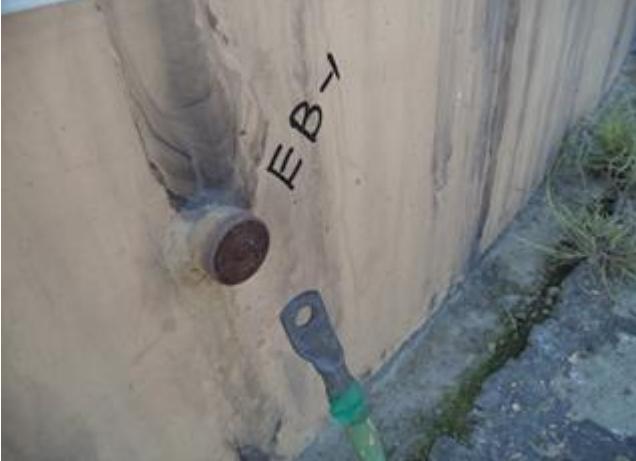
Item	Findings	Recommendations	Repair Priority
1. Tank Earthing	Tank Earthing cable observed disconnect from shell plate.	<ul style="list-style-type: none"> Need to properly connect the earthing cable with tank shell plate 	Offline

<p>Tank Earthing</p> <p>Finding: Tank Earthing cable observed disconnect from shell plate.</p> <p>Recommendation: Need to properly connect the earthing cable with tank shell plate</p> <p>Repair Priority: Offline</p>

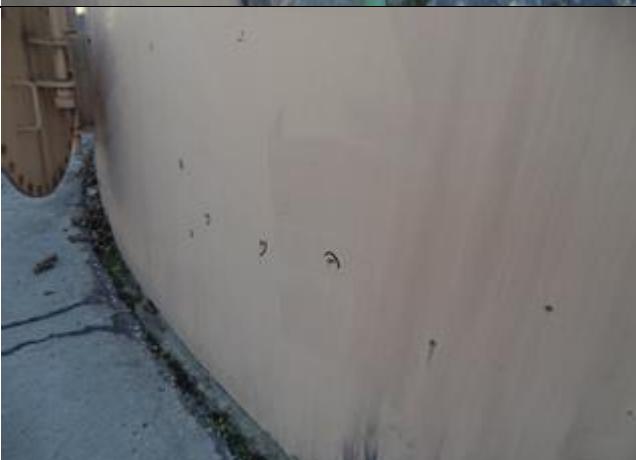
<p>Shell Plate</p> <p>Finding: Signs of paint failure observed on first shell course.</p> <p>Recommendation: To make good surface preparation and recoat as per paint manufacturer's specification.</p> <p>Repair Priority: Offline</p>

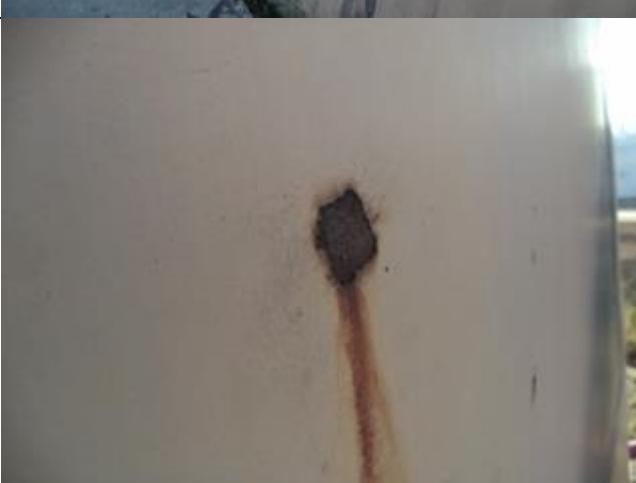
<p>Shell Plate</p> <p>Finding: Paint deterioration scrutinized on different location of shell plates from stairway side.</p> <p>Recommendation: To make good surface preparation and recoat as per paint manufacturer's specification.</p> <p>Repair Priority: Offline</p>

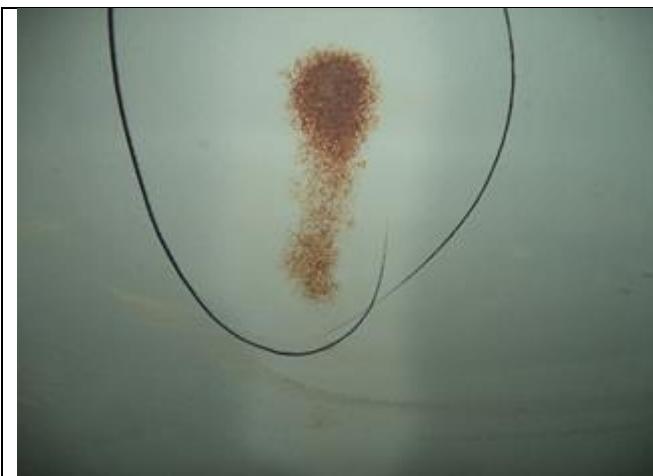
**Internal Shell Plate****Finding:**

3. Internal Shell Plate	At one location paint failure observed on internal shell plate number -1 at nozzle side	<ul style="list-style-type: none"> To make good surface preparation and recoat as per paint manufacturer's specification. 	Offline
	Atmospheric corrosion observed on internal shell plates except first shell course plates.	<ul style="list-style-type: none"> Nil, just for info. 	N/A

At one location paint failure observed on internal shell plate number -1 at nozzle side

To made good surface preparation and recoat as per paint manufacturer' specification.

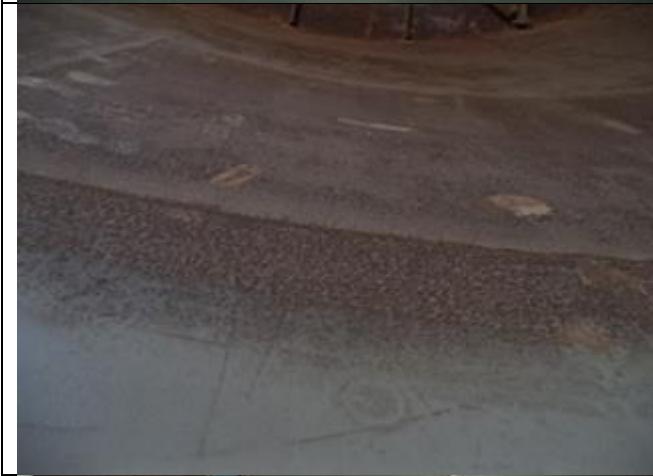
**Internal Shell Plate****Finding:**

Atmospheric corrosion observed on internal shell plates except first shell course plates.

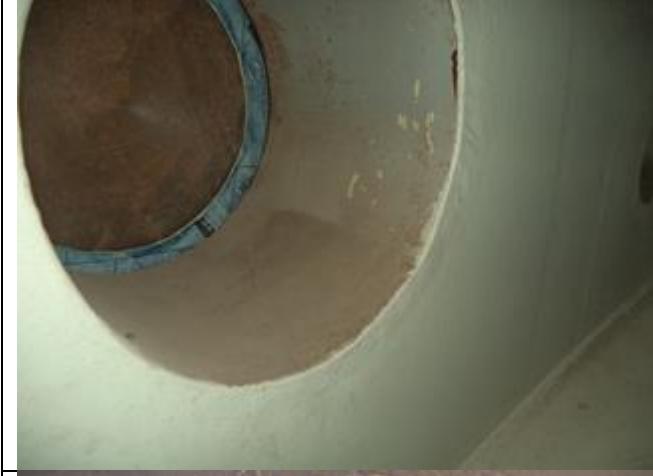
**Shell Nozzle****Finding:**

No pitting observed on internal shell nozzle.

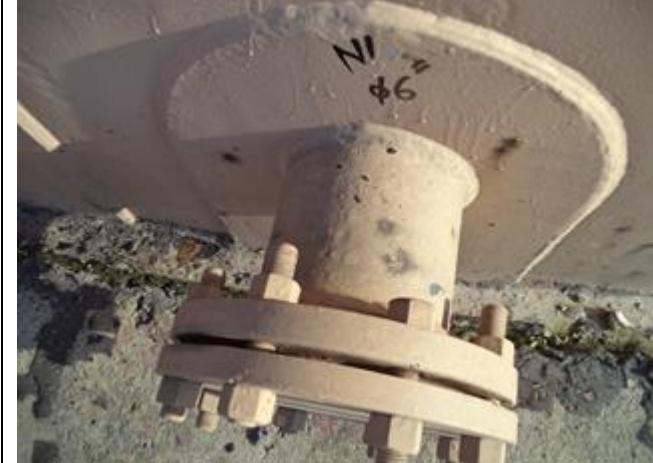
**Shell Nozzle****Finding:**

Visually found in satisfactory condition without paint failure and pitting.

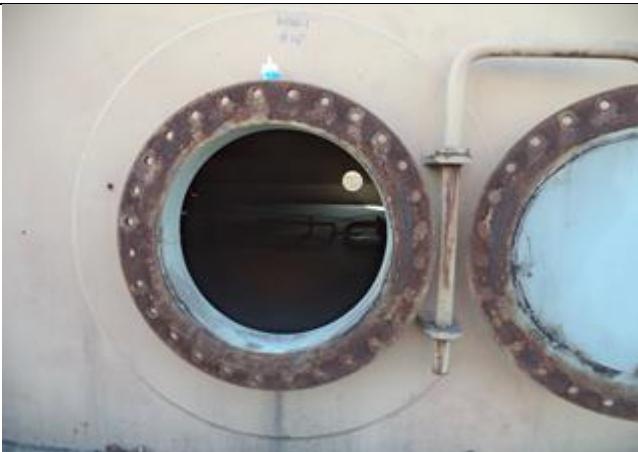
**Manway****Finding:**

Atmospheric corrosion observed on shell manway flange surface.

Need to properly clean it.

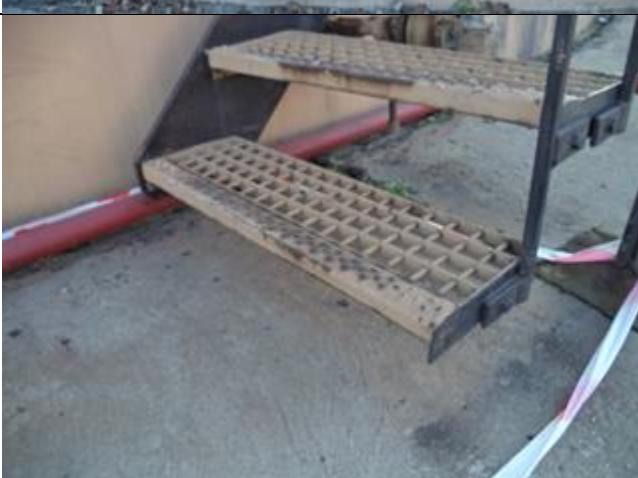
**Stairway****Finding:**

Stairway is not properly supported with foundation due to which shell plates bear more stresses

It should be properly supported with foundation

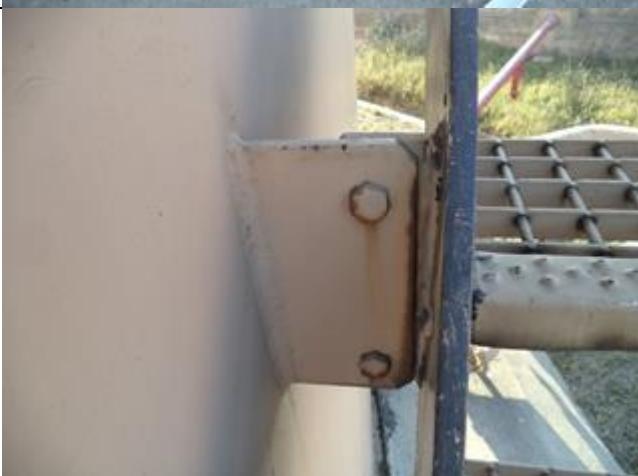
**Stairway****Finding:**

Guest plate of stair case found directly welded with shell plates.

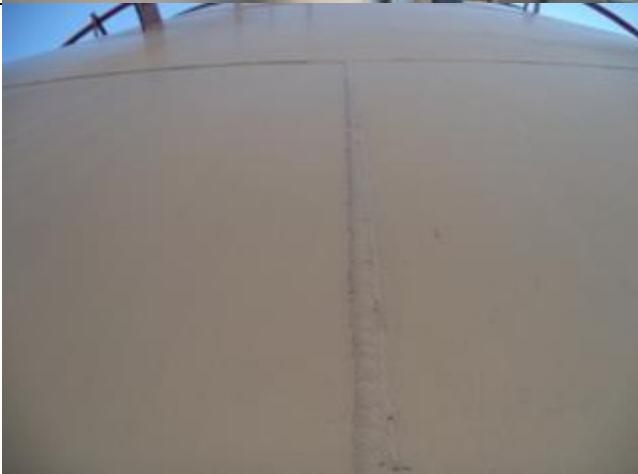
**Weld Seam****Finding:**

Visually horizontal and vertical weld seams found in satisfactory condition.

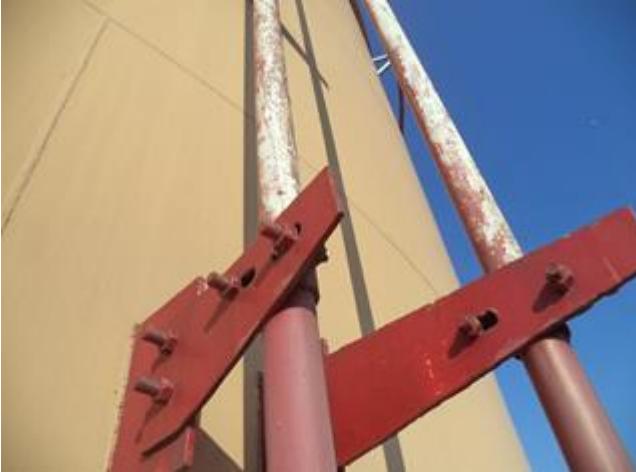
<p>Hydrant Line</p> <p>Finding: As per view from ground level, hydrant line paint found paint blisters & paint flakes.</p> <p>Recommendation: To made good surface preparation and recoat as per paint manufacturer' specification.</p> <p>Repair Priority: N/A</p> <p>Finding: Guest plates of hydrant line directly welded with shell plate.</p> <p>Recommendation: Nil,just for info.</p> <p>Repair Priority: N/A</p>

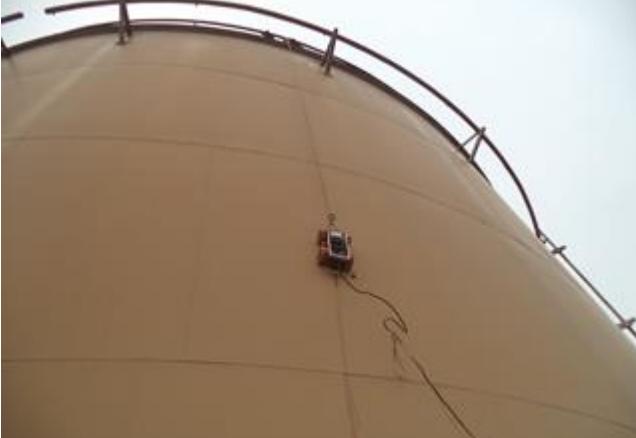
<p>Shell Plate</p> <p>Finding: UT Crawler carreid out on shell plates to record the thickness, No significant metal loss noted during testing.</p> <p>Recommendation: Nil,just for info.</p> <p>Repair Priority: N/A</p>

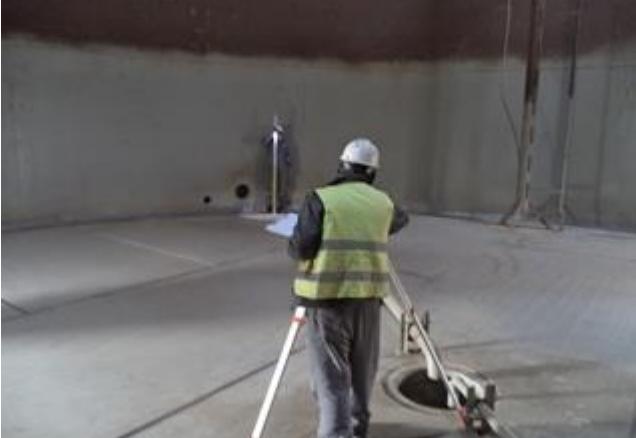
<p>Tank Survey</p> <p>Finding: Tank Survey carried out to check the settlement and plumbness. No abnormality observed. See survey report.</p> <p>Recommendation: Nil,just for info.</p> <p>Repair Priority: N/A</p>

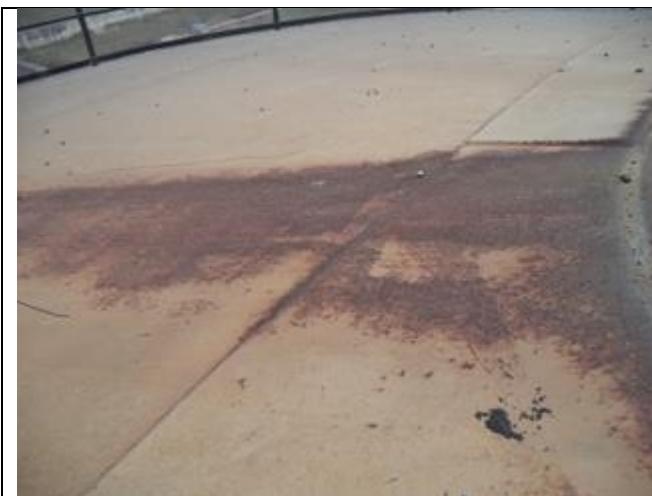
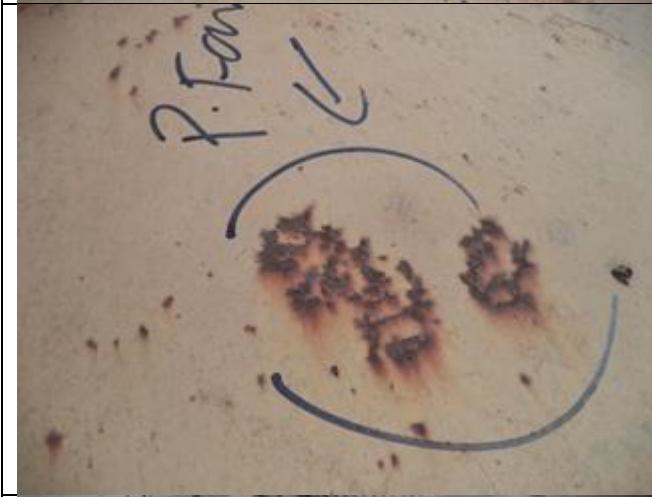
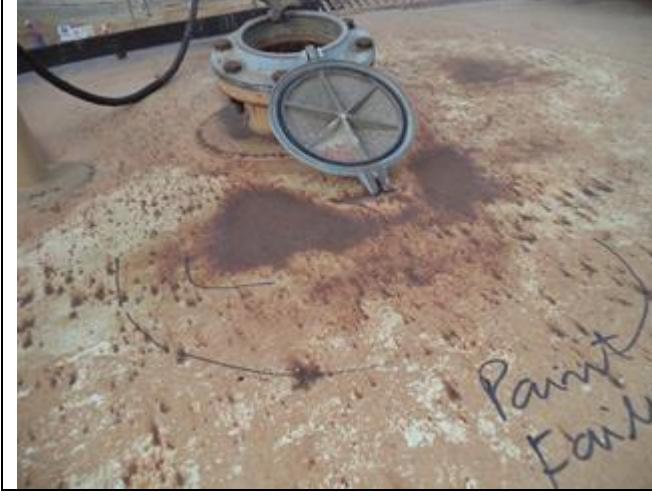
**Roof Plate****Finding:**

Item	Findings	Recommendations	Repair Priority
1. Roof Plate	Paint deterioration & flakes scrutinized on roof plates number 2/1, 3/2, 4/1 and 5/2.	<ul style="list-style-type: none"> To made good surface preparation and recoat as per paint manufacturer' specification. 	Offline

Paint deterioration & flakes scrutinized on roof plates number 2/1, 3/2, 4/1 and 5/2.

To made good surface preparation and recoat as per paint manufacturer' specification.

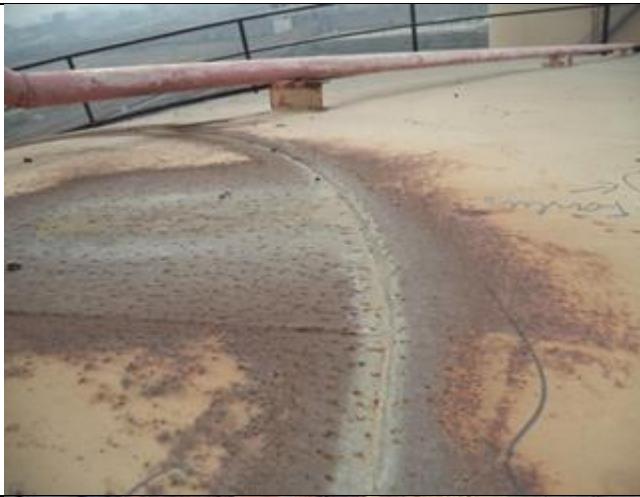
**Crown plate****Finding:**

2. Crown plate	Paint deterioration & flakes scrutinized on roof plates including weld seams and crown plate	<ul style="list-style-type: none"> To made good surface preparation and recoat as per paint manufacturer' specification. 	Offline

Paint deterioration & flakes scrutinized on roof plates including weld seams and crown plate

To made good surface preparation and recoat as per paint manufacturer' specification.

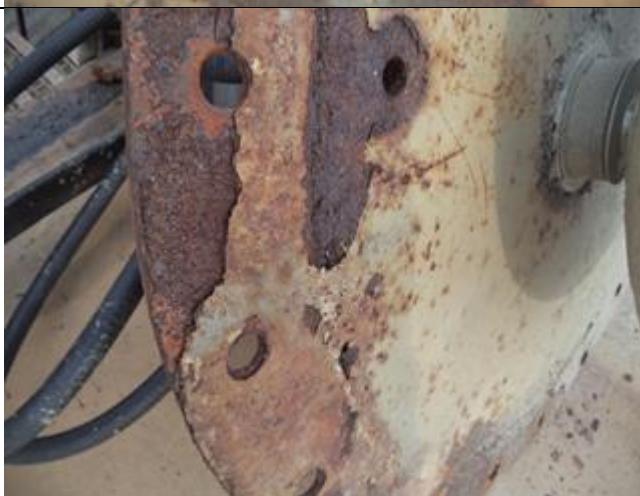
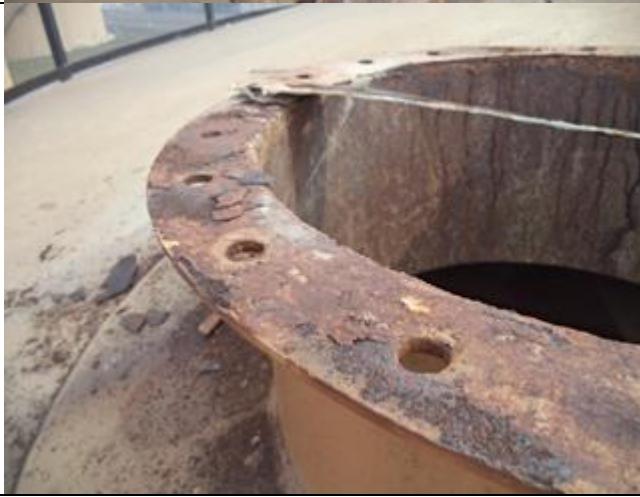
**Manway****Finding:**

3. Manway	Visually manyway found in rusted condition.	<ul style="list-style-type: none"> To made good surface preparation and recoat as per paint manufacturer' specification. 	Offline

Visually manyway found in rusted condition.

To made good surface preparation and recoat as per paint manufacturer' specification.

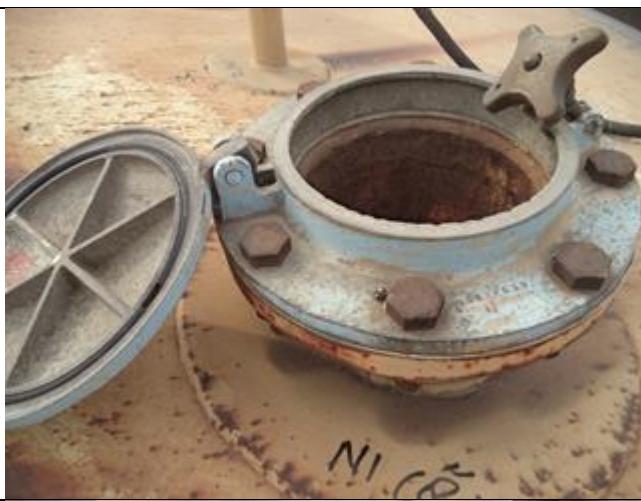
4. Sampling/ Gauging Hatch	Atmospheric corrosion observed on nut bolts of sample hatch.	<ul style="list-style-type: none"> Need to install Appropriate hot dip galvanized coated nut bolts. 	Offline

Atmospheric corrosion observed on nut bolts of sample hatch.

Need to install Appropriate hot dip galvanized coated nut bolts.

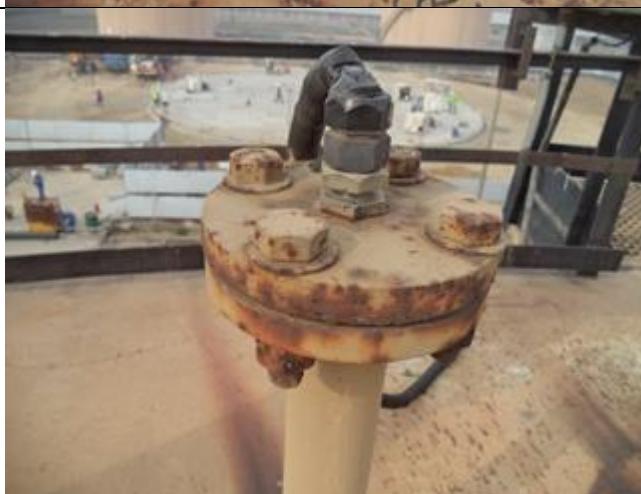
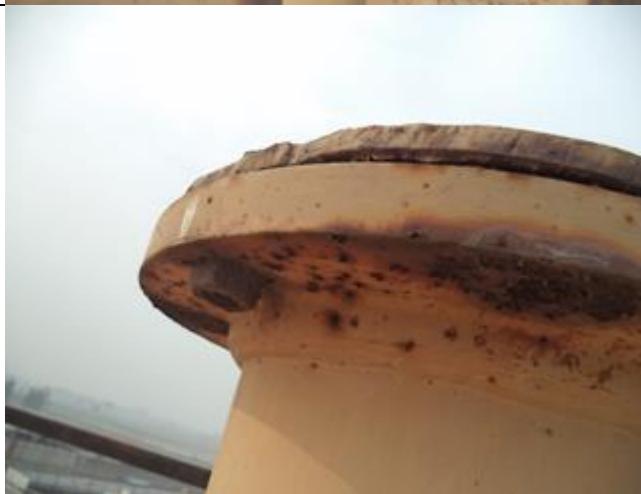
5. Roof Nozzle	Atmospheric corrosion observed on roof nozzle due to paint failure.	<ul style="list-style-type: none"> To made good surface preparation and recoat as per paint manufacturer' specification. 	Offline

Atmospheric corrosion observed on roof nozzle due to paint failure.

To made good surface preparation and recoat as per paint manufacturer' specification.

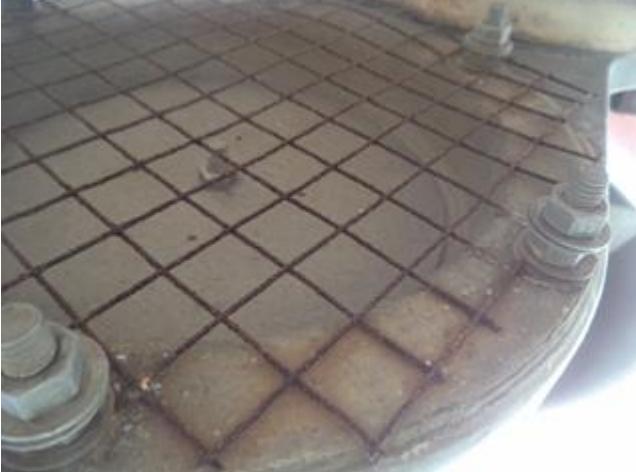
6. Mesh screen	Corrosion noted	<ul style="list-style-type: none"> Need to installed the new Corrosion-resistant coarse-mesh screen (13 mm [1/2 in.] openings) shall be provided to prevent the entrance of birds 	Offline

<p>Mesh screen</p> <p>Finding: Corrosion noted</p> <p>Recommendation: Need to installed the new Corrosion-resistant coarse-mesh screen (13 mm [1/2 in.] openings) shall be provided to prevent the entrance of birds</p> <p>Repair Priority: <i>Offline</i></p>

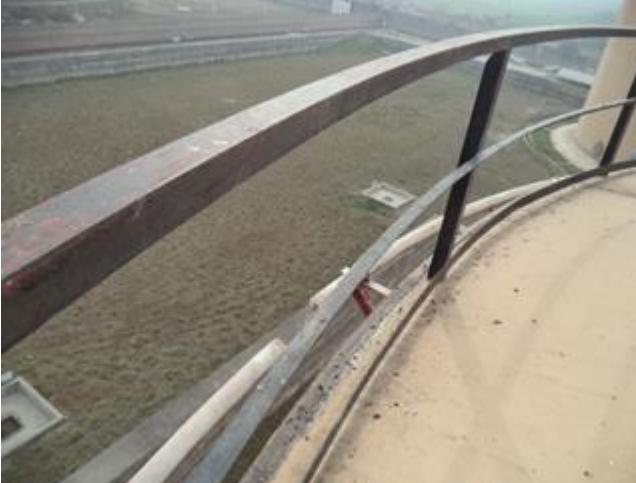
<p>Handrailing</p> <p>Finding: Structural integrity of hand rail was found satisfactory. No visual defect was observed.</p> <p>Recommendation: Nil,just for info.</p> <p>Repair Priority: <i>N/A</i></p>

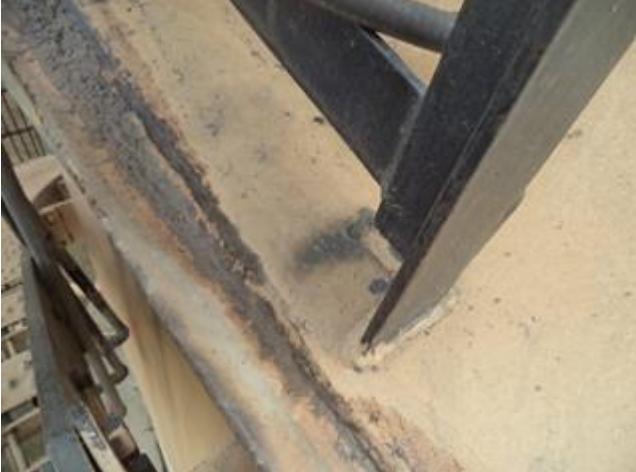
<p>Handrailing</p> <p>Finding: Vertical support of handrailing welded on roof plates.</p> <p>Recommendation: Nil,just for info.</p> <p>Repair Priority: <i>N/A</i></p>

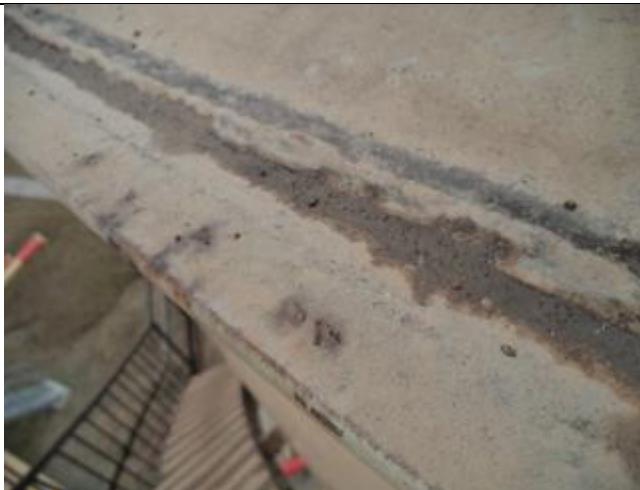
Frangible joint (Joint between roof plate and shell top angle)

During visual inspection of Frangible joint found seal weld with satisfactory condition, without any significant discontinuities

Nil, just for info.

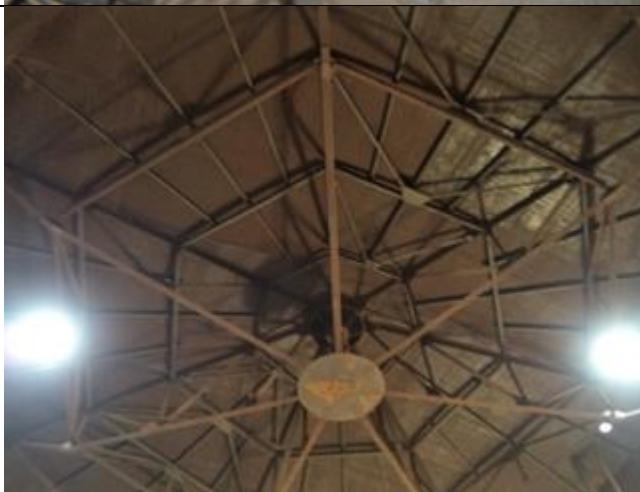
Roof Structure

Visually found in satisfactory condition.

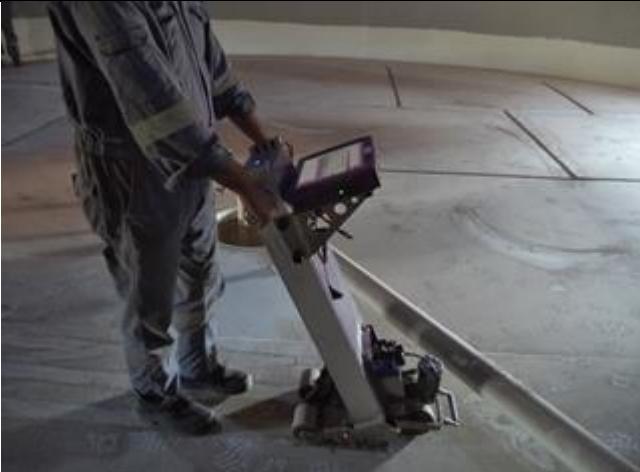
<p>Bottom Plate</p> <p>Finding: Magnetic Flux Leakage 3D scanning carried out on the bottom plates. No significant thickness loss had observed on the bottom plates accessible areas.</p> <p>Recommendation: Nil, just for info.</p> <p>Repair Priority: N/A</p>

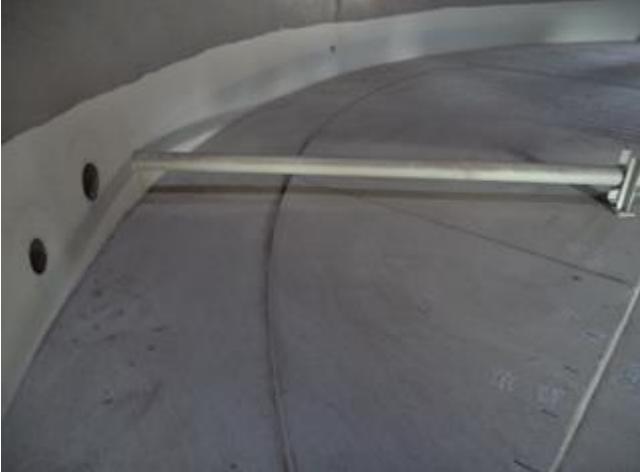
<p>Bottom Plate</p> <p>Finding: Coating observed on bottom plates</p> <p>Recommendation: Nil, just for info.</p> <p>Repair Priority: N/A</p>

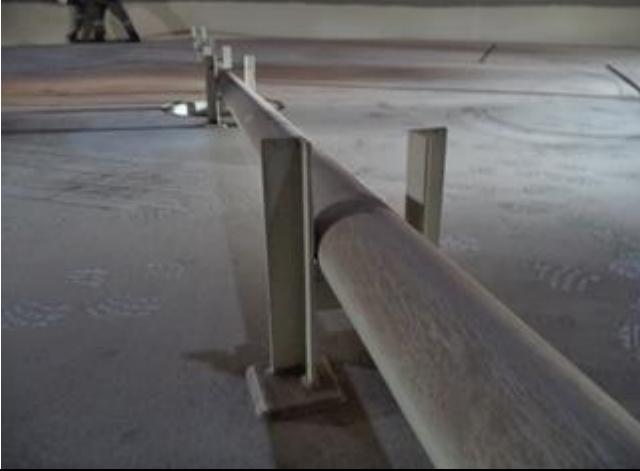
<p>Pipline</p> <p>Finding: Visually found in satisfactory condition.</p> <p>Recommendation: Nil, just for info.</p> <p>Repair Priority: N/A</p>

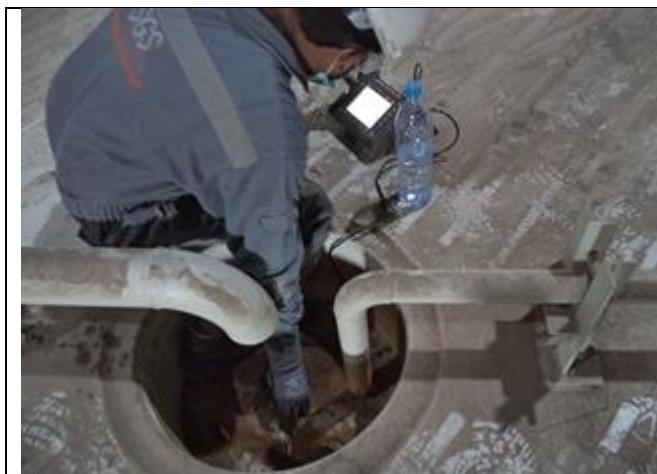
**Sump****Finding:**

UT A scanning performed on supm. No significant metal loss noted during scanning.

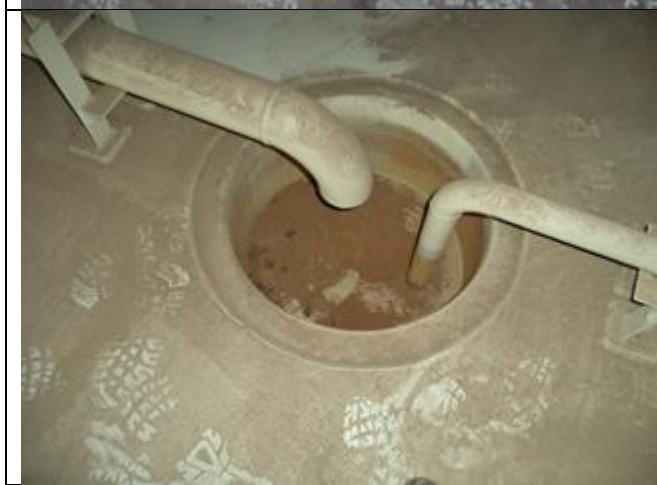
**Sump****Finding:**

Visually found in satisfactory condition.

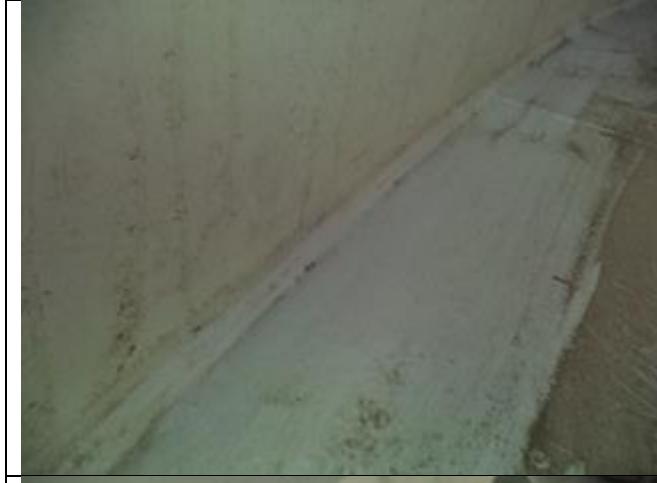
**Shell to Bottom Joint****Finding:**

Shell to bottom joint inspected visually and with NDT method of MPI, where found no surface defects.

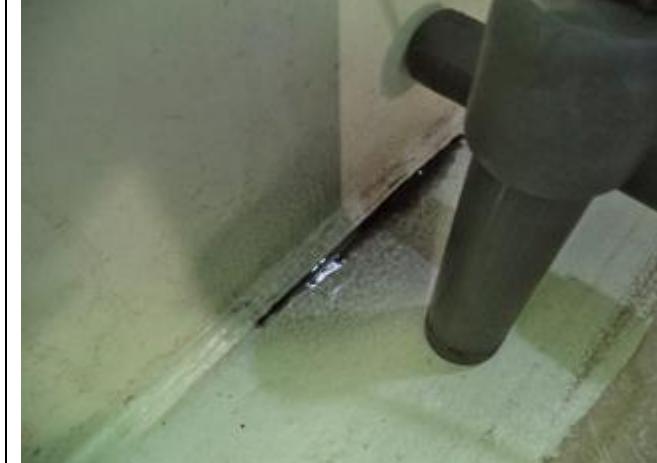
**Shell to Bottom Joint****Finding:**

Same as above

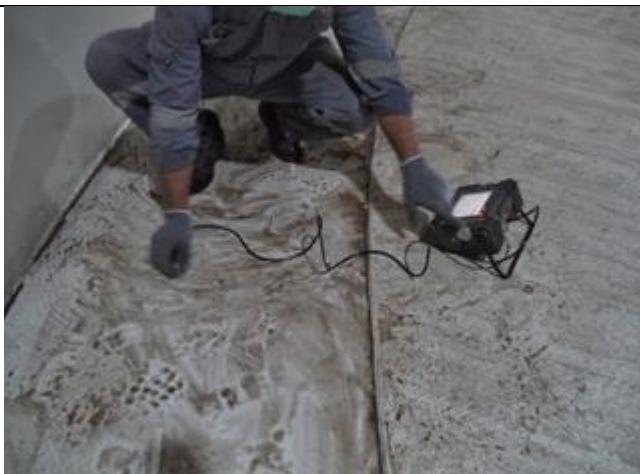
**Annular Plate****Finding:**

UT A scanning performed on annular plates, No significant metal loss noted during scanning.

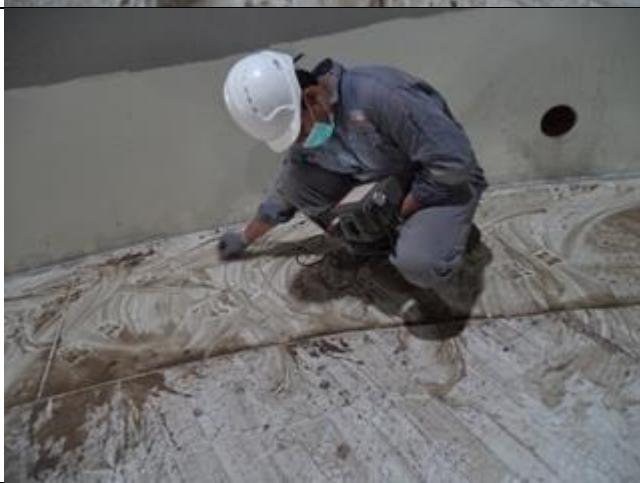
**Annular Plate****Finding:**

Same as above

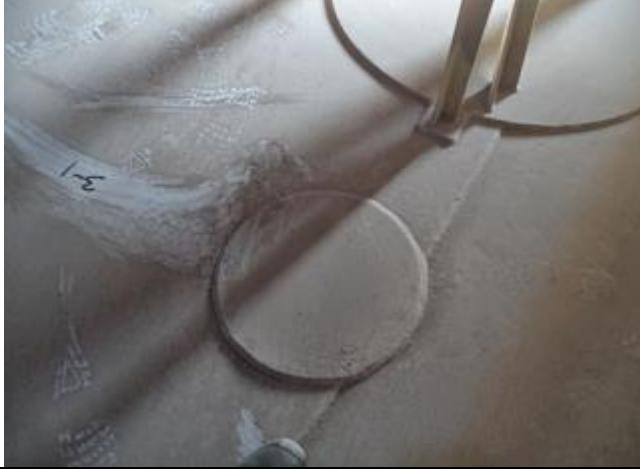
**Datum Plate****Finding:**

Visually found in satisfactory condition.

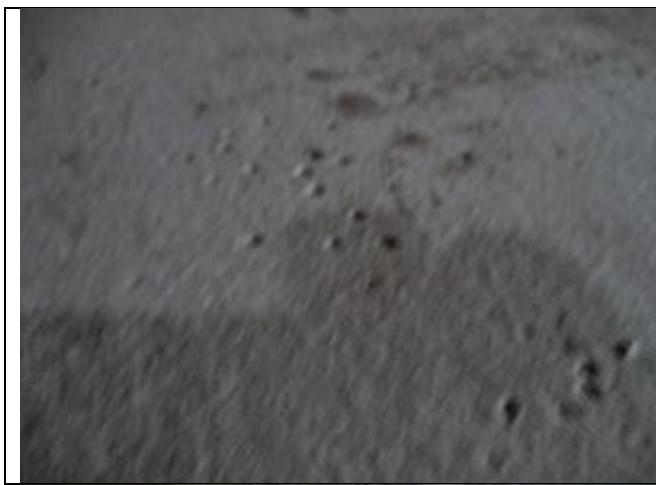
**Bottom Plate****Finding:**

Minor pitting noted on bottom plates at different location.

3.2	Measure the depth of pitting and describe the pitting appearance (sharp edged, lake type, dense, scattered, etc).	✓	0.5 mm pitting observed on few plates

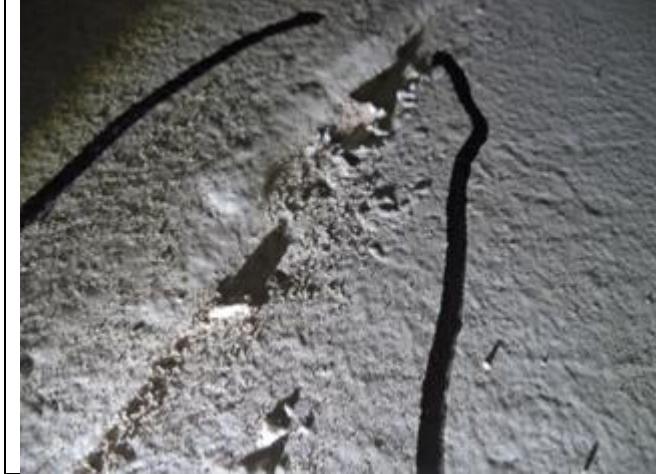
**Weld joints****Finding:**

Weld remnants noted on bottom weld joints at plate number 1/4.

Need to grind flush and repaint after proper surface preparation.

Repair Priority: Offline

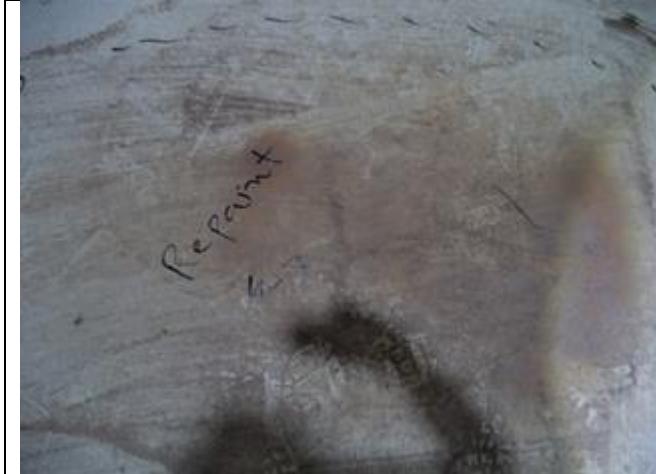
**Bottom Plate****Finding:**

Paint failure noted on bottom plate number 4/3

Need to repaint after proper surface preparation.

Repair Priority: Offline

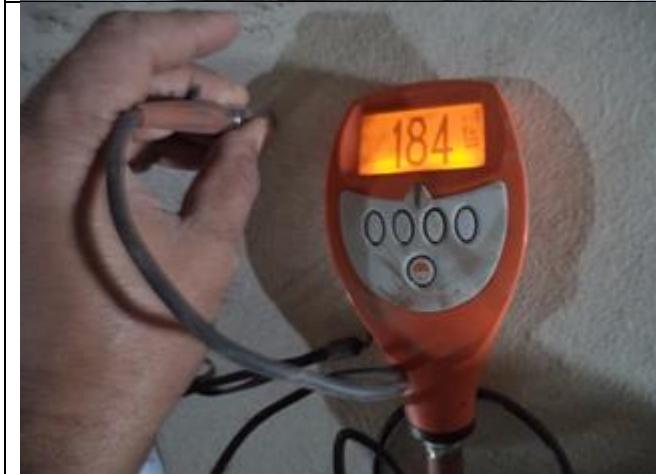
**DFT****Finding:**

DFT carried out on bottom plates. Thickness recorded in the range of 160 to 200 microns
