# Main DDR

## Detailed Diagnostic Report

| Flat referenced in observations | Flat No. 103 and Flat No. 203 |

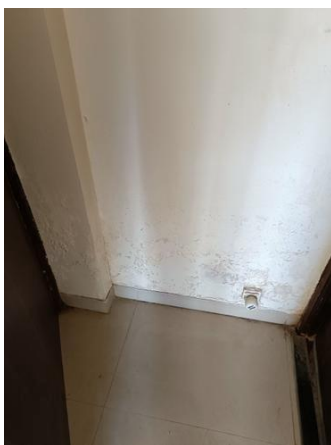
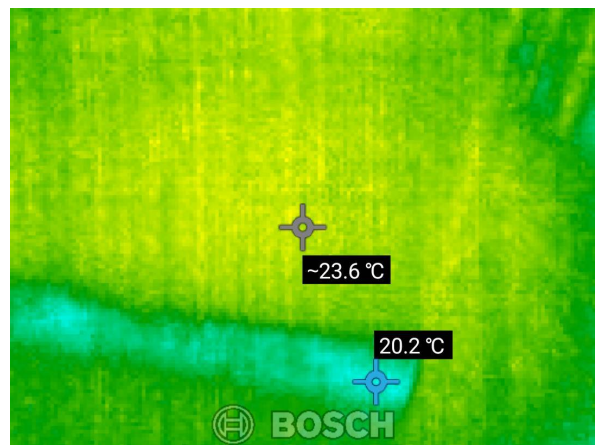
#### 1. Hall, Flat No. 103

| Inspection finding | Dampness observed at skirting level of Hall. |
| Possible source side | Gaps observed between tile joints of Common Bathroom. |
| Thermal reading | Hotspot: 28.8 deg C; Coldspot: 23.4 deg C; Thermal image file: RB02380X.JPG |

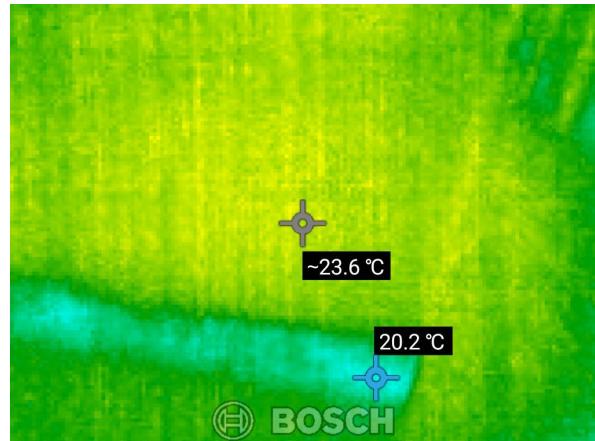
#### 5. Master Bedroom Wall / External Wall, Flat No. 103

| <b>Inspection finding</b> | Dampness and efflorescence observed on Master Bedroom wall surface. |
| <b>Possible source side</b> | Cracks observed on external wall of building near Master Bedroom. |
| <b>Thermal reading</b> | Hotspot: 25.5 deg C; Coldspot: 20.5 deg C; Thermal image file: RB02403X.JPG |

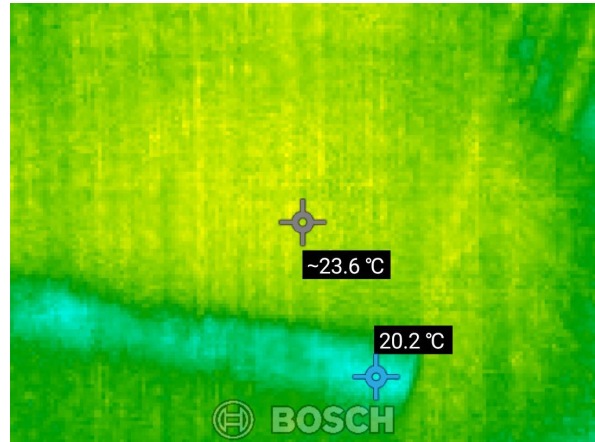
## 6. Parking Ceiling below Flat No. 103

| <b>Inspection finding</b> | Leakage observed at parking ceiling below Flat No. 103. |
| <b>Possible source side</b> | Common Bathroom has plumbing issue and gaps between tile joints. |
| <b>Thermal reading</b> | Hotspot: 25.8 deg C; Coldspot: 20.8 deg C; Thermal image file: RB02404X.JPG |

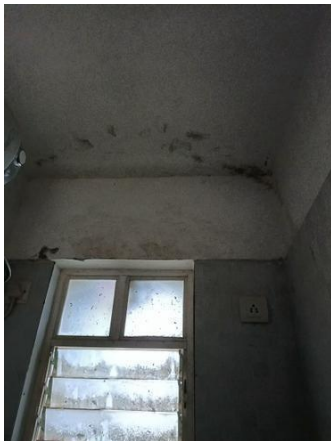
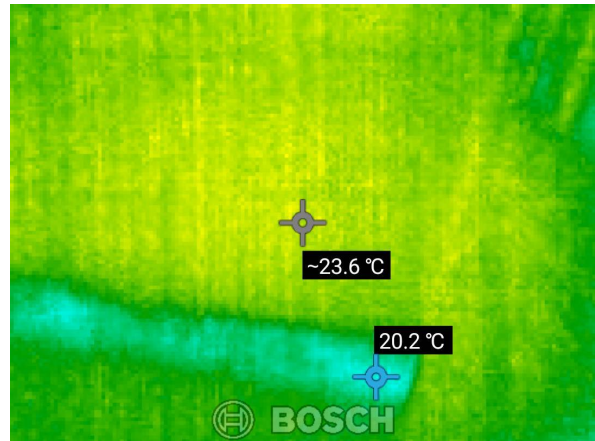
## 7. Common Bathroom Ceiling, Flat No. 103

| <b>Inspection finding</b> | Mild dampness observed at ceiling of Common Bathroom. |
| <b>Possible source side</b> | Gap between tile joints of Common and Master Bedroom Bathrooms of Flat No. 203; outlet leakage is mentioned in detailed observation. |
| <b>Thermal reading</b> | Hotspot: 26.2 deg C; Coldspot: 21.2 deg C; Thermal image file: RB02405X.JPG |
