# Main DDR

## Detailed Diagnostic Report

Generated from uploaded inspection and thermal documents/images. The system uses local rules only and does not call any paid AI API. Missing or unclear fields are marked as Not Available.

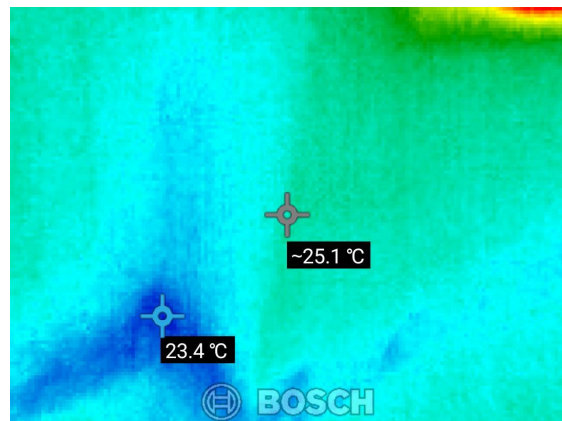
#### 1. Parking Ceiling below Flat No. 103

| Thermal reading | Hotspot: 28.8 deg C; Coldspot: 23.4 deg C; Thermal image file: RB02380X.JPGDevice |

Thermal/source image supporting this observation

- Repair confirmed leakage/plumbing source before cosmetic treatment.
- Seal tile joint gaps and inspect bathroom outlet/Nahani trap areas where mentioned.
- Treat damp walls/skirting only after the source has been repaired.
- Repair external cracks or wall openings where observed.
- Re-inspect the same areas after repair and compare with fresh thermal readings if available.
