# Main DDR

## Detailed Diagnostic Report

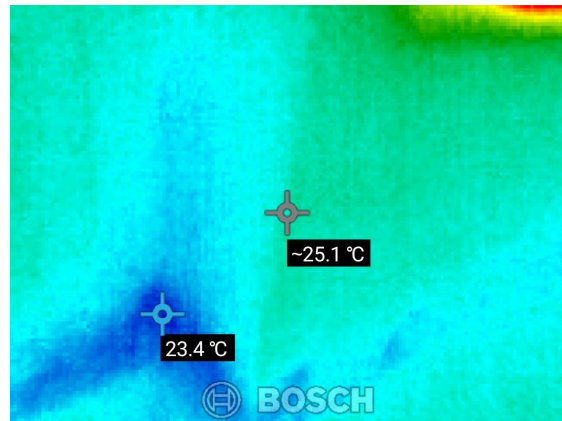
#### 1. Parking Ceiling below Flat No. 103

| Inspection finding | Leakage observed at parking ceiling below Flat No. 103. |
| Possible source side | Common Bathroom plumbing issue and tile joint gaps observed. |
| Reason | possible plumbing leakage; open tile joints or trap area allowing water movement; moisture movement visible in affected area |
| Thermal reading | Hotspot: 28.8 deg C; Coldspot: 23.4 deg C; Thermal image file: RB02380X.JPGDevice |

- Repair confirmed leakage/plumbing source before cosmetic treatment.
- Seal tile joint gaps and inspect bathroom outlet/Nahani trap areas where mentioned.
- Treat damp walls/skirting only after the source has been repaired.
- Repair external cracks or wall openings where observed.
- Re-inspect the same areas after repair and compare with fresh thermal readings if available.
