# Main DDR

## Detailed Diagnostic Report

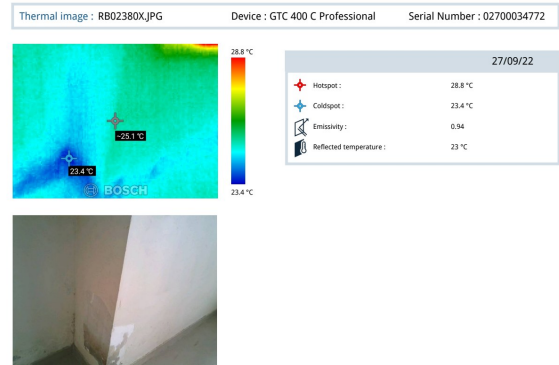
#### 1. Parking Ceiling below Flat No. 103

| Thermal reading | Hotspot: 28.8 deg C; Coldspot: 23.4 deg C; Thermal image file: RB02380X.JPGDevice |

Thermal/source image supporting this observation

- Repair confirmed leakage/plumbing source before cosmetic treatment.
- Seal tile joint gaps and inspect bathroom outlet/Nahani trap areas where mentioned.
- Treat damp walls/skirting only after the source has been repaired.
- Repair external cracks or wall openings where observed.
- Re-inspect the same areas after repair and compare with fresh thermal readings if available.

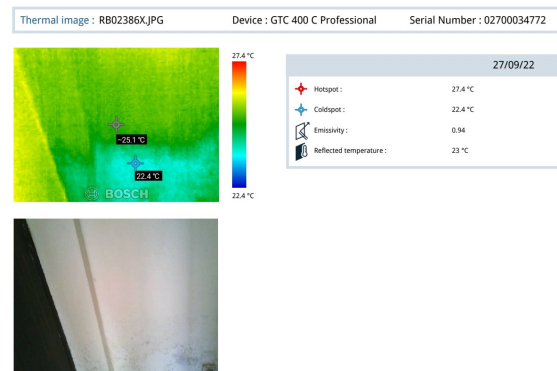
#### 2. Common Bathroom Ceiling, Flat No. 103

| Thermal reading | Hotspot: 27.4 deg C; Coldspot: 22.4 deg C; Thermal image file: RB02386X.JPGDevice |

Thermal/source image supporting this observation
