# FLASH EVENT - HIPO

## Fresh Concrete Blowout from Pipeline

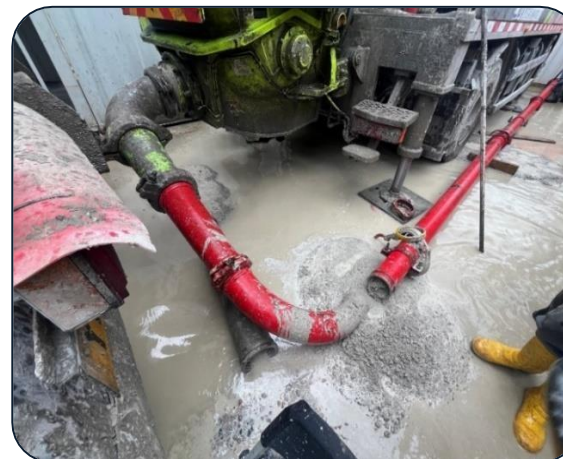
Concreting process area

During the pouring of concrete for a slab, fresh concrete blew out from displacement joints along the pipelines throughout the entire concreting process area.

- Prioritize the direct-feed concreting method, and If not feasible, minimize the length of concrete pipeline and number of bends
- Ensure the use of proper types of concrete pipe connectors according to concrete plan
- When relevant, inform concrete supplier with detailed concreting arrangements (bends, lengths), and maintain effective coordination during concreting process
- Ensure that all necessary competencies for achieving the task are mobilised

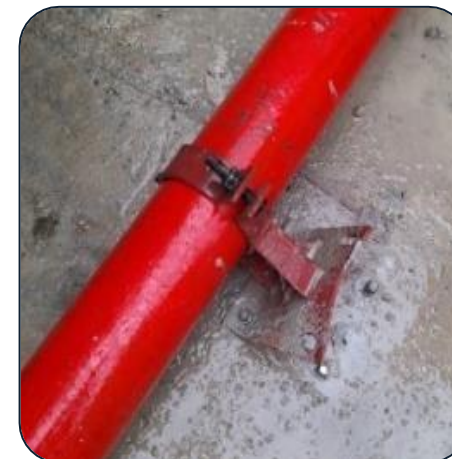
The brackets used to tie down the pipes were found to be distorted, and some anchored bolts came off from the brackets due to the drastic force.

- Mixed use of concrete pipe connectors, which are incompatible (low and high pressure bolts)

Damaged anchored bolts
