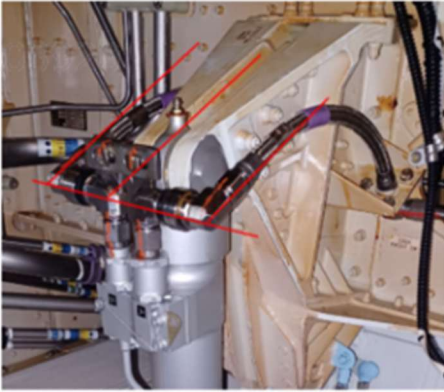
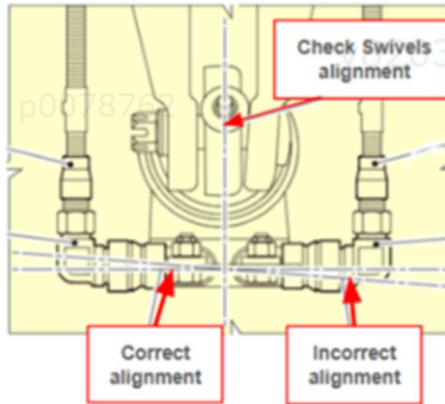
Perform GVI to inspect rupture of braids and/or wires of the hydraulic hose will induce a loss of stability of the outer braid, and subsequently cracking of the inner PTFE tube.

Note : As the timeframe between first wire rupture and PTFE tube cracking is hardly predictable, we recommend to replace any hoses with wires broken in accordance with AMM TASK 20-23-11-200-003-A "Permitted Damage and Defects on Flexible Hydraulic Hoses" requirements. The identified failure mode (wire braid damage) allows to detect in advance of the hose rupture and make these inspections effective.
